# Memorial Union Assessment Report

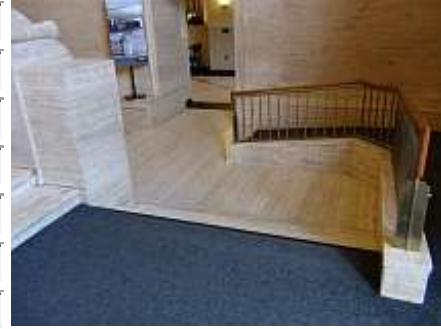
Field Date:	8/8/2011	Report Date:	11/15/2011	Barrier #	36B
Bldg Name:	Memorial Union				
Location:	Mezzanine - West Rotunda Stairs to Ballroom				
X Coordinate:		Y Coordinate:			
Barrier Area:	Stairways				
Barrier Type:	Handrail - Both Sides				
Code References:	OSSC 1109.8.6 and 2010 ADAS 505.10.2				
As Built Meas:	24	Quantity:	LF		
Barrier Severity:	2 Recommended	Function:	Staff		
Description:	No handrail provided at both sides of stairs to gallery level				
As Built Desc:	No handrail provided at both sides of stairs from entry door landing to gallery level				
Solution:	Provide compliant handrails at both sides of stairway				
Cost Estimate:	\$0.00	Status:	Open	Official Responsible:	Oregon State University (OSU)
Implementation Priority:	4	Implementation Phase:		Implementation Date:	
Notes:

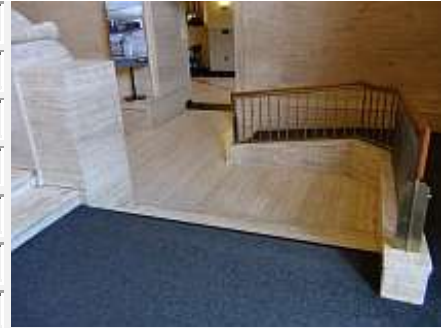
Field Date:	8/8/2011	Report Date:	11/15/2011	Barrier #	36C
Bldg Name:	Memorial Union				
Location:	Mezzanine - West Rotunda Stairs to Ballroom				
X Coordinate:		Y Coordinate:			
Barrier Area:	Stairways				
Barrier Type:	Surface Condition - Existing				
Code References:	2010 ADAS 504.4				
As Built Meas:	0	Quantity:	SF		
Barrier Severity:	4 Low Severity	Function:	Staff		
Description:	Stairway surface is not slip resistant				
As Built Desc:	Marble surface does not appear to be slip resistant				
Solution:	Remediation must respect historic nature of facility				
Cost Estimate:	\$0.00	Status:	Open	Official Responsible:	Oregon State University (OSU)
Implementation Priority:	4	Implementation Phase:		Implementation Date:	
Notes:

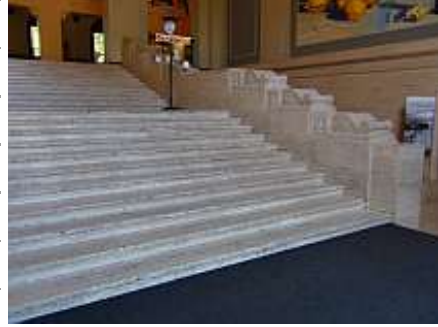
Field Date:	8/8/2011	Report Date:	11/15/2011	Barrier #	38A
Bldg Name:	Memorial Union				
Location:	Mezzanine - Central Rotunda Stairway to Level 1				
X Coordinate:		Y Coordinate:			
Barrier Area:	Stairways				
Barrier Type:	Handrail Extension - Top				
Code References:	OSSC 1109.8.6.(2)				
As Built Meas:	0	Quantity:	LF		
Barrier Severity:	2 Recommended	Function:	Staff		
Description:	Top Handrail extension not parallel to ground/floor surface				
As Built Desc:	Top handrail extension not parallel to ground surface				
Solution:	Provide compliant handrails at both sides of stairway. See barrier A for cost estimate				
Cost Estimate:	\$0.00	Status:	Open	Official Responsible:	Oregon State University (OSU)
Implementation Priority:	4	Implementation Phase:		Implementation Date:	
Notes:

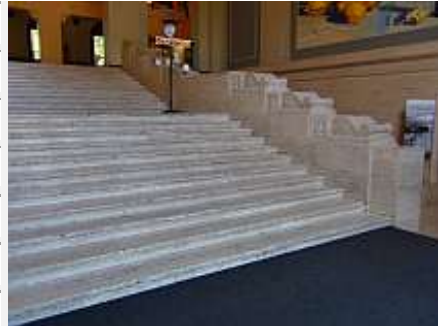
Field Date:	8/8/2011	Report Date:	11/15/2011	Barrier #	38B
Bldg Name:	Memorial Union				
Location:	Mezzanine - Central Rotunda Stairway to Level 1				
X Coordinate:		Y Coordinate:			
Barrier Area:	Stairways				
Barrier Type:	Contrasting Color - ADA				
Code References:	2010 ADAS Advisory 504.4				
As Built Meas:	400	Quantity:	LF or TREAD		
Barrier Severity:	2 Recommended	Function:	Staff		
Description:	No contrasting color on each tread of interior stairway				
As Built Desc:	Treads lack contrasting color defined as 70% contrast				
Solution:	Consider providing contrasting color on each tread				
Cost Estimate:	\$14,000.00	Status:	Open	Official Responsible:	Oregon State University (OSU)
Implementation Priority:	2	Implementation Phase:		Implementation Date:	
Notes:

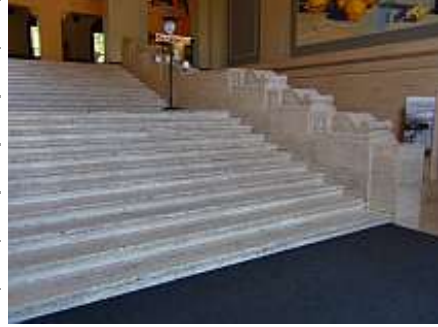
Field Date:	8/8/2011	Report Date:	11/15/2011	Barrier #	38C
Bldg Name:	Memorial Union				
Location:	Mezzanine - Central Rotunda Stairway to Level 1				
X Coordinate:		Y Coordinate:			
Barrier Area:	Stairways				
Barrier Type:	Surface Condition - Existing				
Code References:	2010 ADAS 504.4				
As Built Meas:	0	Quantity:	SF		
Barrier Severity:	4 Low Severity	Function:	Staff		
Description:	Stairway surface is not slip resistant				
As Built Desc:	Marble surface does not appear to be slip resistant				
Solution:	Remediation must respect historic nature of facility				
Cost Estimate:	\$0.00	Status:	Open	Official Responsible:	Oregon State University (OSU)
Implementation Priority:	4	Implementation Phase:		Implementation Date:	
Notes:

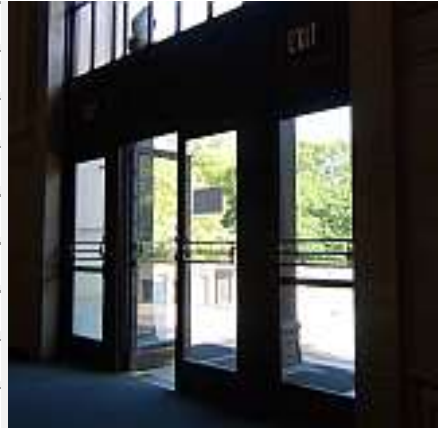
Field Date:	8/8/2011	Report Date:	11/15/2011	Barrier #	39
Bldg Name:	Memorial Union				
Location:	Mezzanine - Main Entry to Rotunda				
X Coordinate:		Y Coordinate:			
Barrier Area:	Signage				
Barrier Type:	Tactile Exit Signs - Door				
Code References:	OSSC 1011.3				
As Built Meas:	1	Quantity:	EACH		
Barrier Severity:	1 Necessary	Function:	Staff		
Description:	Ground floor doors that exit to exterior lacks tactile exit sign				
As Built Desc:	Exit door with low level illuminated sign lacks tactile exit sign				
Solution:	Provide compliant sign stating "EXIT" at exit sides of door				
Cost Estimate:	\$250.00	Status:	Open	Official Responsible:	Oregon State University (OSU)
Implementation Priority:	4	Implementation Phase:		Implementation Date:	
Notes:

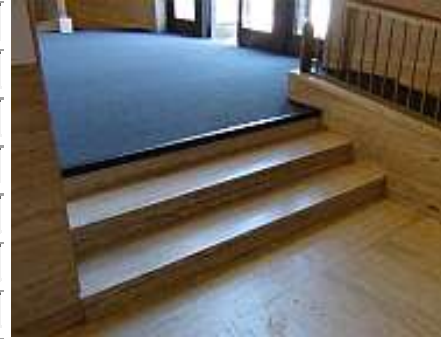
Field Date:	8/8/2011	Report Date:	11/15/2011	Barrier #	41A
Bldg Name:	Memorial Union				
Location:	Mezzanine - East Rotunda Stairs to Ballroom				
X Coordinate:		Y Coordinate:			
Barrier Area:	Stairways				
Barrier Type:	Contrasting Color - ADA				
Code References:	2010 ADAS Advisory 504.4				
As Built Meas:	24	Quantity:	LF or TREAD		
Barrier Severity:	2 Recommended	Function:	Staff		
Description:	No contrasting color on each tread of interior stairway				
As Built Desc:	Treads lack contrasting color defined as 70% contrast at stairs from entry door landing to gallery level				
Solution:	Consider providing contrasting color on each tread				
Cost Estimate:	\$840.00	Status:	Open	Official Responsible:	Oregon State University (OSU)
Implementation Priority:	2	Implementation Phase:		Implementation Date:	
Notes:

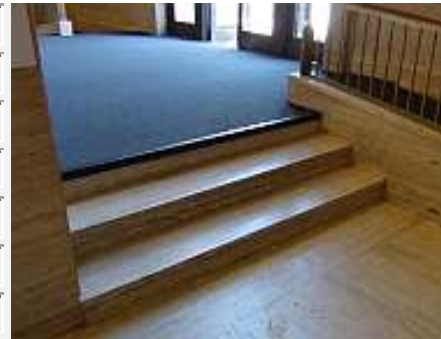
Field Date:	8/8/2011	Report Date:	11/15/2011	Barrier #	41B
Bldg Name:	Memorial Union				
Location:	Mezzanine - East Rotunda Stairs to Ballroom				
X Coordinate:		Y Coordinate:			
Barrier Area:	Stairways				
Barrier Type:	Handrail - Both Sides				
Code References:	OSSC 1109.8.6 and 2010 ADAS 505.10.2				
As Built Meas:	24	Quantity:	LF		
Barrier Severity:	2 Recommended	Function:	Staff		
Description:	No handrail provided at both sides of stairs to gallery level				
As Built Desc:	No handrail provided at both sides of stairs from entry door landing to gallery level				
Solution:	Provide compliant handrails at both sides of stairway				
Cost Estimate:	\$0.00	Status:	Open	Official Responsible:	Oregon State University (OSU)
Implementation Priority:	4	Implementation Phase:		Implementation Date:	
Notes:

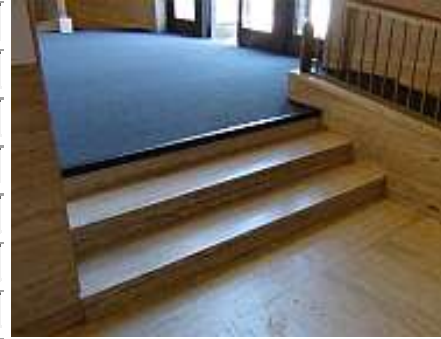
Field Date:	8/8/2011	Report Date:	11/15/2011	Barrier #	41C
Bldg Name:	Memorial Union				
Location:	Mezzanine - East Rotunda Stairs to Ballroom				
X Coordinate:		Y Coordinate:			
Barrier Area:	Stairways				
Barrier Type:	Surface Condition - Existing				
Code References:	2010 ADAS 504.4				
As Built Meas:	0	Quantity:	SF		
Barrier Severity:	4 Low Severity	Function:	Staff		
Description:	Stairway surface is not slip resistant				
As Built Desc:	Marble surface does not appear to be slip resistant				
Solution:	Remediation must respect historic nature of facility				
Cost Estimate:	\$0.00	Status:	Open	Official Responsible:	Oregon State University (OSU)
Implementation Priority:	4	Implementation Phase:		Implementation Date:	
Notes:

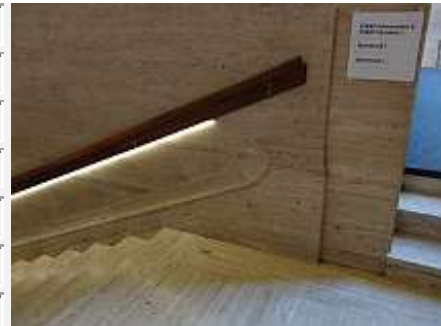
Field Date:	8/8/2011	Report Date:	11/15/2011	Barrier #	42A
Bldg Name:	Memorial Union				
Location:	Mezzanine - East Rotunda Stairways to Ballroom				
X Coordinate:		Y Coordinate:			
Barrier Area:	Stairways				
Barrier Type:	Handrail Extension				
Code References:	OSSC 1109.8.6.(2) and 2010 ADAS 505.10.2				
As Built Meas:	2	Quantity:	LF		
Barrier Severity:	2 Recommended	Function:	Staff		
Description:	Handrail extension does not return to wall, guard or landing surface				
As Built Desc:	Handrail end protrudes into path of travel which could cause injury				
Solution:	Provide compliant handrails at both sides of stairway				
Cost Estimate:	\$450.00	Status:	Open	Official Responsible:	Oregon State University (OSU)
Implementation Priority:	4	Implementation Phase:		Implementation Date:	
Notes:
