**Appendix 5.08**  
**2012 FFA Facility Study**

**PARKING STRUCTURE  
ONE  
ASSESSMENT**

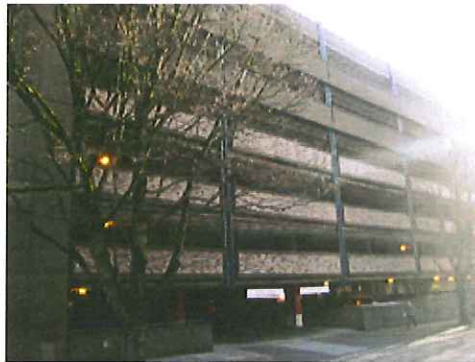
In March of 2011, Portland State University contracted FFA Architecture and Interiors and their consultant team to provide a 'Parking Facilities Condition Assessment' of nine garages currently owned and operated by PSU.

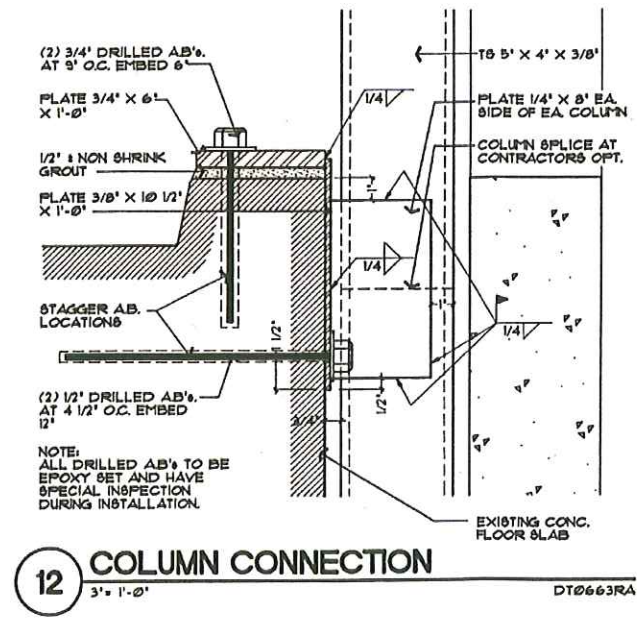
1992 PRECAST PANEL CONNECTION DETAIL

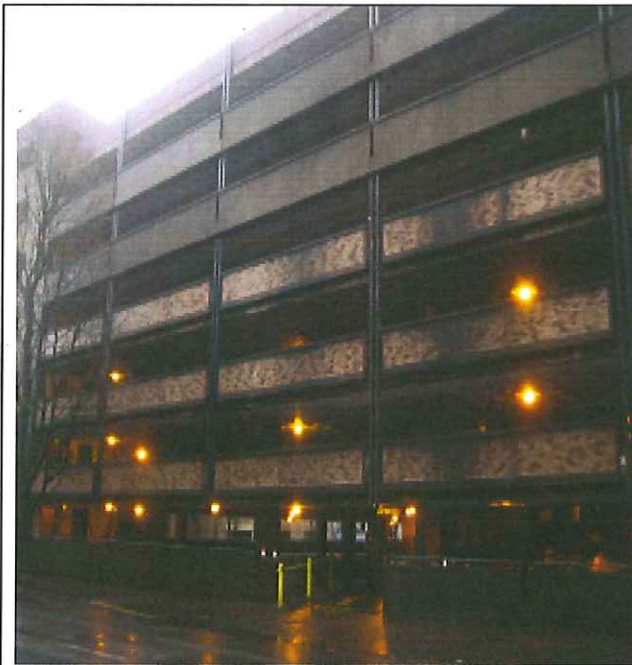
West elevation saturated by rain run-off and overflowing gutter system. Moss, mildew and general 'muck' coat several panels.

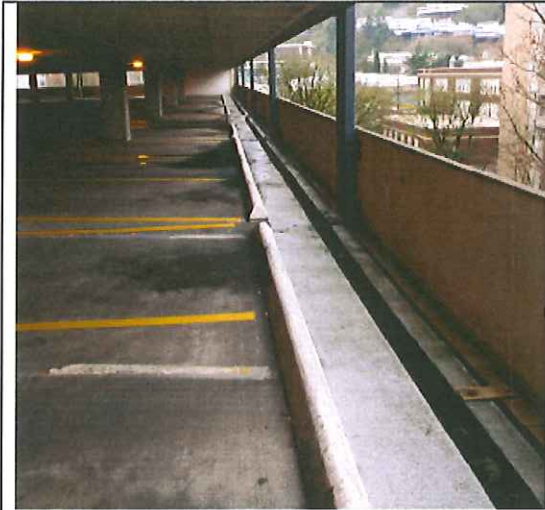
Seventh floor, west elevation, standing water at center of span and dry drains at each end.

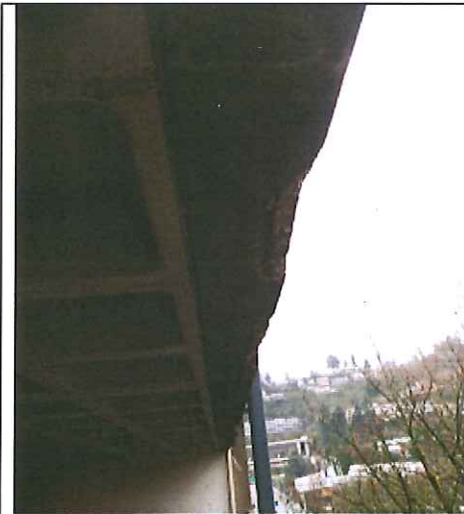
Eighth floor west elevation concrete beam deterioration

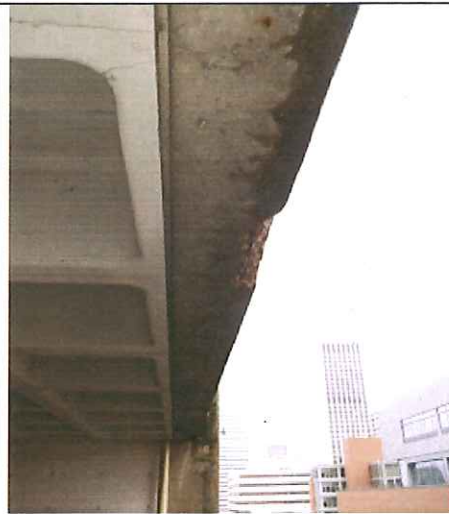
Eighth floor east elevation concrete beam deterioration

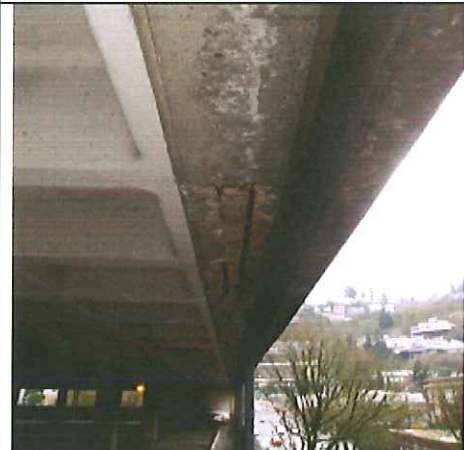
Seventh floor west elevation concrete beam deterioration

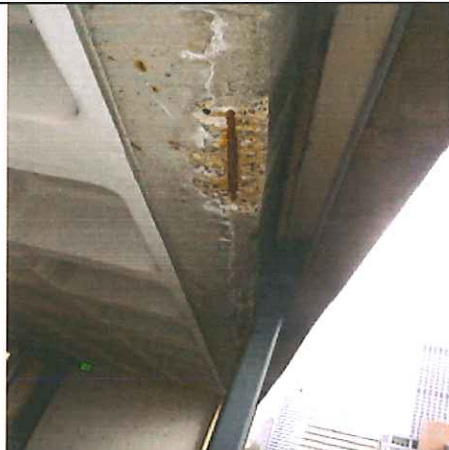
Seventh floor east elevation concrete beam deterioration

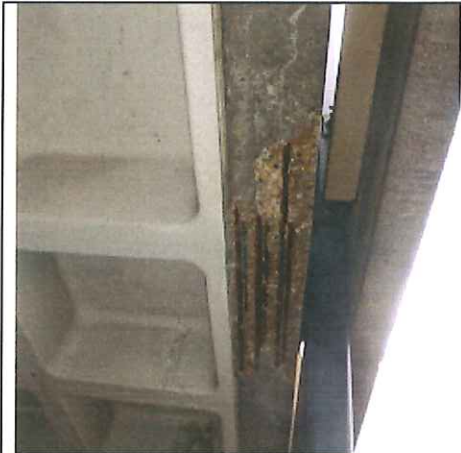
Seventh floor north elevation concrete beam deterioration

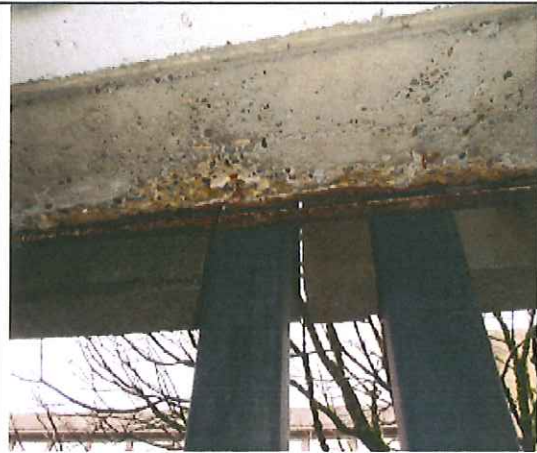
Sixth floor west elevation concrete beam deterioration

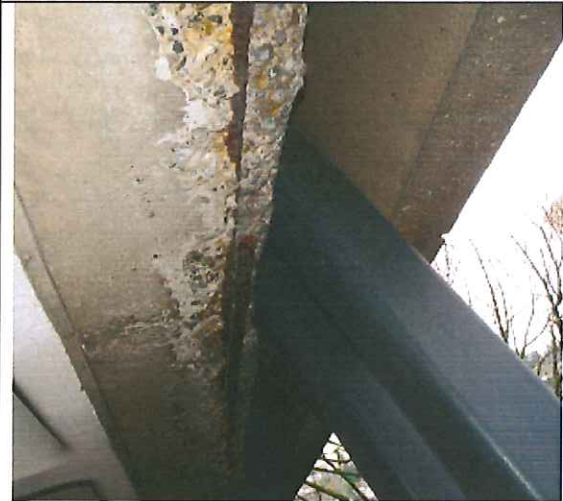
Sixth floor west elevation concrete beam deterioration

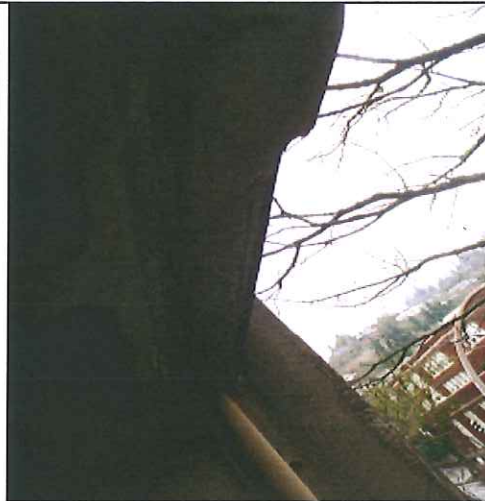
Fifth floor west elevation concrete beam deterioration.

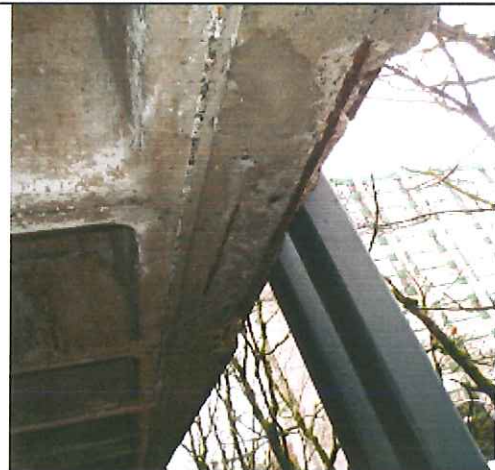
Fifth floor west elevation concrete beam deterioration.

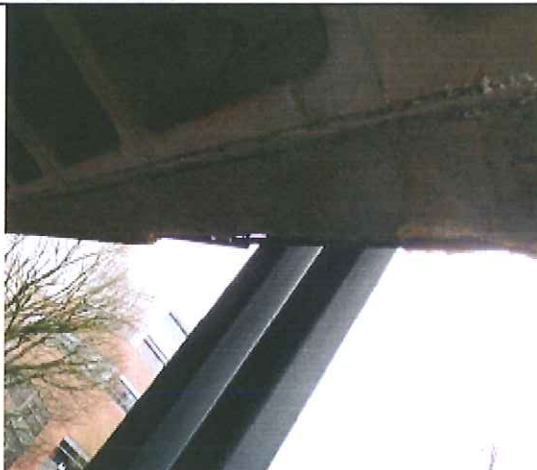
Fifth floor east elevation concrete beam deterioration.

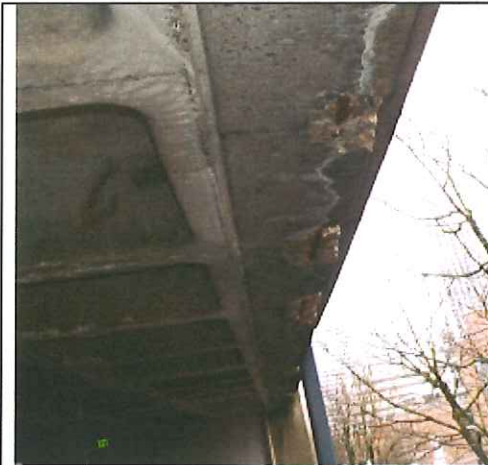
Fifth floor east elevation concrete beam deterioration.

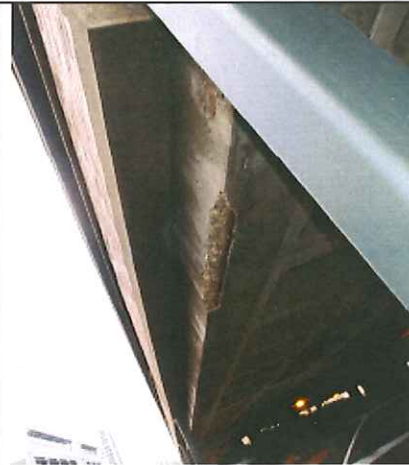
Fifth floor north elevation concrete beam deterioration.

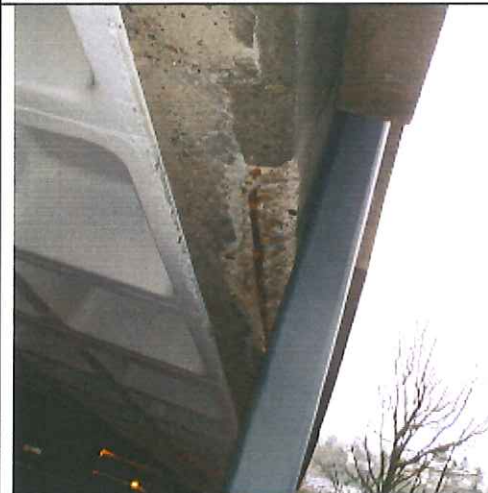
Fourth floor west elevation concrete beam deterioration.

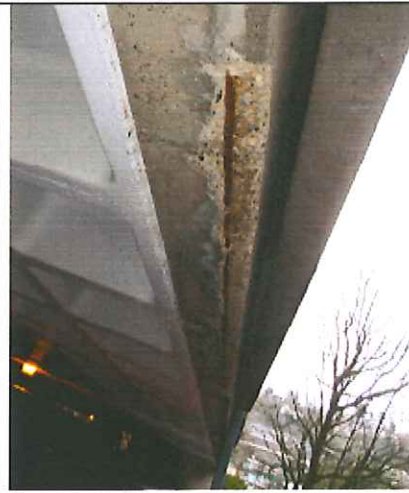
Fourth floor west elevation concrete beam deterioration.

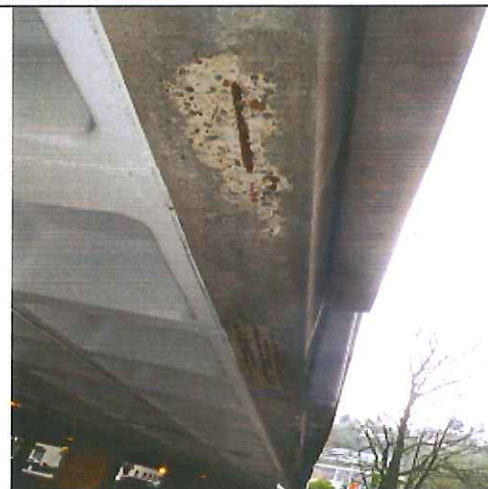
Third floor west elevation concrete beam deterioration.

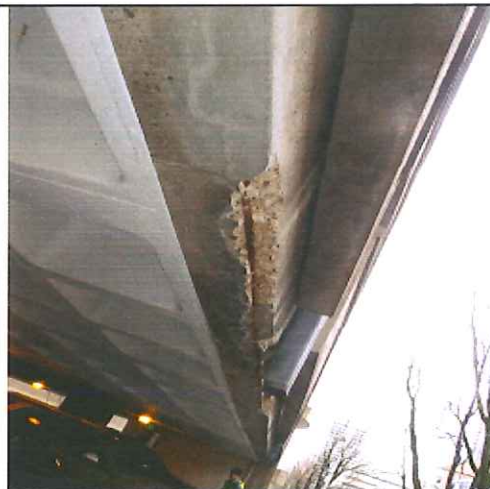
Third floor east elevation concrete beam deterioration.

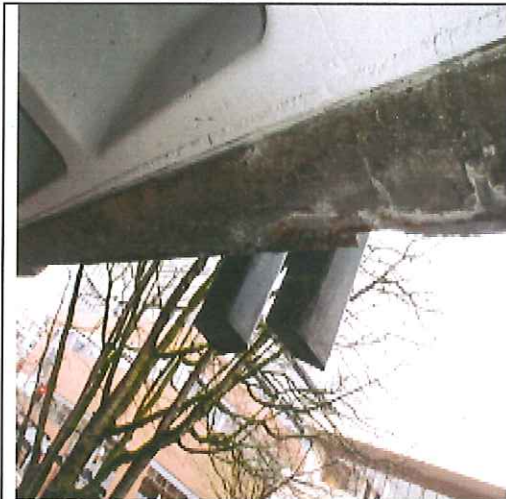
Third floor east elevation concrete beam deterioration.

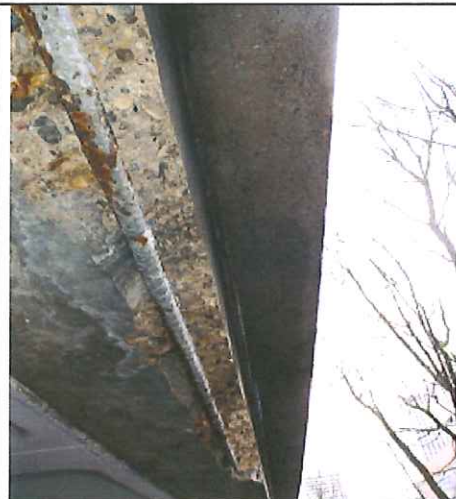
Third floor east elevation concrete beam deterioration.

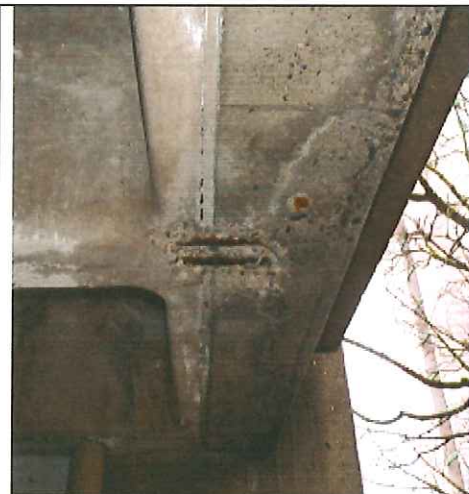
Waffle joists at fourth floor north elevation

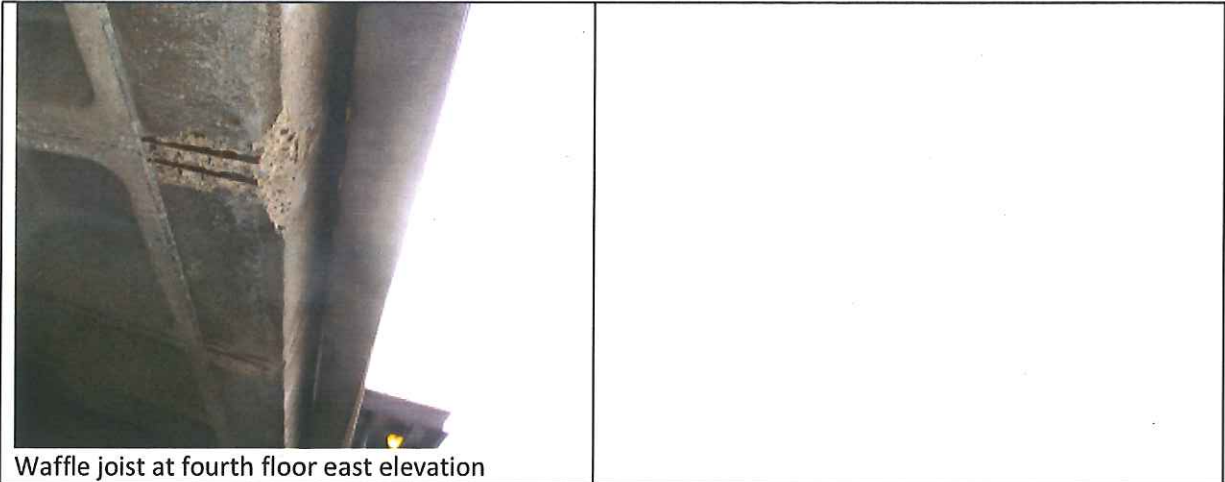
Waffle joists at fifth floor north elevation

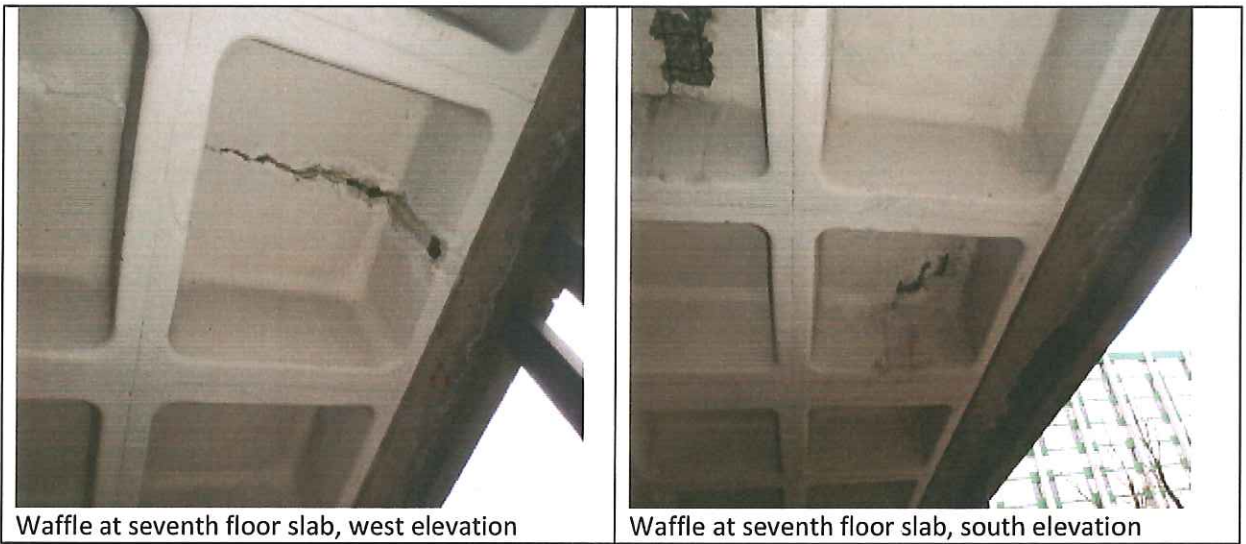
The waffle slab construction method was common for this type of structure in the 1960's. The actual concrete thickness is less than three inches at the deck. This relatively thin slab allows for only nominal reinforcement which is usually wire mesh. With the constant freeze / thaw cycle of the saturated perimeter beam, the perimeter waffles in many areas show signs of deterioration. The deterioration is typically evident in the oil stains and film at the cracks and in more advanced areas with rust stains, concrete spalls and exposed wire mesh.

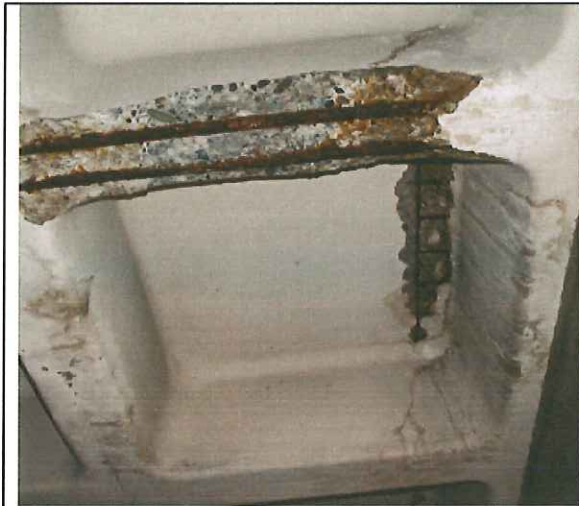
Waffle at Sixth floor slab, north elevation

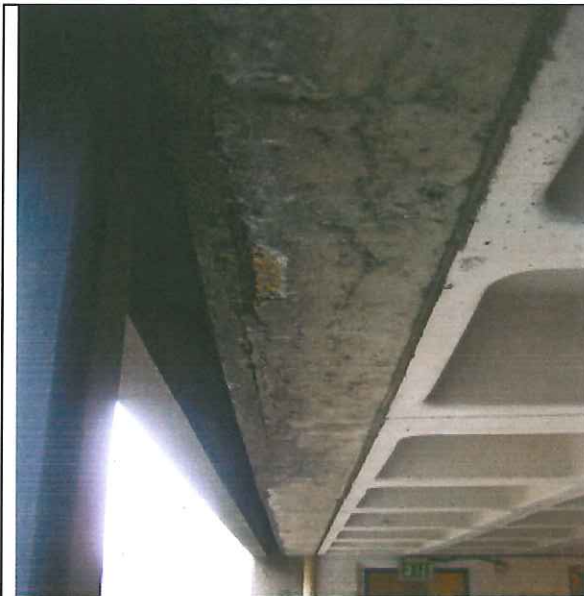
West elevation perimeter beam deterioration at steel tube section connection.

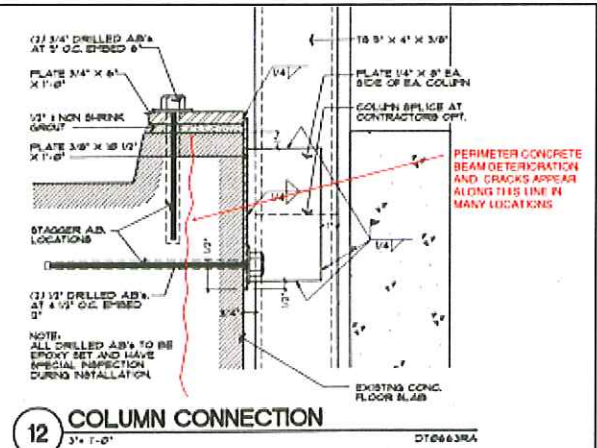
Tube section connection detail.

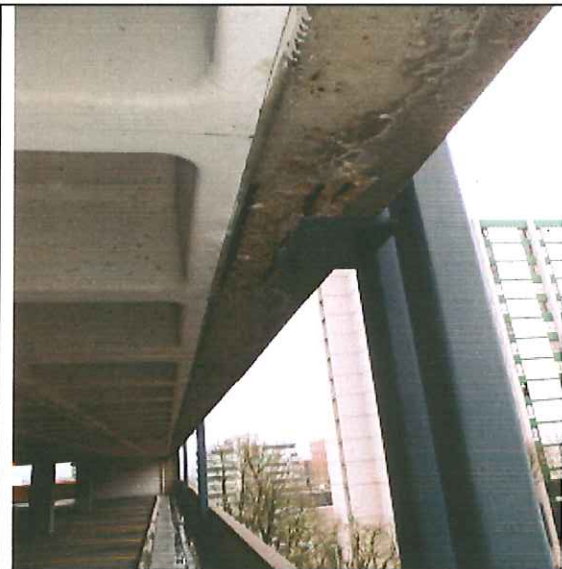
South Elevation eighth level slab /T.S. connection, note extensive deterioration of concrete beam at this location.

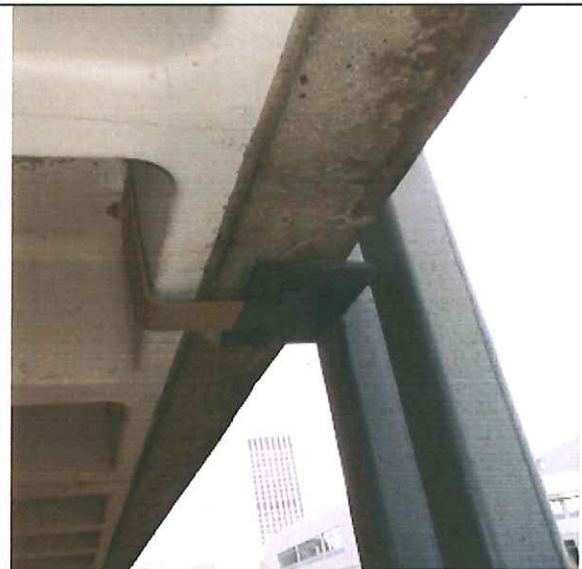
East Elevation eighth level slab /T.S. connection, note repair plate installed and water stained saturated concrete beam.

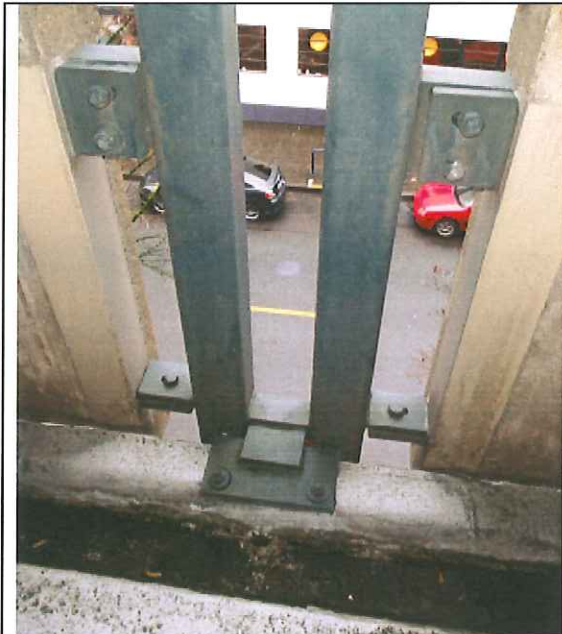
Typical T.S. connect to perimeter beams, bolts installed in the outer 3" of the beam

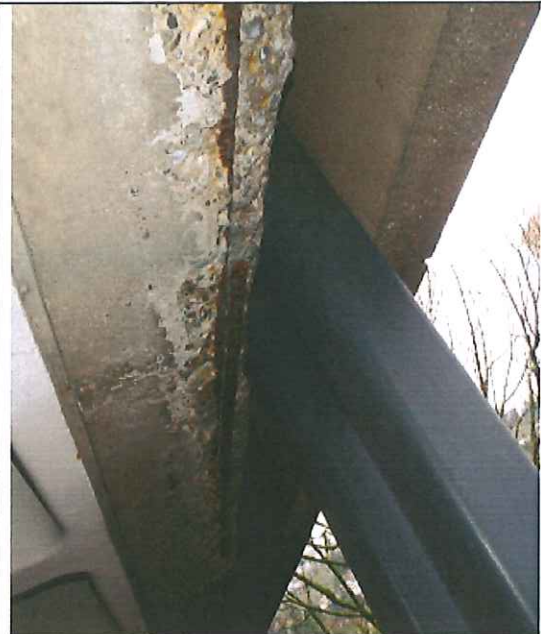
Deterioration of the perimeter beam occurs at or near many of the T.S. connections.

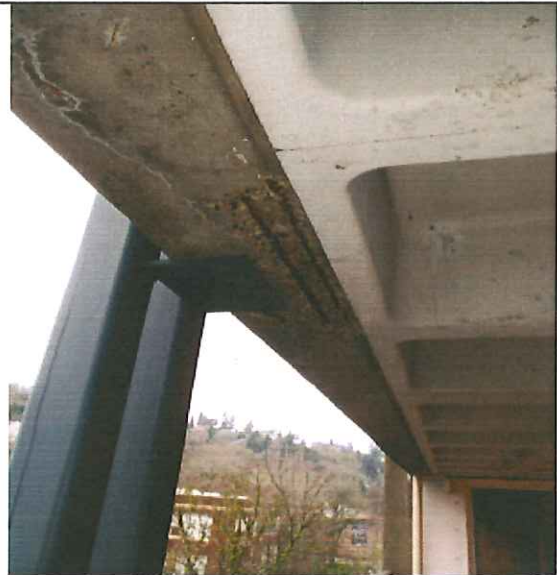
West elevation, sixth floor

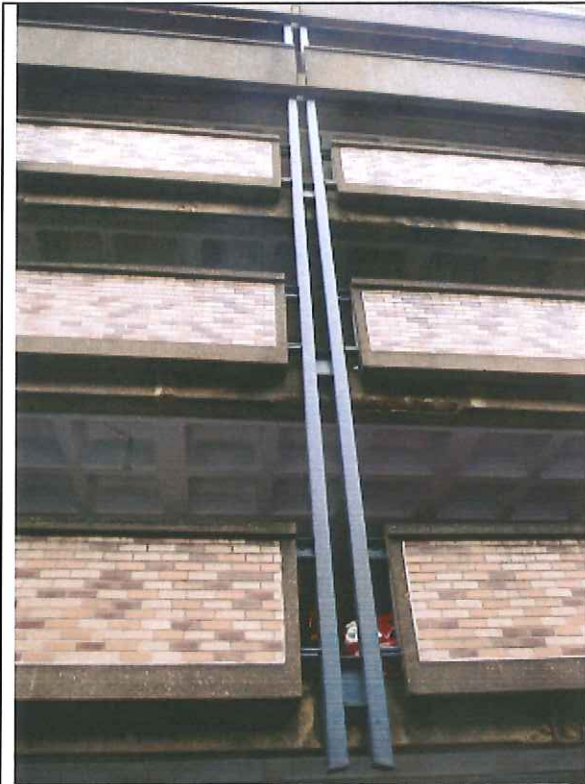
West elevation , deterioration at or immediately adjacent to the tube section connections

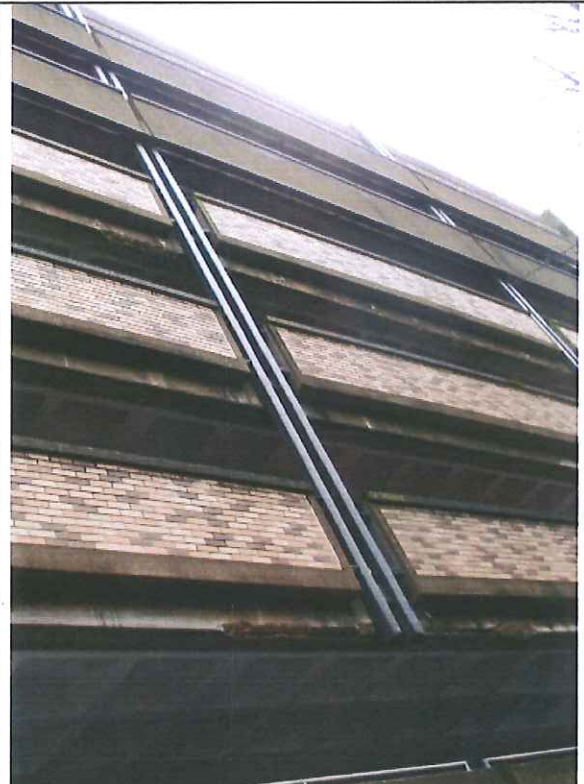
East elevation , deterioration at or immediately adjacent to the tube section connections

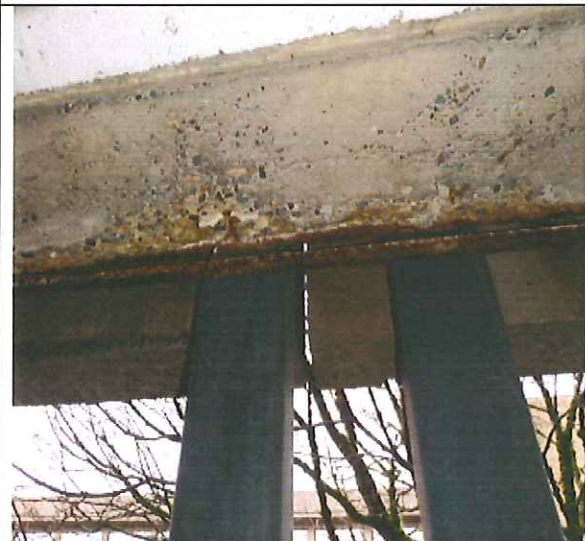
West Elevation, Fifth floor deterioration of concrete perimeter beam at T.S. connection

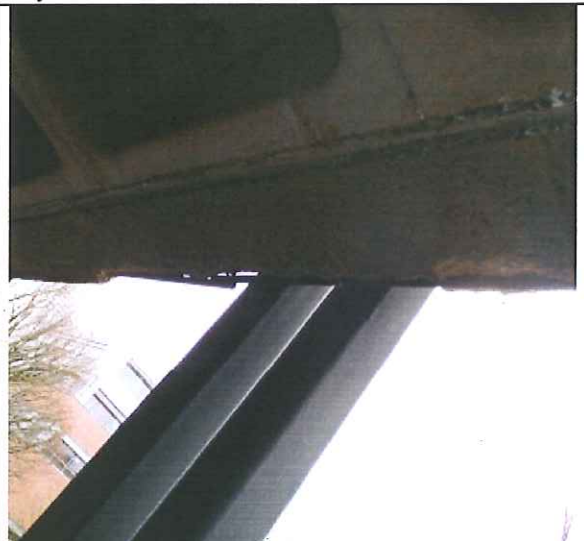
East Elevation, Fourth floor deterioration of concrete perimeter beam at T.S. connection

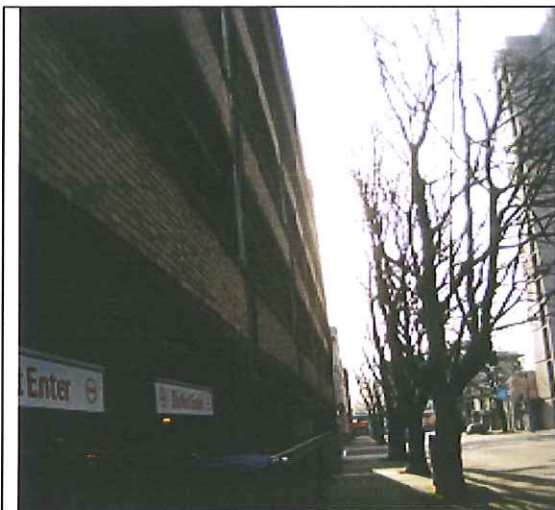
East Elevation, bowed precast panels

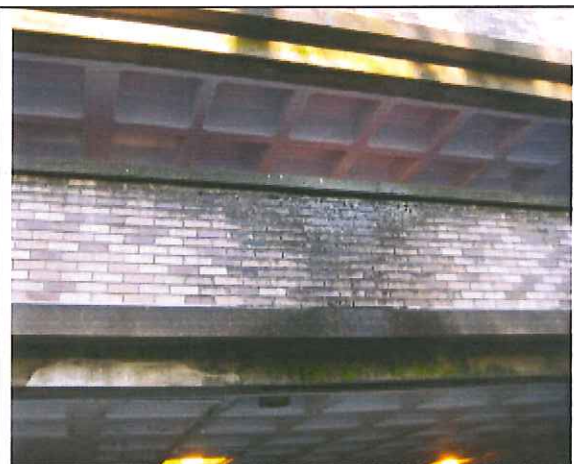
West elevation panel at level three, gutters at levels seven, six and five directly above do not drain. Water over flows the gutter at midspan while drains at each end remain dry. Heavy overflow conditions saturate the panels and edge beams below causing a buildup of moss and mildew and continuous deterioration of the steel reinforcement.

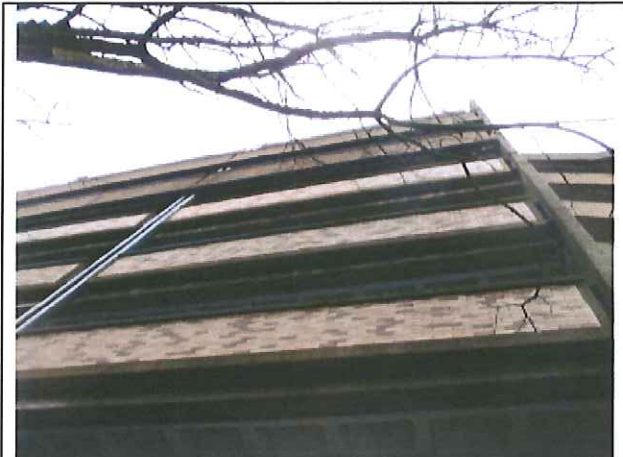
East Elevation, north end, similar conditions to the west elevation. The slope of the gutter in these areas is negative, causing water to overflow the gutter and run down the face of the panels.

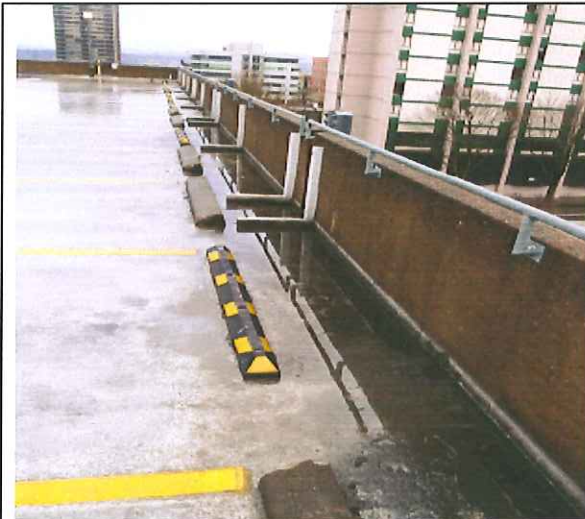
Eighth level, south guardrail, standing water at center while drains at ends are dry. Water is saturating the panel's cold joint and causing corrosion of steel reinforcement.

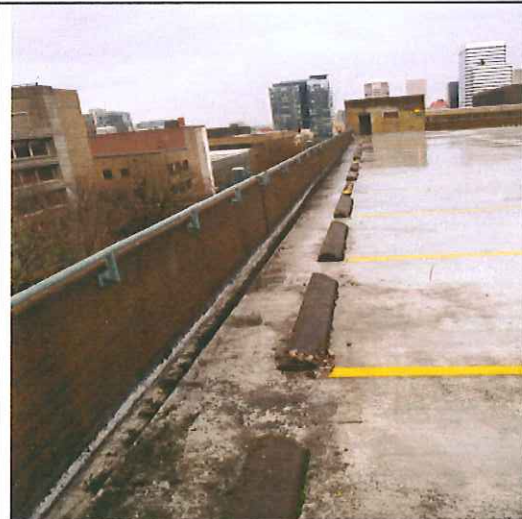
Eighth level, west guardrail, standing water at center while drains at ends are dry. Water is saturating the panel's cold joint and causing corrosion of steel reinforcement.

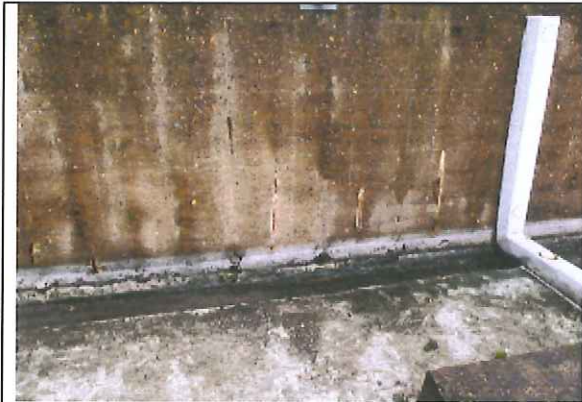
Eighth level, south guardrail, exposed panel reinforcement and deteriorated water proofing at cold joint

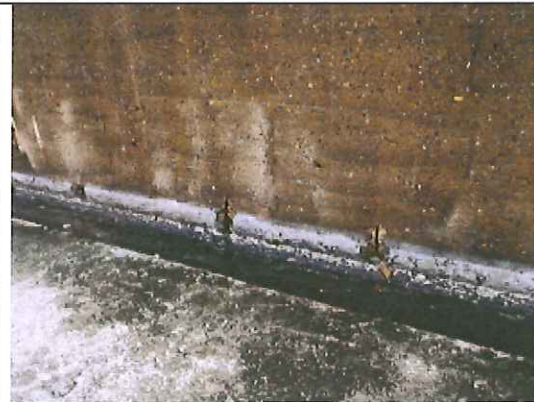
Eighth level, east guardrail, exposed panel reinforcement and deteriorated water proofing at cold joint

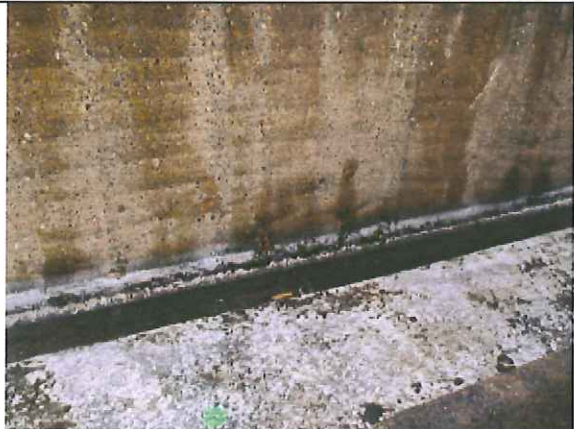
Eighth level, north guardrail, exposed panel reinforcement and deteriorated water proofing at cold joint

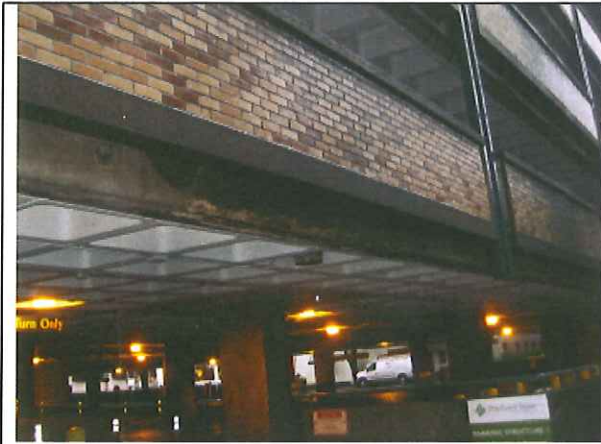
West entry, deteriorated concrete at beam

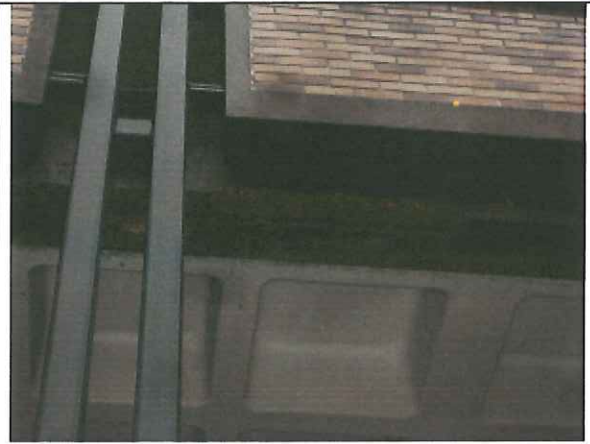
West elevation level 3, deteriorated concrete at beam at tube section connection.

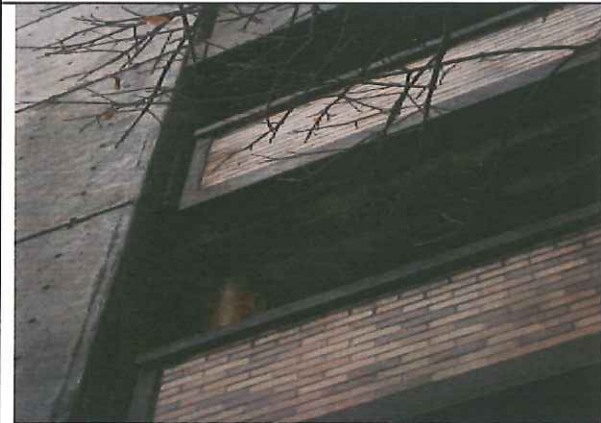
West Elevation, perimeter beam connection at N.W. stair.

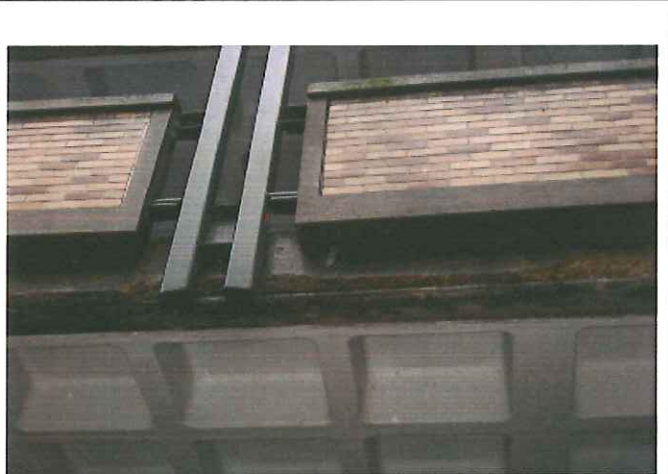
East Elevation, rebar is completely disengaged from the concrete beam.
