Appendix 5.09
GPR Data

Portland State Parking Structure PS1

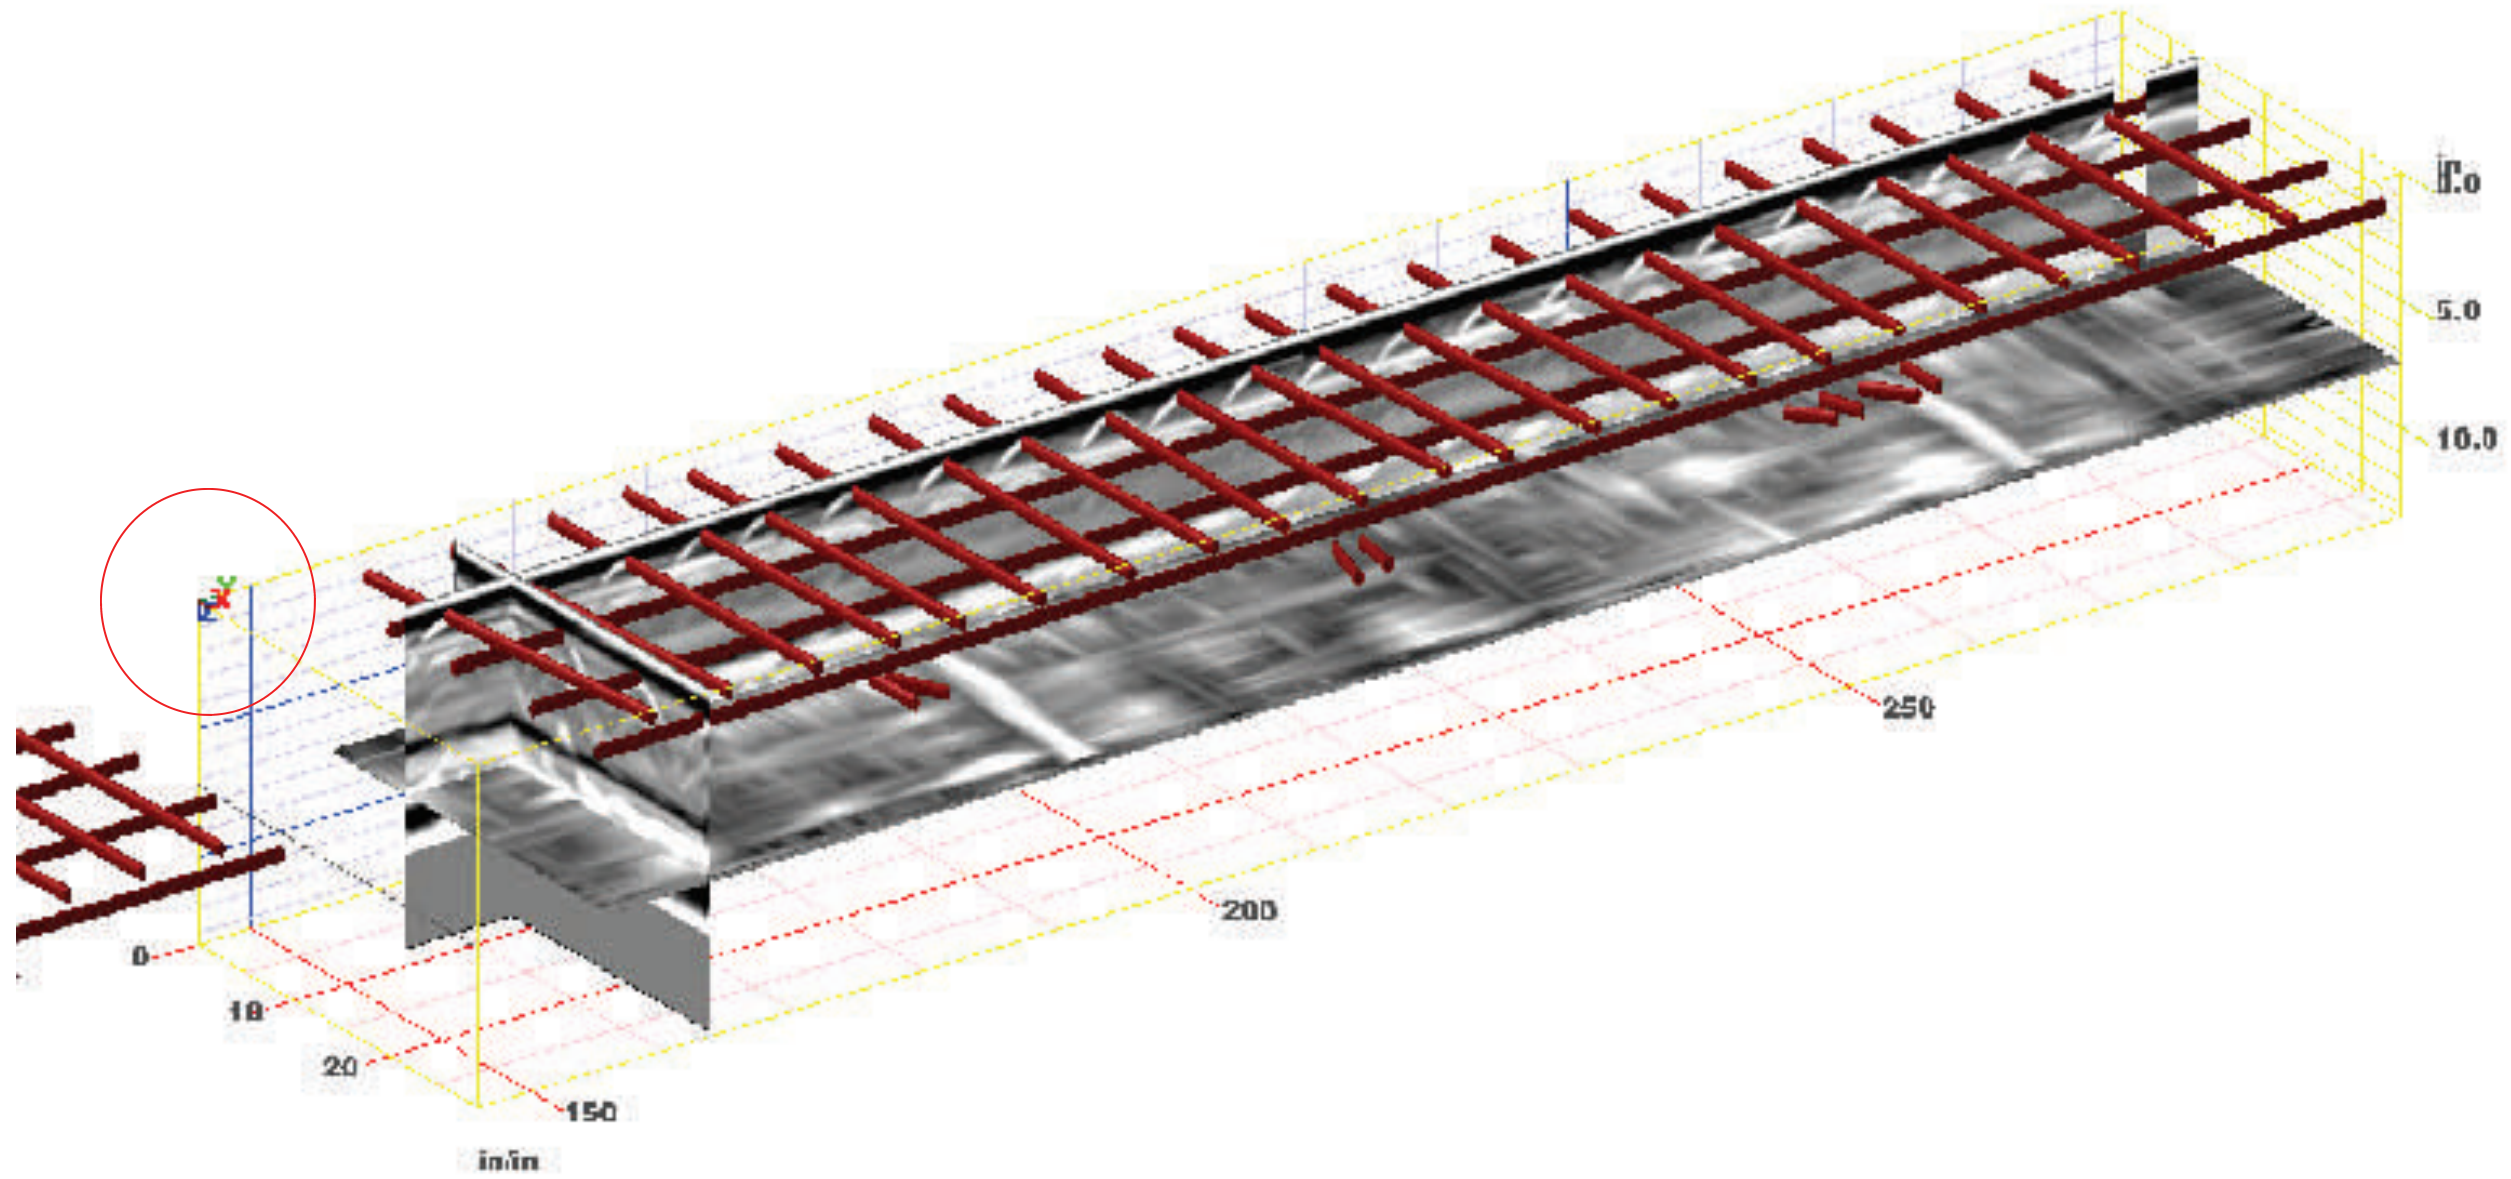
Right half of panel wall. Single mat of reinforcing each direction.

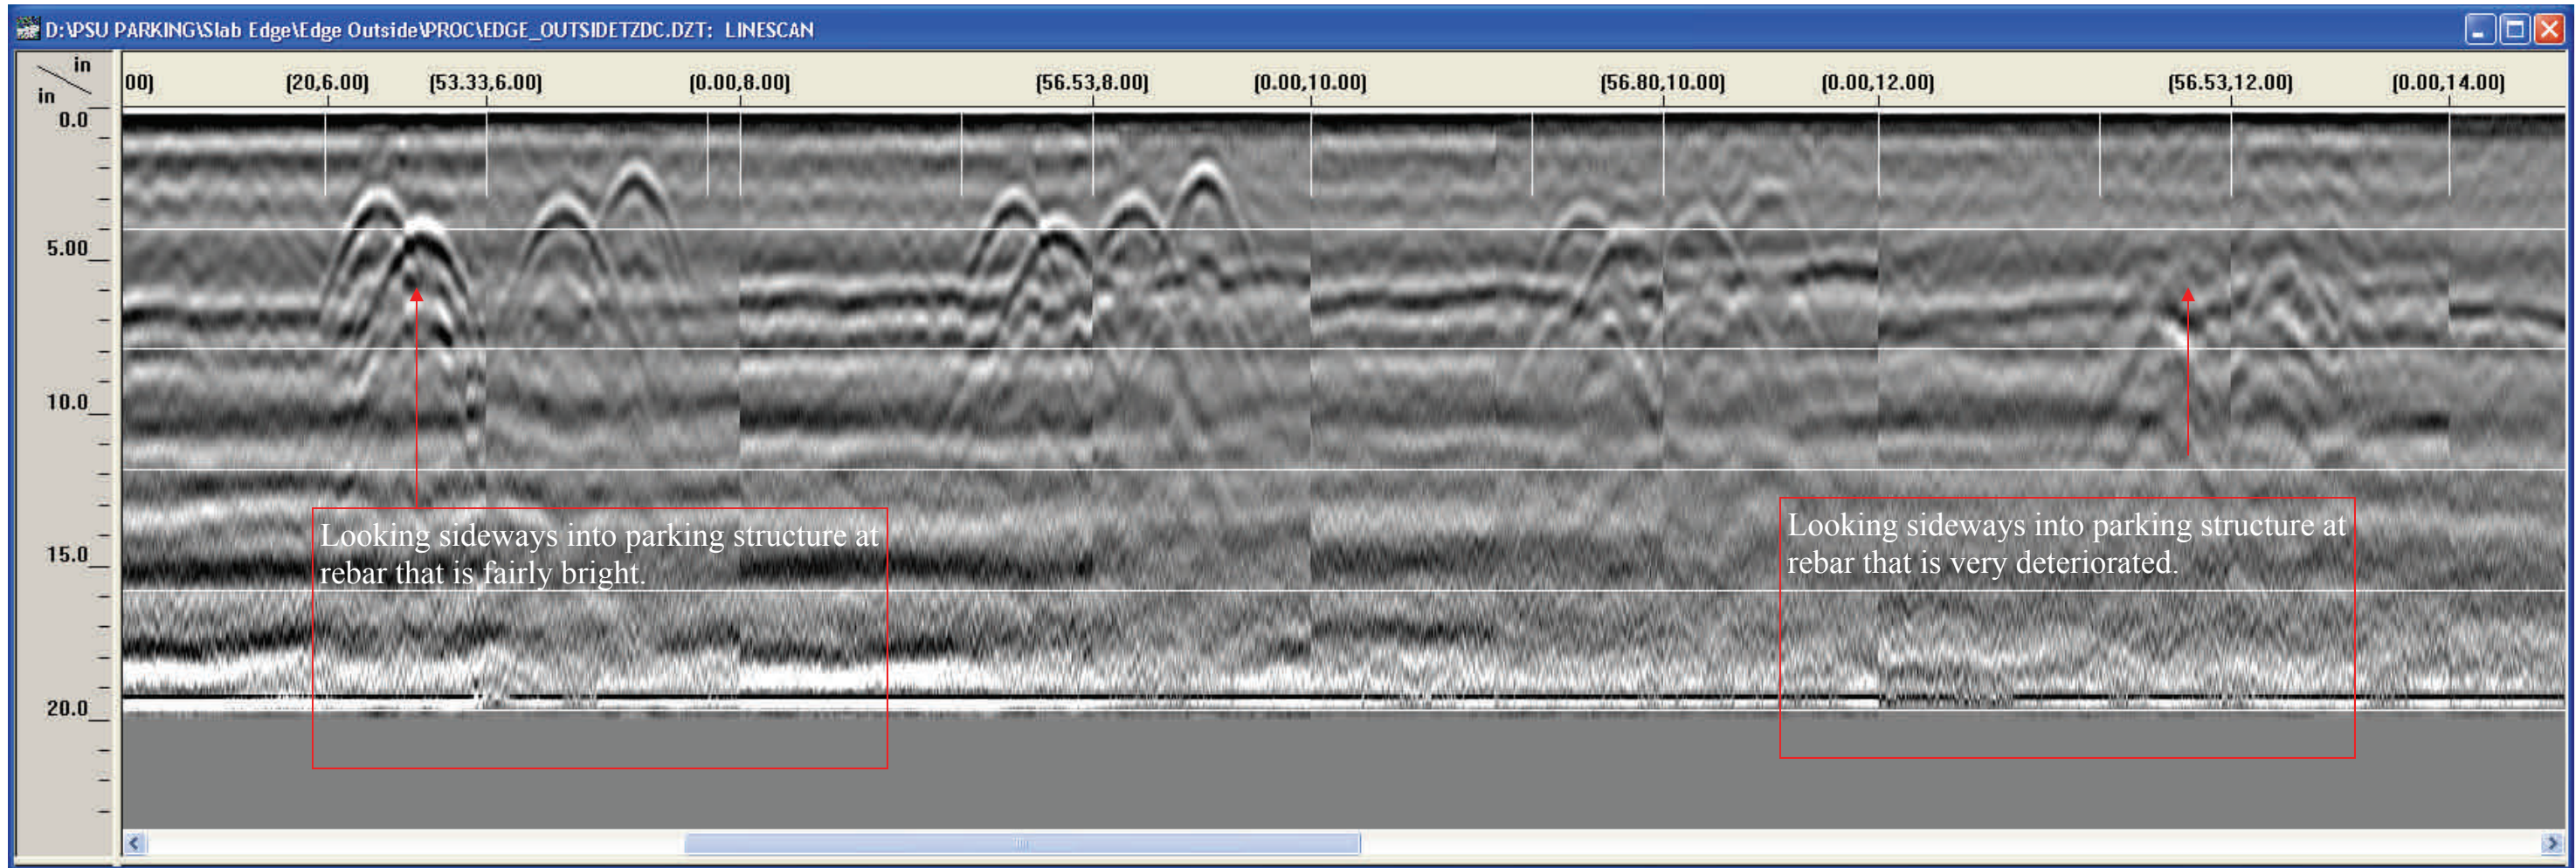
Looking sideways into beam and parking structure. Above scans are horizontal data collections showing rebar running up and down in the beam. Note conditions of vertical rebar as shown.

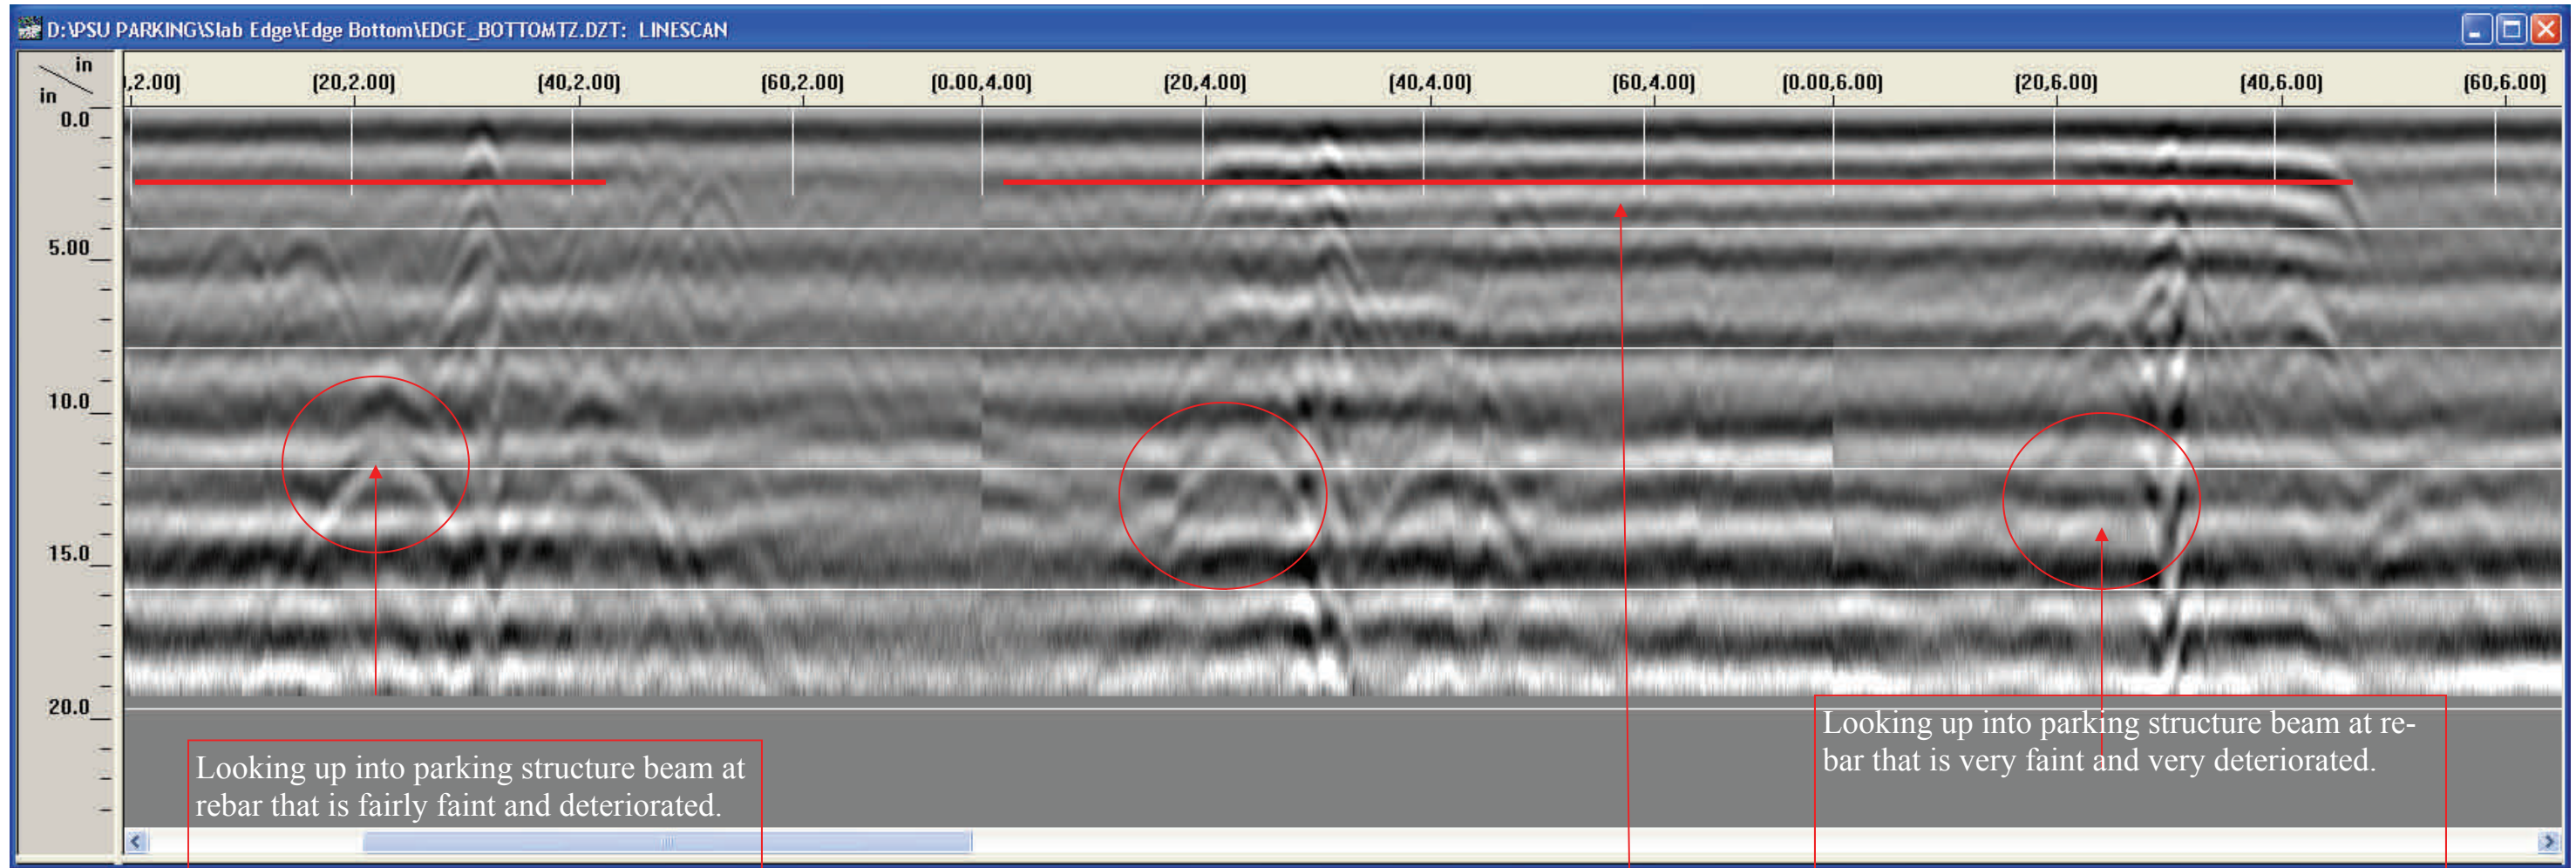
West side beam bottom view on 5th floor looking up.

These are longitudinal scans running with the bottom of the beam face. These are the same rebar shown 3 times on 2" centers.

Note the delaminated areas as shown with the horizontal red lines.

Looking up into parking structure beam at rebar that is very faint and very deteriorated.

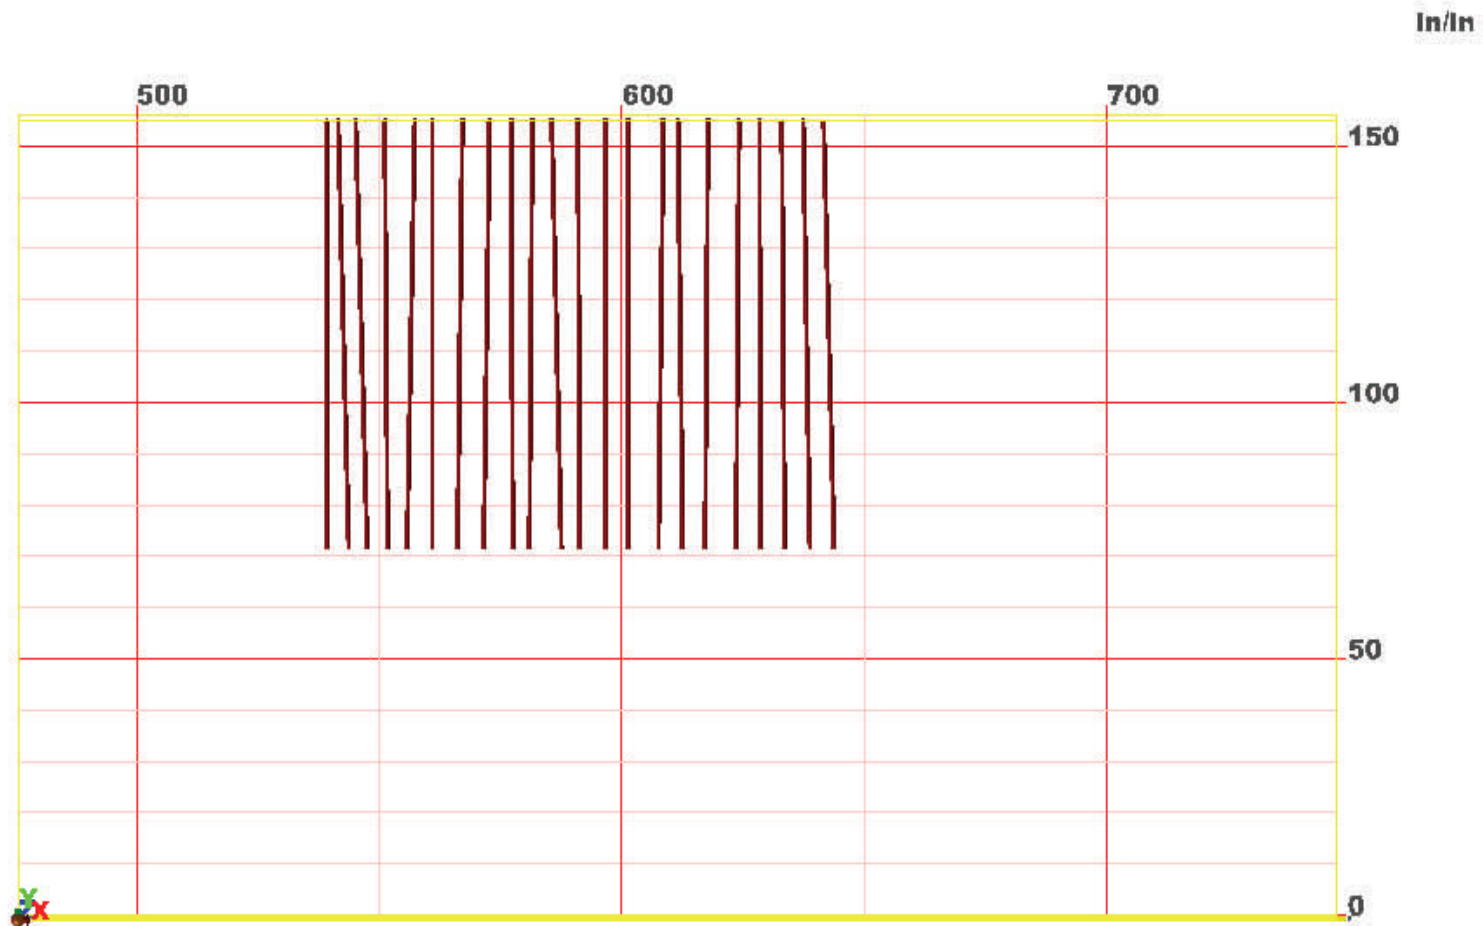
Sixth floor west side at column 2 from the north reinforcement.
This view is looking down on the 6th floor at your feet. 22
pieces of rebar.

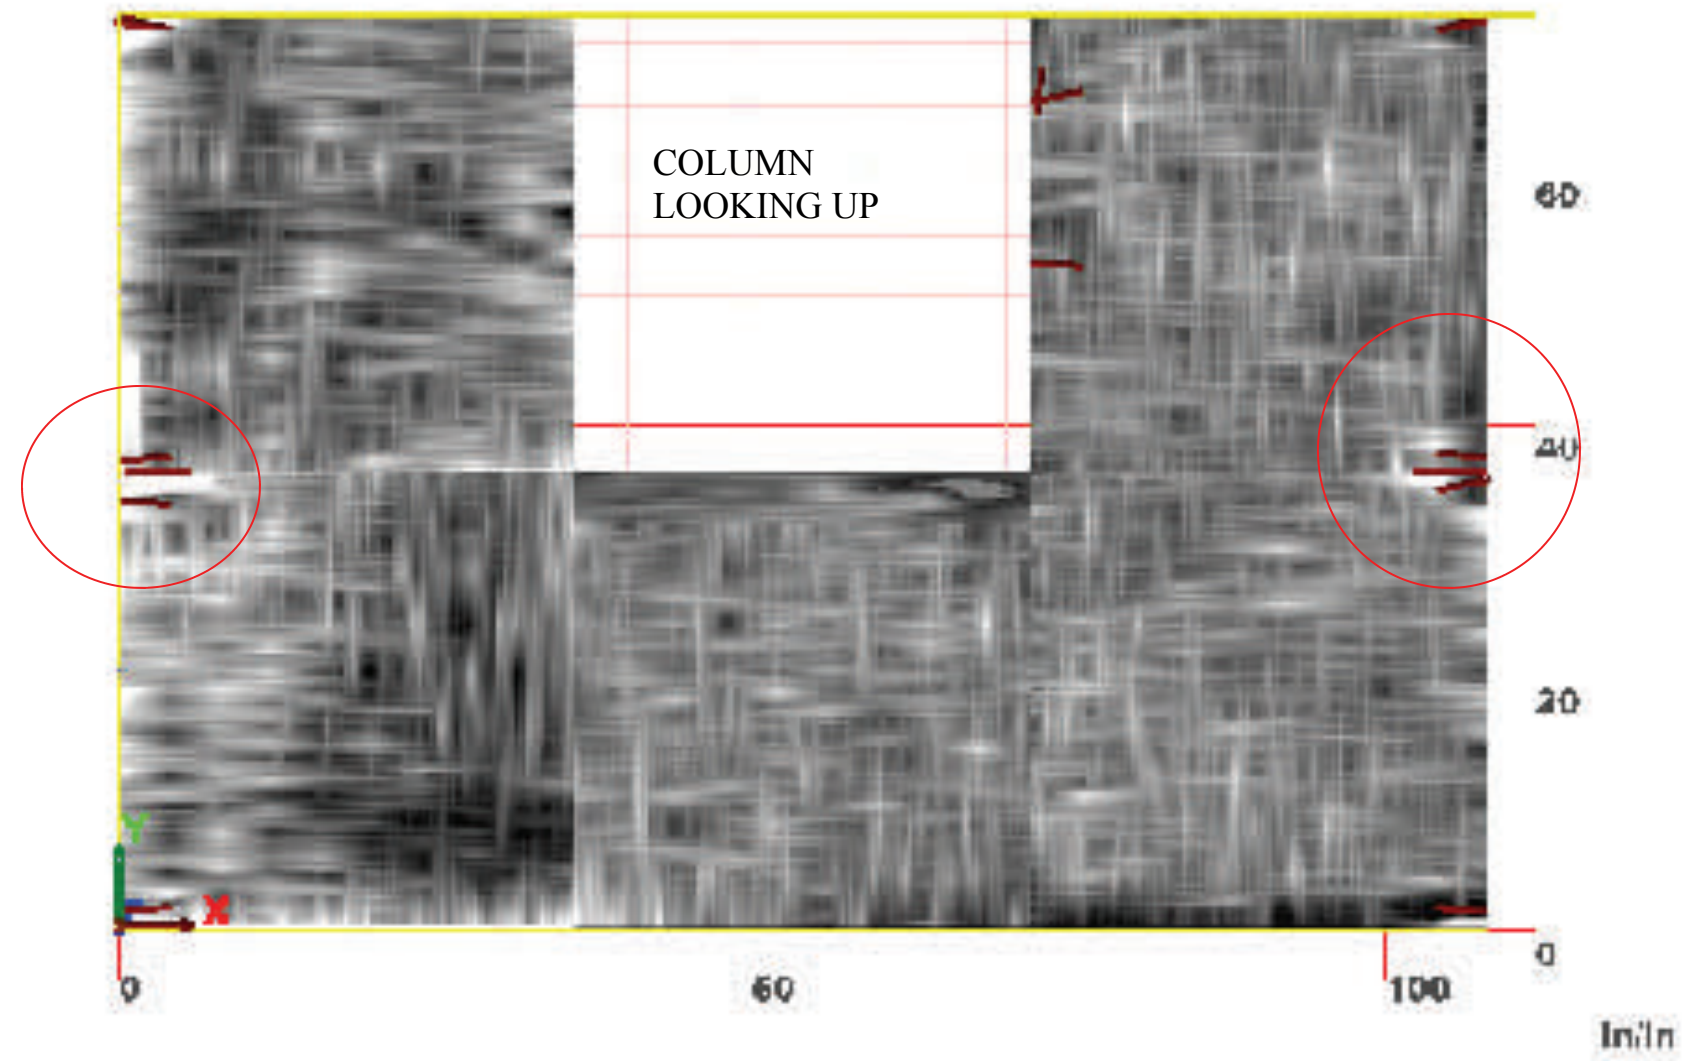
Plan view of column cap on 5th floor looking up. See page 18 for location. Note that the short stubs of rebar shown is the only rebar seen in the first 11" of depth.

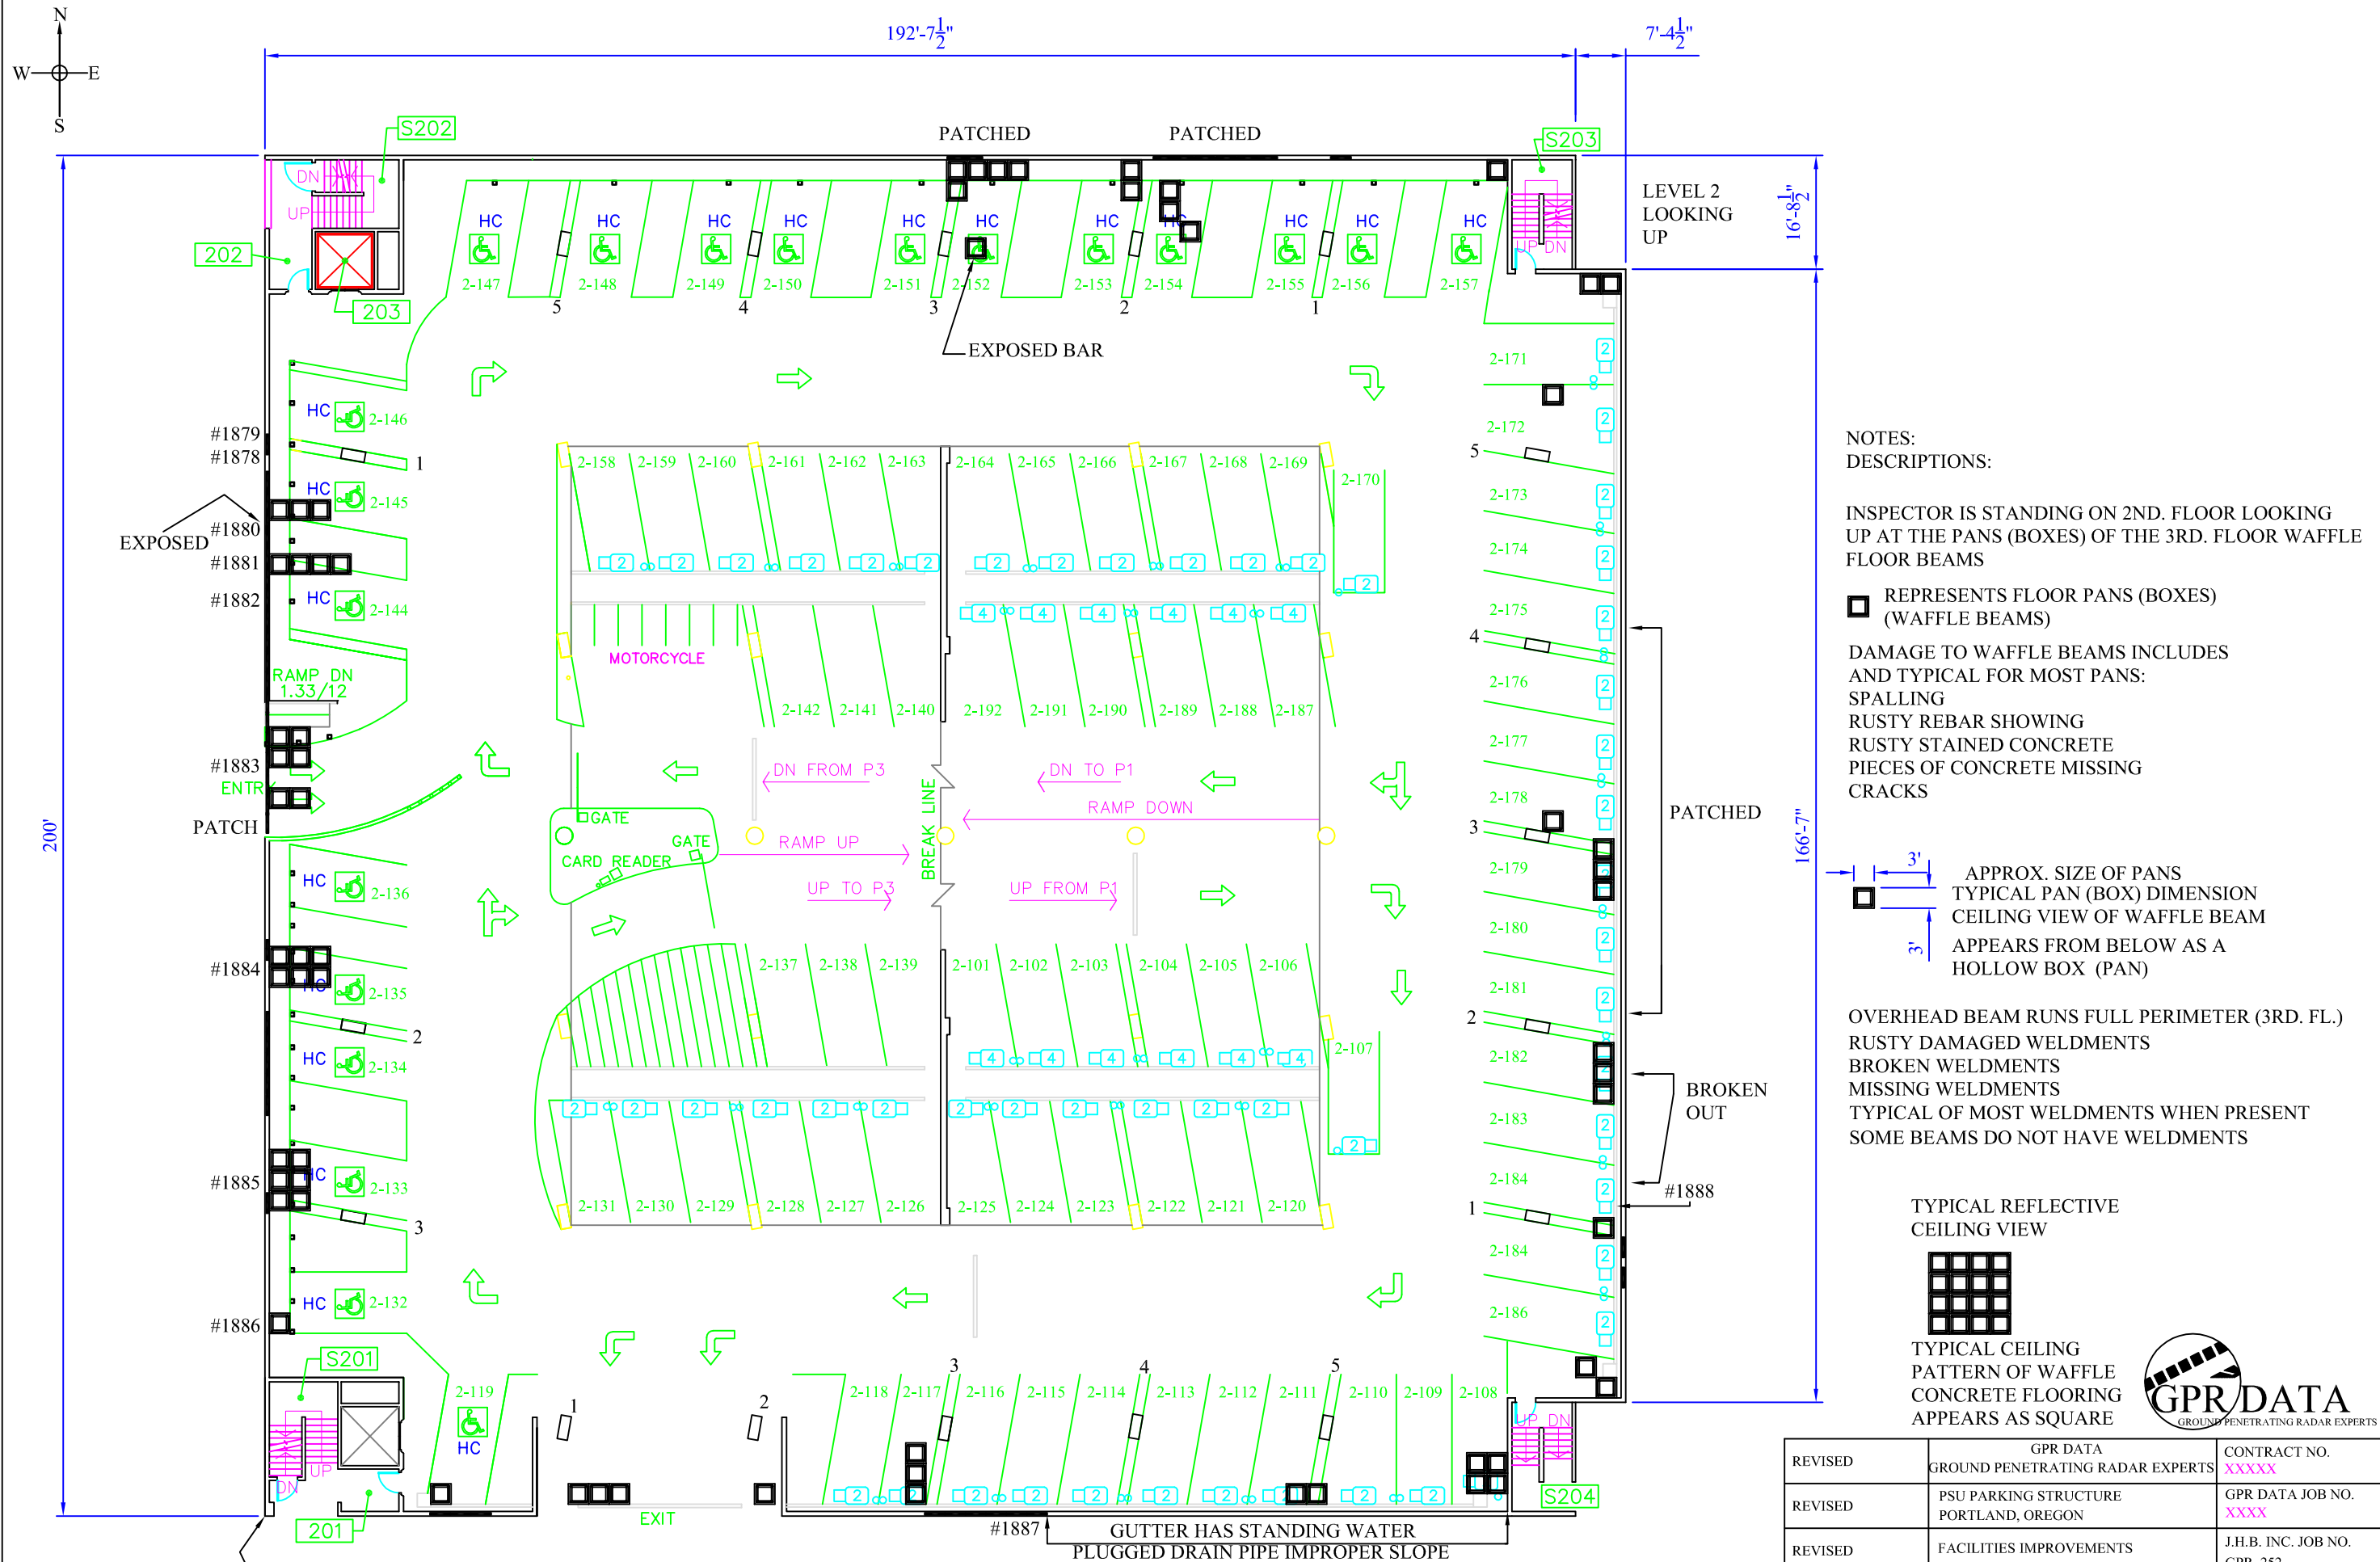
NOTES:
 DESCRIPTIONS:
 INSPECTOR IS STANDING ON 2ND. FLOOR LOOKING UP AT THE PANS (BOXES) OF THE 3RD. FLOOR WAFFLE FLOOR BEAMS
 ■ REPRESENTS FLOOR PANS (BOXES) (WAFFLE BEAMS)
 DAMAGE TO WAFFLE BEAMS INCLUDES AND TYPICAL FOR MOST PANS:
 SPALLING
 RUSTY REBAR SHOWING
 RUSTY STAINED CONCRETE
 PIECES OF CONCRETE MISSING
 CRACKS

OVERHEAD BEAM RUNS FULL PERIMETER (3RD. FL.)
 RUSTY DAMAGED WELDMENTS
 BROKEN WELDMENTS
 MISSING WELDMENTS
 TYPICAL OF MOST WELDMENTS WHEN PRESENT
 SOME BEAMS DO NOT HAVE WELDMENTS

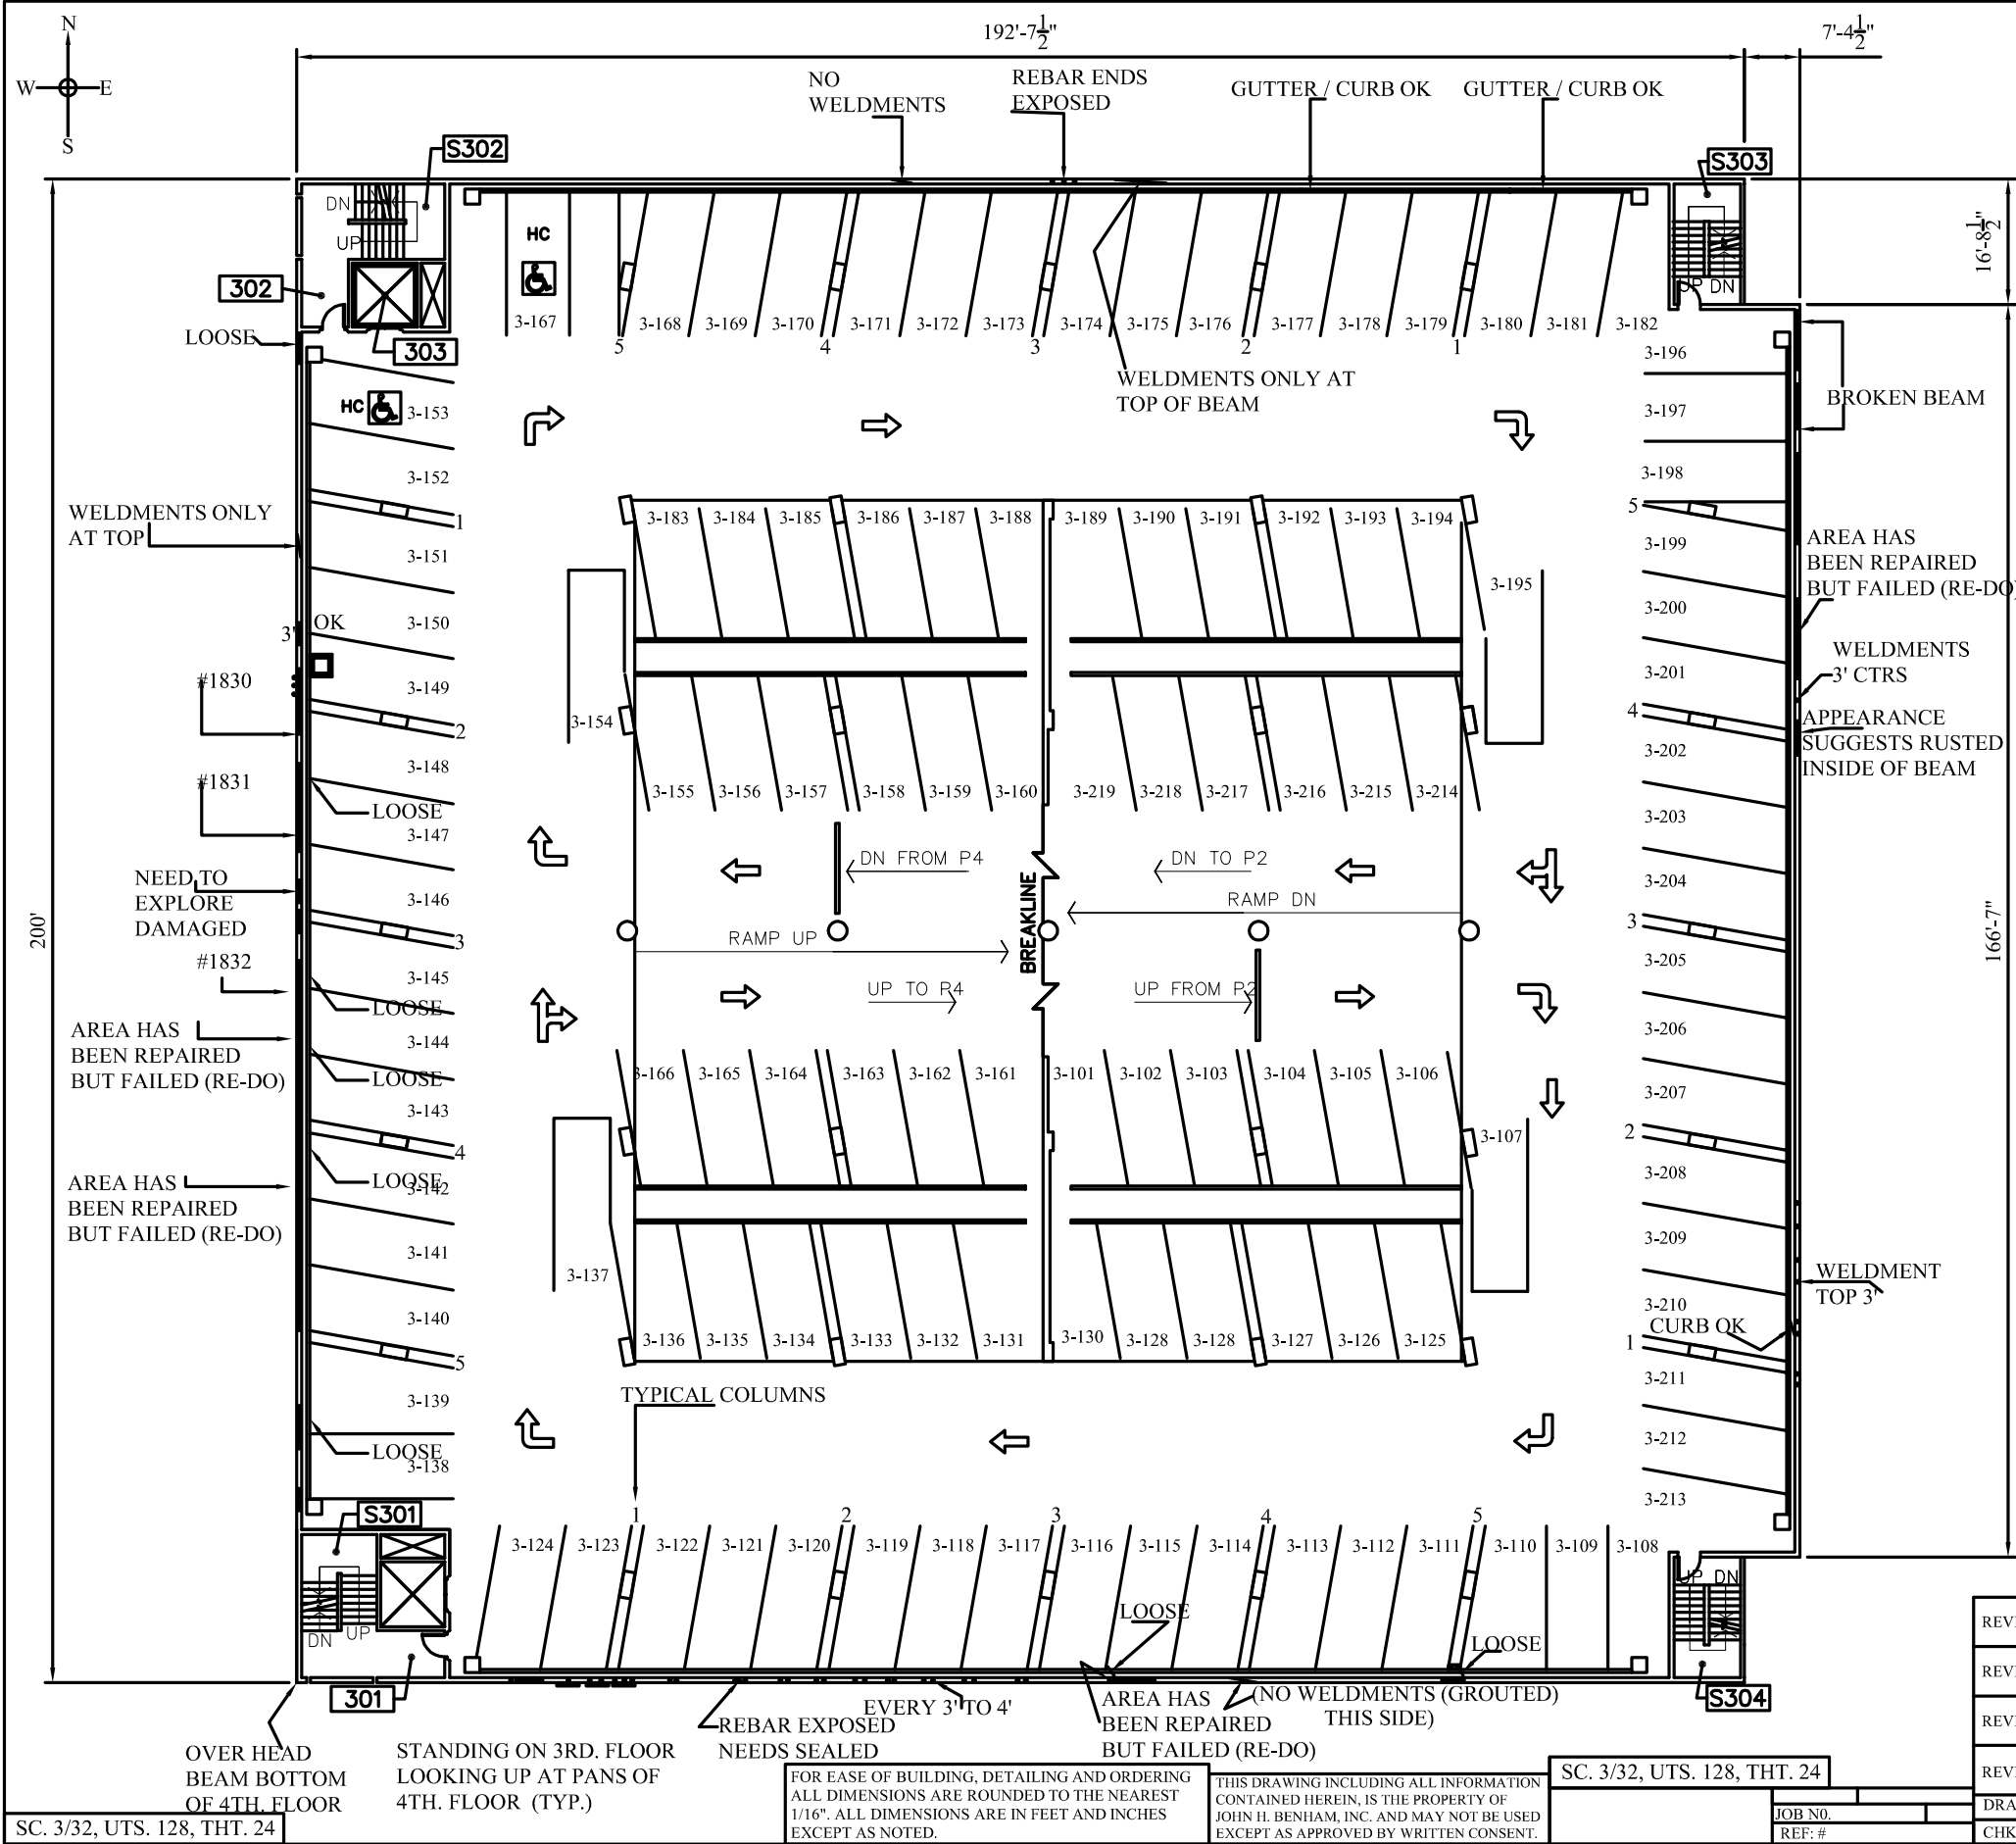
INSPECTOR IS STANDING ON 3RD. FLOOR LOOKING UP AT THE PANS (BOXES) OF THE 4TH. FLOOR WAFFLE FLOOR BEAMS

DAMAGE TO WAFFLE BEAMS INCLUDES AND TYPICAL FOR MOST PANS:
SPALLING
RUSTY REBAR SHOWING
RUSTY STAINED CONCRETE
PIECES OF CONCRETE MISSING
CRACKS

OVERHEAD BEAM RUNS FULL PERIMETER (4TH. FL.)
RUSTY DAMAGED WELDMENTS
BROKEN WELDMENTS
MISSING WELDMENTS
TYPICAL OF MOST WELDMENTS WHEN PRESENT
SOME BEAMS DO NOT HAVE WELDMENTS

WELDMENTS SHOWING AT TOP OF BEAM ON N, W, E SIDES OF STRUCTURE NEED REPAIRED OR REPLACED. SOUTH SIDE LOOKS OK. THIS IS LOOKING UP TO 4TH. FLOOR.

LOOSE = MEANING CONCRETE IS JUST HANGING THERE AND NEEDS TO BE REMOVED BEFORE THE PIECES FALL TO THE GROUND STRIKING PASSER BY'S. MANY AREAS ON ALL FLOORS NEED TO BE SCALED OF ALL LOOSE CONCRETE.

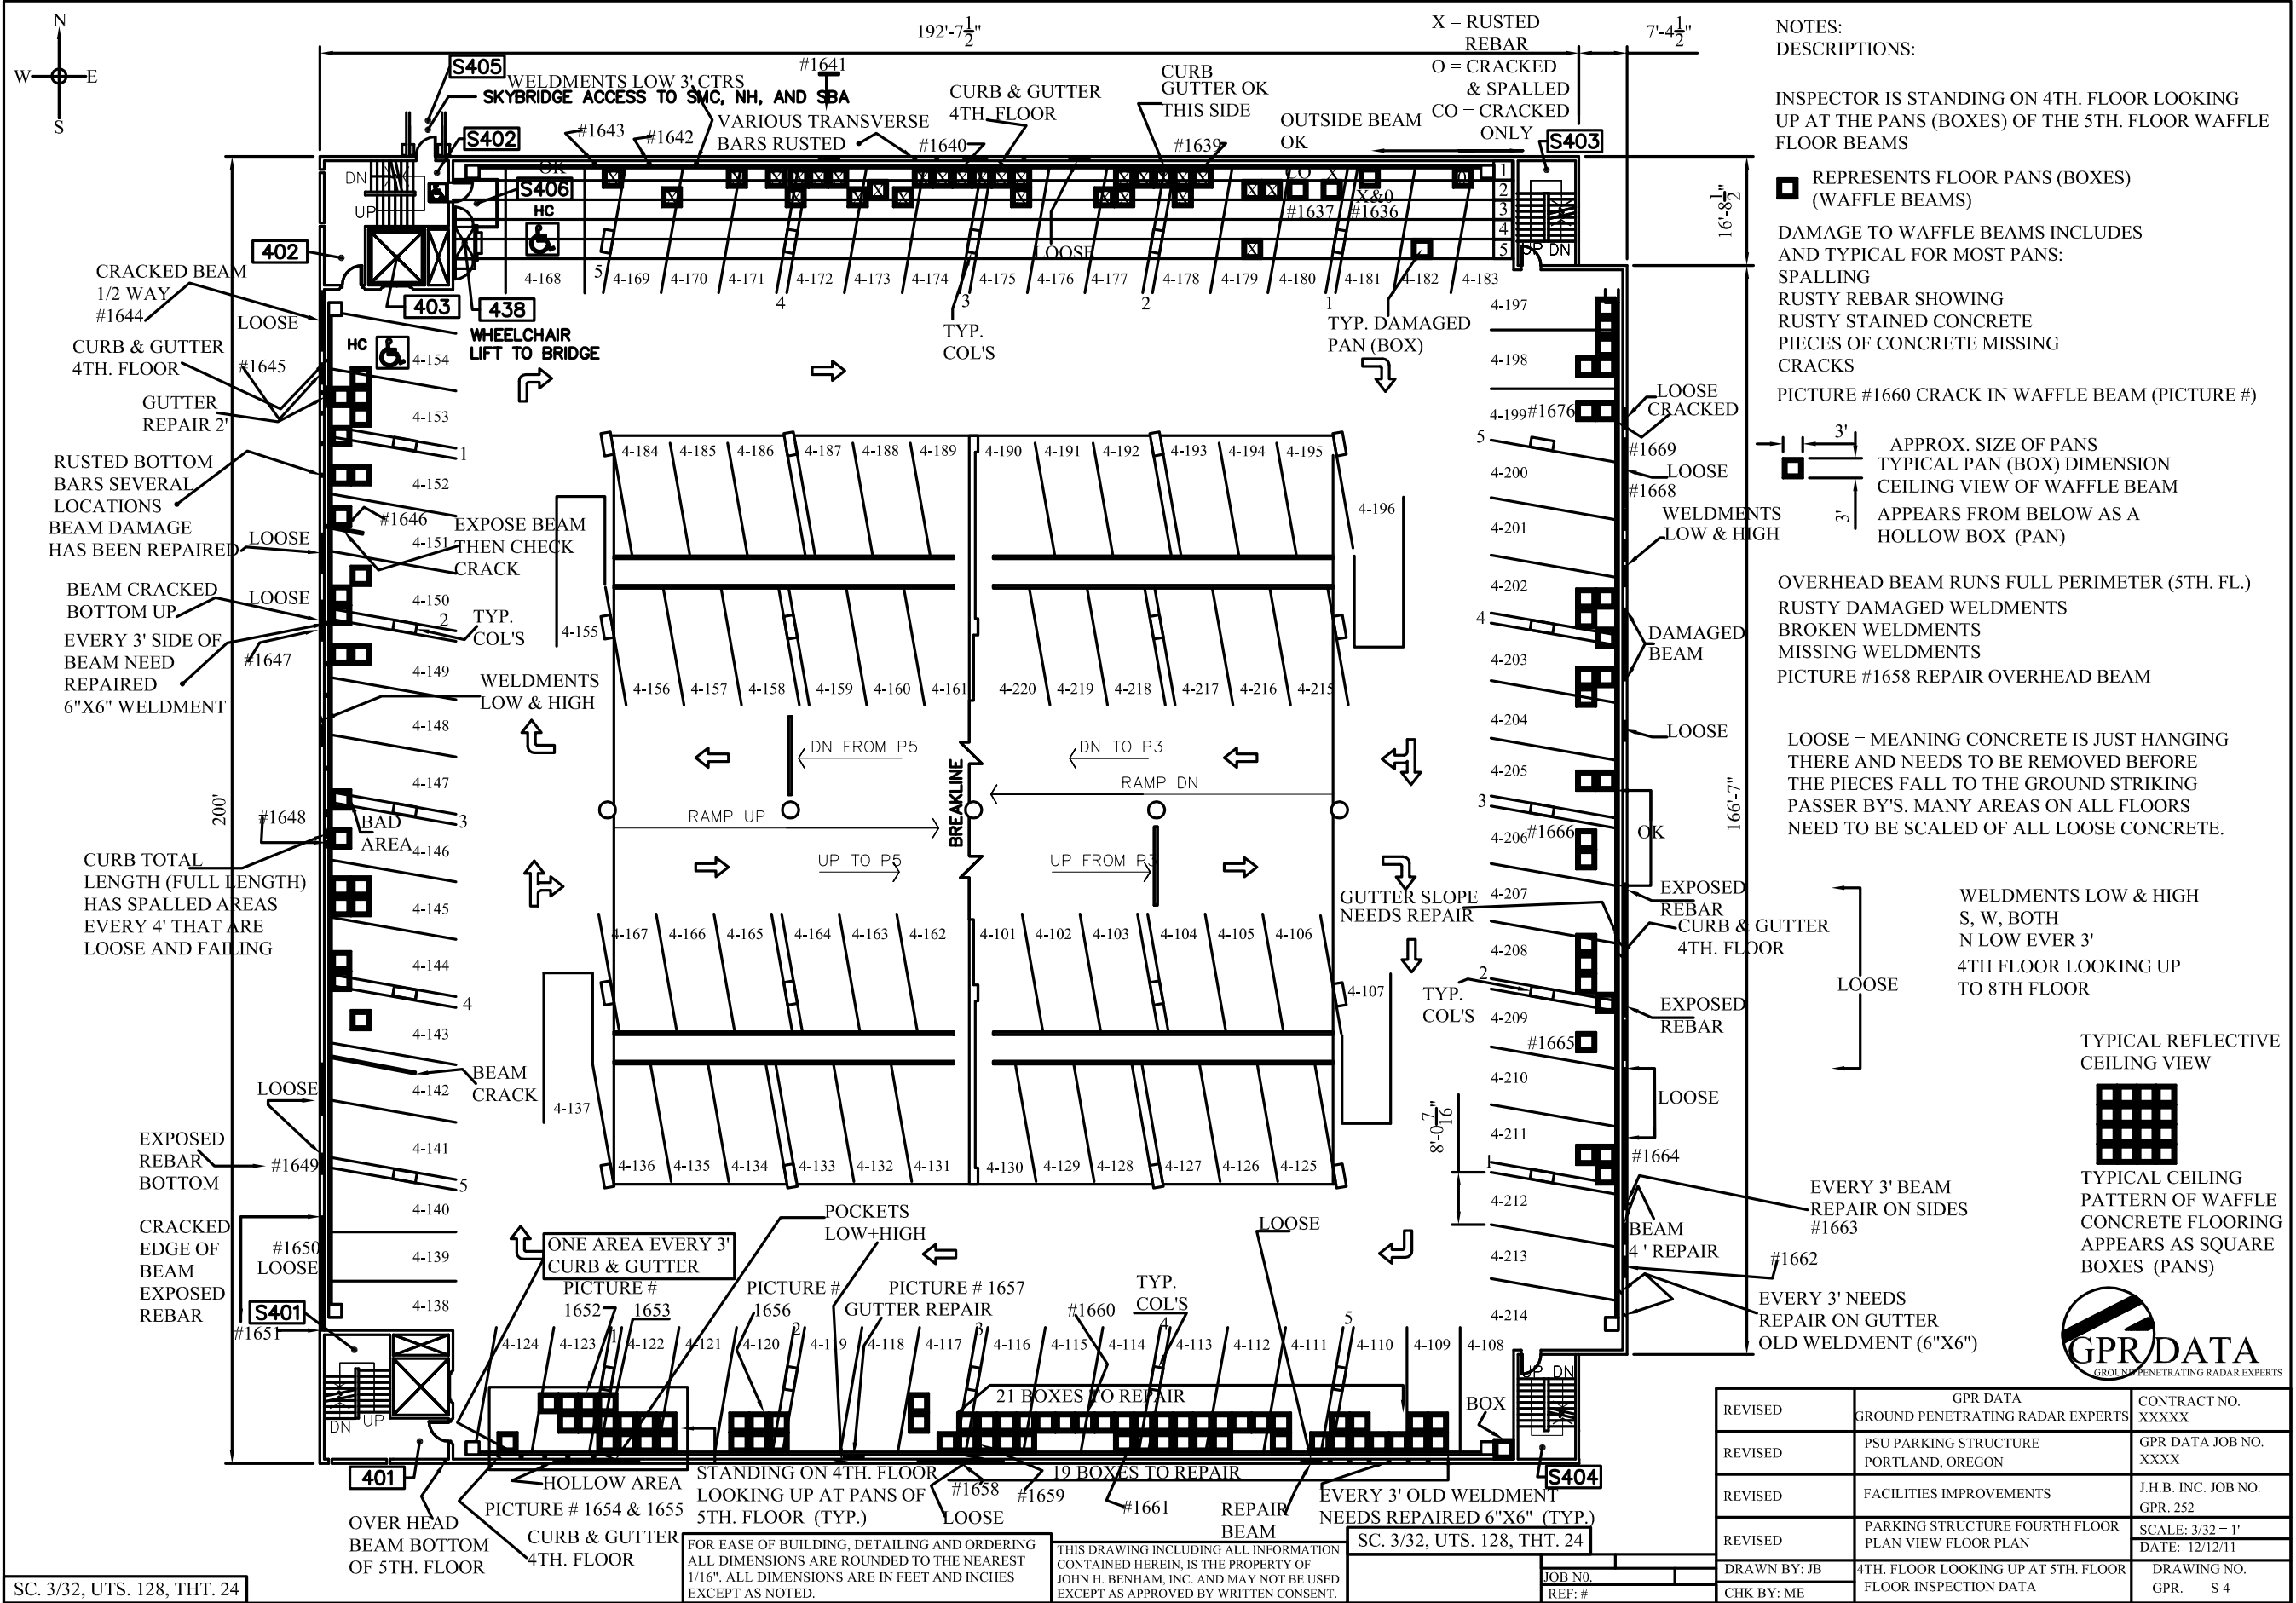
REPRESENTS FLOOR PANS (BOXES) (WAFFLE BEAMS)
 DAMAGE TO WAFFLE BEAMS INCLUDES AND TYPICAL FOR MOST PANS:
 SPALLING
 RUSTY REBAR SHOWING
 RUSTY STAINED CONCRETE
 PIECES OF CONCRETE MISSING
 CRACKS
 PICTURE #1660 CRACK IN WAFFLE BEAM (PICTURE #)

OVERHEAD BEAM RUNS FULL PERIMETER (5TH. FL.)
 RUSTY DAMAGED WELDMENTS
 BROKEN WELDMENTS
 MISSING WELDMENTS
 PICTURE #1658 REPAIR OVERHEAD BEAM

LOOSE = MEANING CONCRETE IS JUST HANGING THERE AND NEEDS TO BE REMOVED BEFORE THE PIECES FALL TO THE GROUND STRIKING PASSER BY'S. MANY AREAS ON ALL FLOORS NEED TO BE SCALED OF ALL LOOSE CONCRETE.

WELDMENTS LOW & HIGH
 S, W, BOTH
 N LOW EVER 3'
 4TH FLOOR LOOKING UP TO 8TH FLOOR
