Appendix 5.09
GPR Data

Portland State Parking Structure PS1

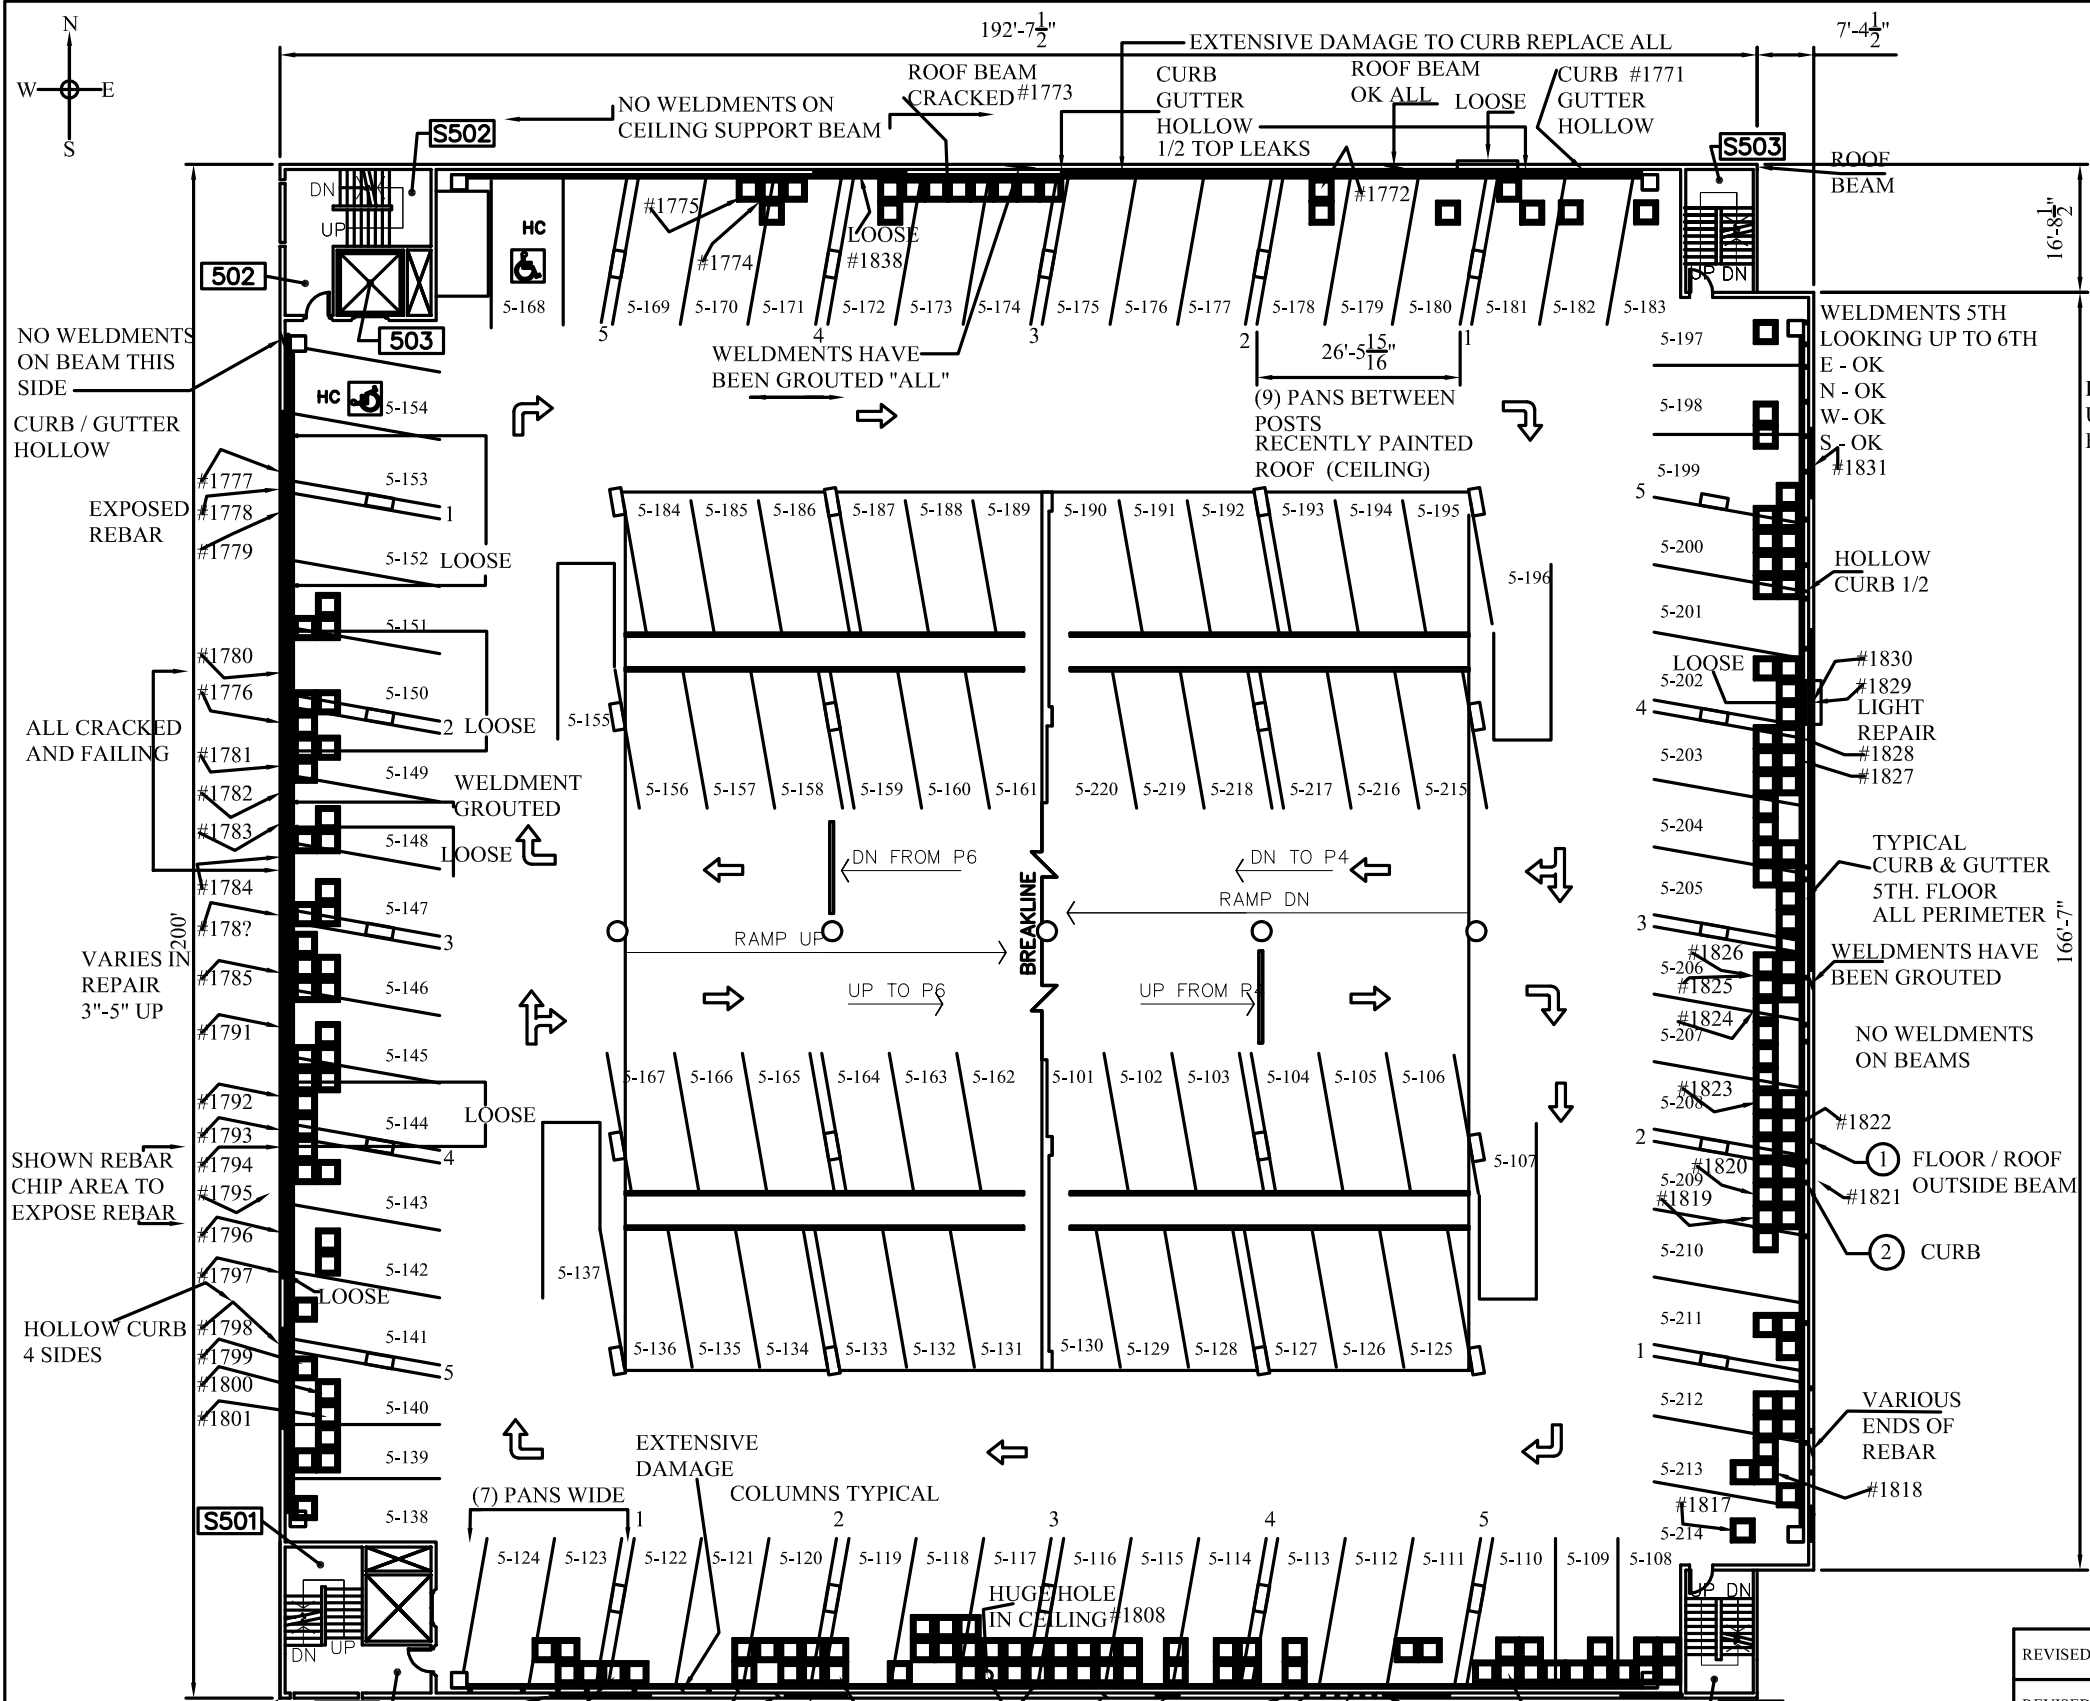
☐ REPRESENTS FLOOR PANS (BOXES)
 (WAFFLE BEAMS)
 DAMAGE TO WAFFLE BEAMS INCLUDES
 AND TYPICAL FOR MOST PANS:
 SPALLING
 RUSTY REBAR SHOWING
 RUSTY STAINED CONCRETE
 PIECES OF CONCRETE MISSING
 CRACKS

OVERHEAD BEAM RUNS FULL PERIMETER (6TH. FL.)
 RUSTY DAMAGED WELDMENTS
 BROKEN WELDMENTS
 MISSING WELDMENTS
 TYPICAL OF MOST WELDMENTS WHEN PRESENT
 SOME BEAMS DO NOT HAVE WELDMENTS

CURB &
 GUTTER HAS
 HOLLOW AREAS
 NEEDS REPLACED

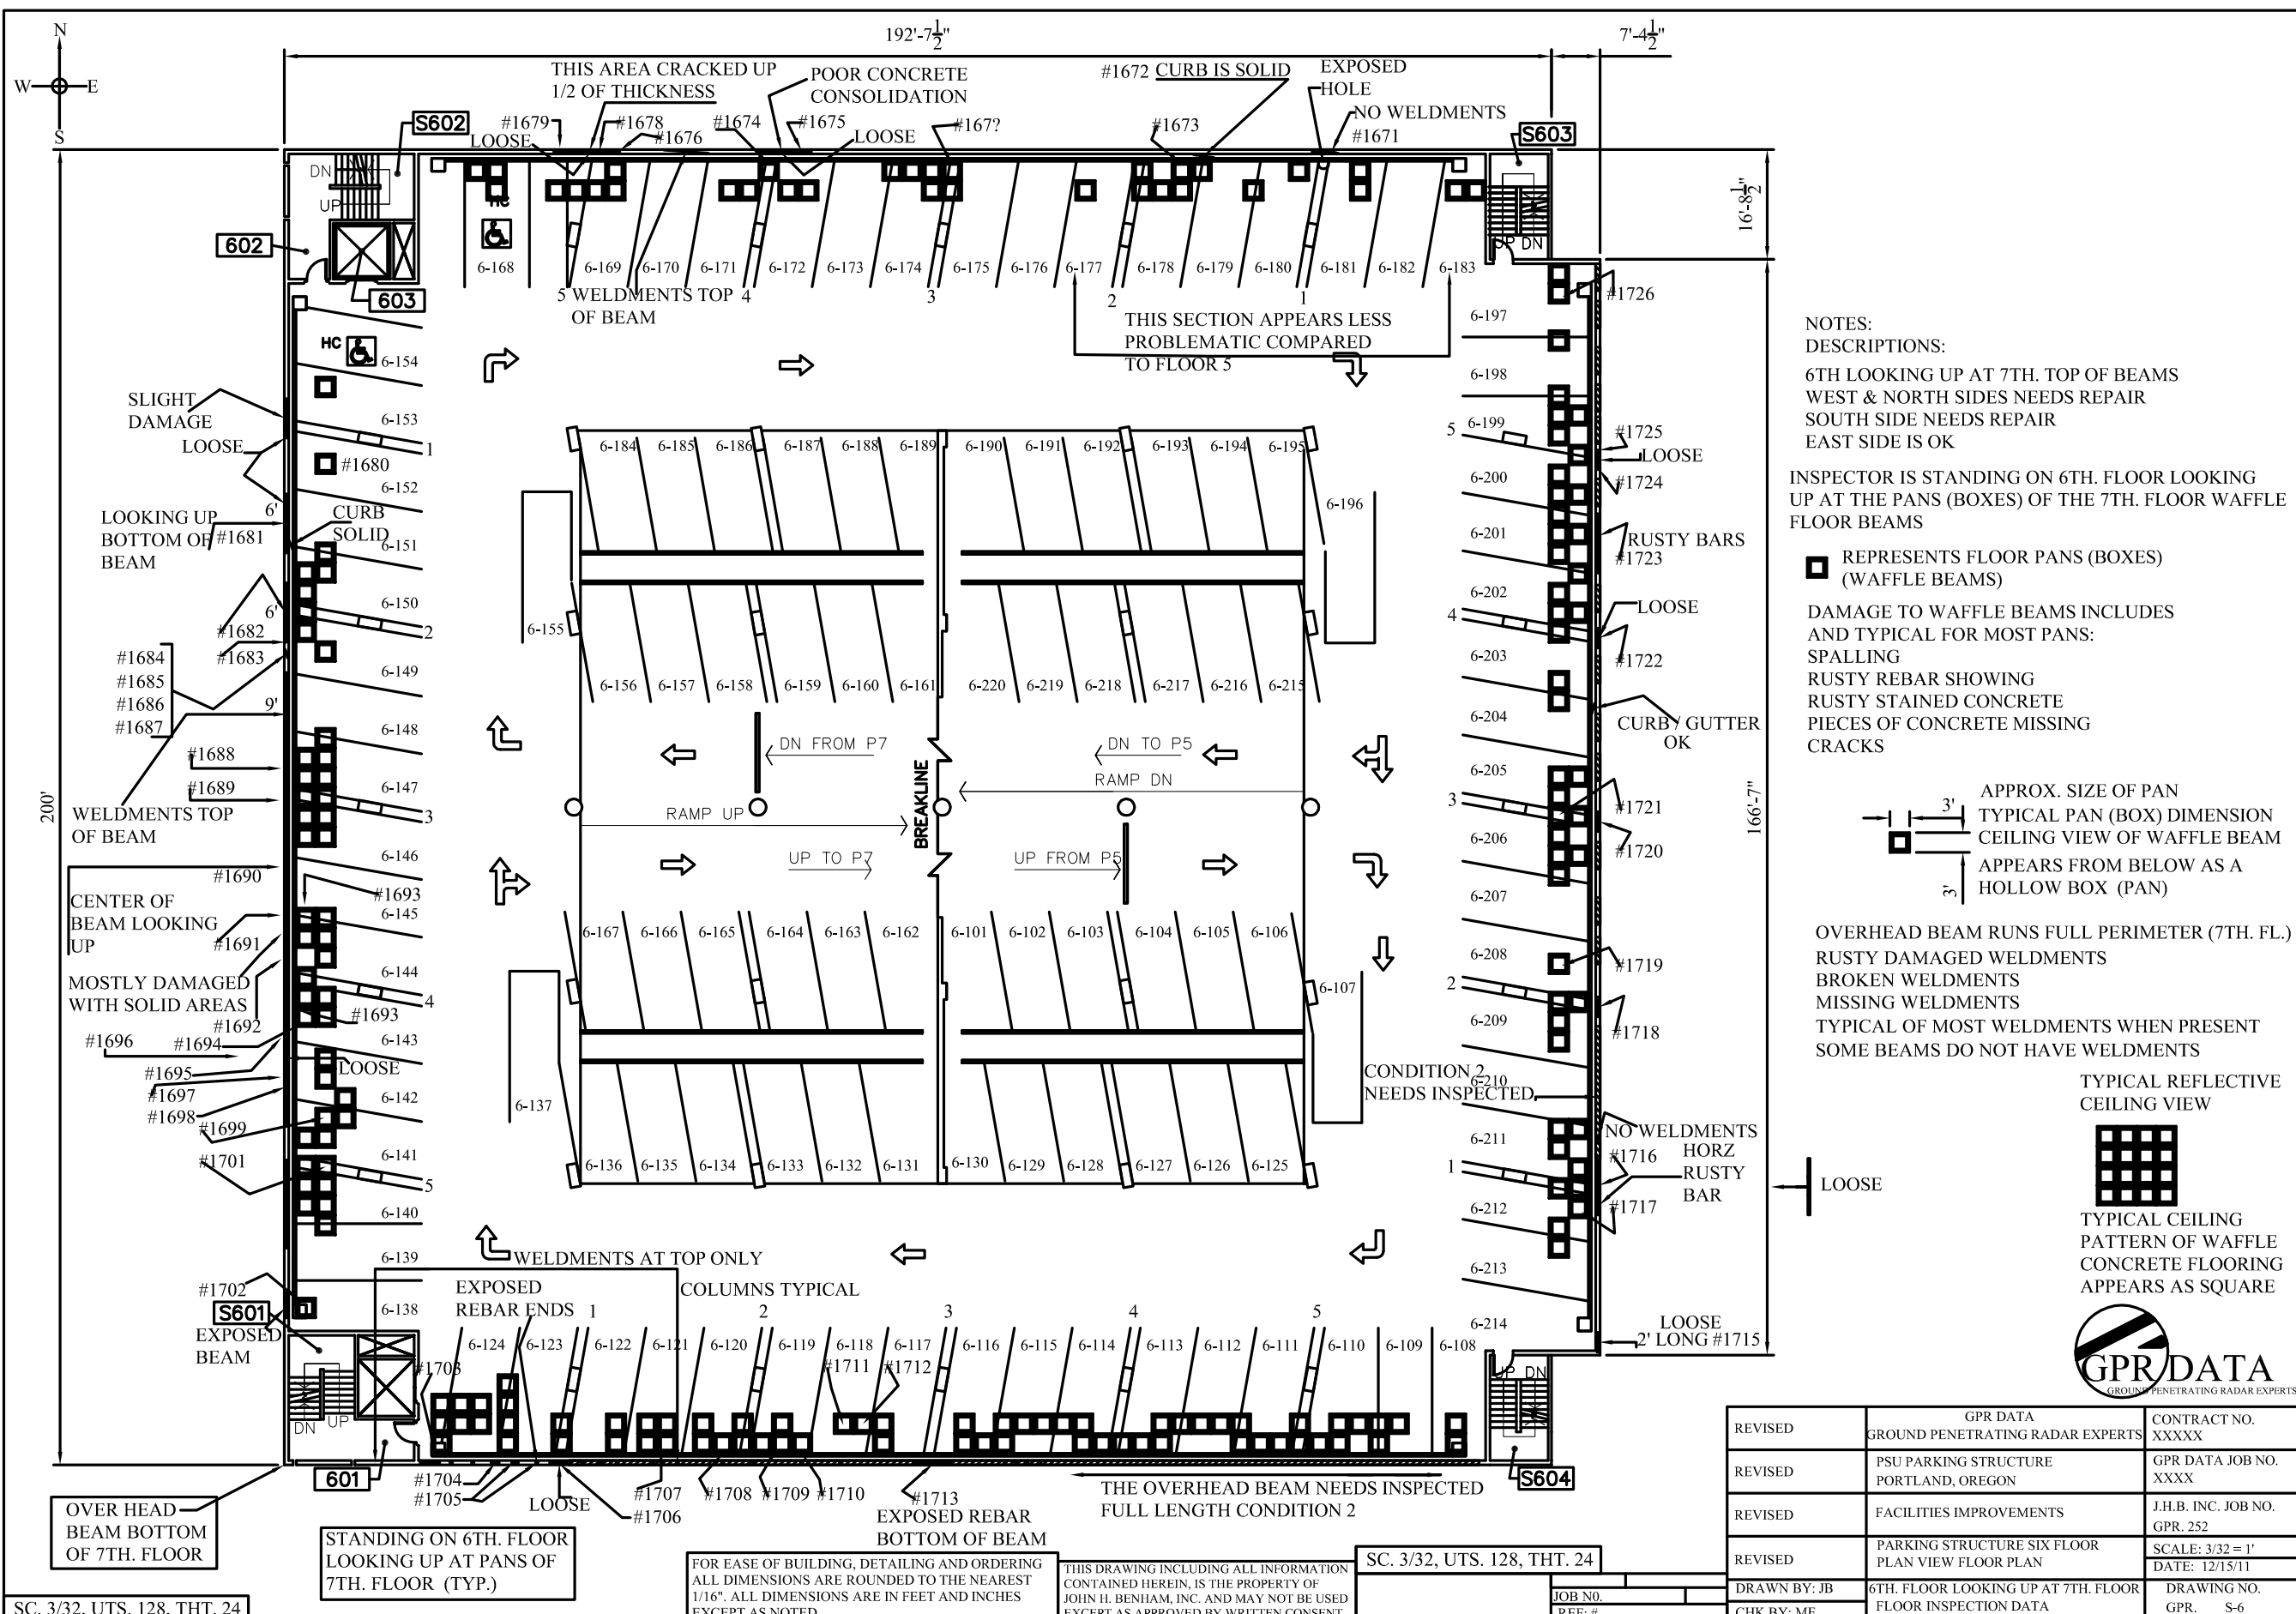
INSPECTOR IS STANDING ON 6TH. FLOOR LOOKING UP AT THE PANS (BOXES) OF THE 7TH. FLOOR WAFFLE FLOOR BEAMS

- REPRESENTS FLOOR PANS (BOXES) (WAFFLE BEAMS)
- DAMAGE TO WAFFLE BEAMS INCLUDES AND TYPICAL FOR MOST PANS:
 SPALLING
 RUSTY REBAR SHOWING
 RUSTY STAINED CONCRETE
 PIECES OF CONCRETE MISSING
 CRACKS

- OVERHEAD BEAM RUNS FULL PERIMETER (7TH. FL.)
- RUSTY DAMAGED WELDMENTS
- BROKEN WELDMENTS
- MISSING WELDMENTS
- TYPICAL OF MOST WELDMENTS WHEN PRESENT
- SOME BEAMS DO NOT HAVE WELDMENTS

NOTES:
 DESCRIPTIONS:
 6TH LOOKING UP AT 7TH. TOP OF BEAMS
 WEST & NORTH SIDES NEEDS REPAIR
 SOUTH SIDE NEEDS REPAIR
 EAST SIDE IS OK

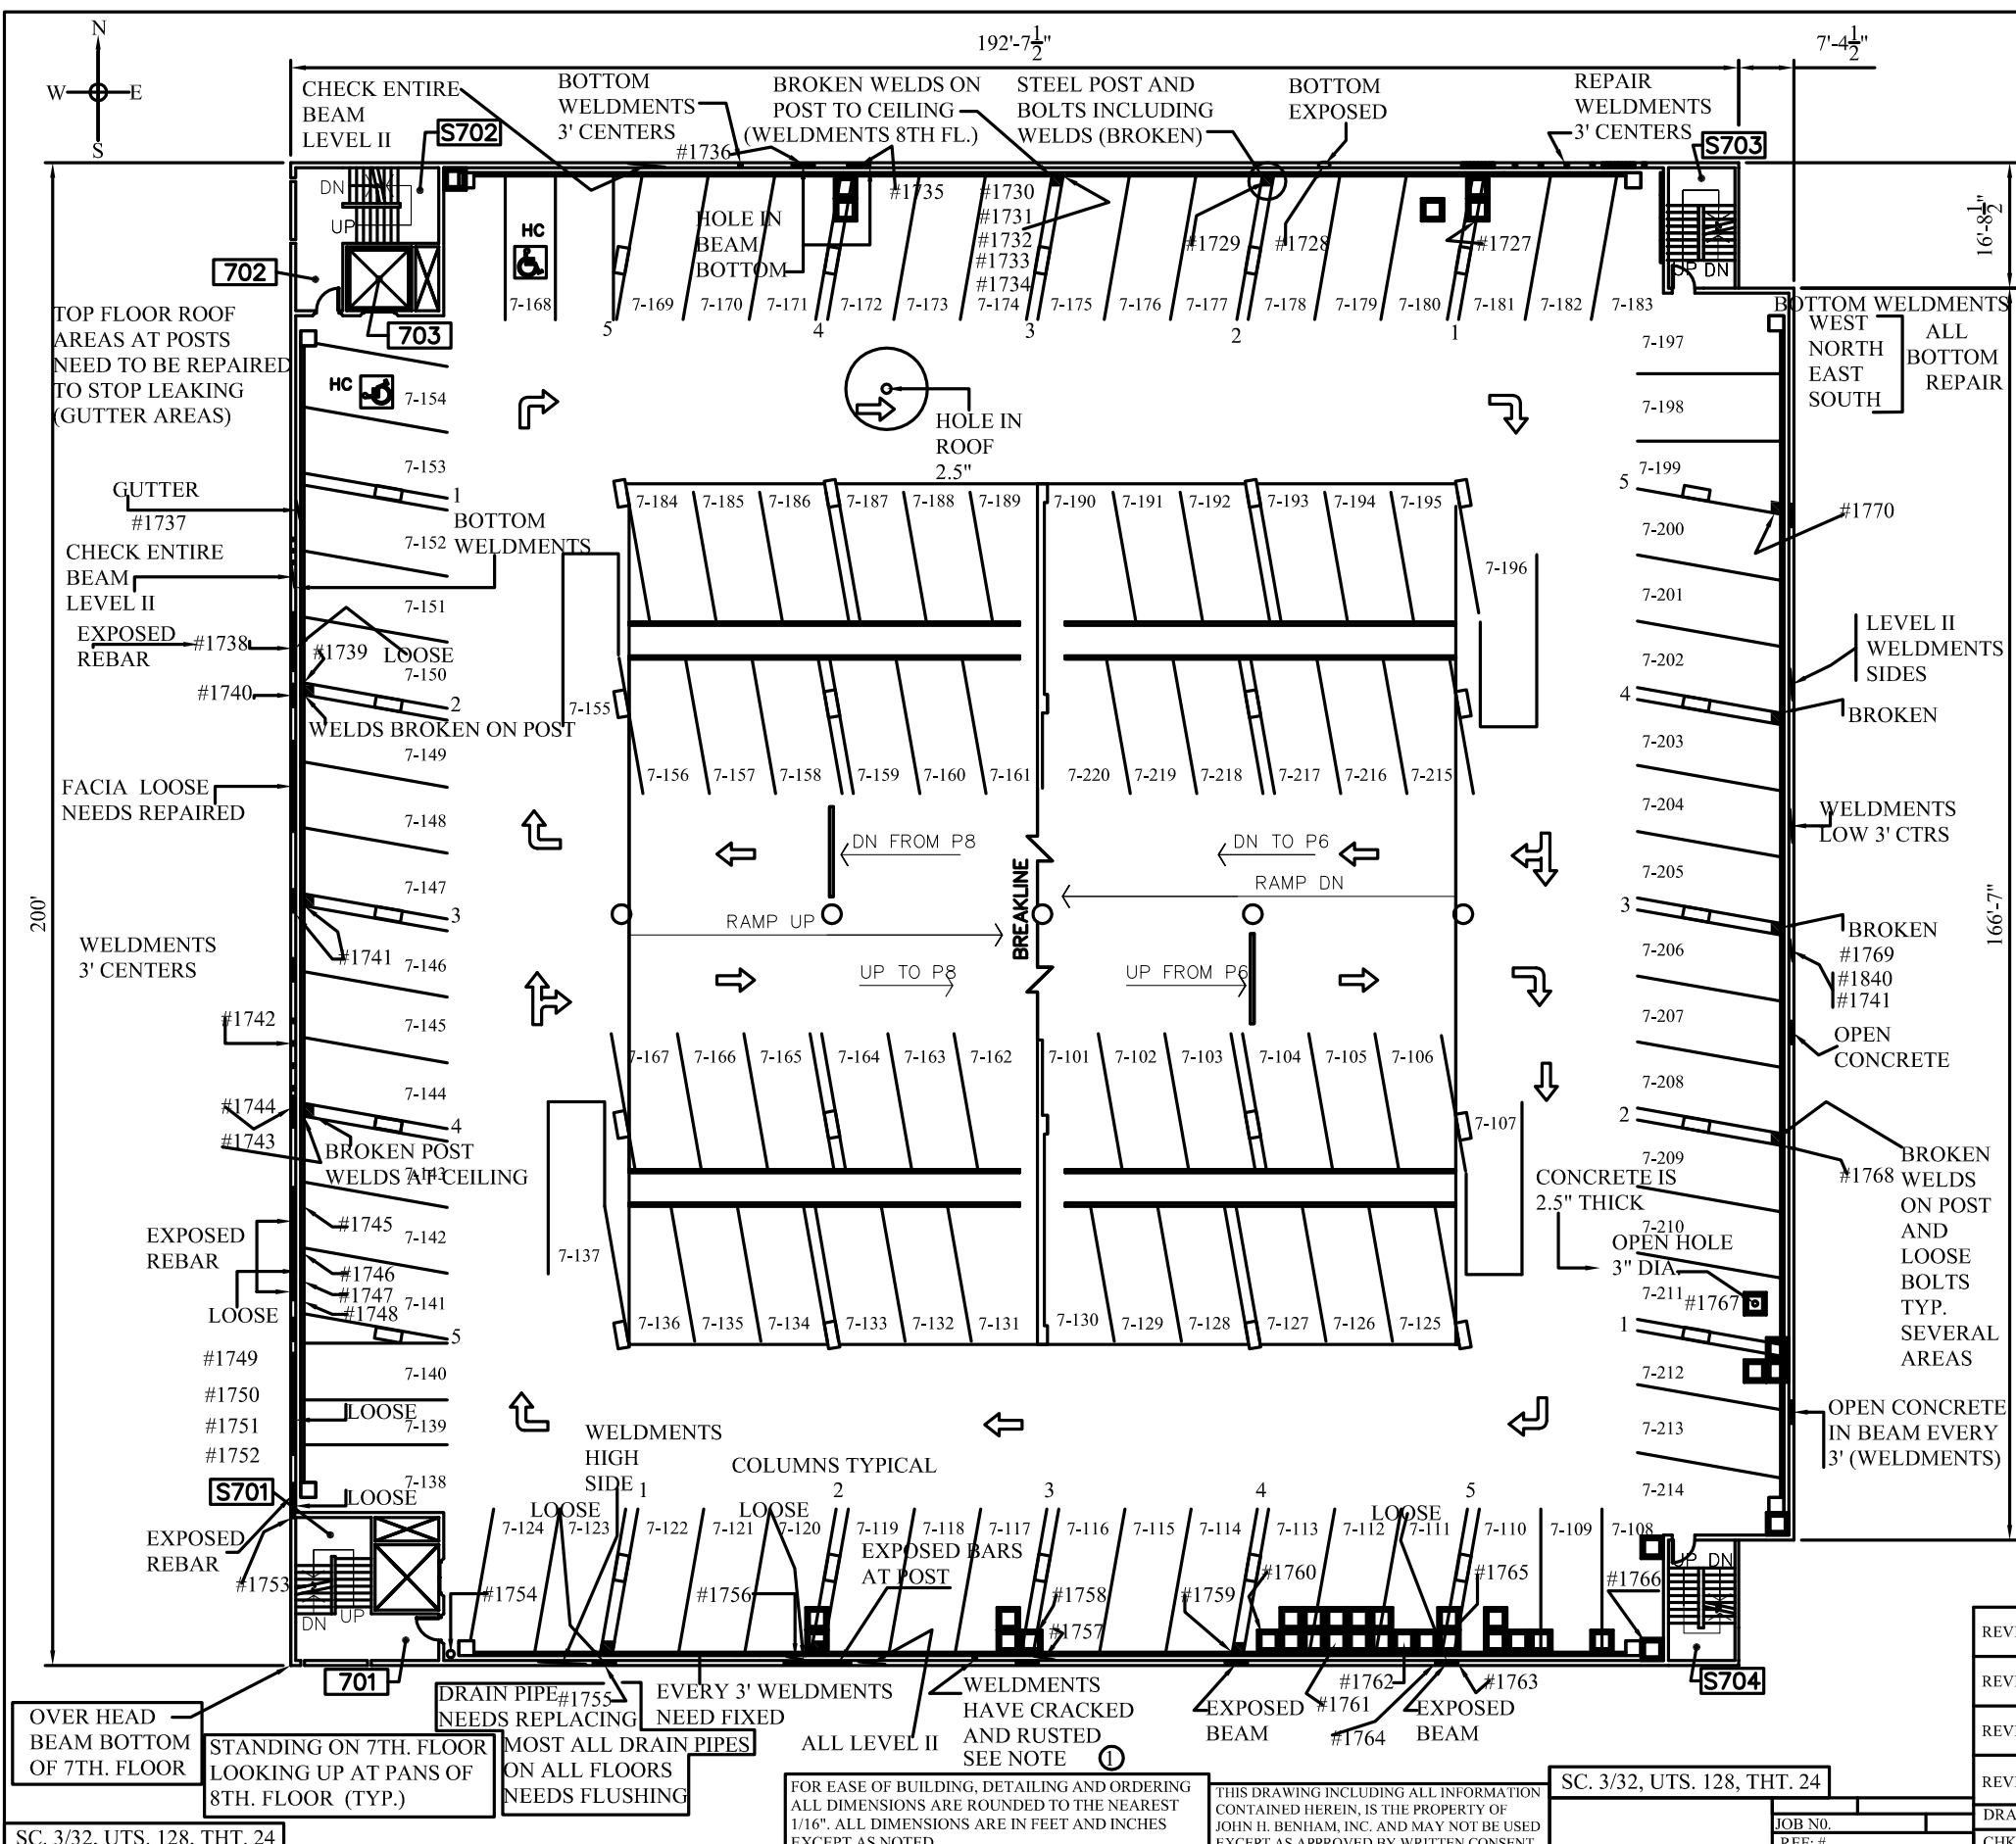
NOTE: ①
 IT APPEARS THAT SOME WELDMENTS ARE EXPANDING AND CONTRACTING: RUSTING EXPANDING AND CONTRACTING DESTROYING THE BEAMS AROUND THE PERIMETER PROBLEM EXISTING ON ALL FLOORS

THE WAFFLE PAN BEAMS NEED TO BE ALLOWED TO EXPAND IN LENGTH: BEAMS COULD BE TEARING THEM SELVES APART (ALSO CONTRACTING)

LIFE TO STRUCTURE IS DEPENDENT UPON CORRECT DRAINAGE. IT APPEARS THAT GUTTERS DO NOT HAVE ENOUGH SLOPE AND DOWN SPOUTS ARE PLUGGED CAUSING WATER TO OVER FLOW AND MIGRATE INTO CRACKS ATTACKING REBAR ALSO COULD BE SOME FREEZE AND THAW.

■ REPRESENTS FLOOR PANS (BOXES) (WAFFLE BEAMS)
 DAMAGE TO WAFFLE BEAMS INCLUDES AND TYPICAL FOR MOST PANS:
 SPALLING
 RUSTY REBAR SHOWING
 RUSTY STAINED CONCRETE
 PIECES OF CONCRETE MISSING
 CRACKS

OVERHEAD BEAM RUNS FULL PERIMETER (7TH. FL.)
 RUSTY DAMAGED WELDMENTS
 BROKEN WELDMENTS
 MISSING WELDMENTS
 TYPICAL OF MOST WELDMENTS WHEN PRESENT
 SOME BEAMS DO NOT HAVE WELDMENTS

WELDMENTS HAVE CRACKED AND RUSTED SEE NOTE ①
 EXPOSED BEAM #1761
 EXPOSED BEAM #1764
 EXPOSED REBAR #1753
 EXPOSED REBAR #1746
 EXPOSED REBAR #1747
 EXPOSED REBAR #1748
 EXPOSED REBAR #1749
 EXPOSED REBAR #1750
 EXPOSED REBAR #1751
 EXPOSED REBAR #1752
 EXPOSED REBAR #1753
 EXPOSED REBAR #1754
 EXPOSED REBAR #1755
 EXPOSED REBAR #1756
 EXPOSED REBAR #1757
 EXPOSED REBAR #1758
 EXPOSED REBAR #1759
 EXPOSED REBAR #1760
 EXPOSED REBAR #1761
 EXPOSED REBAR #1762
 EXPOSED REBAR #1763
 EXPOSED REBAR #1764
 EXPOSED REBAR #1765
 EXPOSED REBAR #1766

OVER HEAD BEAM BOTTOM OF 7TH. FLOOR
 STANDING ON 7TH. FLOOR LOOKING UP AT PANS OF 8TH. FLOOR (TYP.)
 DRAIN PIPE #1755 NEEDS REPLACING
 MOST ALL DRAIN PIPES ON ALL FLOORS NEEDS FLUSHING
 EVERY 3' WELDMENTS NEED FIXED
 ALL LEVEL II

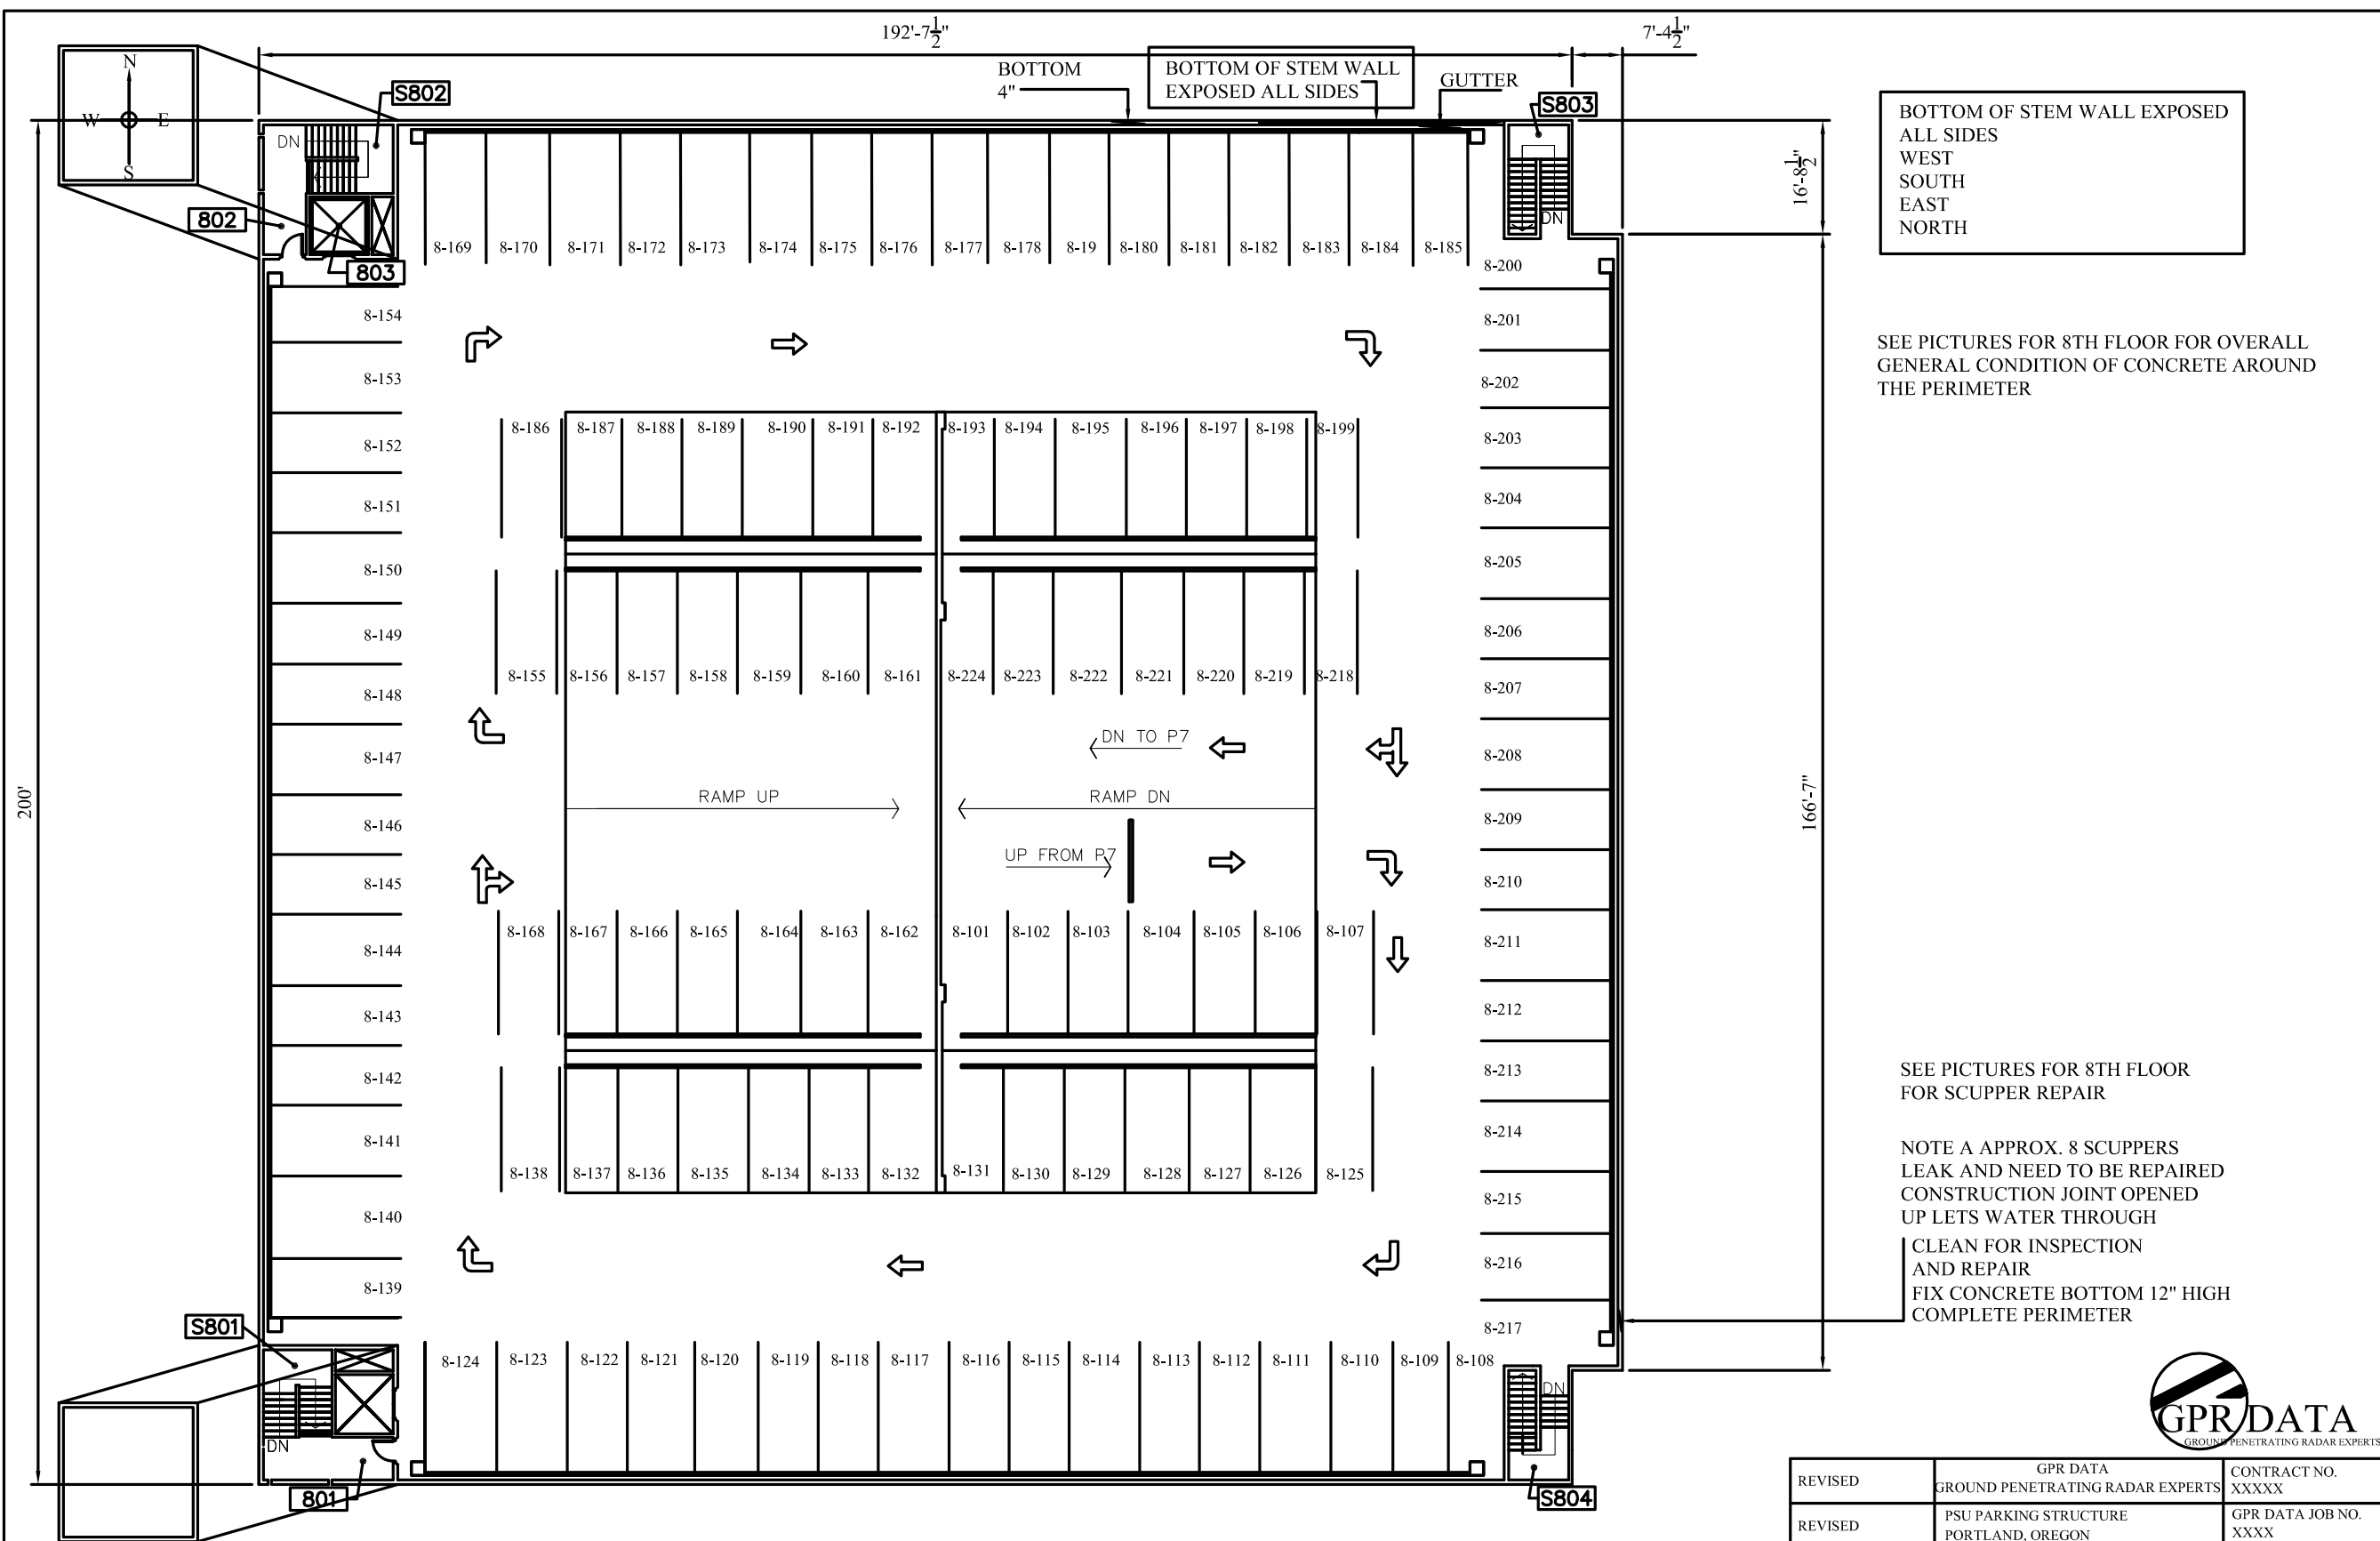
BOTTOM OF STEM WALL EXPOSED ALL SIDES
WEST
SOUTH
EAST
NORTH

NOTE A APPROX. 8 SCUPPERS LEAK AND NEED TO BE REPAIRED
CONSTRUCTION JOINT OPENED UP LETS WATER THROUGH
CLEAN FOR INSPECTION AND REPAIR
FIX CONCRETE BOTTOM 12" HIGH COMPLETE PERIMETER
