Appendix 5.01 Lincoln Hall Asbestos Survey,  
July 2008

# ASBESTOS BUILDING INSPECTION

**LINCOLN HALL  
1620 SW PARK AVENUE  
PORTLAND, OREGON 97201**

FORENSIC ANALYTICAL PROJECT NO. PJ4386

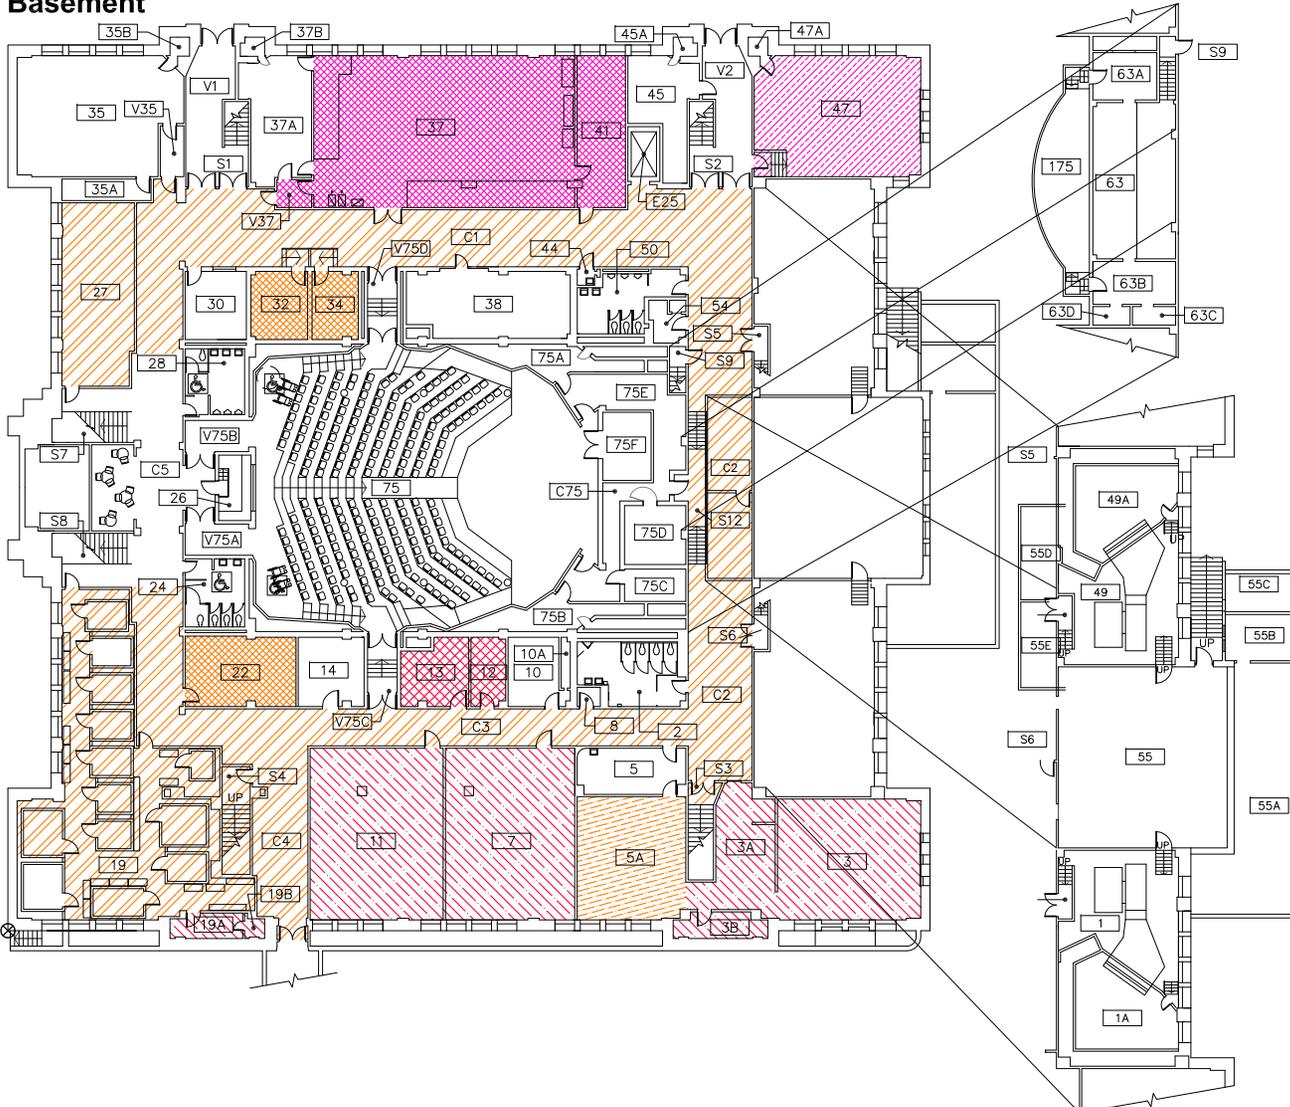
Lincoln Hall  
 Basement  
 ACM Locations

- Floor Tile, 9" x 9" Yellow w/ White, Brown and Red Streaks, and Black Mastic
- Floor Tile, 9" x 9" Grey w/ Black and White Specks
- Floor Tile, 9" x 9" Grey w/ Cream and Black Streaks, and Black Mastic

- Floor Tile, 9" x 9" Green w/ Off White Streaks, and Black Mastic
- Floor Tile, 9" x 9" Beige w/ Brown Streaks, and Black Mastic
- Floor Tile, 9" x 9" Off White w/ Black Streaks, and Black Mastic

- Floor Tile, 9" x 9" Medium Green Streaked
- Floor Tile, 12" x 12" Off White w/ Green Streaks, and Black Mastic
- Floor Tile, 9" x 9" Light Green w/ Blue Streaks, and Black Mastic

- Floor Tile, 9" x 9" Grey w/ Cream and Orange Streaks
- Floor Tile, 12" x 12" Tan w/ White and Brown Streaks, and Black Mastic
- Floor Tile, 12" x 12" Tan w/ White and Brown Specks, and Black Mastic

- Sheet Vinyl, Green Textured Pattern
- Floor Tile, 12" x 12" Light Green w/ Brown and White Streaks
- Floor Tile, 9" x 9" Cream w/ Dark Green Streaks
- Floor Tile, 9" x 9" Brown w/ Cream and Orange Streaks, and Black Mastic

- Floor Tile, 12" x 12" Off White w/ Grey/Green Streaks
- Floor Tile, 12" x 12" White w/ Black Specks
- Floor Material, Cementitious\*\*

ACM not shown:  
 Floor Tile and Mastic under Carpet  
 Adhesive behind Cove Base (Brown)  
 Rigid Pipe Insulation  
 Aircell Pipe Insulation  
 Pipe Fitting Insulation - All Systems  
 Cement Asbestos Board - Room 303 (Old Vent Hood)  
 Aircell Duct Insulation  
 Insulation Panel  
 Silver Paint - Roof  
 Drywall & Asbestos Containing Joint Compound  
 Note: Asbestos-containing second layer floor materials may present in areas not depicted on the diagrams.

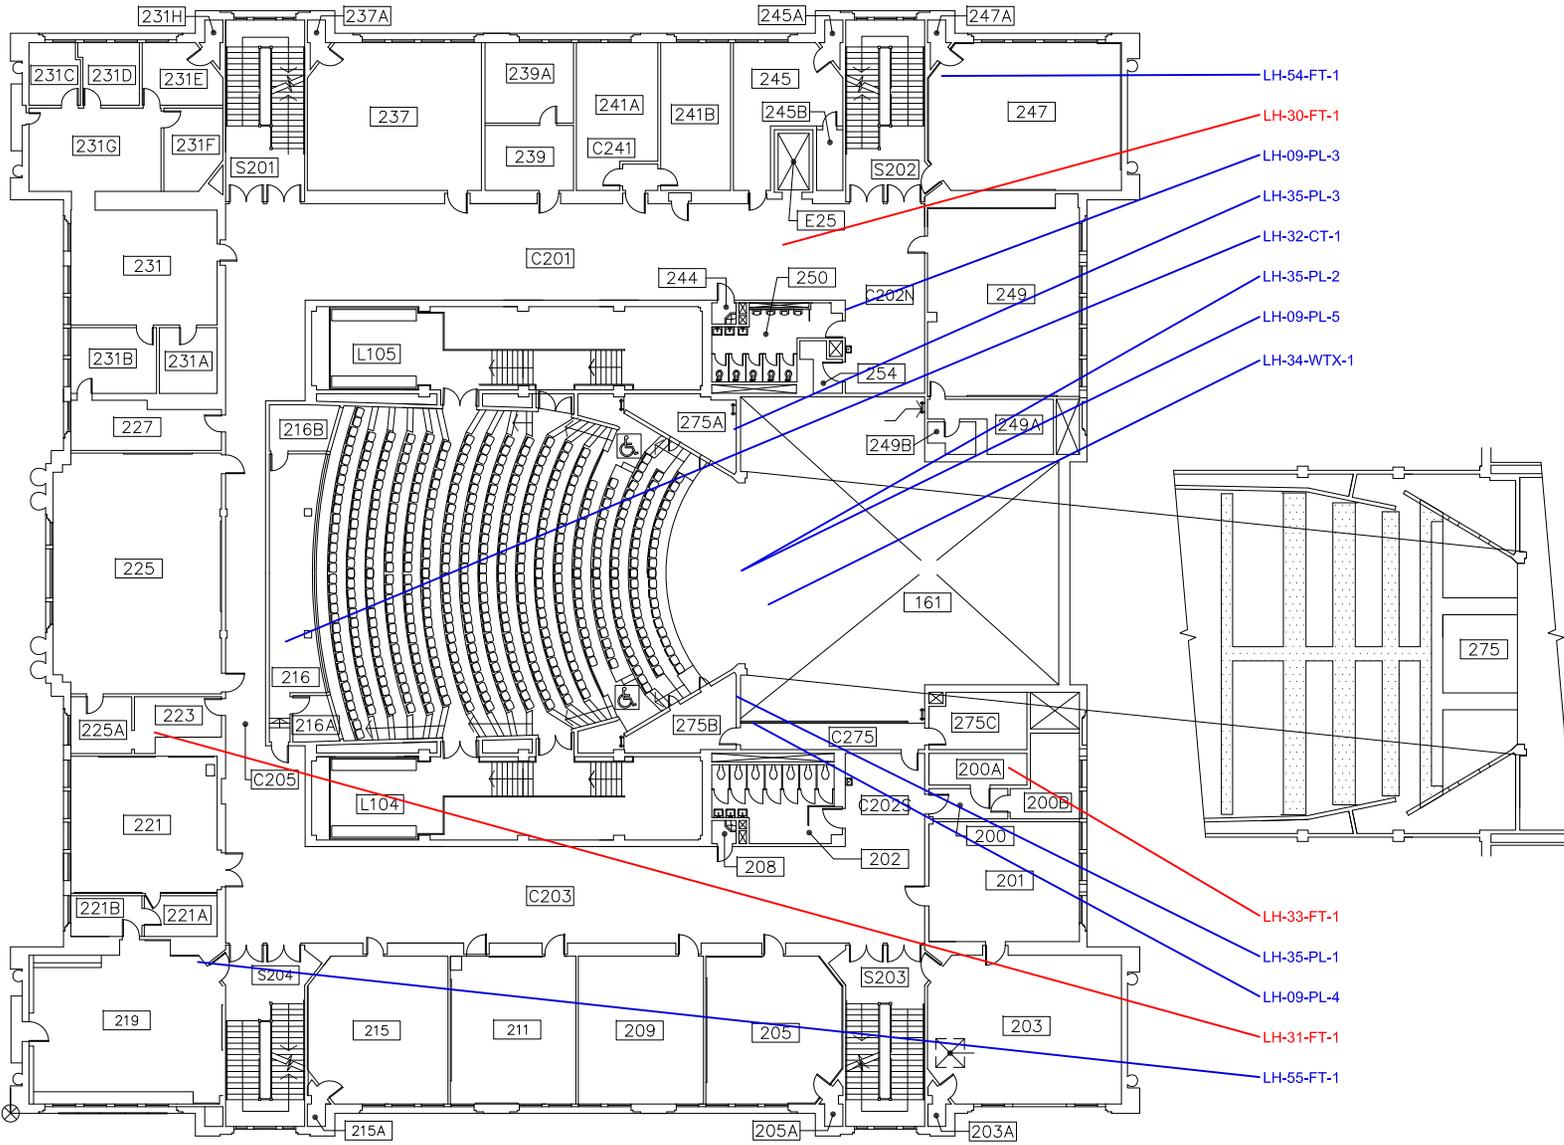
Lincoln Hall  
 2nd Floor  
 Samples Locations

- LH-54-FT-1
- LH-30-FT-1
- LH-09-PL-3
- LH-35-PL-3
- LH-32-CT-1
- LH-35-PL-2
- LH-09-PL-5
- LH-34-WTX-1
- LH-33-FT-1
- LH-35-PL-1
- LH-09-PL-4
- LH-31-FT-1
- LH-55-FT-1
