ASBESTOS BUILDING INSPECTION

**PETER W. STOTT CENTER
930 SW HALL STREET
PORTLAND, OREGON 97201**

JULY 11, 2008

FORENSIC ANALYTICAL PROJECT NO. PJ5587

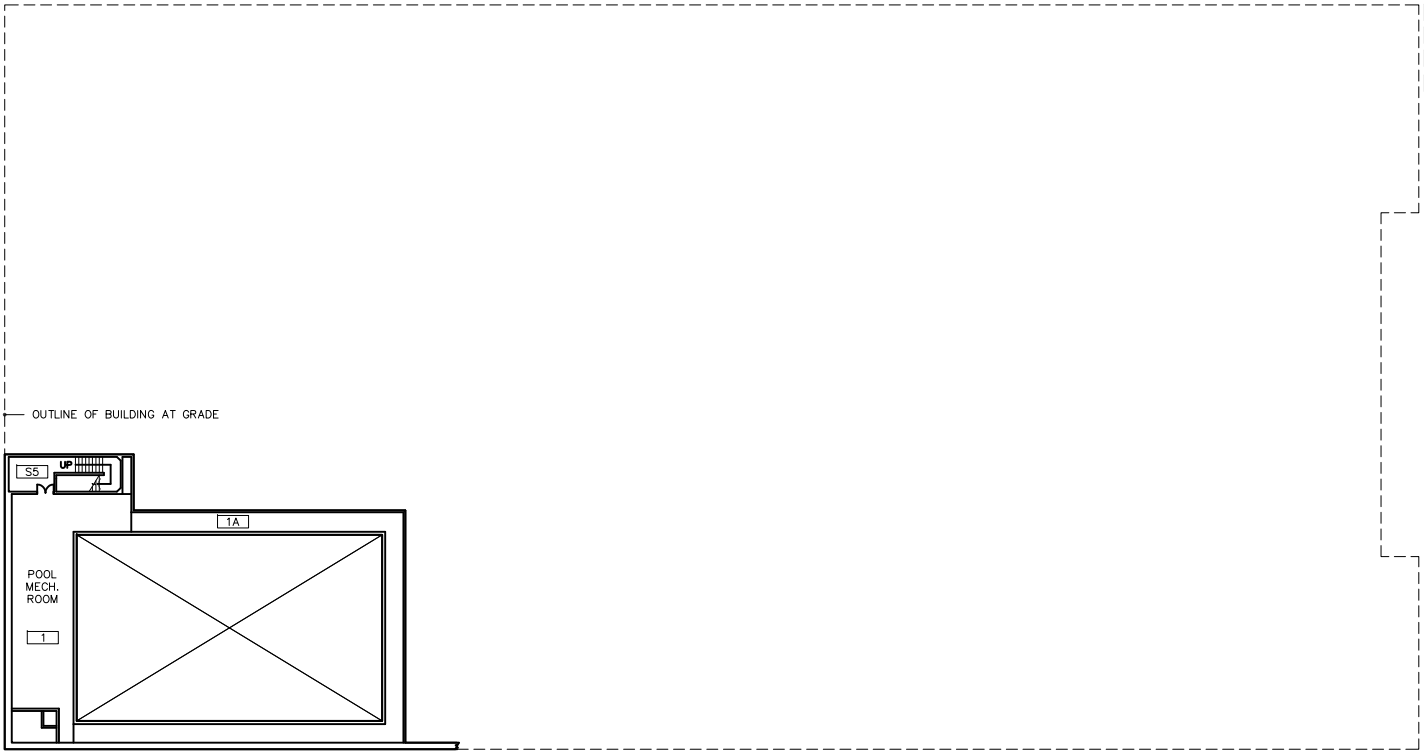
Peter Stott Center
 Basement
 ACM Locations

Floor Tile, 9" x 9" Brown Streaked, and Black Mastic
 -

Ceiling Tile, 12" x 12" Holed
 -

Acoustical Ceiling Texture
 -

Spray-Applied Fireproofing
- ACM not shown:
 Duct Seam Tape
 Pipe Fitting Insulation
 Pipe Insulation

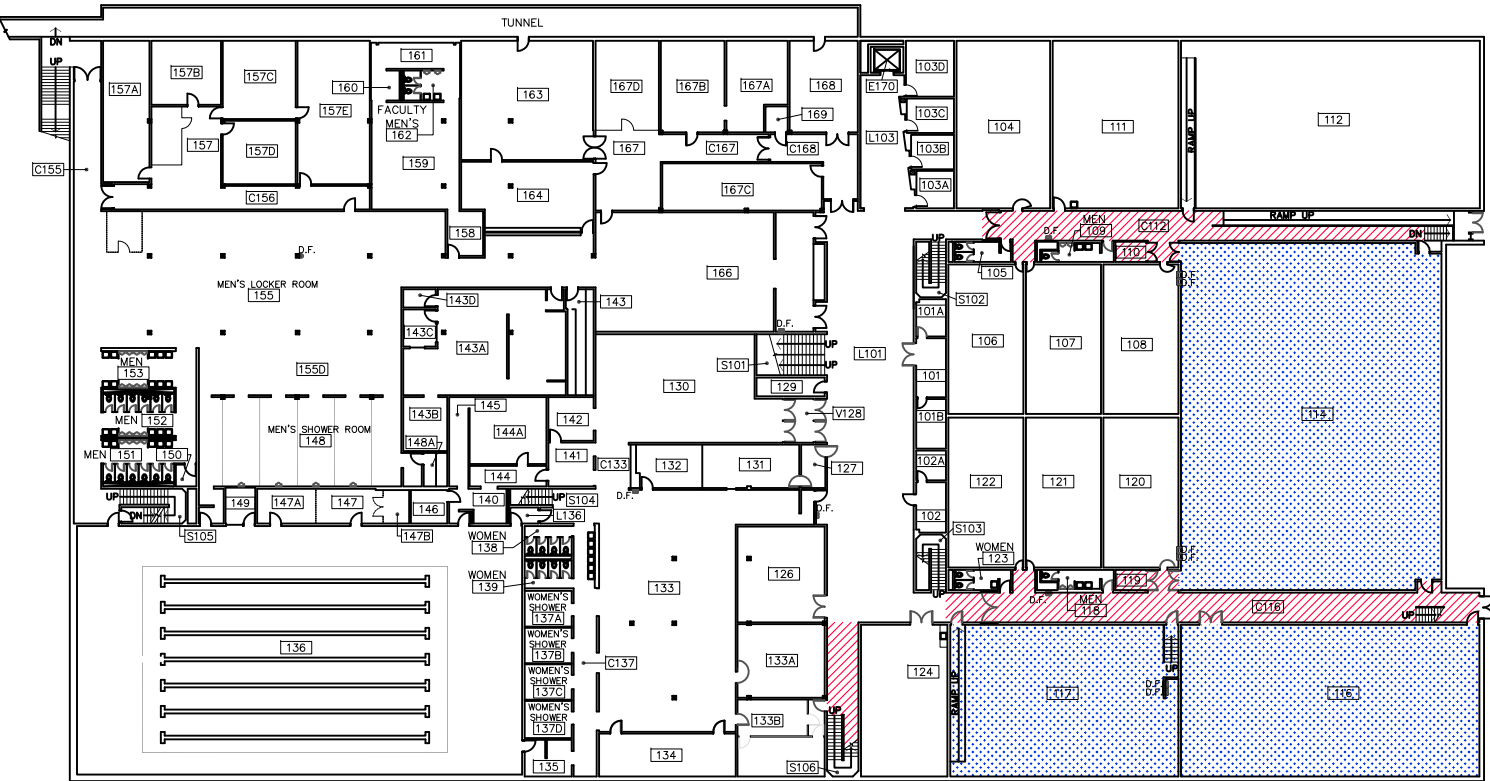
**Peter Stott Center
1st Floor
ACM Locations**

- Floor Tile, 9" x 9" Brown Streaked, and Black Mastic
 - Ceiling Tile, 12" x 12" Holes
 - Acoustical Ceiling Texture
 - Spray-Applied Fireproofing
- ACM not shown:
 Dust Seam Tape
 Pipe Fitting Insulation
 Pipe Insulation

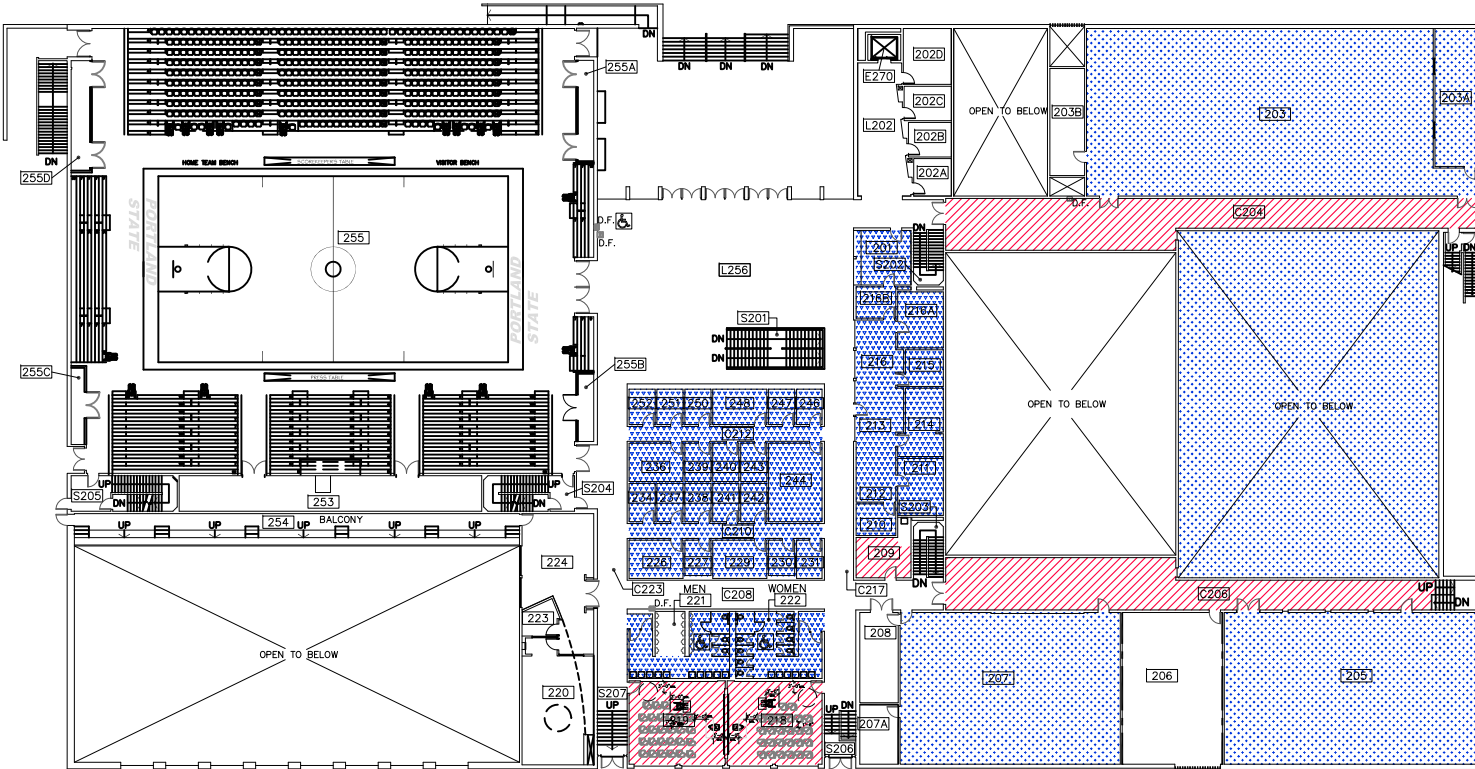
Peter Stott Center
2nd Floor
ACM Locations

- Floor Tile, 9" x 9" Brown Streaked, and Black Mastic
- Ceiling Tile, 12" x 12" Holed
- Acoustical Ceiling Texture
- Spray-Applied Fireproofing
- ACM not shown:
 - Duct Seam Tape
 - Pipe Fitting Insulation
 - Pipe Insulation

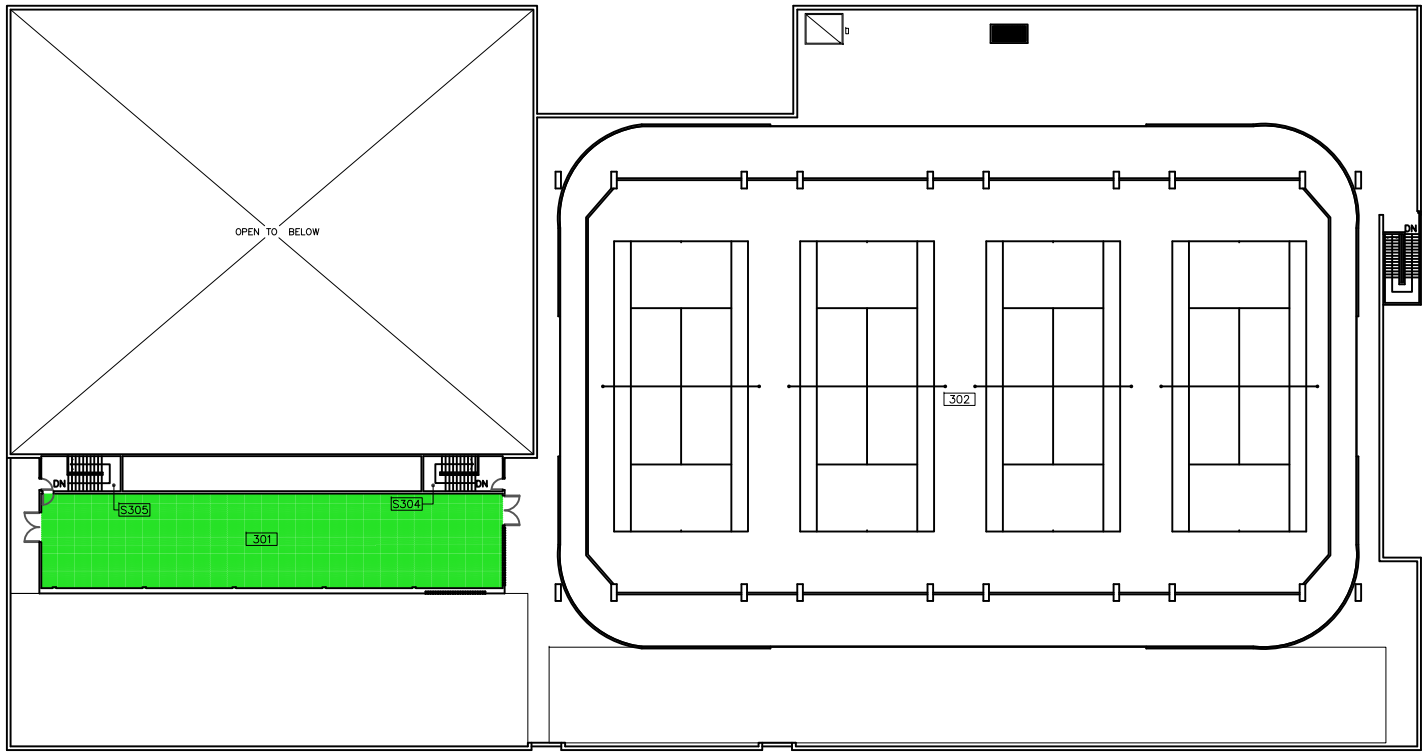
Peter Stott Center
 Roof
 ACM Locations

Floor Tile, 9" x 9" Brown Streaked, and Black Mastic
 -

Ceiling Tile, 12" x 12" Holed
 -

Acoustical Ceiling Texture
 -

Spray-Applied Fireproofing
- ACM not shown:
 Duct Seam Tape
 Pipe Fitting Insulation
 Pipe Insulation

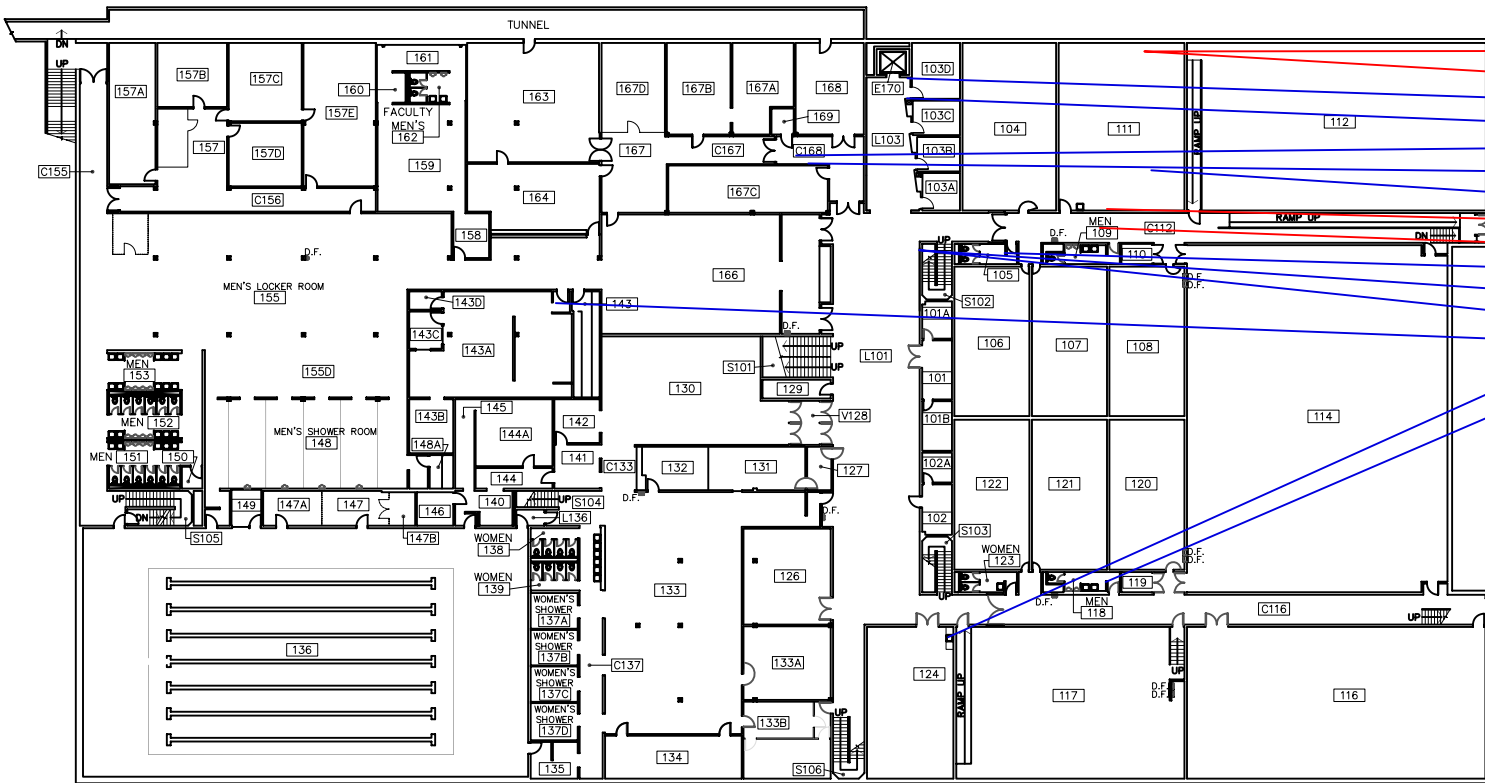
Peter Stott Center
 1st Floor
 Sample Locations

- PSC-16-TS#1
- PSC-17-TS#1
- PSC-14-FT-1
- PSC-07-DWJC-2
- PSC-19-CT-1
- PSC-07-DWJC-3
- PSC-15-VJC-1
- PSC-09-TS#1
- PSC-09-TS#3
- PSC-10-PL-4
- PSC-12-FT-1
- PSC-13-FT-1
- PSC-18-SV-1
- PSC-22-SU-1
- PSC-10-PL-3

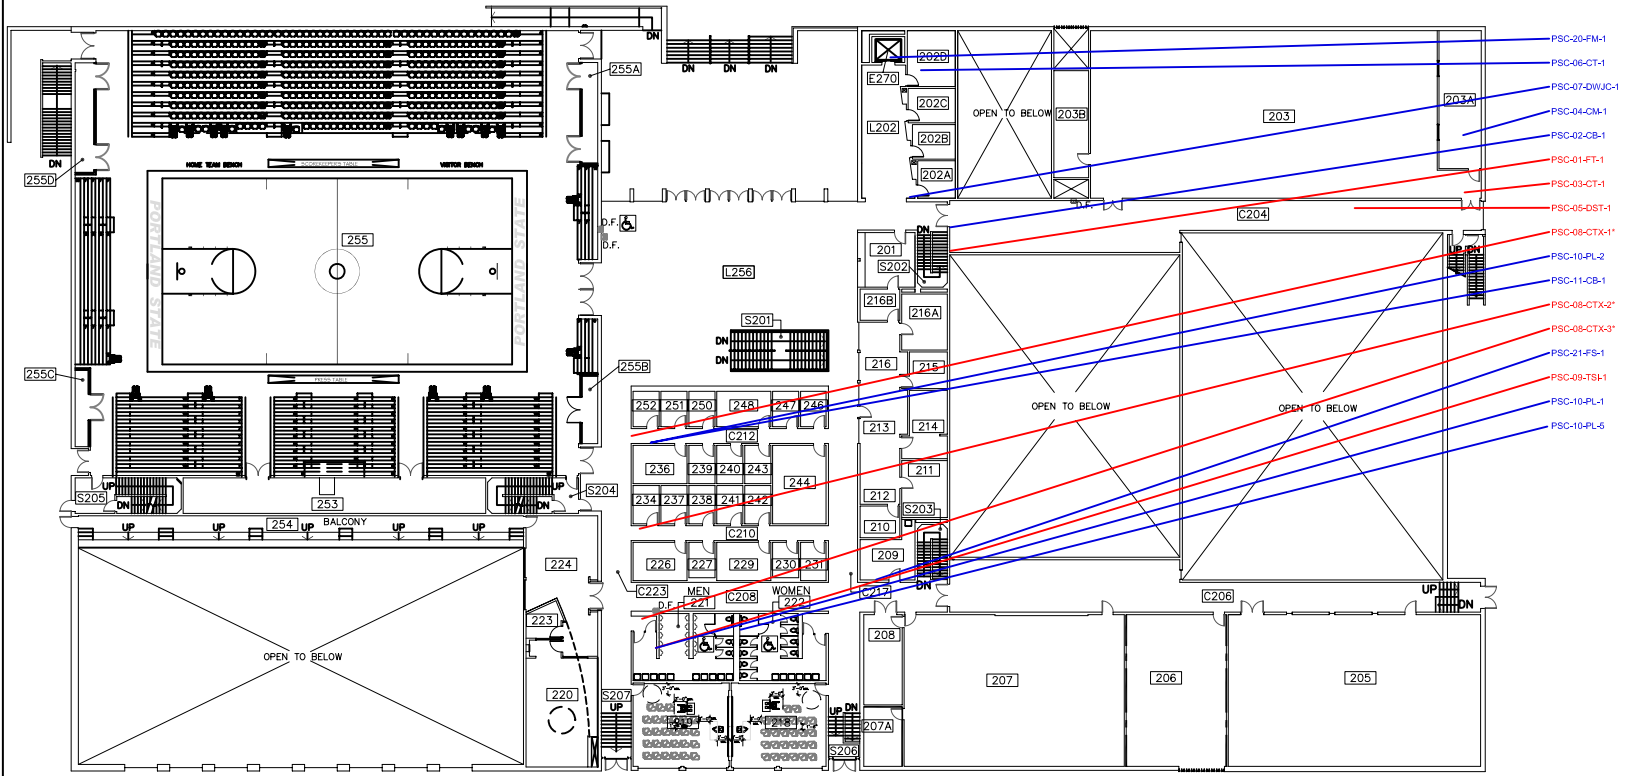
Peter Stott Center
 2nd Floor
 Sample Locations

- PSC-20-FM-1
- PSC-06-CT-1
- PSC-07-DWJC-1
- PSC-04-CM-1
- PSC-02-CB-1
- PSC-01-FT-1
- PSC-03-CT-1
- PSC-05-DST-1
- PSC-08-CTX-1*
- PSC-10-PL-2
- PSC-11-CB-1
- PSC-08-CTX-2*
- PSC-08-CTX-3*
- PSC-21-FS-1
- PSC-09-TSH-1
- PSC-10-PL-1
- PSC-10-PL-6
