ASBESTOS BUILDING INSPECTION

**UNIVERSITY SERVICES BUILDING
617 SW MONTGOMERY STREET
PORTLAND, OREGON 97201**

JULY 7, 2008

FORENSIC ANALYTICAL PROJECT NO. PJ5563

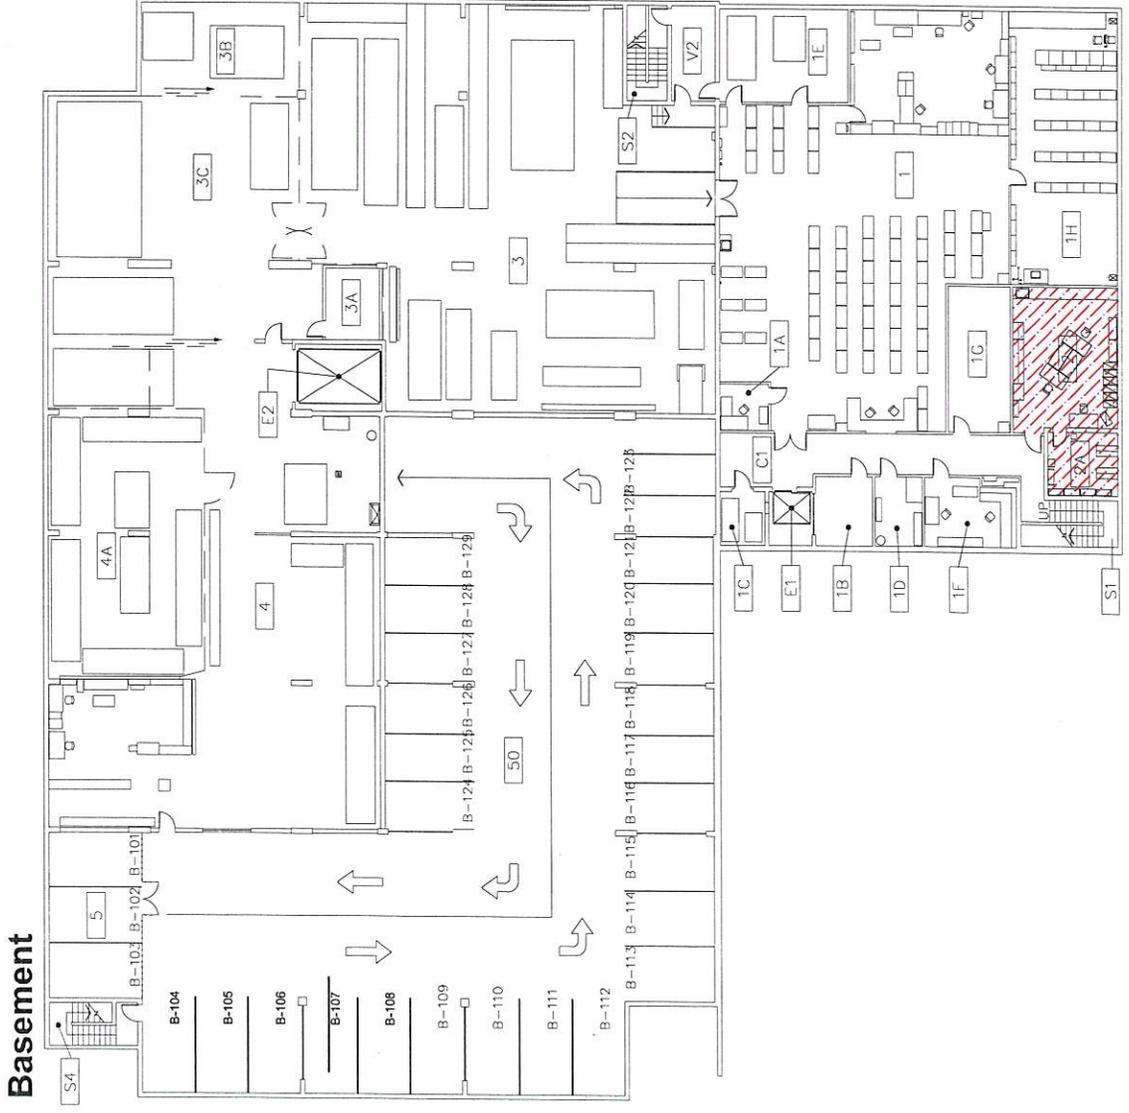
University Services Building
 Basement
 ACM Locations

- Floor Tile, 12" x 12" Beige w/ Brown Specks, and Black Mastic
 - Ceiling Tile, 2' x 4' Fissured w/ Pinholes**
 - Acoustical Ceiling Texture
 - Floor Tile, 12" x 12" Off White w/ Green Streaks**
 - Floor Tile, 12" x 12" Tan Marbled
 - Spray-Applied Fireproofing
- ACM not shown:
 Pipe Fitting Insulation
 Sink Undercoating, Black
 Duct Seam Tape
 Rigid Pipe Insulation
 Rigid Tank Insulation
 Roof Patch & Repair Material

** - This material contains a trace amount of asbestos.

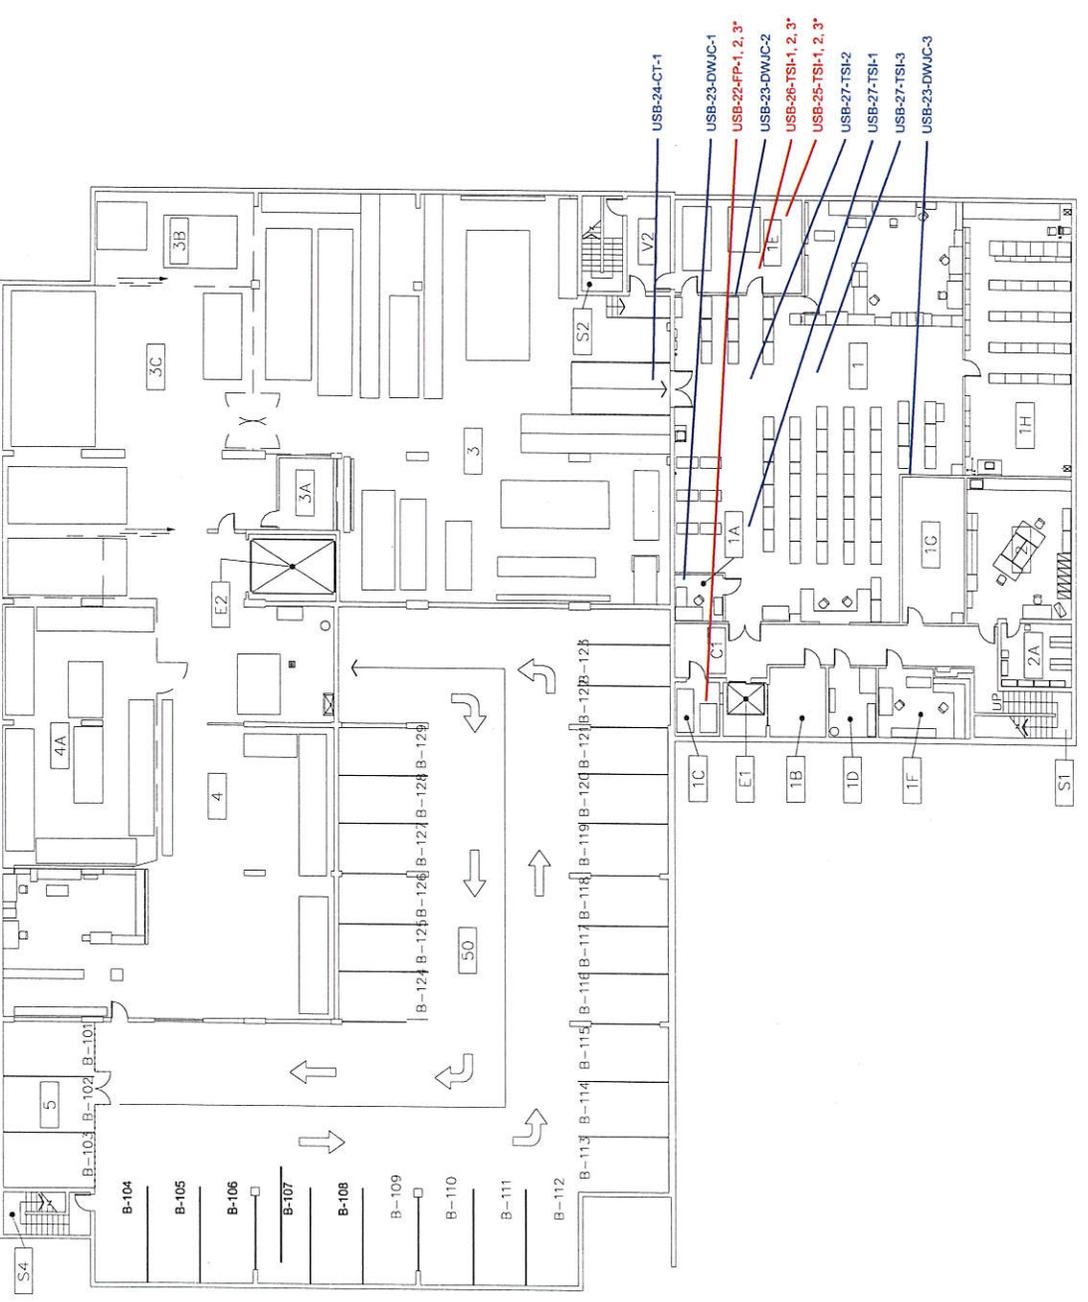
University Services Building
 Basement
 Samples Locations

** This sample is part of a set in which one of the samples tested positive for asbestos.
 ** This sample contained a trace amount of asbestos.

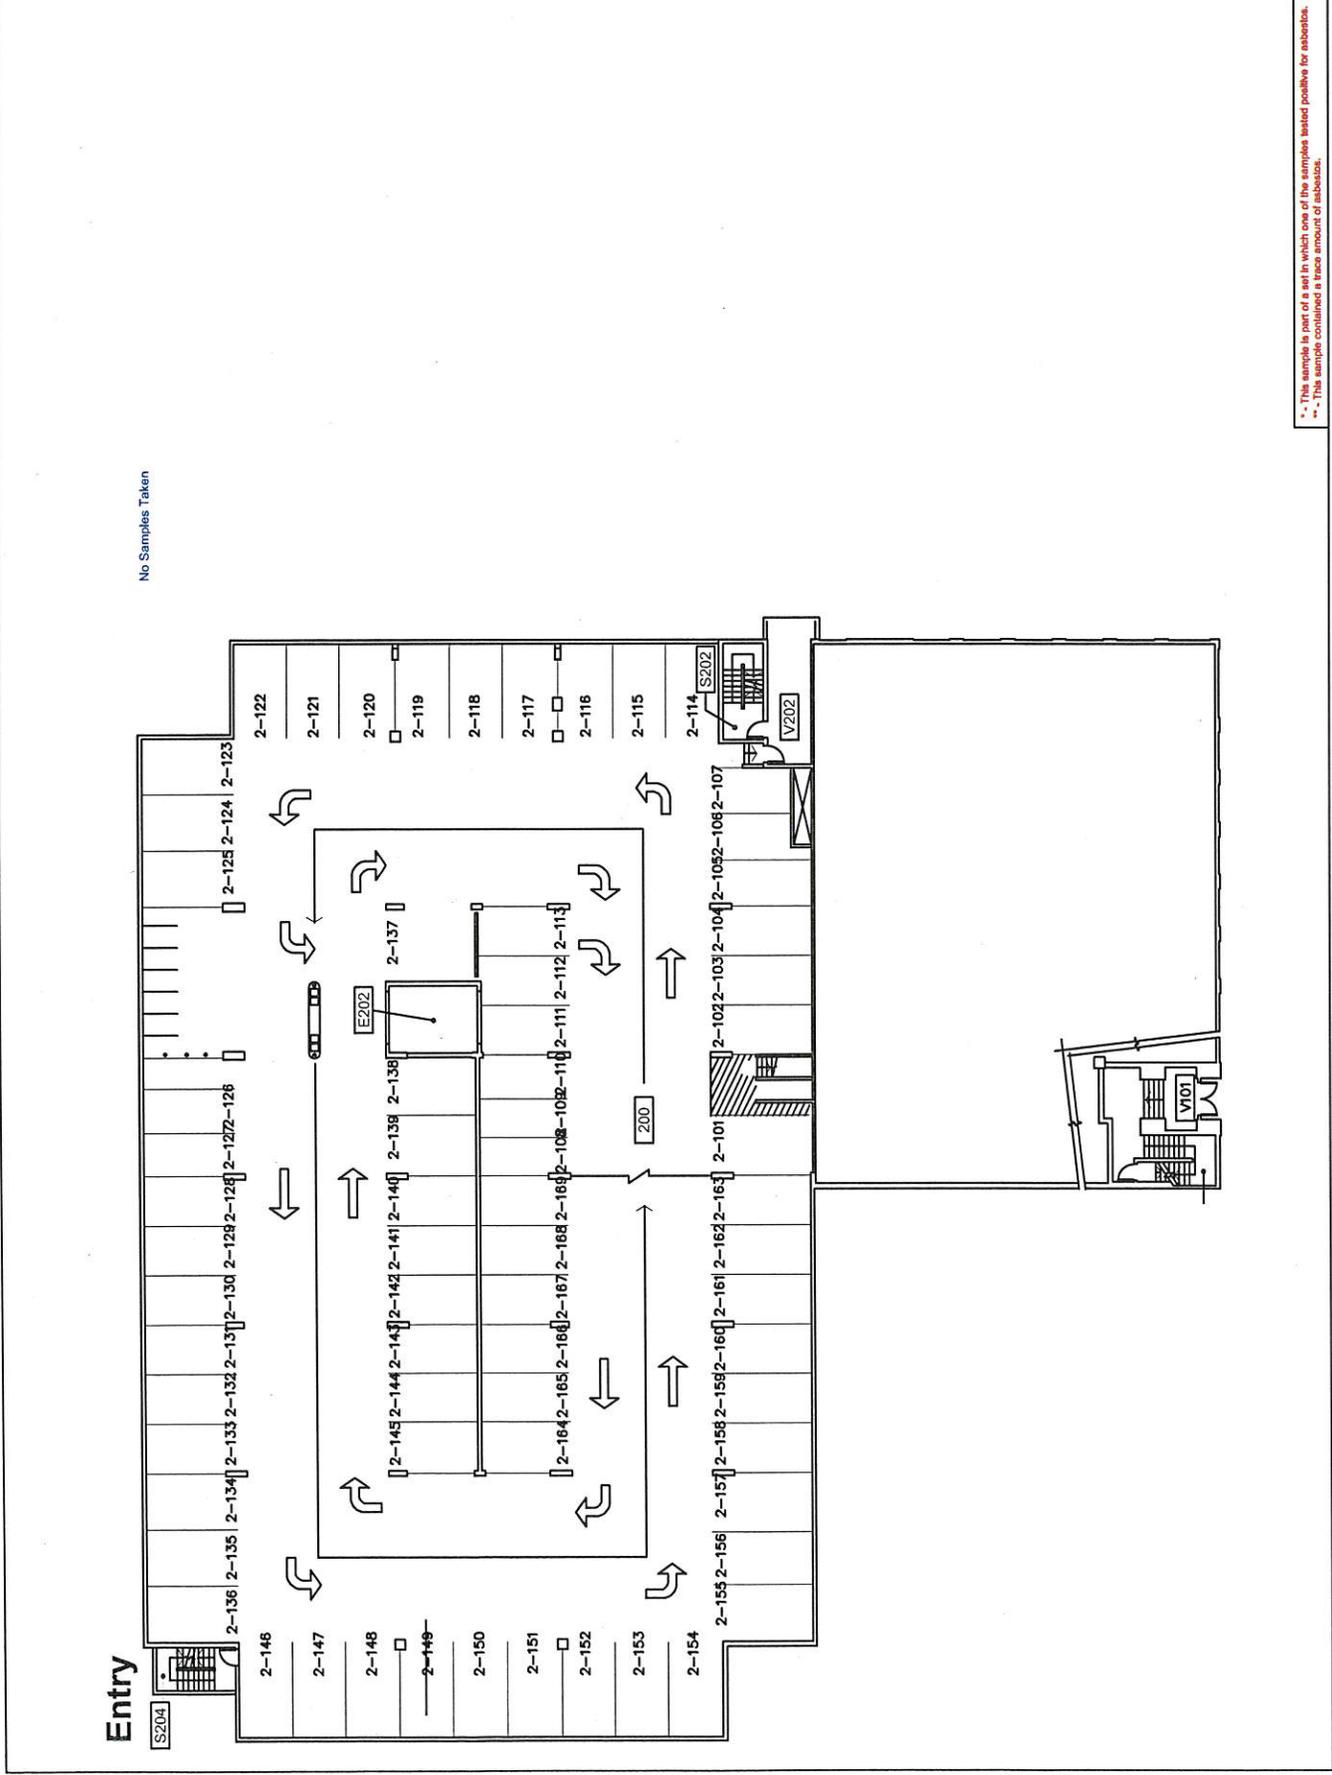
University Services Building
 Entry Floor
 Samples Locations

* - This sample is part of a set in which one of the samples tested positive for asbestos.
 ** - This sample contained a trace amount of asbestos.

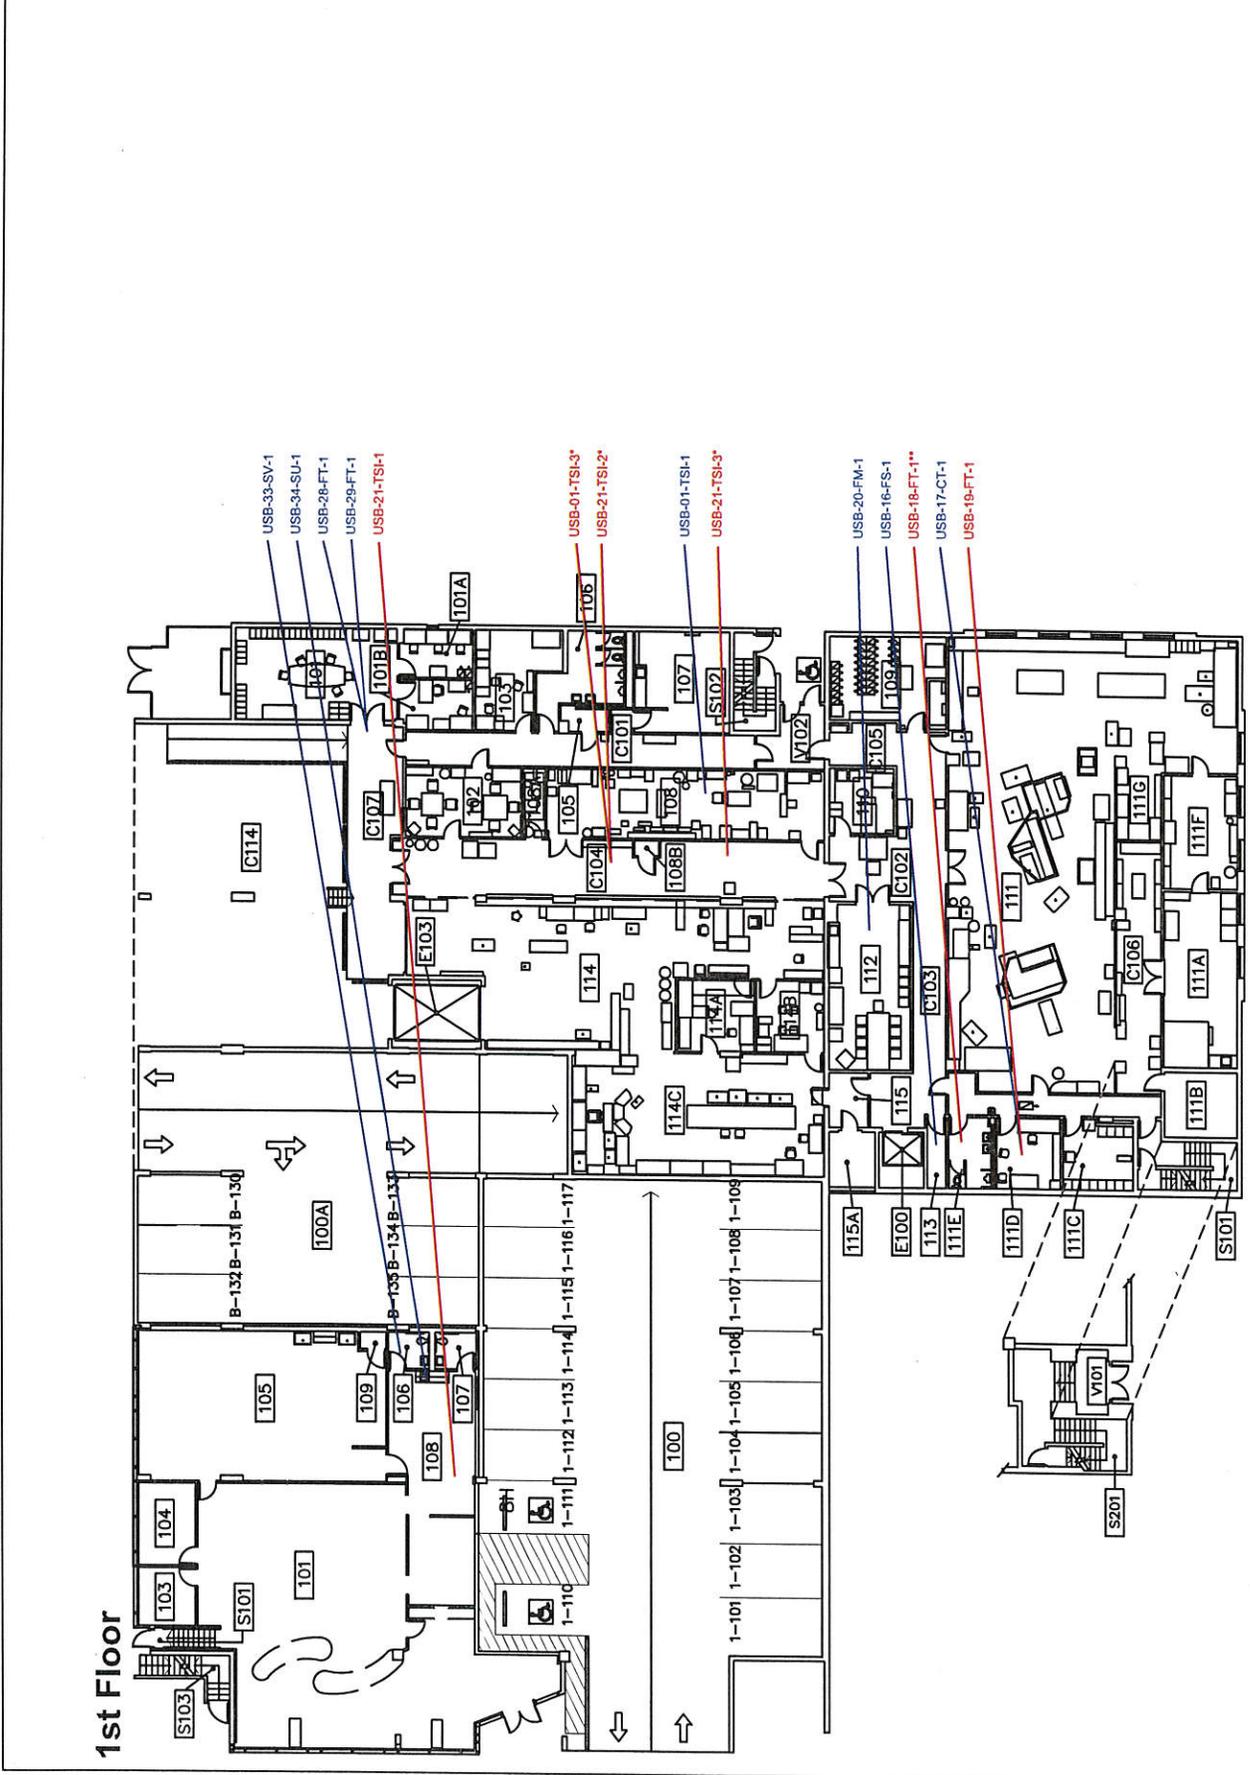
University Services Building
 1st Floor
 Samples Locations

.. This sample is part of a set in which one of the samples tested positive for asbestos.
 ** - This sample contained a trace amount of asbestos.

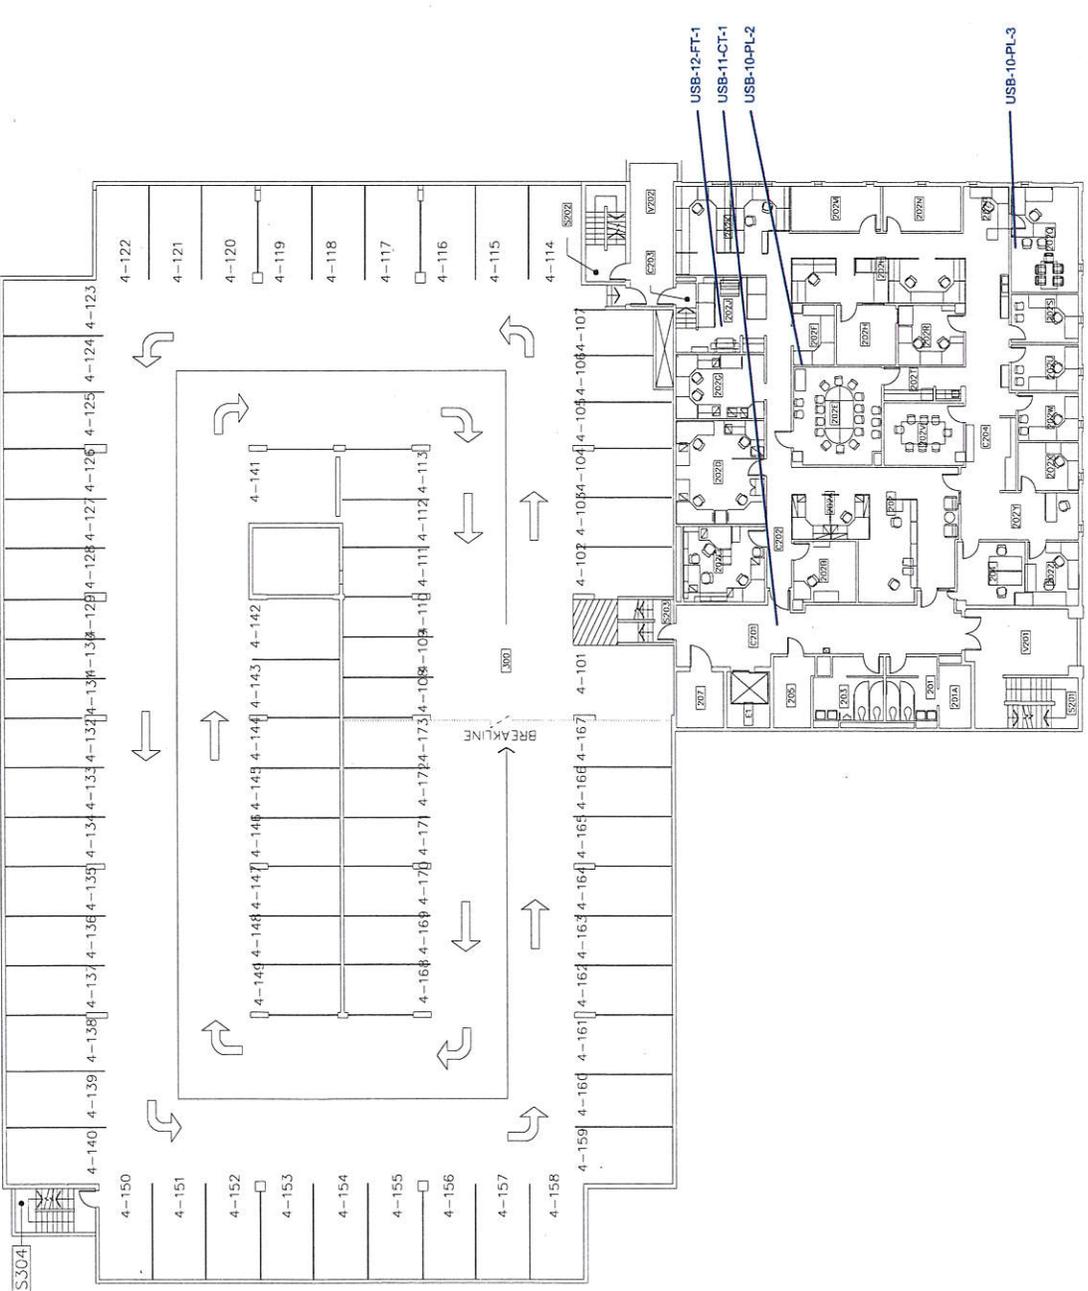
University Services Building
2nd Floor
Samples Locations

* - This sample is part of a set in which one of the samples tested positive for asbestos.
** - This sample contained a trace amount of asbestos.

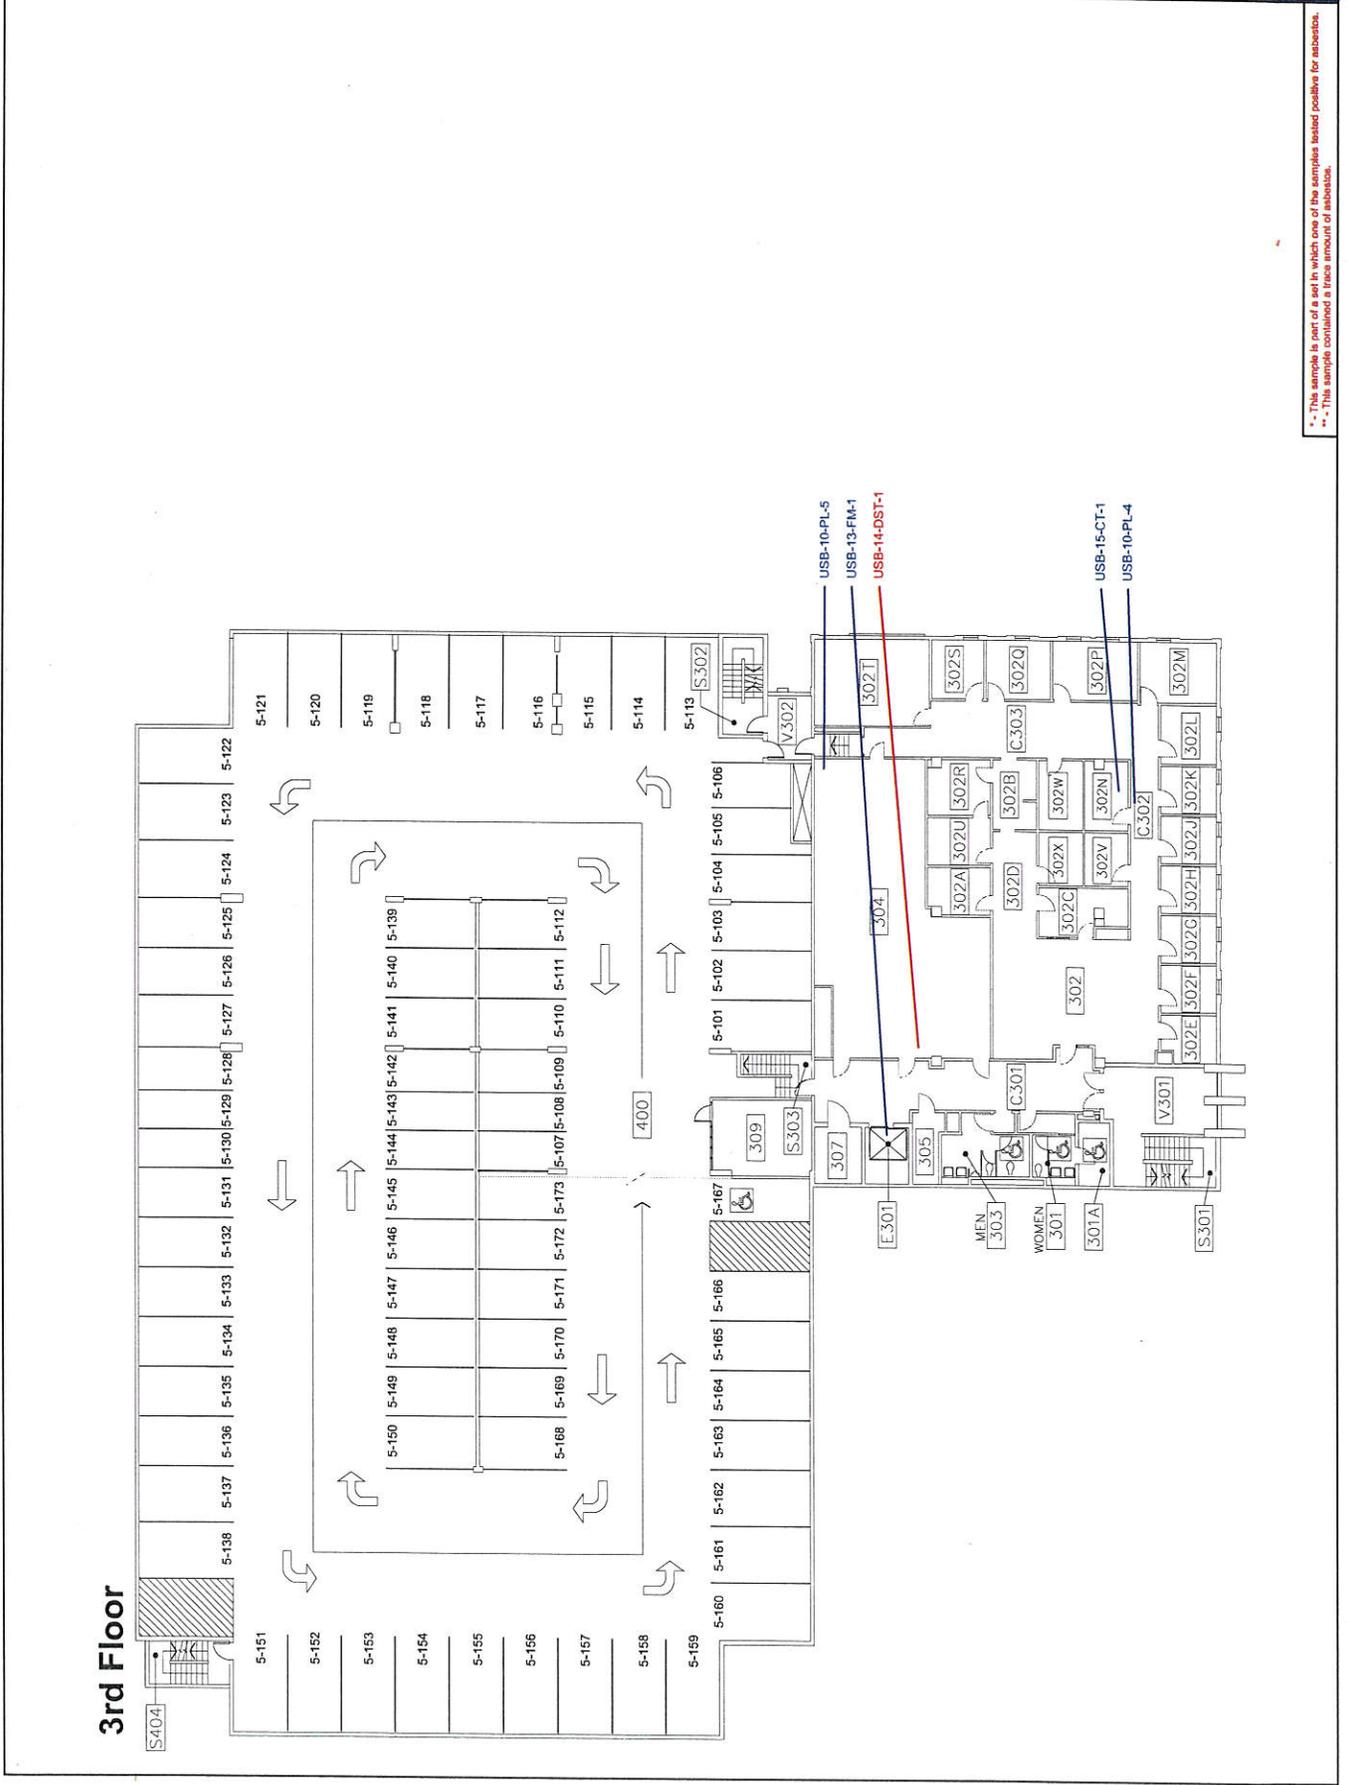
University Services Building
 3rd Floor
 Samples Locations

* - This sample is part of a set in which one of the samples tested positive for asbestos.
 ** - This sample contained a trace amount of asbestos.

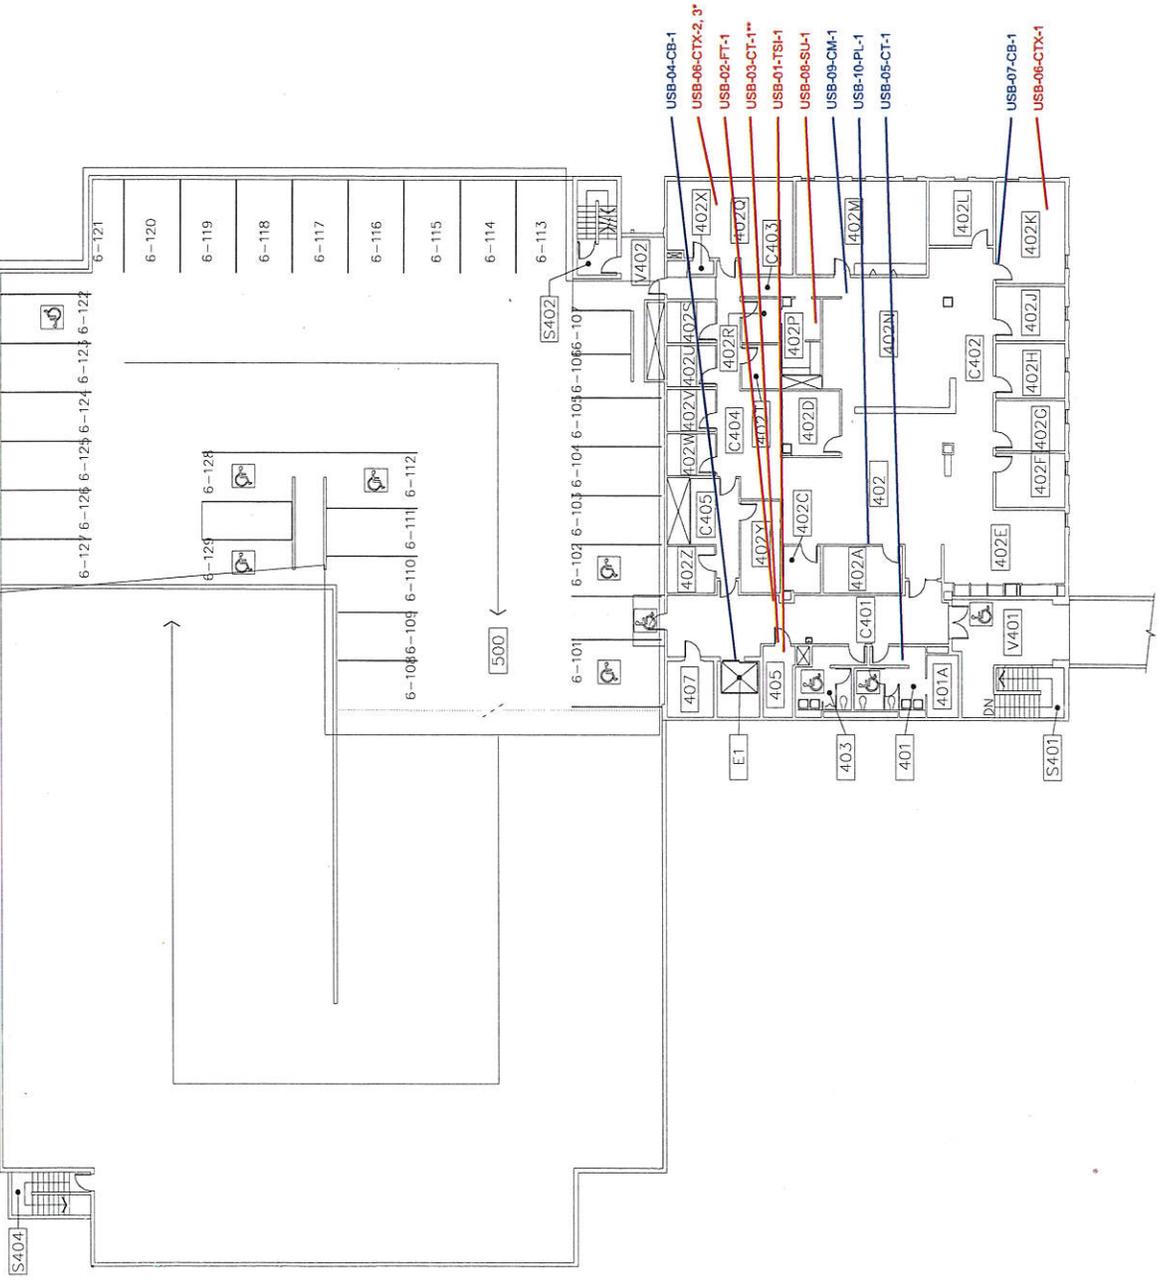
University Services Building
4th Floor
Samples Locations

.. This sample is part of a set in which one of the samples tested positive for asbestos.
.. This sample contained a trace amount of asbestos.

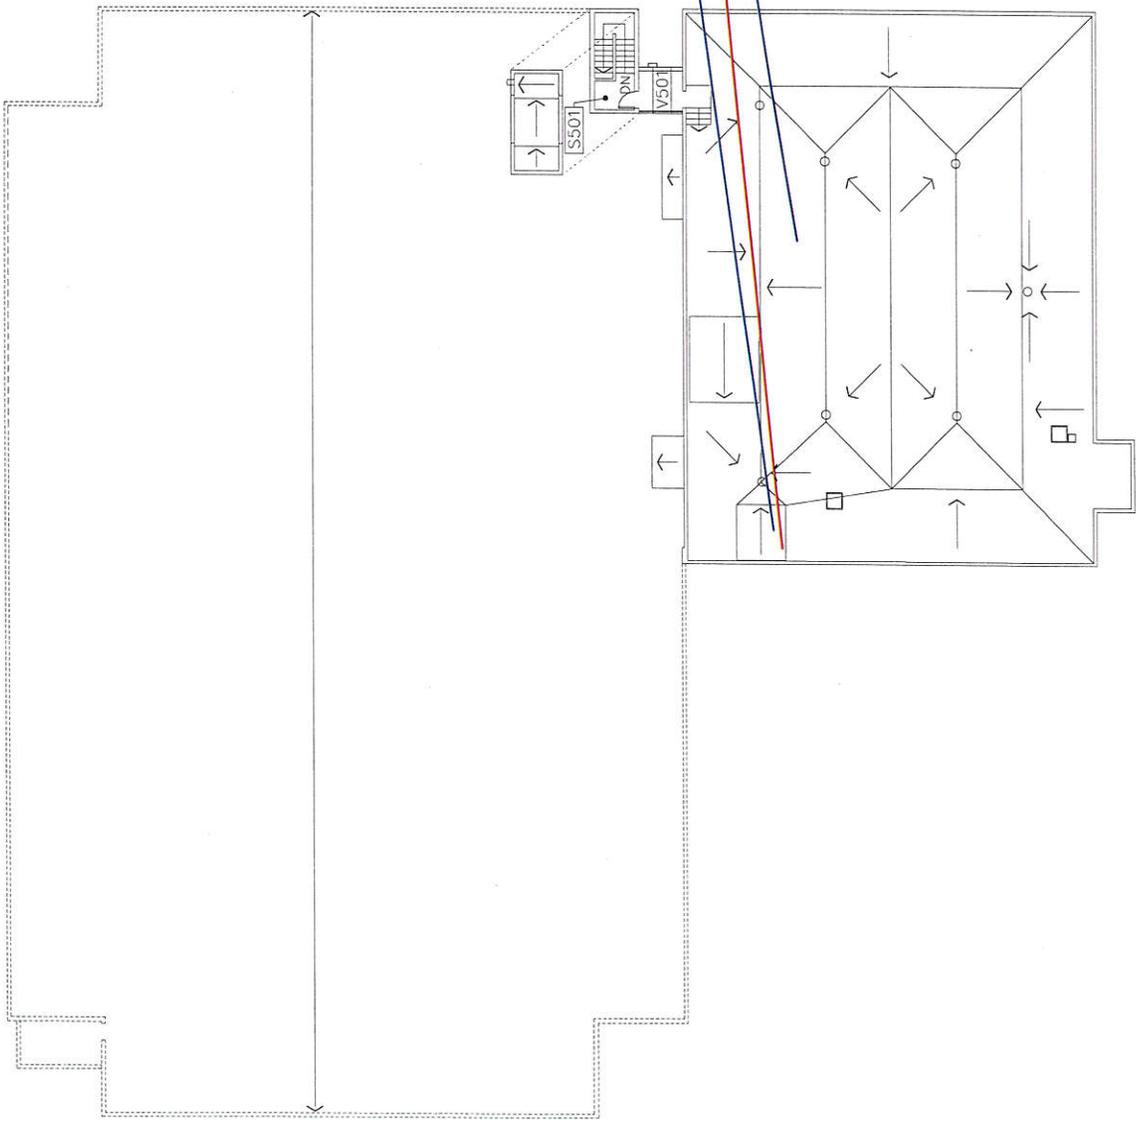
University Services Building
 Roof Plan
 Samples Locations

* - This sample is part of a set in which one of the samples tested positive for asbestos.
 ** - This sample contained a trace amount of asbestos.
