# ASBESTOS BUILDING INSPECTION

**GRADUATE SCHOOL OF EDUCATION  
615 SW HARRISON STREET  
PORTLAND, OREGON 97201**

JULY 11, 2008

FORENSIC ANALYTICAL PROJECT NO. PJ5552

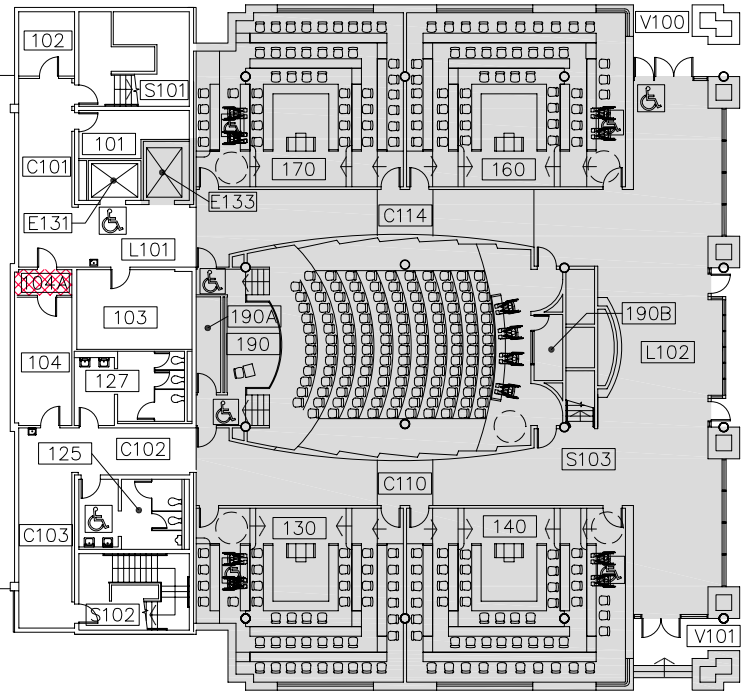
Graduate School of Education  
 1st Floor  
 ACM Locations

- Floor Tile, 12" x 12" Brown w/ Dark Brown and White Specks\*\* and Black Mastic
  - Sheet Vinyl, Brown Pebble Pattern
- ACM not shown:  
 Slink Undercoating, Black  
 HVAC Compound, Grey

\*\* - This material contains a trace amount of asbestos

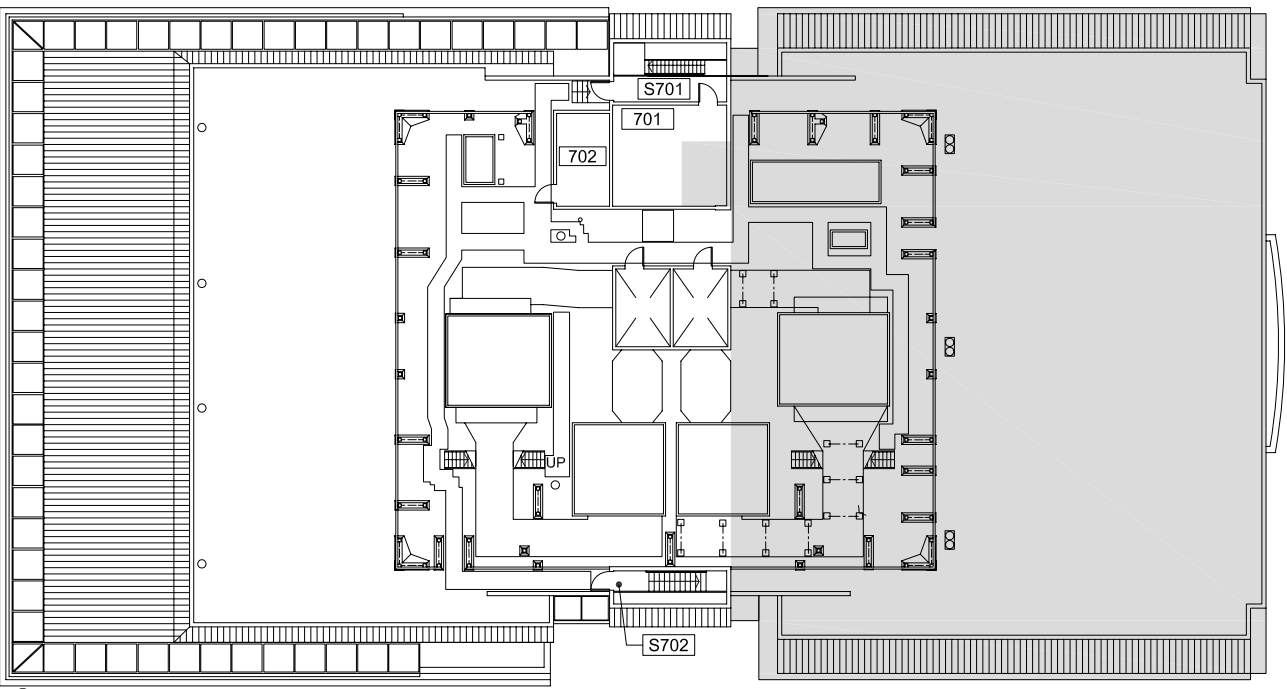
Graduate School of Education  
7th Floor  
ACM Locations

Floor Tile, 12" x 12" Brown w/ Dark Brown and White Specks\*\* and Black Mastic
-

Sheet Vinyl, Brown Pebble Pattern

ACM not shown:  
Sink Undercoating, Black  
HVAC Compound, Grey

\*\* - This material contains a trace amount of asbestos

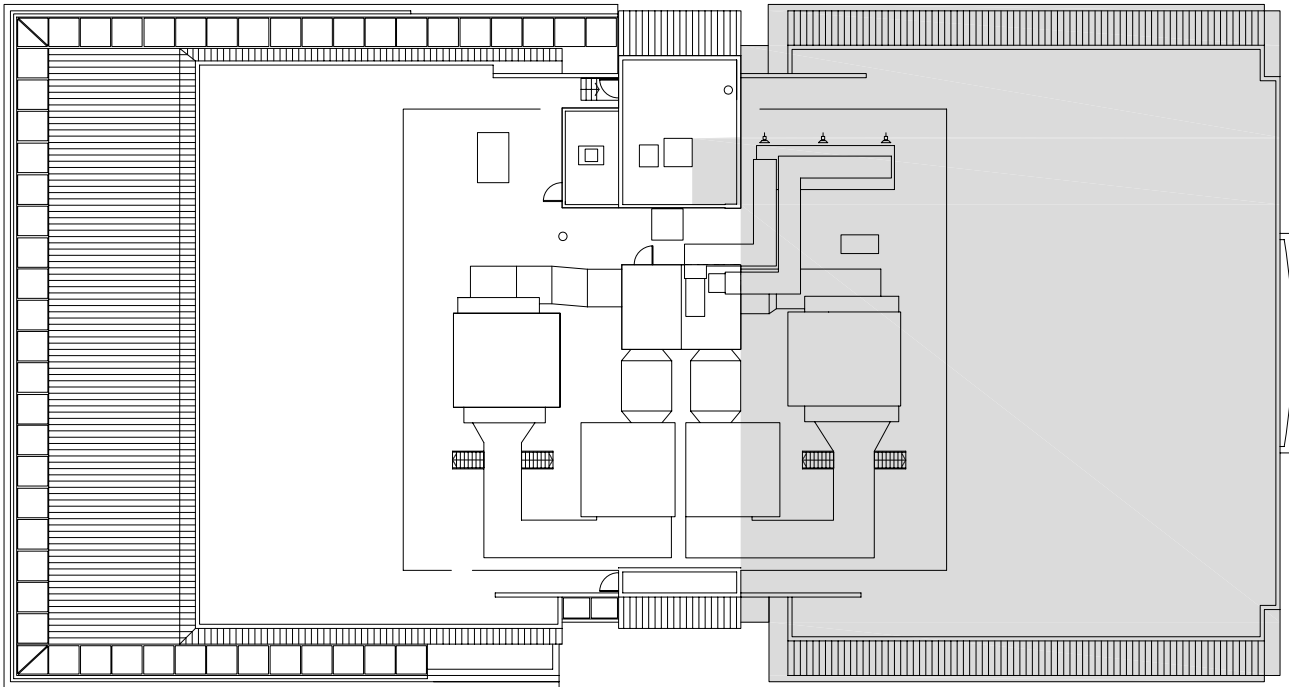
Graduate School of Education  
Roof  
ACM Locations

Floor Tile, 12" x 12" Brown w/ Dark Brown and White Specks\*\* and Black Mastic
  -

Sheet Vinyl, Brown Pebble Pattern
- ACM not shown:  
Sink Undercoating, Black  
HVAC Compound, Grey

\*\* - This material contains a trace amount of asbestos

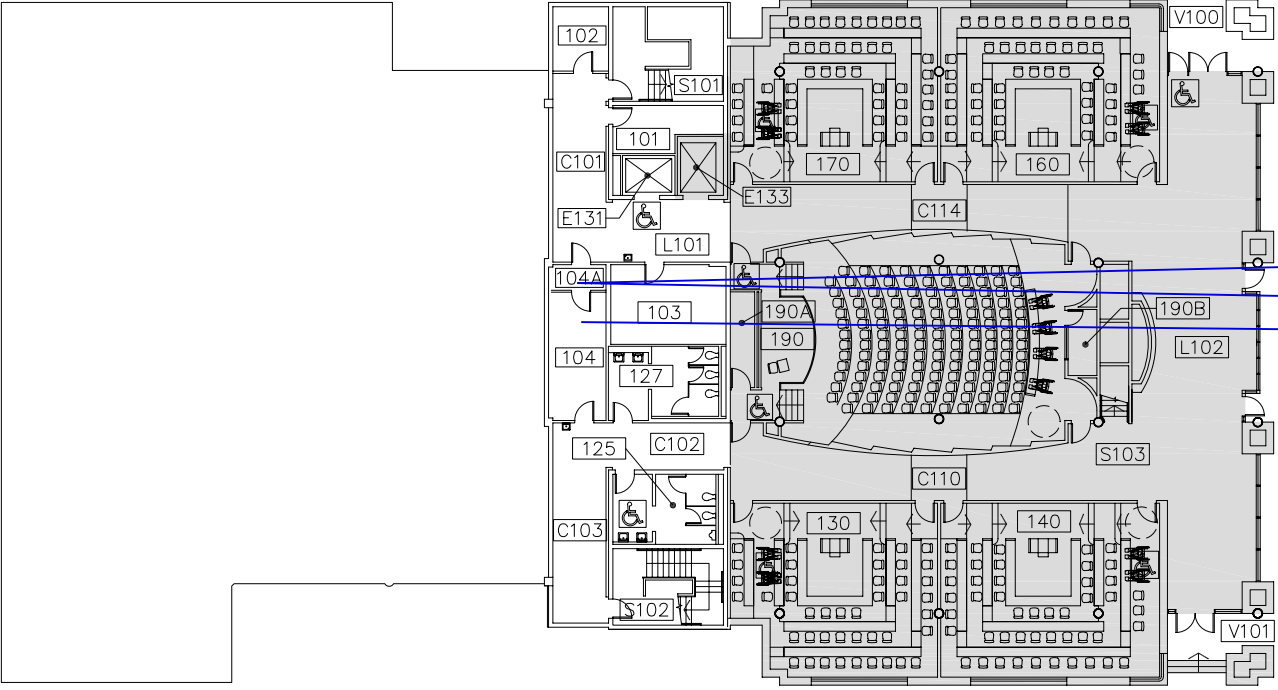
Graduate School of Education  
 1st Floor  
 Sample Locations

ED-15-DST-1  
 ED-16-TSI-1, 2, 3  
 ED-17-TSI-1, 2, 3

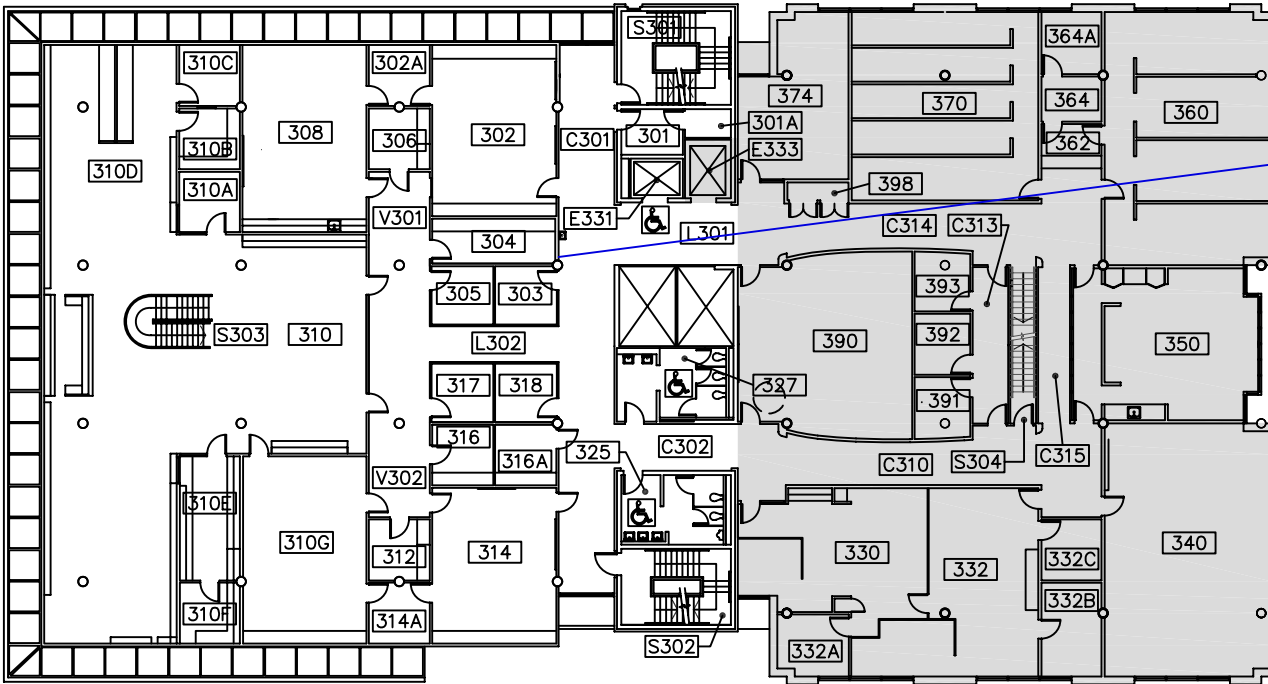
Graduate School of Education  
3rd Floor  
Sample Locations

ED-10-PL-4

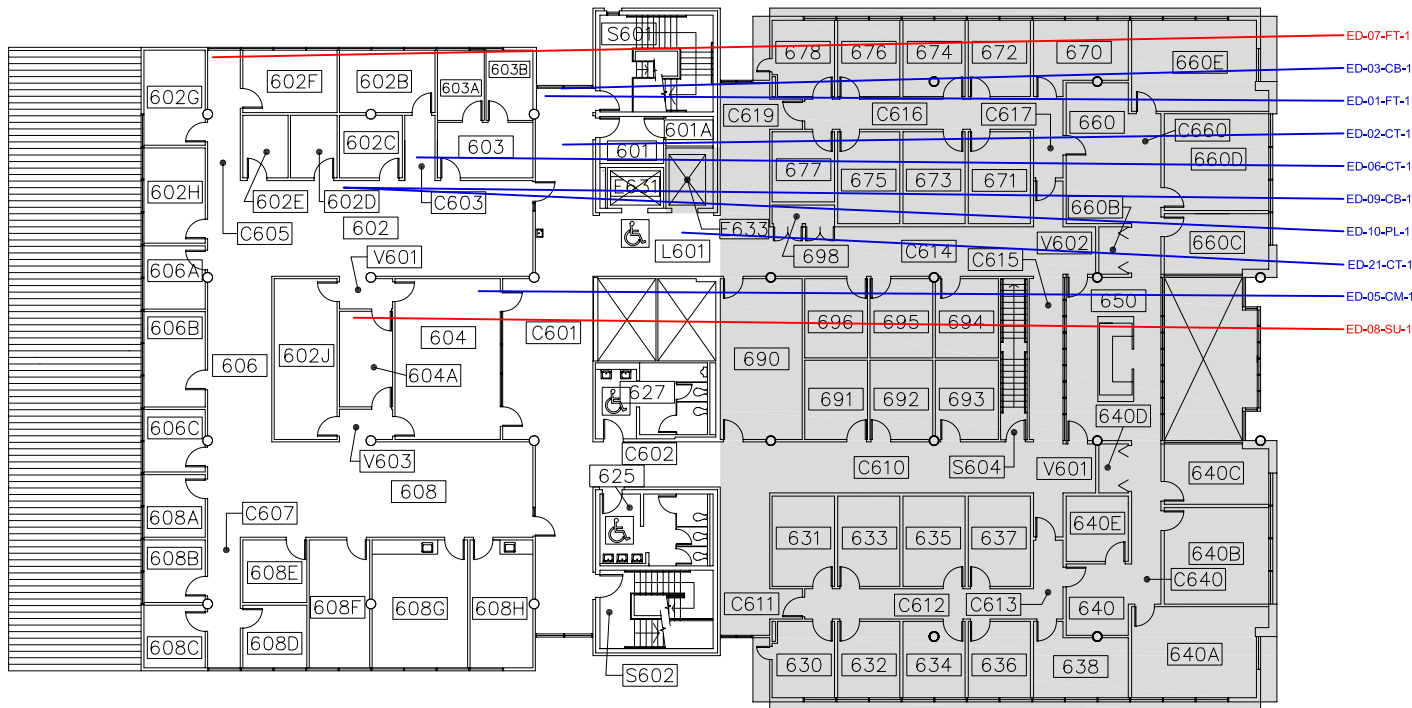
Graduate School of Education  
6th Floor  
Sample Locations

- ED-07-FT-1
- ED-03-CB-1
- ED-01-FT-1
- ED-02-CT-1
- ED-06-CT-1
- ED-09-CB-1
- ED-10-PL-1
- ED-21-CT-1
- ED-05-CM-1
- ED-08-SU-1

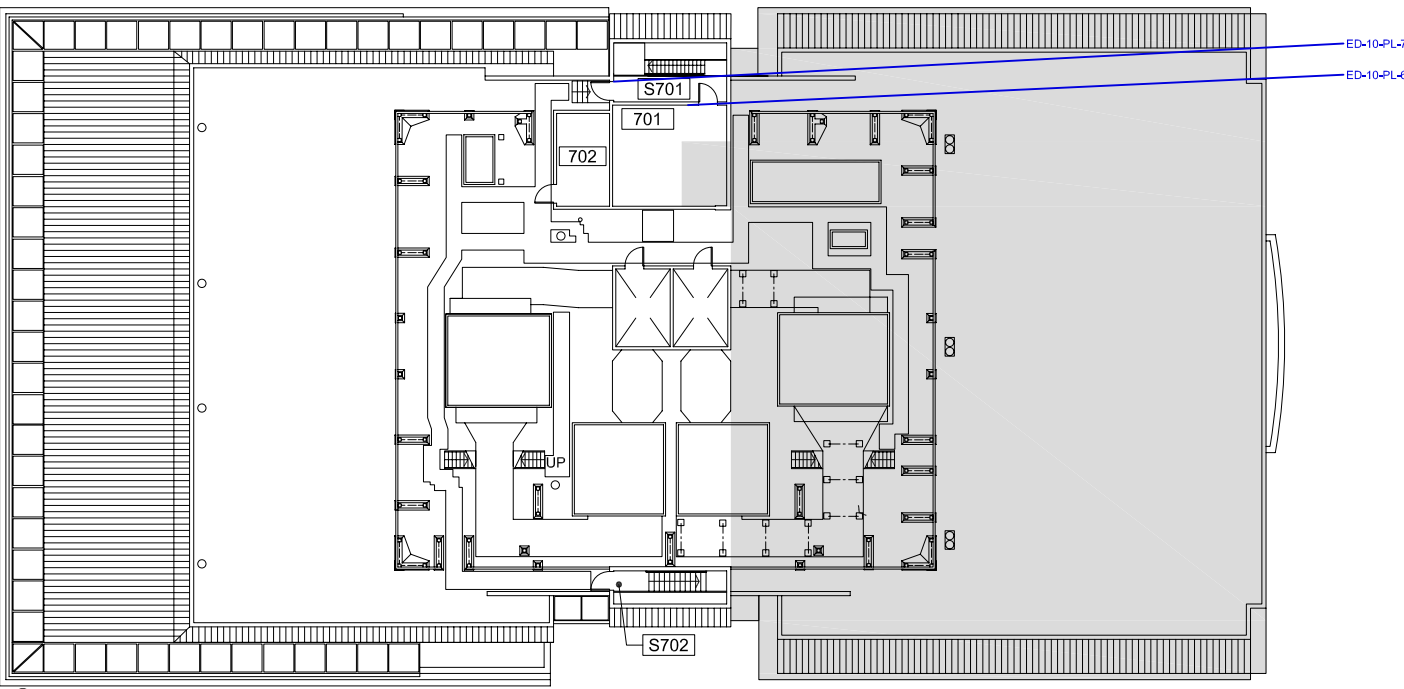
Graduate School of Education  
7th Floor  
Sample Locations

ED-10-PL-7  
ED-10-PL-6

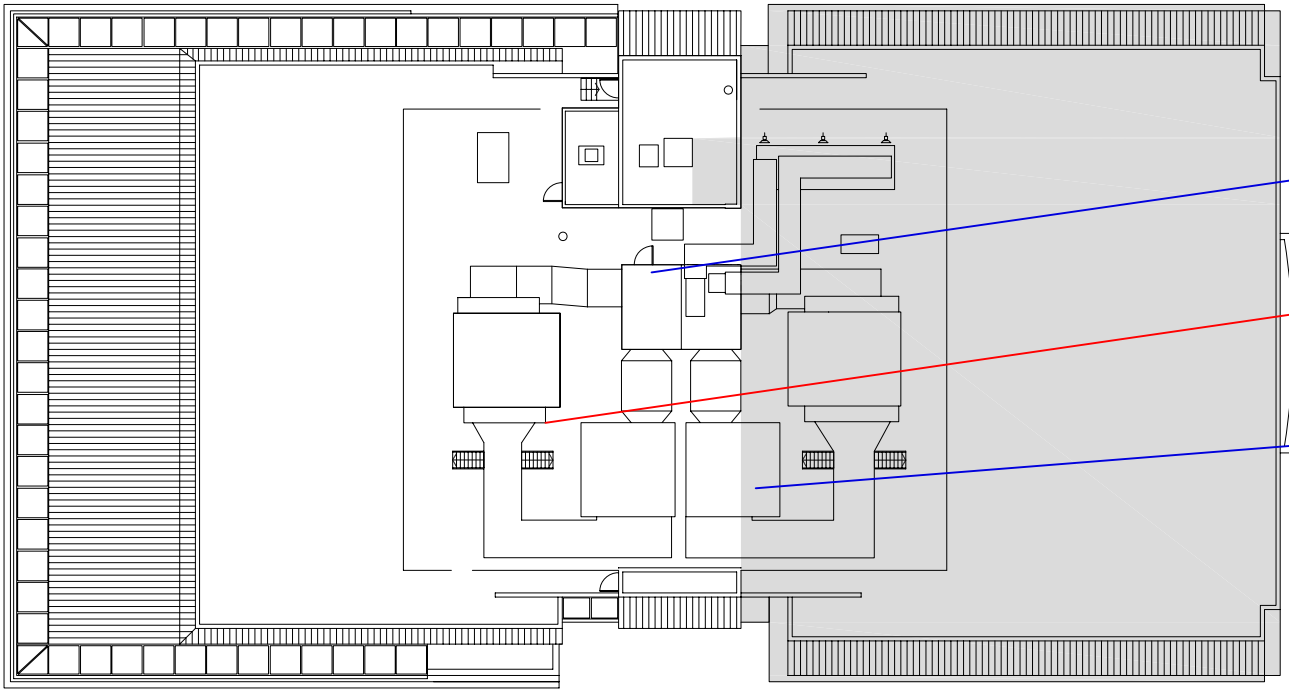
Graduate School of Education  
Roof  
Sample Locations

ED-SBA-20-DSC-1	HVAC Compound, Grey	ED/SBA - Roof, Center	ED/SBA - Roof	3% Chrysotile	Partially Inaccessible Not Quantified	Good

ED-SBA-18-DSC-1

ED-SBA-20-DSC-1

ED-SBA-19-TSI-1, 2, 3
