Online Partial Discharge Testing

Emerson Network Power | Electrical Reliability Services

Portland State University
617 SW Montgomery Street
Portland, OR 97201

**OLPD Permanent Sensor Installation,
Test and MV System Inspection
Report**

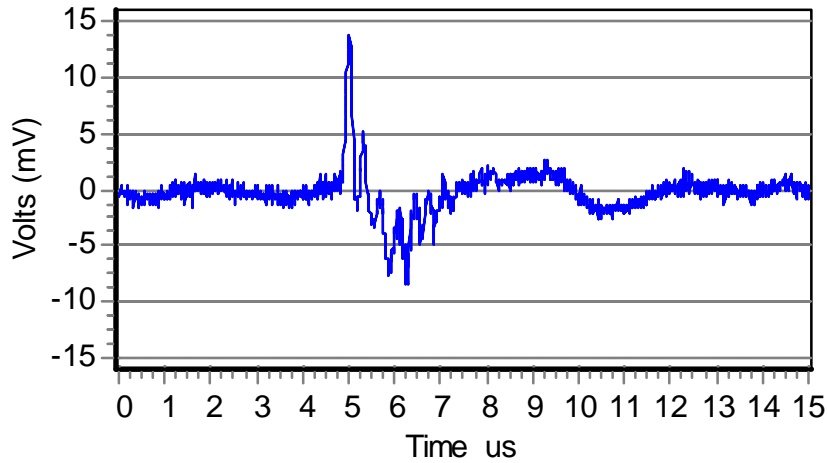
PD levels at only 1 POA were of a magnitude that resulted in severity category “RED.” POA 18 is located at the line side of the Chiller Bus Disconnect of Cramer Hall. The Channel 3 HFCT detected a PD magnitude of 544pC of cable PD. Since the TEV sensor detected no PD, and since on a graph of the 60Hz power frequency current, the PD detected by the HFCT was greatest near 0 degrees (PD that occurs around 0 and/or 180 degrees is generally indicative of a void in the insulation), it is most probable that the source of this PD is located within the termination of this cable. See graphs shown below.

POA 18 Line side Chiller Bus Disconnect - Cramer Hall. 14mV at 189°, 1.06MHZ, segment 3489

ERS recommends that PSU consider replacing this cable, and improving the termination method on the line side in the process. See Appendix A for additional information.

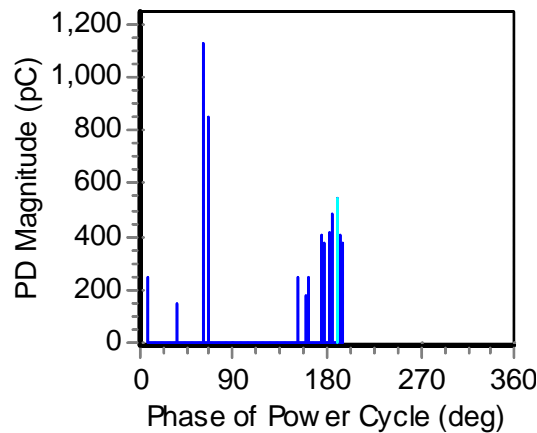
POA 18 Line side Chiller Bus Disconnect - Cramer Hall. Channel 3 HFCT, 544pC at 189°

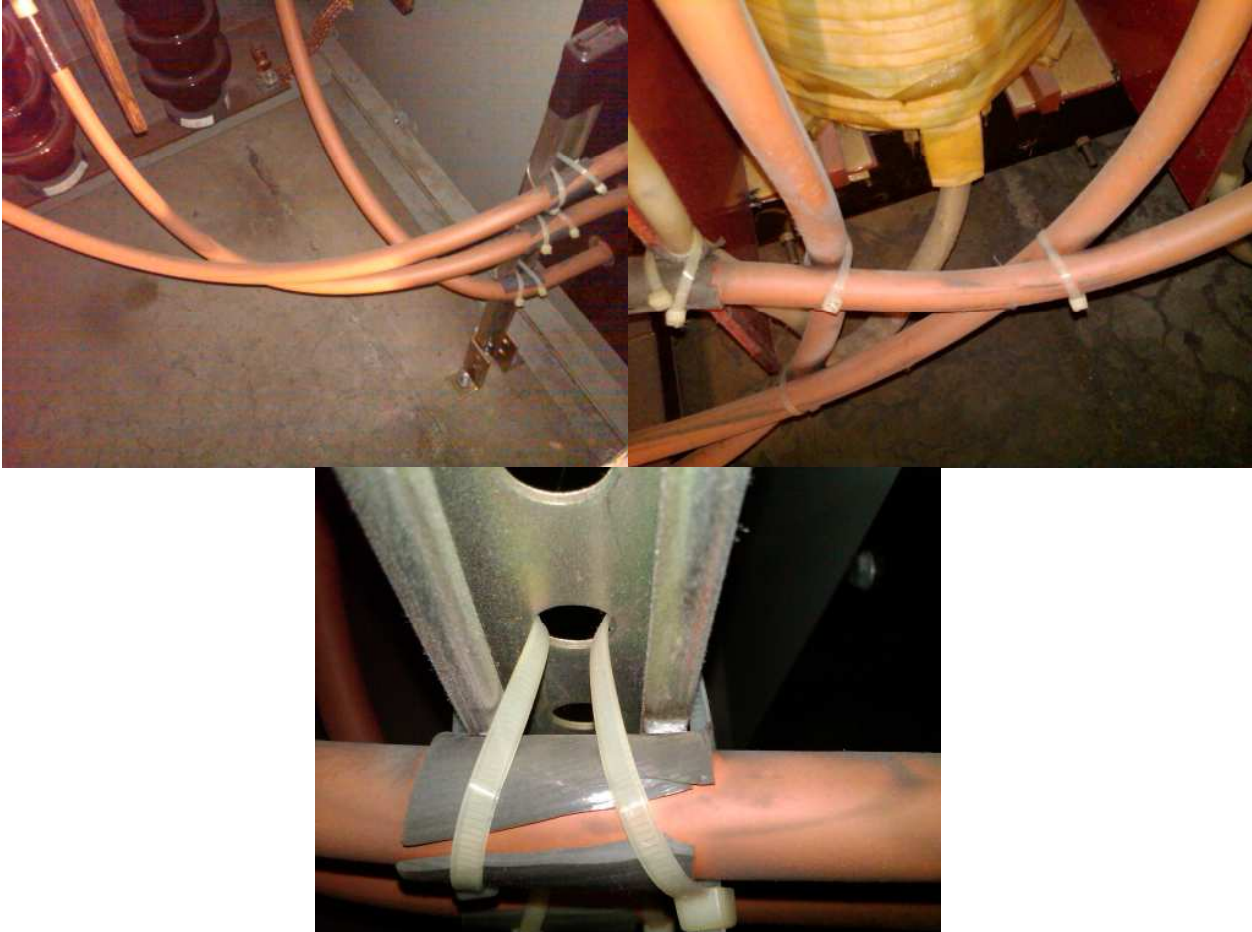
- 5.9 The disconnect switch and jumpers at the XSB building transformer were inspected and the cabling was found to be installed incorrectly, which will eventually result in a failure at this point (please see pictures below).

The jumpers to the line side of the switch and from the load side to the transformer should be removed and replaced. When new cables are installed, care should be taken to maintain proper clearances phase-to-phase and phase-to-ground.
