# Report of Procedures and Findings

From Internal, Underwater Inspection  
of  
250KG Reservoir  
for

Oregon Institute of Technology  
by

## Underwater Inspection of 250KG Reservoir

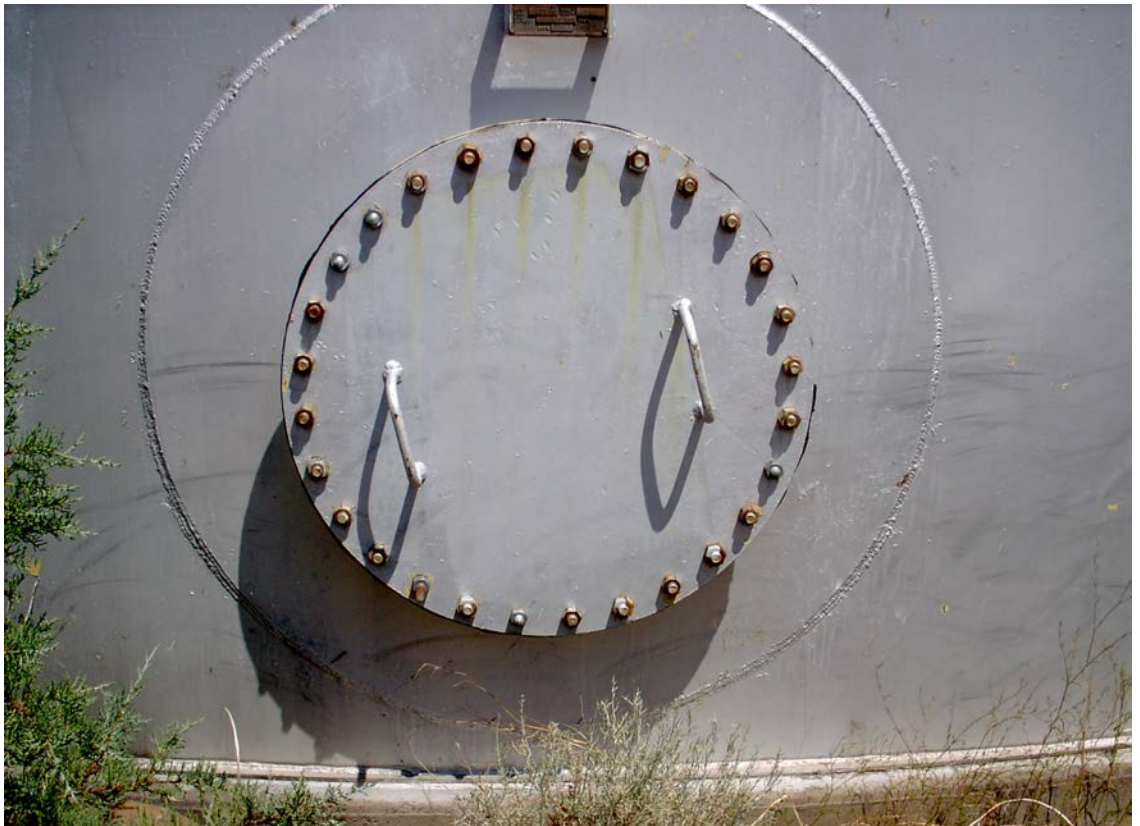
Image #  
6

Component	Condition				Pic. #'s	Comments	
	NA	Ex.	Good	Fair			Poor
<b>Liquid Level Indicator</b>			X			7,13	Appeared to be in good condition from exterior. Manual level tag appeared to be inoperable.
<b>Man Entries</b>			X			6	Rust Grade <sup>2</sup> <u>9</u> . Minor surface corrosion on the man way bolts. Appeared to be in good condition.
<b>Exterior Overflow</b>			X			5	Rust Grade <sup>2</sup> <u>8</u> . Minor surface corrosion on exterior of overflow. Recommend placing a fine mesh screen to prevent insects and debris from entering the reservoir.
<b>Entry Hatch</b>			X			8	Rust Grade <sup>2</sup> <u>6</u> . Minor surface corrosion on knife-edge and interior of hatch lid. No weather stripping present. Recommend placing weather stripping to prevent insects and debris from entering the reservoir.
<b>Interior Ladder</b>				X		16	Rust Grade <sup>2</sup> <u>7</u> .
<b>Telemetry Sensor</b>			X				Appeared to be in good condition.

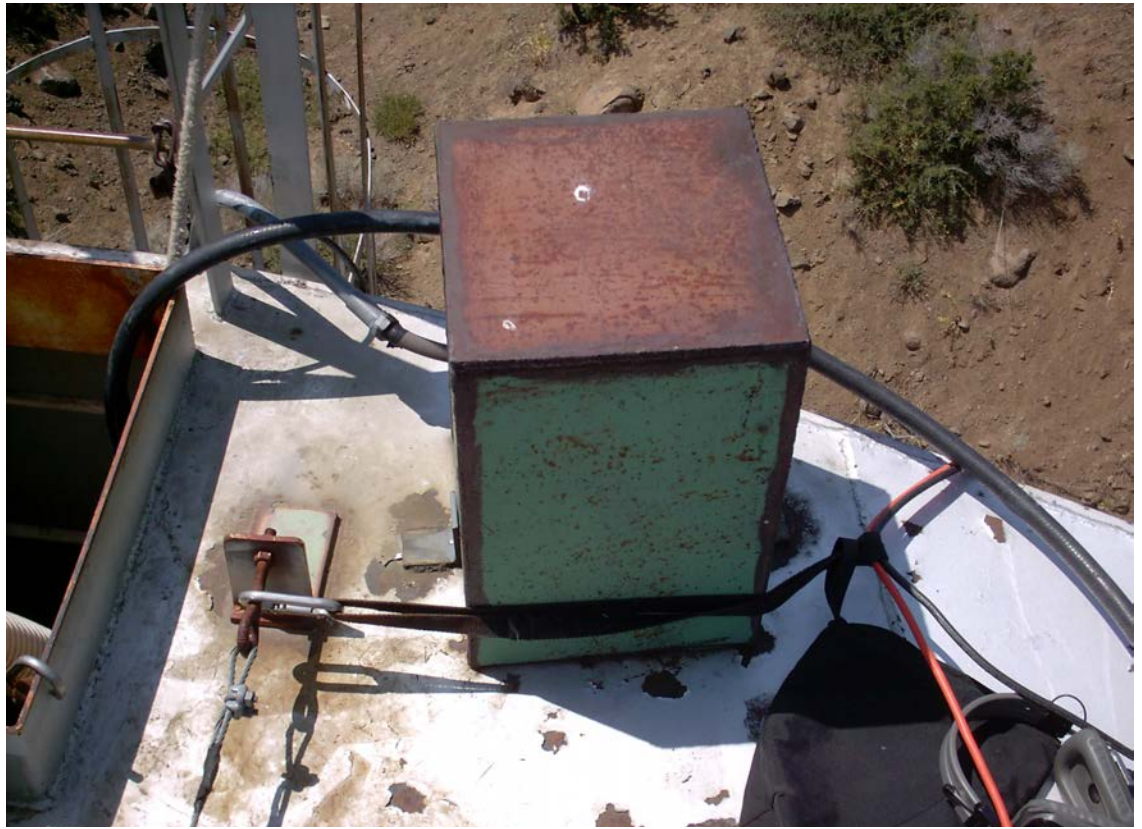
Image #  
9

<b>Roof Vents</b>			X			15	Rust Grade <sup>2</sup> <b><u>9.</u></b>
<b>Exterior Telemetry</b>			X			9,14	Rust Grade <sup>2</sup> <b><u>6.</u></b> Exterior telemetry covers have minor surface corrosion.

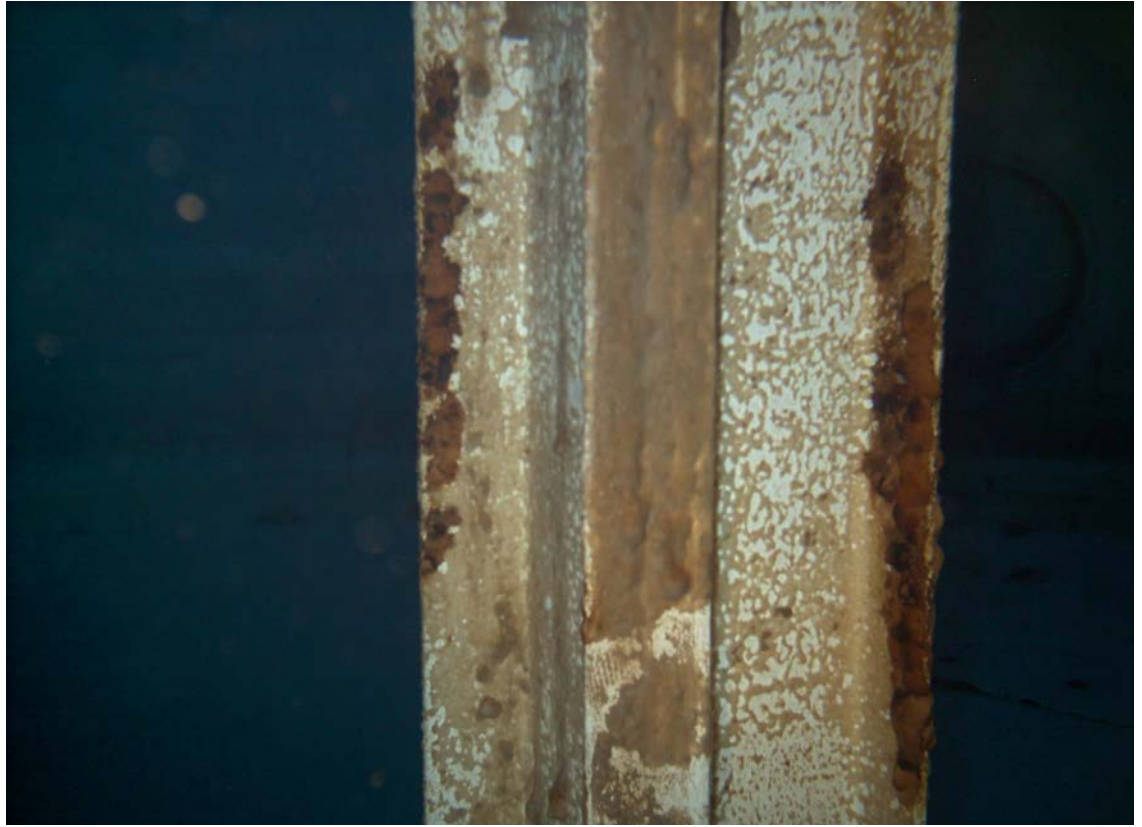
Image #  
21

<b>Support Columns</b>							Minor to moderate surface corrosion.
<i>Center Support Column</i>				X		21,22	Rust Grade <sup>2</sup> <u>7</u> .
<b>Interior Overflow Pipe</b>			X			32	Rust Grade <sup>2</sup> <u>9</u> .

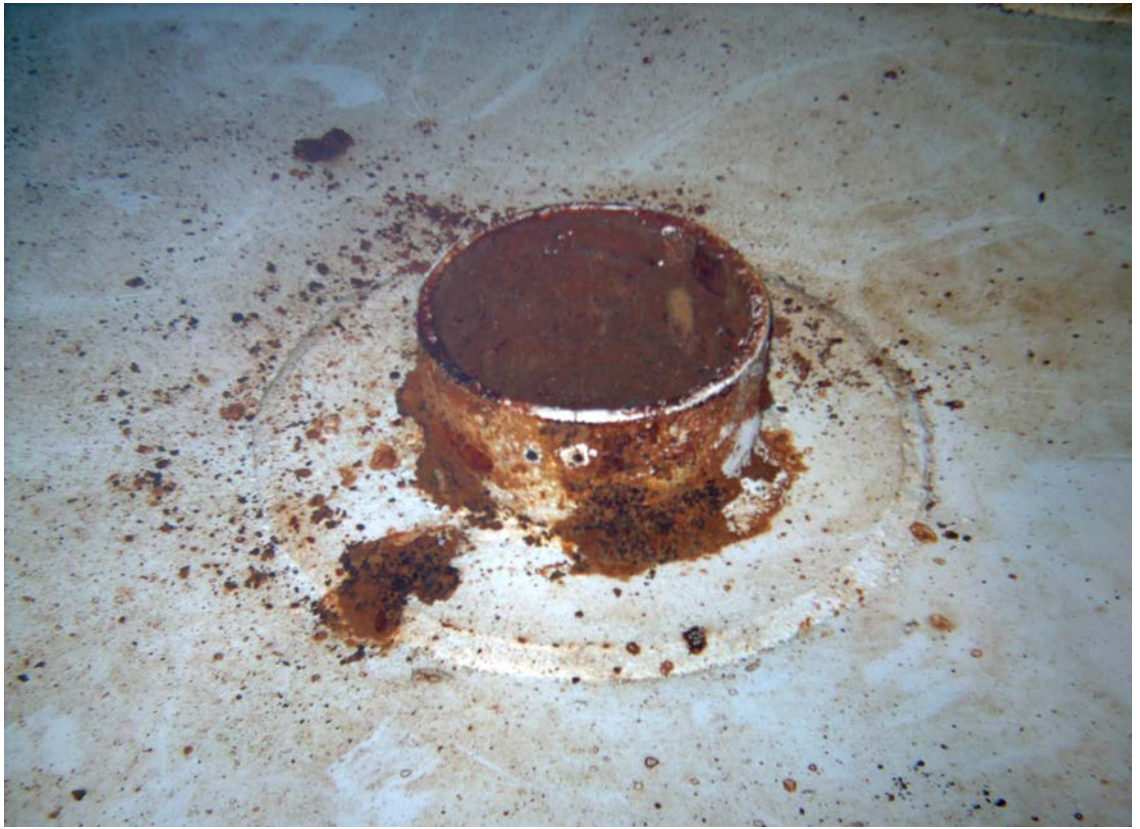
Image #  
27

Component	Condition					Pic. #'s	Comments
	NA	Ex.	Good	Fair	Poor		
<i>Interior Inlet</i>				X		27	Rust Grade <sup>2</sup> <u>4.</u>
<i>Interior Outlet</i>				X		29	Rust Grade <sup>2</sup> <u>4.</u>
<i>Interior Drain/Scour</i>				X		28	Rust Grade <sup>2</sup> <u>4.</u>
<i>Interior Ceiling</i>							Recommend blast and recoat of ceiling.
<i>Ceiling 12:00</i>				X		31	Rust Grade <sup>2</sup> <u>6.</u>
<i>Ceiling 3:00</i>				X		34	Rust Grade <sup>2</sup> <u>6.</u>
<i>Ceiling 6:00</i>				X			Rust Grade <sup>2</sup> <u>6.</u>
<i>Ceiling 9:00</i>				X		33	Rust Grade <sup>2</sup> <u>6.</u>
<i>Ceiling Center</i>				X			Rust Grade <sup>2</sup> <u>6.</u>
<i>Other/Repair</i>							
<i>Other/Repair</i>							
<i>Other/Repair</i>
