ASBESTOS BUILDING INSPECTION

**BRANFORD PRICE MILLAR LIBRARY
1875 SW PARK AVENUE
PORTLAND, OREGON 91201**

JULY 22, 2008

FORENSIC ANALYTICAL PROJECT NO. PJ5605

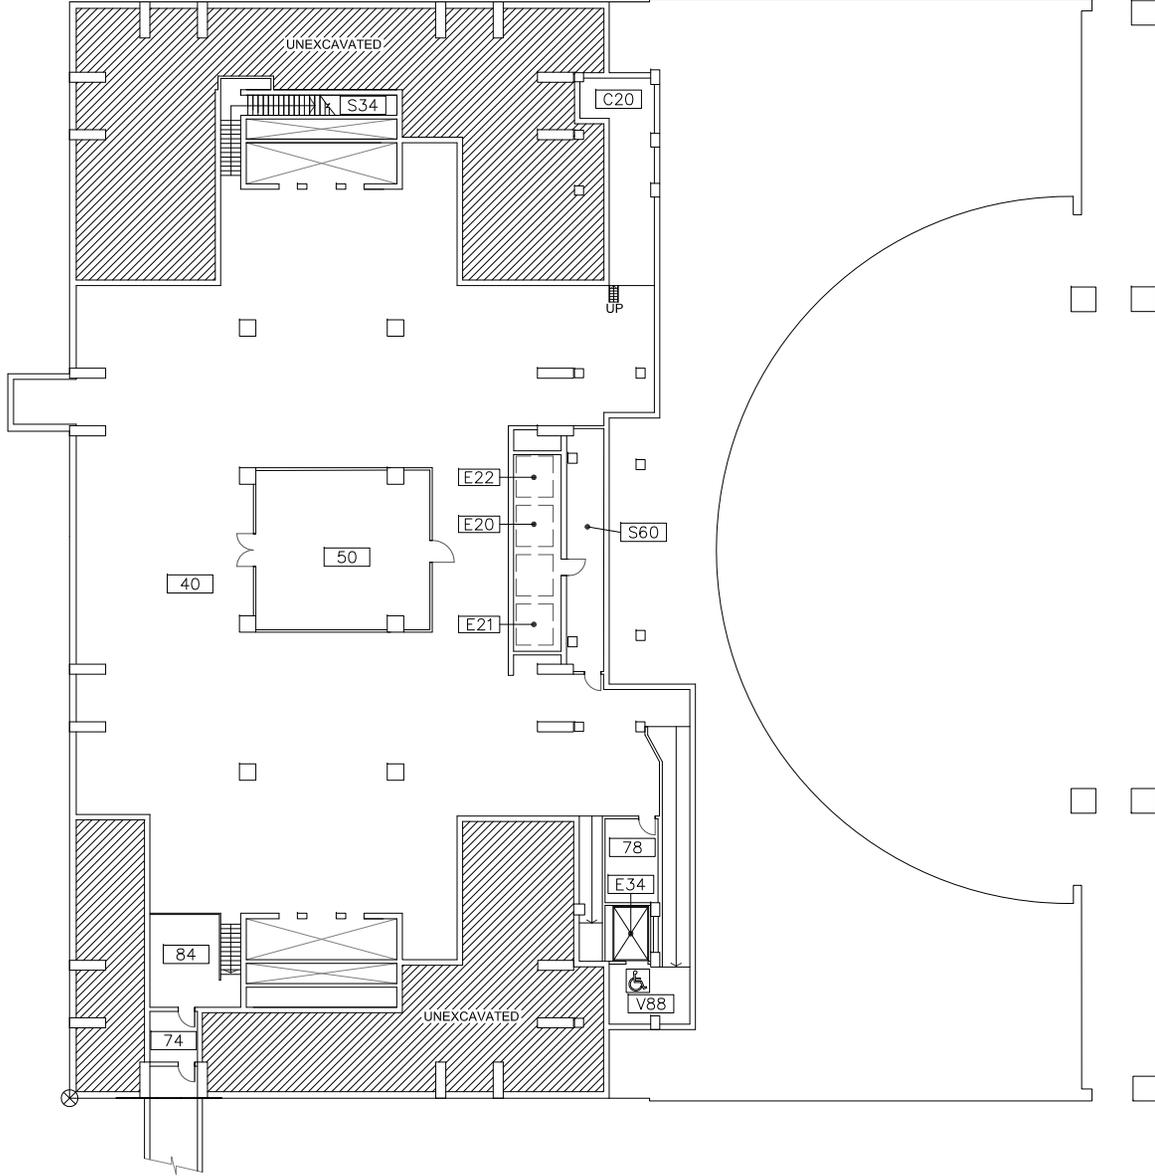
Brantford Price Miller Library
 Subbasement
 ACM Locations

Floor Tile, 9" x 9" Tan w/ White & Brown Streaks, and Black Mastic

ACM not shown:
 Rigid Pipe Insulation
 Pipe Fitting Insulation
 Rigid Tank Insulation

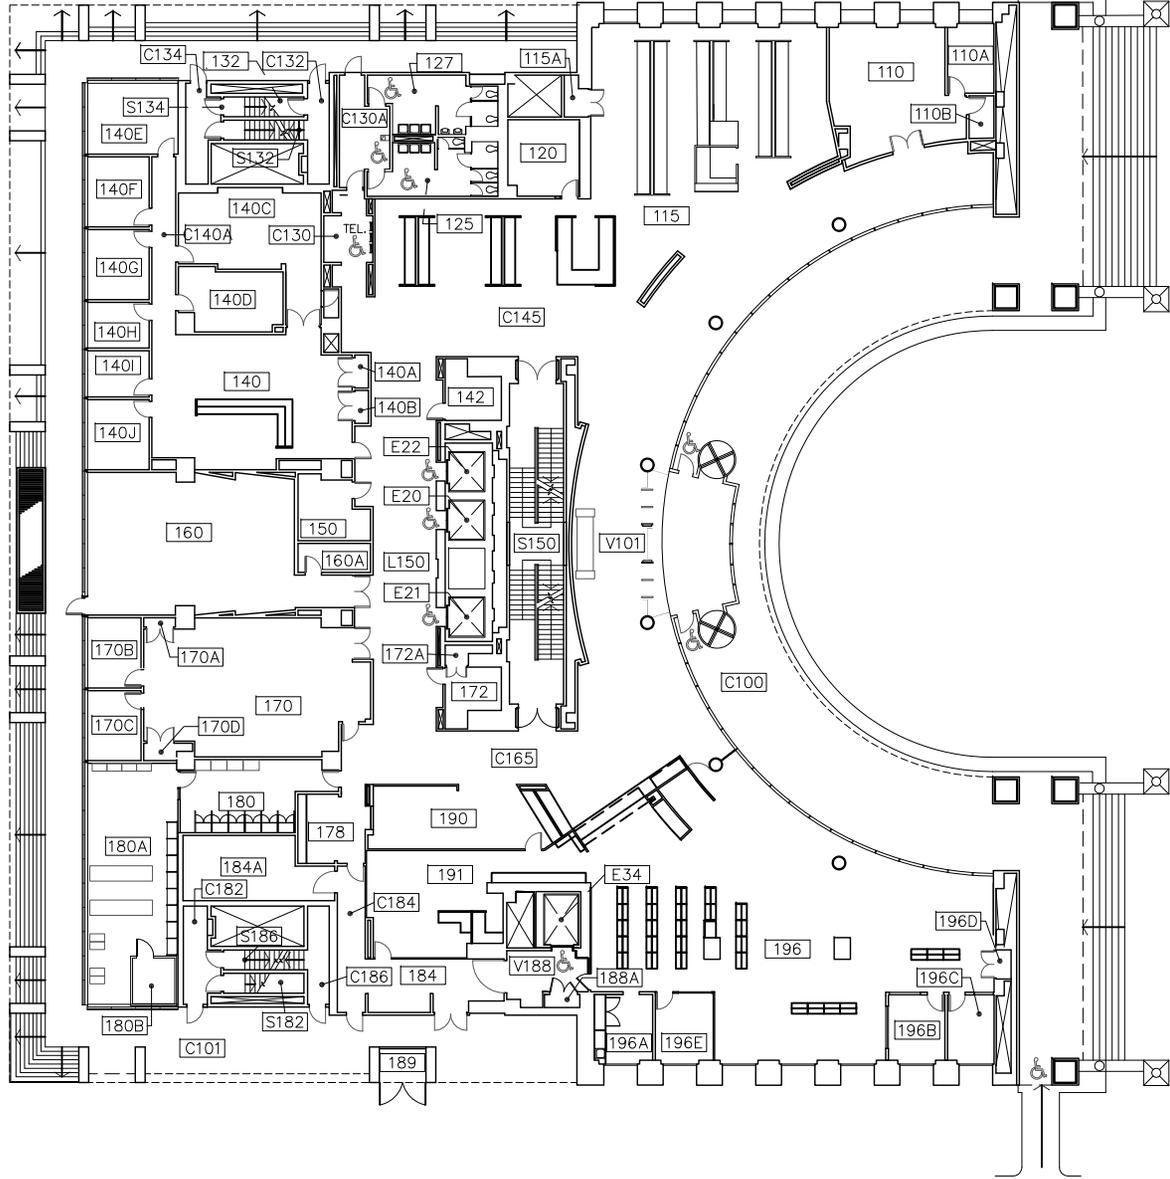
Brantford Price Miller Library
 1st Floor
 ACM Locations

Floor Tile, 9" x 9" Tan w/ White & Brown Streaks, and Black Mastic

ACM not shown:
 Rigid Pipe Insulation
 Pipe Fitting Insulation
 Rigid Tank Insulation

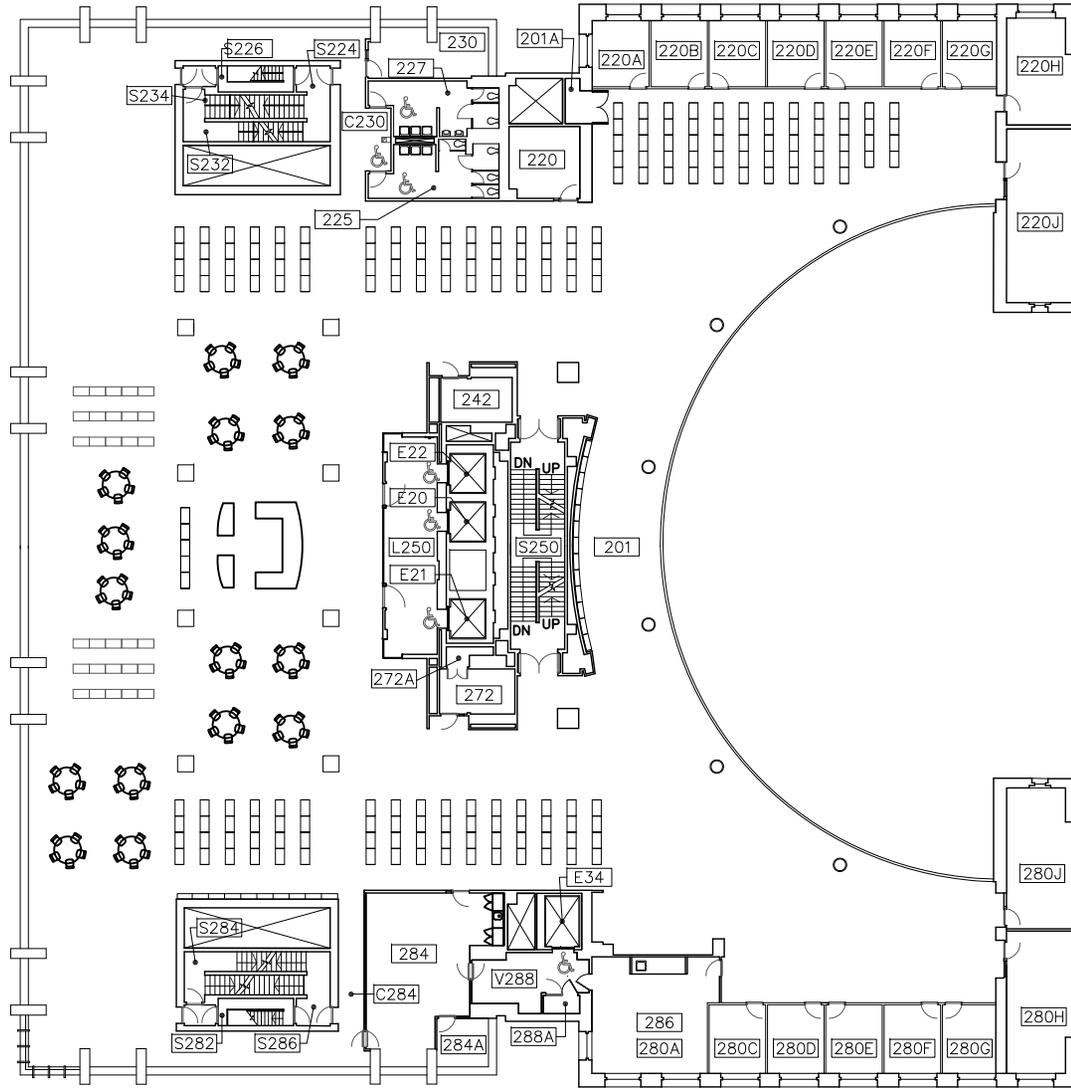
Brantford Price Miller Library
2nd Floor
ACM Locations

Floor Tile, 9" x 9" Tan w/ White & Brown Streaks, and Black Mastic

ACM not shown:
Rigid Pipe Insulation
Pipe Fitting Insulation
Rigid Tank Insulation

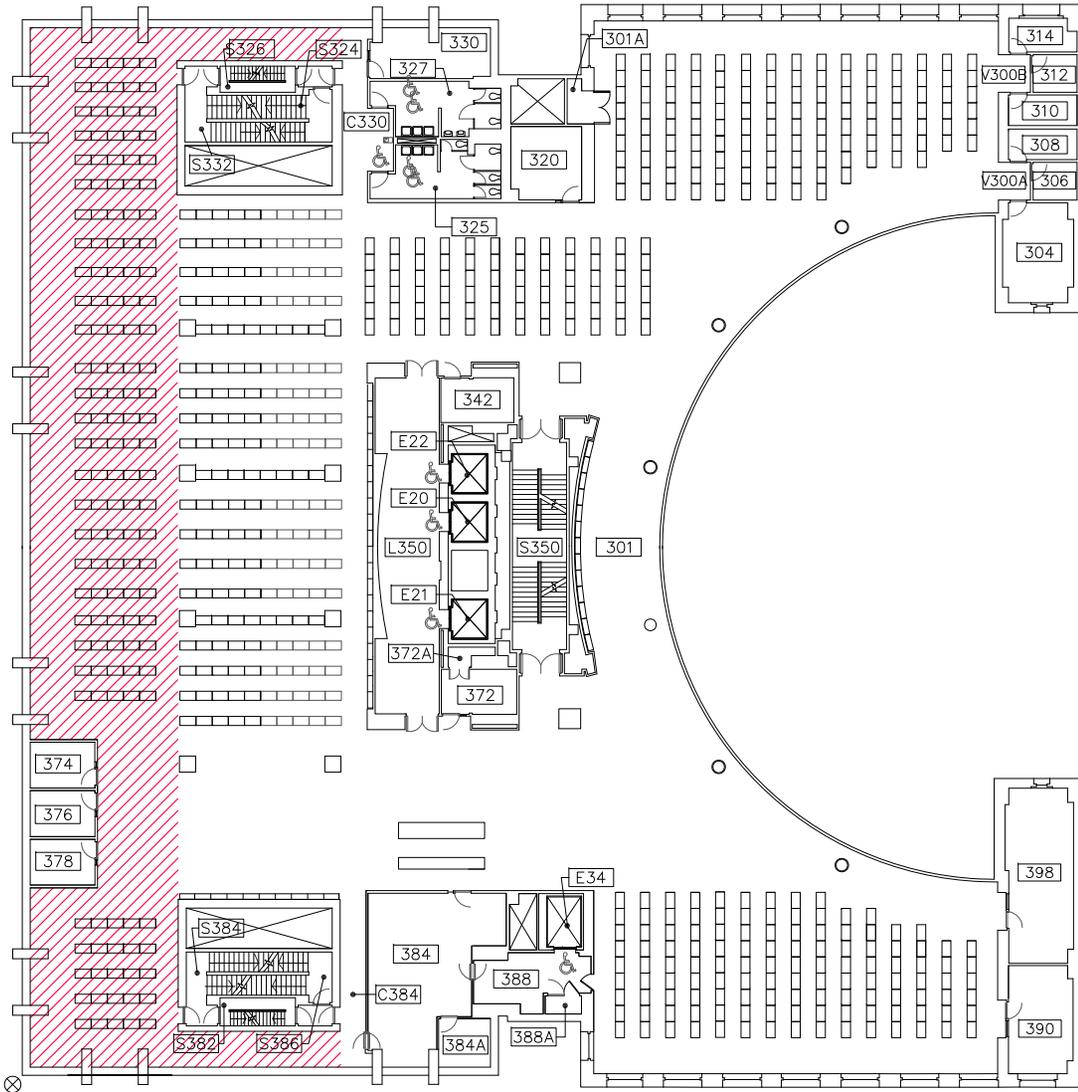
Brantford Price Miller Library
 3rd Floor
 ACM Locations

Floor Tile, 9" x 9" Tan w/ White & Brown Streaks, and Black Mastic

ACM not shown:
 Rigid Pipe Insulation
 Pipe Fitting Insulation
 Rigid Tank Insulation

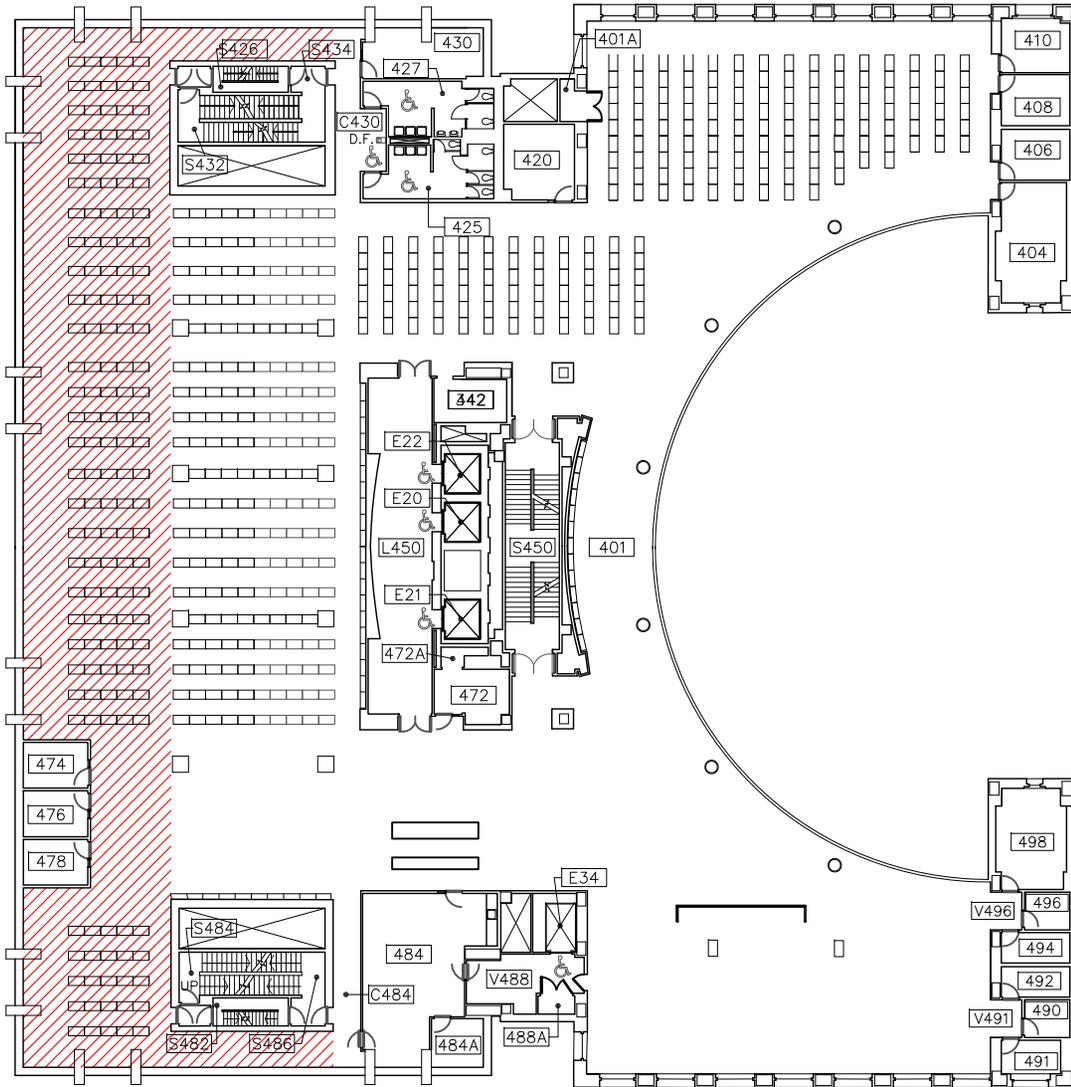
Brantford Price Miller Library
 4th Floor
 ACM Locations

Floor Tile, 9" x 9" Tan w/ White & Brown Streaks, and Black Mastic

ACM not shown:
 Rigid Pipe Insulation
 Pipe Fitting Insulation
 Rigid Tank Insulation

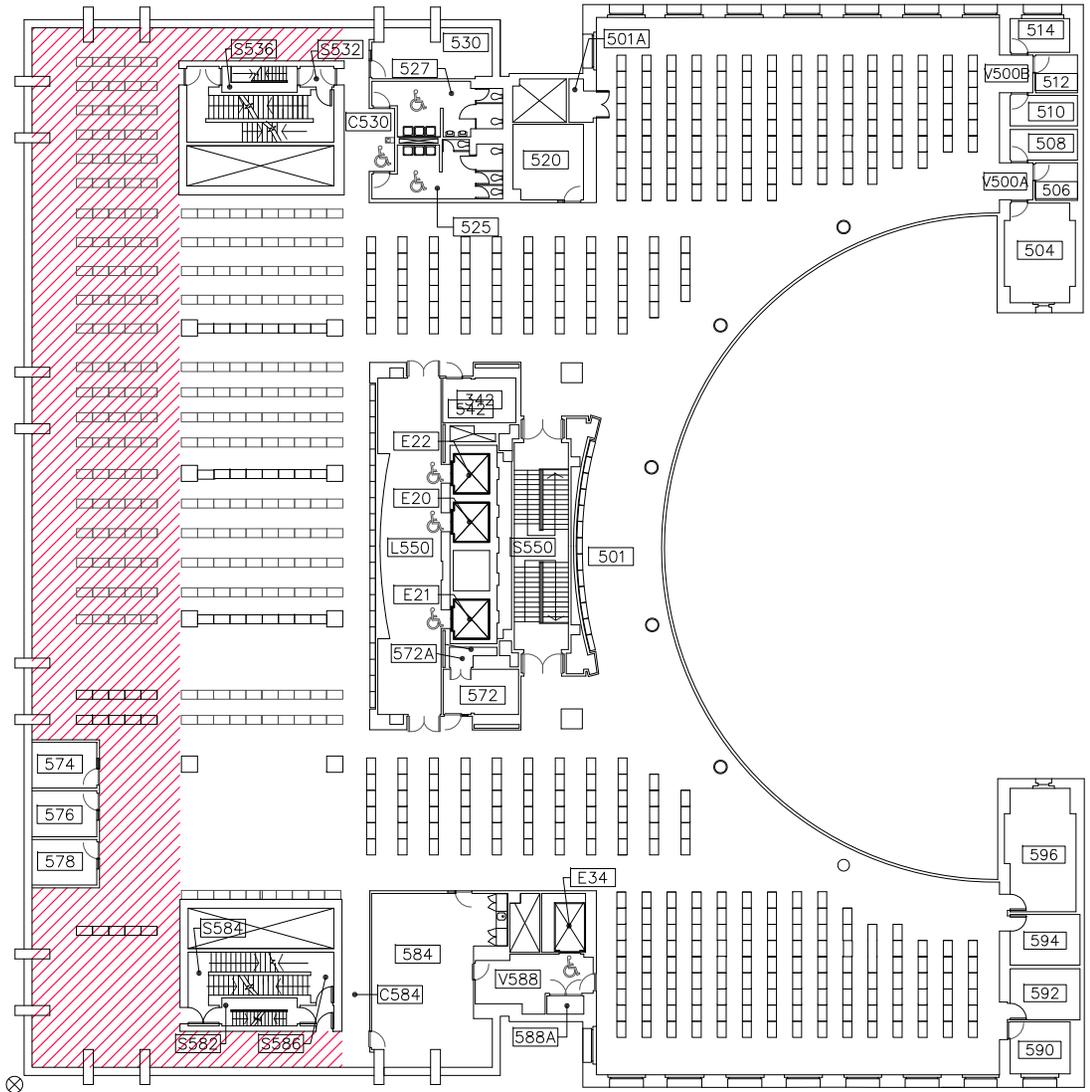
Brantford Price Miller Library
 5th Floor
 ACM Locations

Floor Tile, 9" x 9" Tan w/ White & Brown Streaks, and Black Mastic

ACM not shown:
 Rigid Pipe Insulation
 Pipe Fitting Insulation
 Rigid Tank Insulation

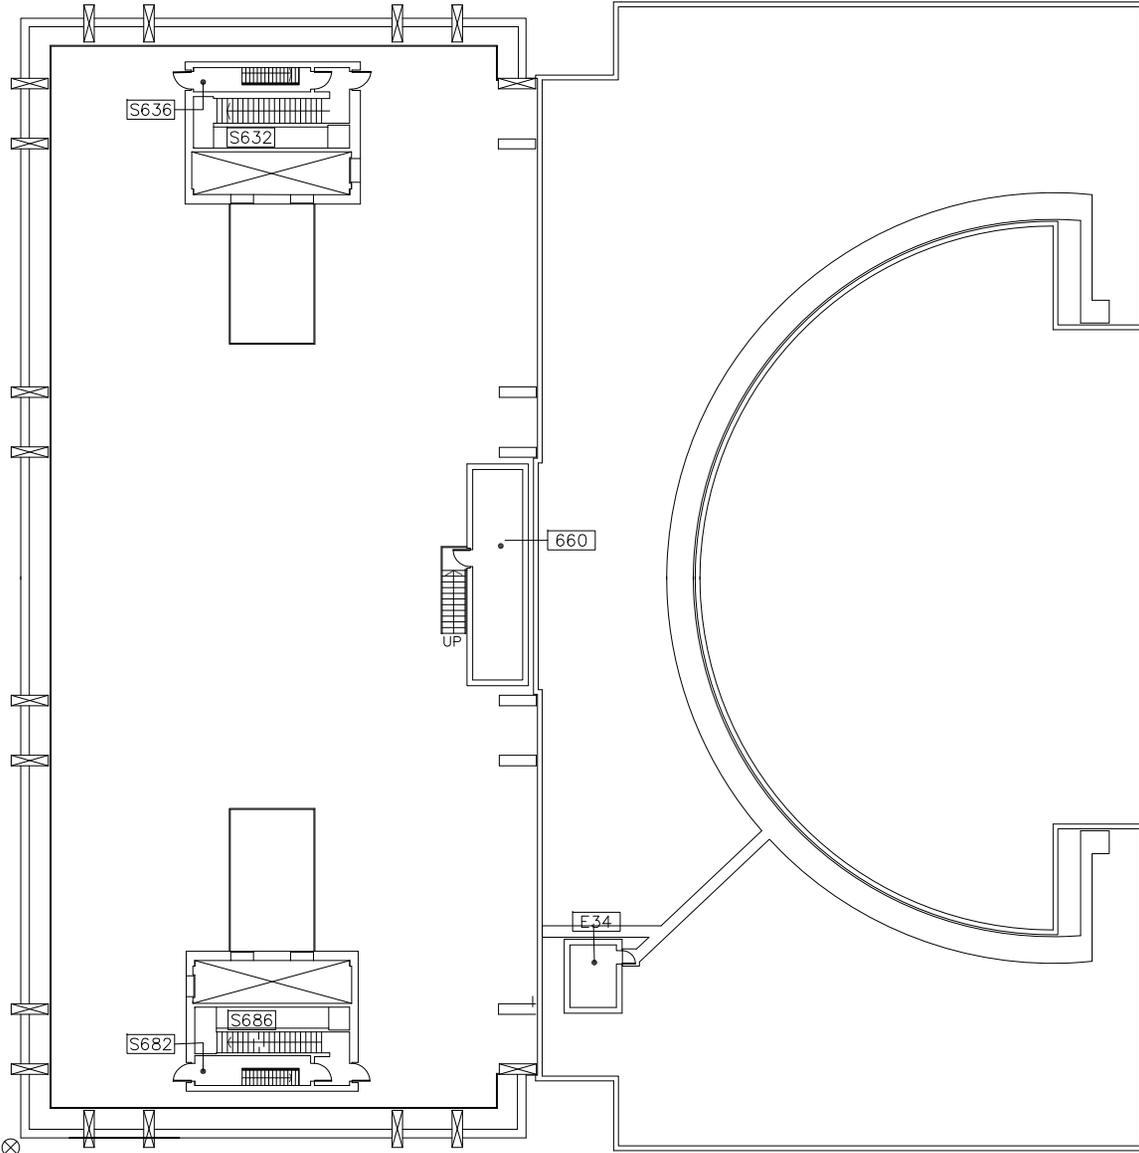
Brantford Price Miller Library
 Penthouse
 ACM Locations

Floor Tile, 9" x 9" Tan w/ White & Brown Streaks, and Black Mastic

ACM not shown:
 Rigid Pipe Insulation
 Pipe Fitting Insulation
 Rigid Tank Insulation

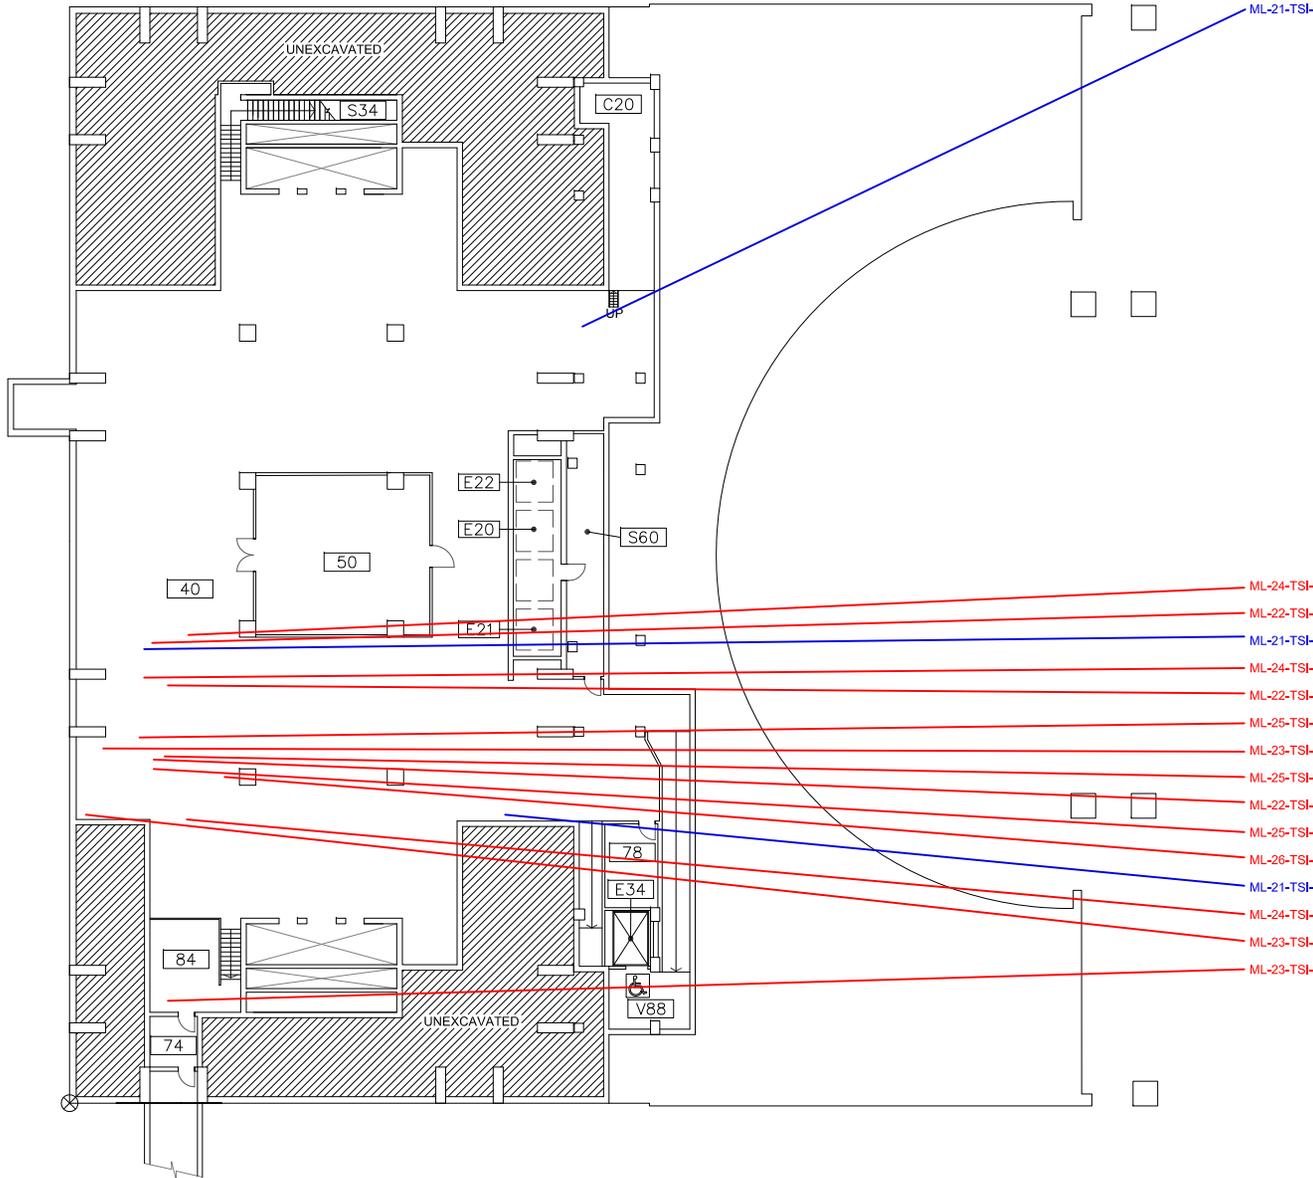
Branford Price Miller Library
Subbasement
Samples Locations

ML-21-TSI-2

- ML-24-TSI-2*
- ML-22-TSI-3*
- ML-21-TSI-3
- ML-24-TSI-1
- ML-22-TSI-2*
- ML-25-TSI-1
- ML-23-TSI-1
- ML-25-TSI-3*
- ML-22-TSI-1
- ML-25-TSI-2*
- ML-26-TSI-1
- ML-21-TSI-1
- ML-24-TSI-3*
- ML-24-TSI-2*
- ML-23-TSI-3*

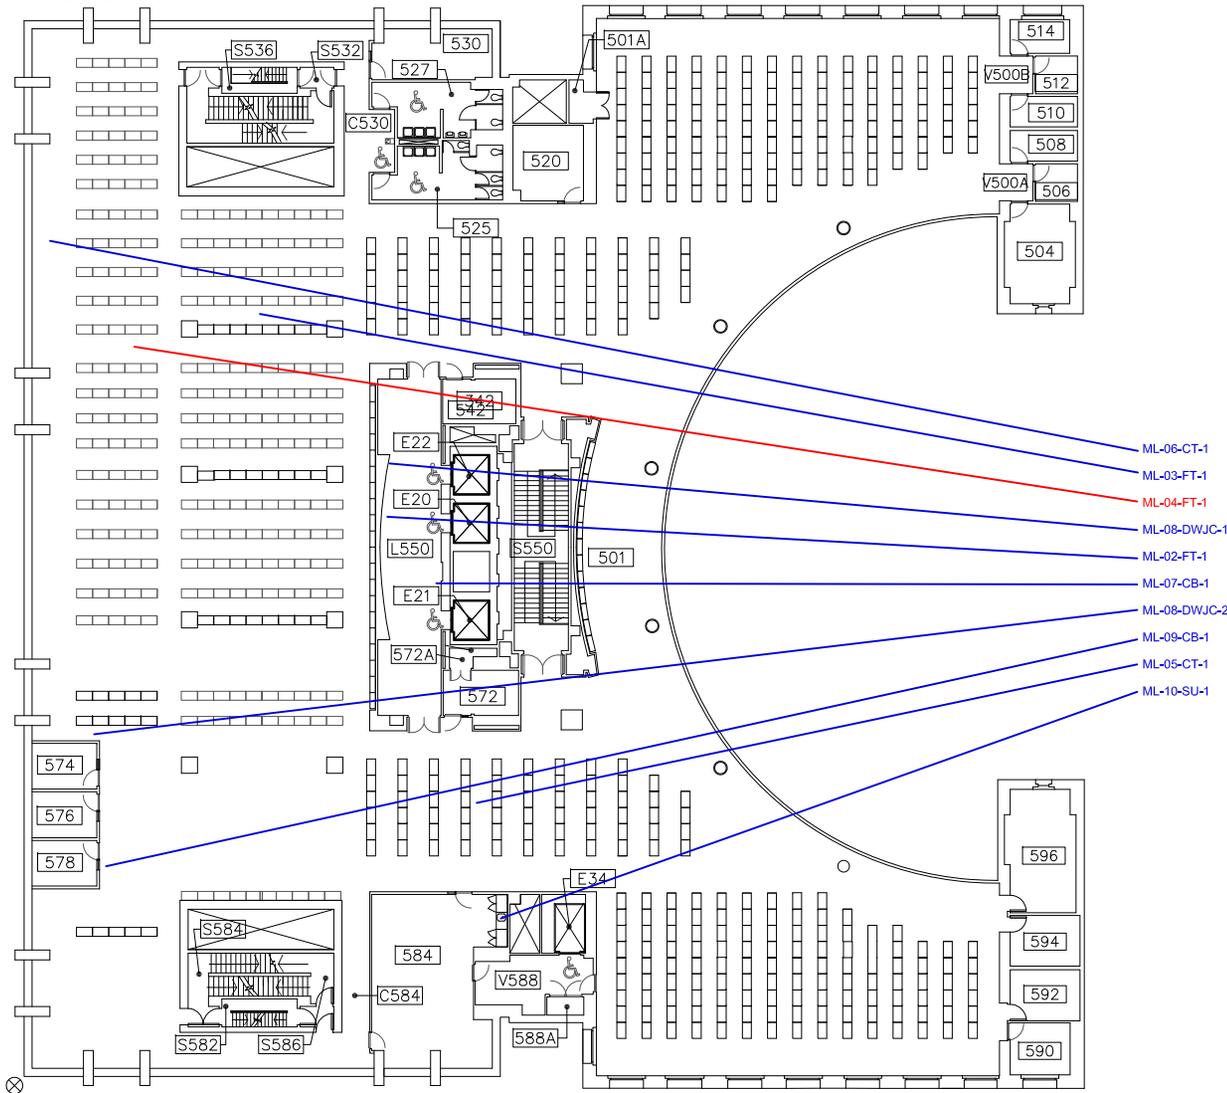
Branford Price Miller Library
 5th Floor
 Samples Locations

- ML-06-CT-1
- ML-03-FT-1
- ML-04-FT-1
- ML-08-DWJC-1
- ML-02-FT-1
- ML-07-CB-1
- ML-08-DWJC-2
- ML-09-CB-1
- ML-05-CT-1
- ML-10-SU-1
