ASBESTOS BUILDING INSPECTION

**SMITH MEMORIAL STUDENT UNION
1825 SW BROADWAY
PORTLAND, OREGON 97201**

JULY 10, 2008

FORENSIC ANALYTICAL PROJECT NO. PJ5584

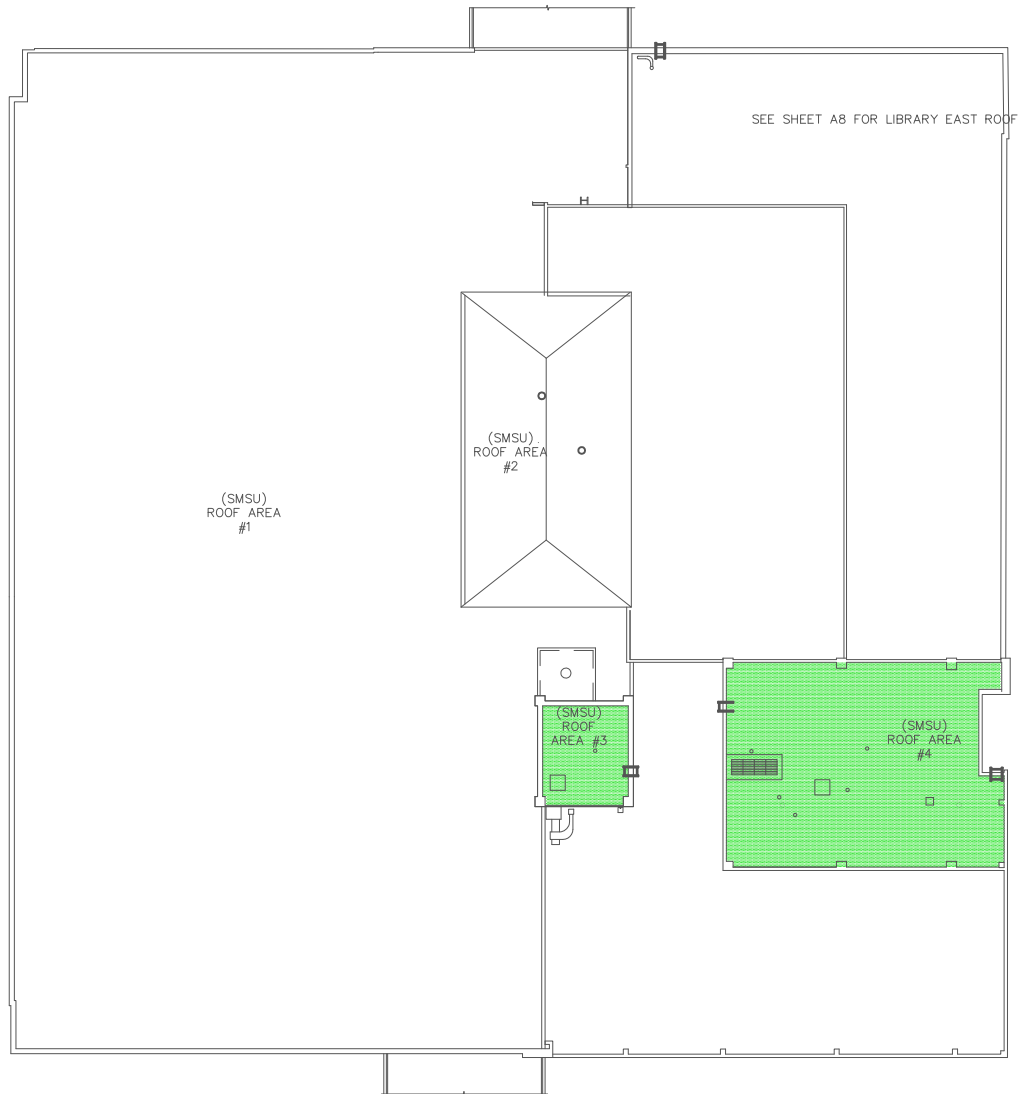
Smith Memorial Student Union
 Roof
 ACM Locations

ACM not shown:
 Duct Seam Tape
 Rigid Pipe Insulation
 Vibration Joint Cloth
 Alrcell Pipe Insulation

Samples of the roof were not collected at the request of PSU.

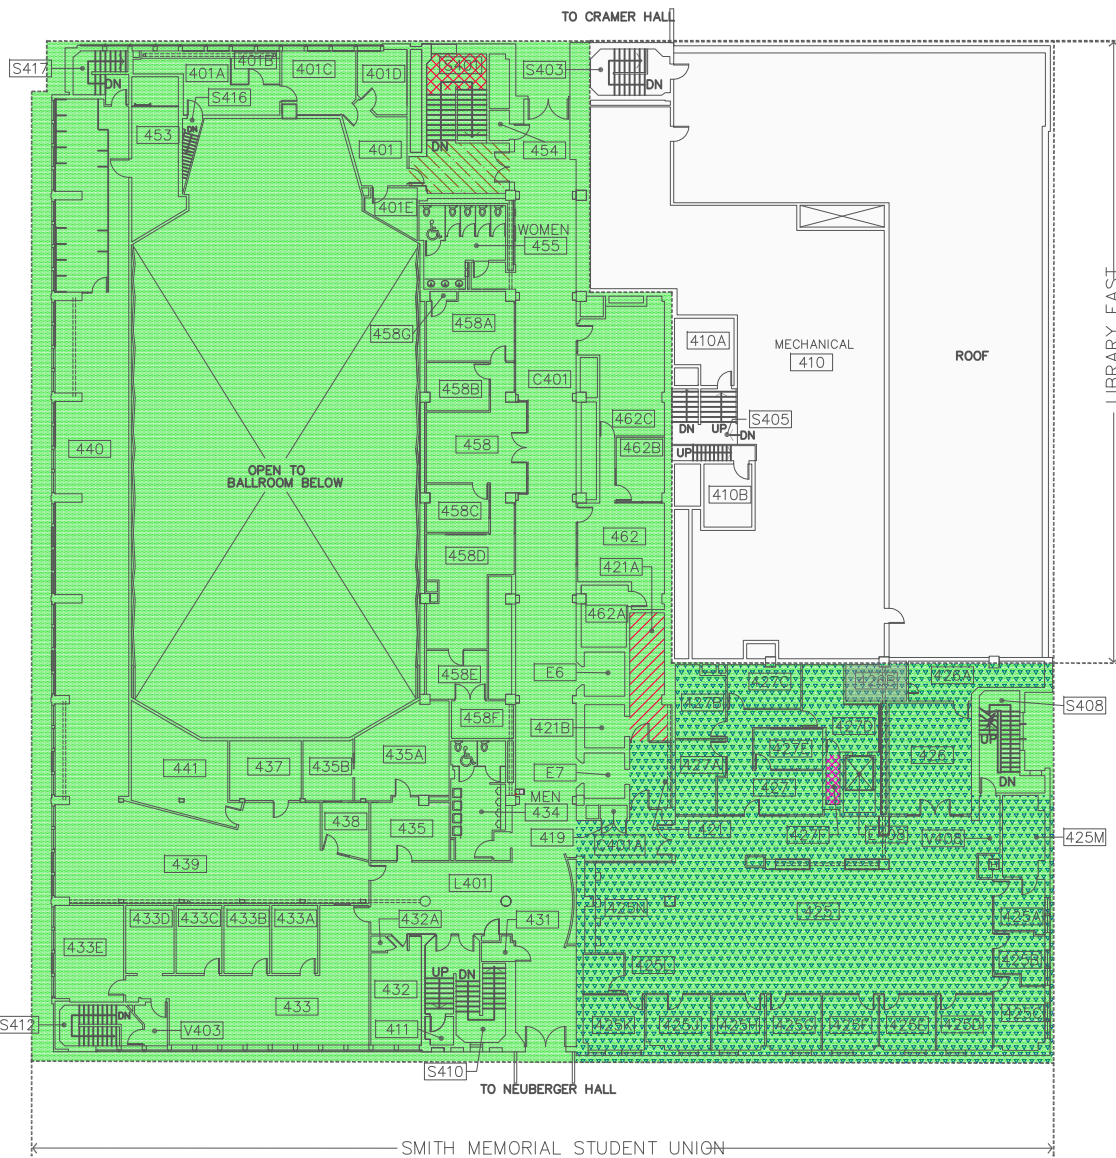
Smith Memorial Student Union
 4th Floor
 ACM Locations

ACM not shown:
 Duct Seam Tape
 Rigid Pipe Insulation
 Vibration Joint Cloth
 Aircell Pipe Insulation

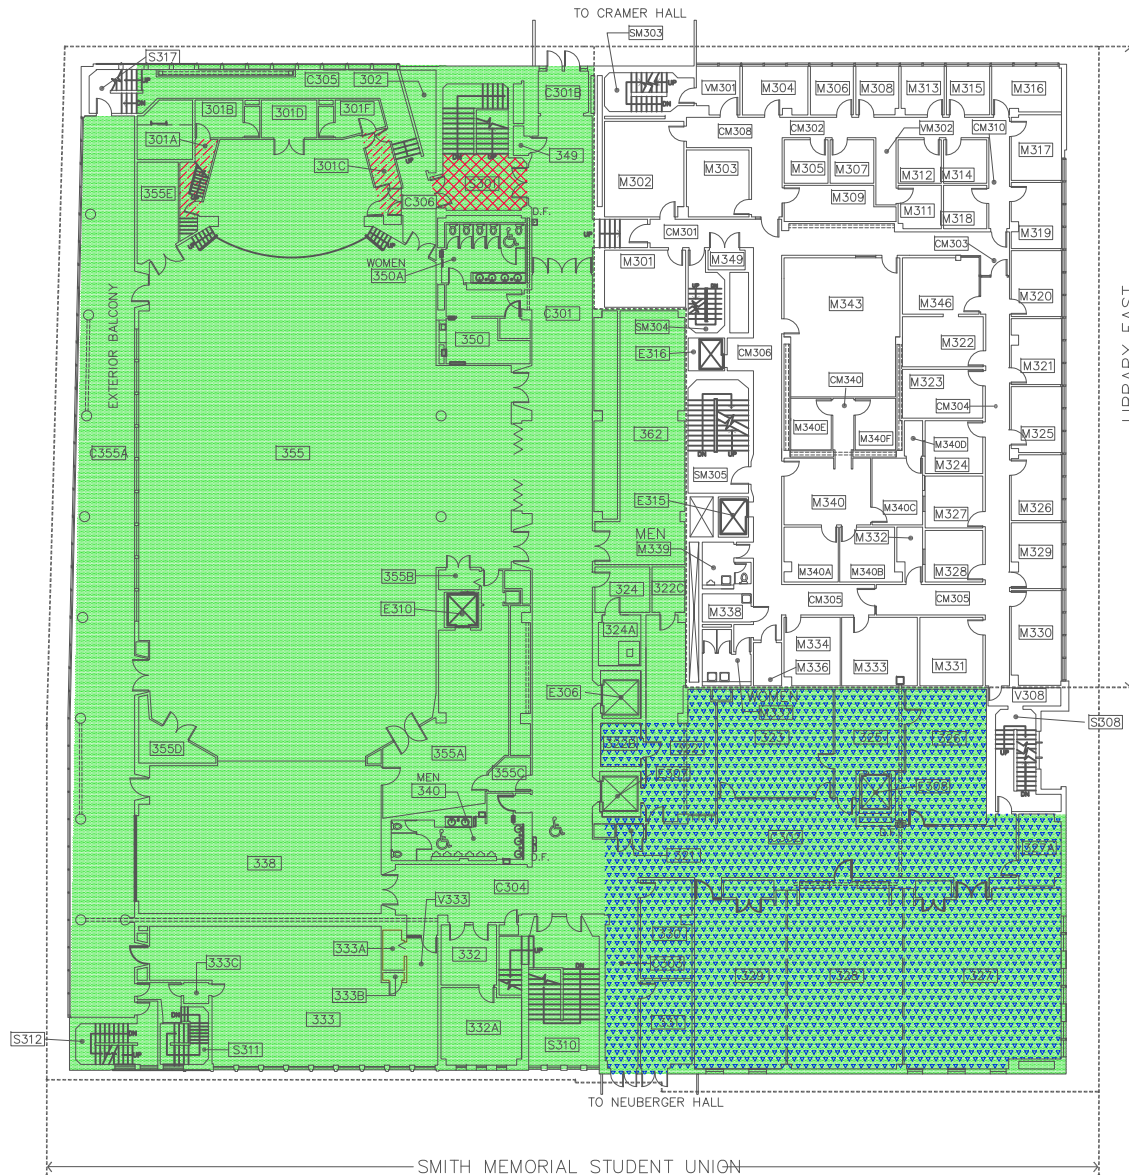
Smith Memorial Student Union
 3rd Floor
 ACM Locations

ACM not shown:
 Duct Seam Tape
 Rigid Pipe Insulation
 Vibration Joint Cloth
 Arcell Pipe Insulation

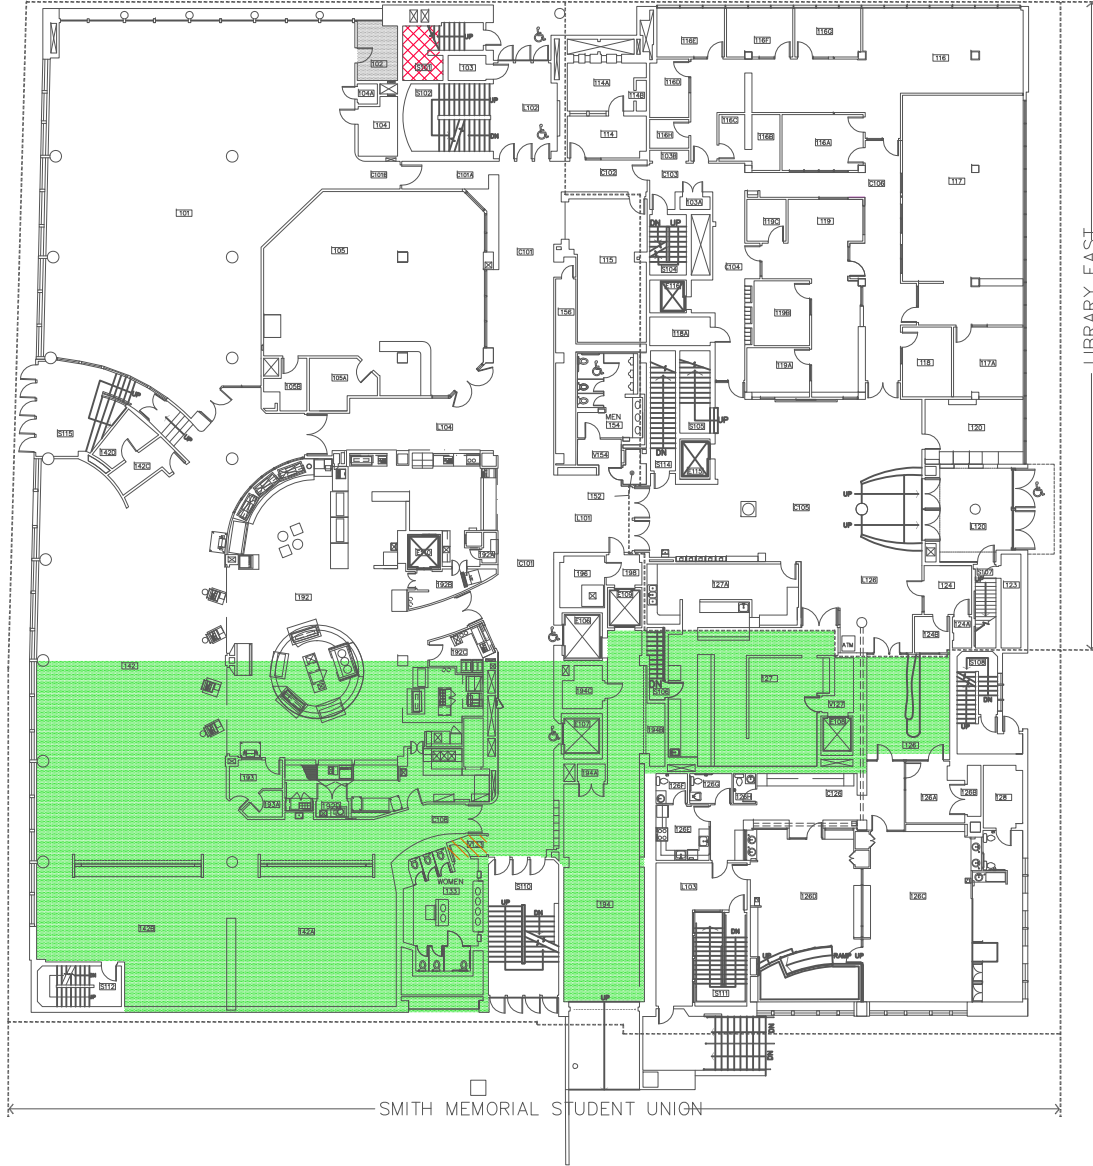
Smith Memorial Student Union
 1st Floor
 ACM Locations

ACM not shown:
 Duct Seam Tape
 Rigid Pipe Insulation
 Vibration Joint Cloth
 Aircell Pipe Insulation

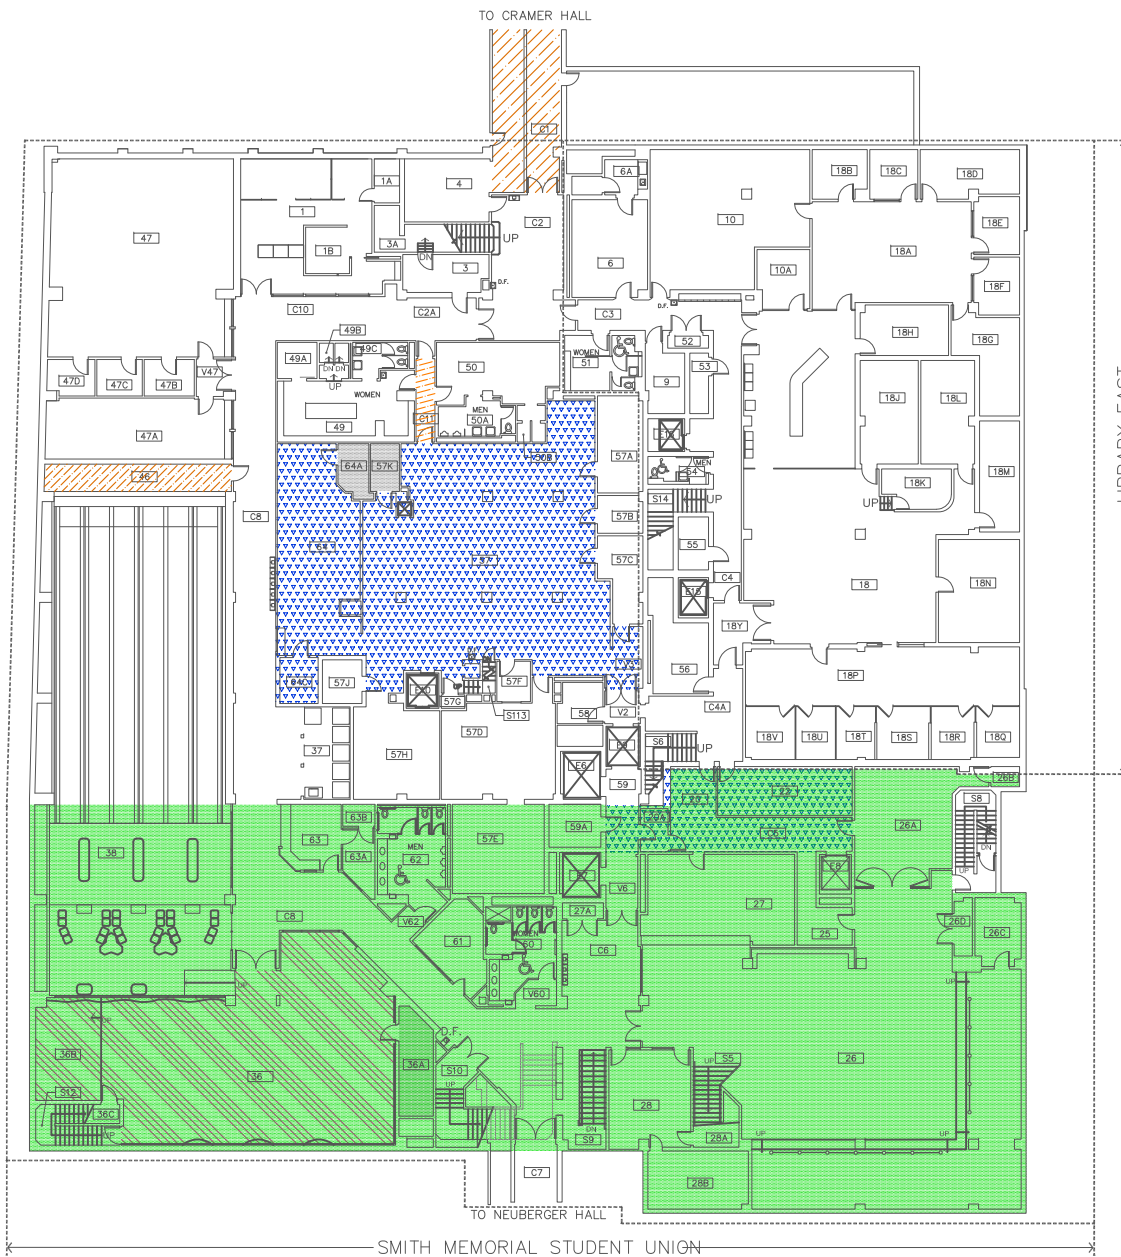
Smith Memorial Student Union
 Basement
 ACM Locations

ACM not shown:
 Duct Seam Tape
 Rigid Pipe Insulation
 Vibration Joint Cloth
 Arcell Pipe Insulation

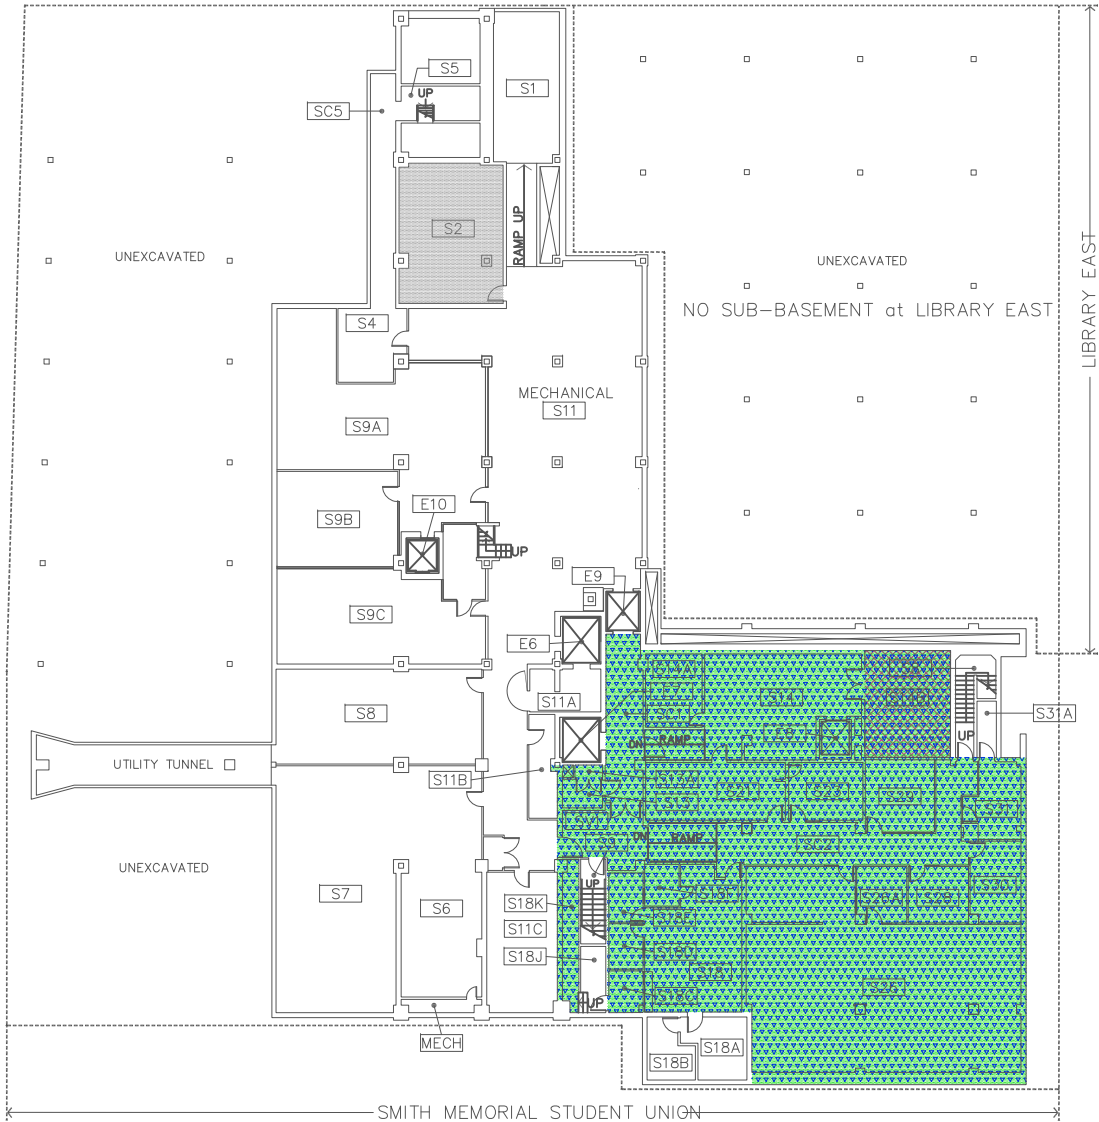
Smith Memorial Student Union
 Sub-Basement
 ACM Locations

ACM not shown:
 Duct Seam Tape
 Rigid Pipe Insulation
 Vibration Joint Cloth
 Aircell Pipe Insulation
