ASBESTOS BUILDING INSPECTION

**LIBRARY EAST
1825 SW BROADWAY
PORTLAND, OREGON 97201**

JUNE 23, 2008

FORENSIC ANALYTICAL PROJECT NO. PJ5592

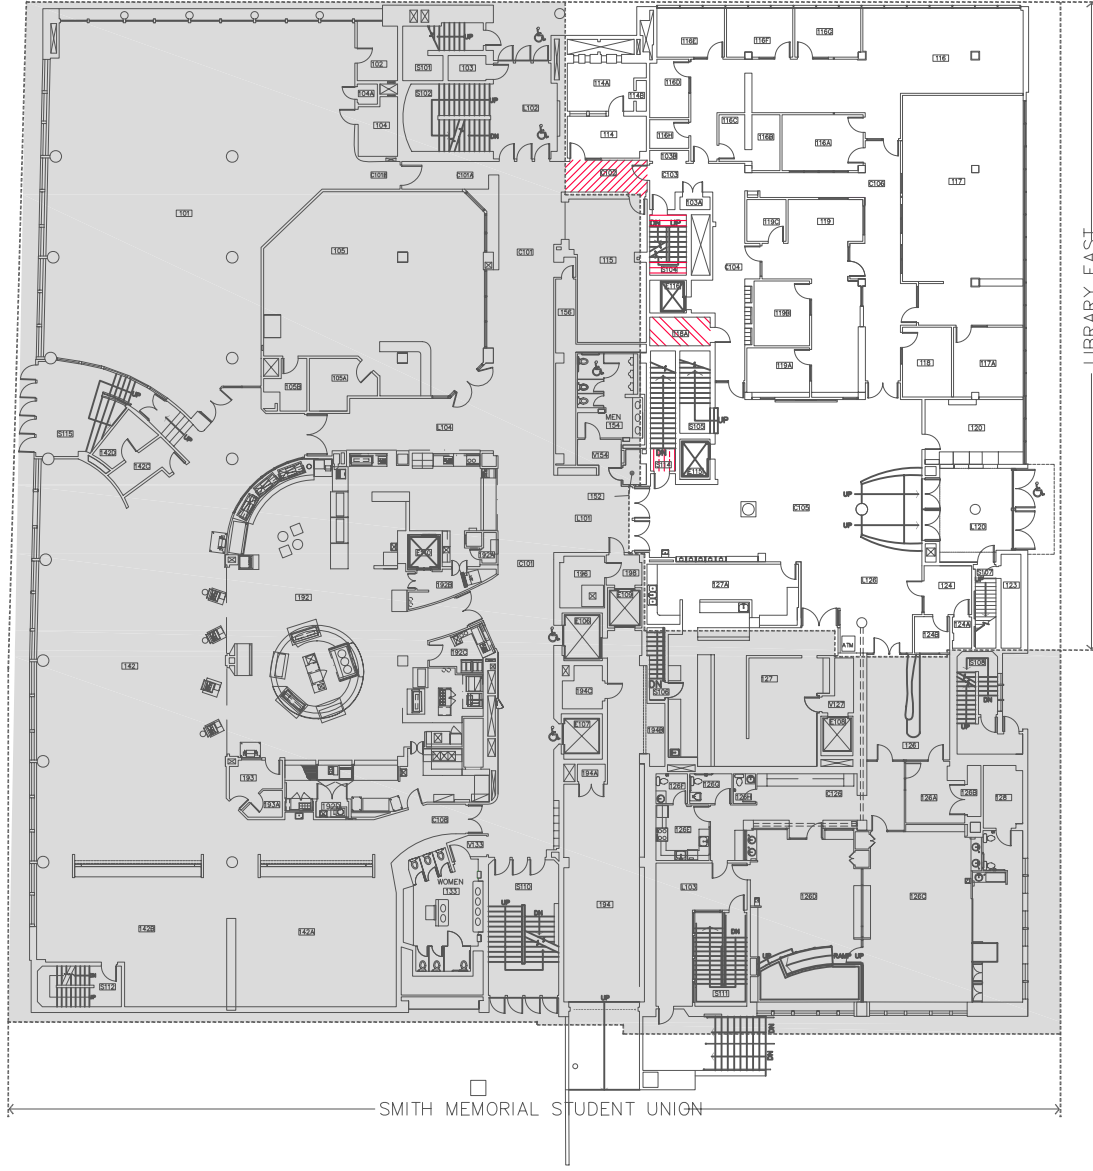
Library East
 1st Floor
 ACM Locations

- Floor Tile, 12" x 12" Beige w/ Green Specks
- Floor Tile, 9" x 9" Tan w/ White Streaks and Black Mastic
- Floor Tile, 9" x 9" Orange w/ White Streaks and Black Mastic
- Floor Tile, 9" x 9" Grey w/ White Streaks and Black Mastic
- Floor Tile, 9" x 9" Black w/ Large White Streaks and Black Mastic
- Floor Tile, 9" x 9" Green Streaked and Black Mastic
- Floor Tile, 9" x 9" Dusty Rose and Black Mastic
- Ceiling Tile, 2" x 4" Fissured w/ Pinholes - Drop
- Cement Asbestos Board

ACM not shown:
 Drywall and Joint Compound
 Rigid Pipe Insulation
 Pipe Fitting Insulation
 Duct Seam Tape

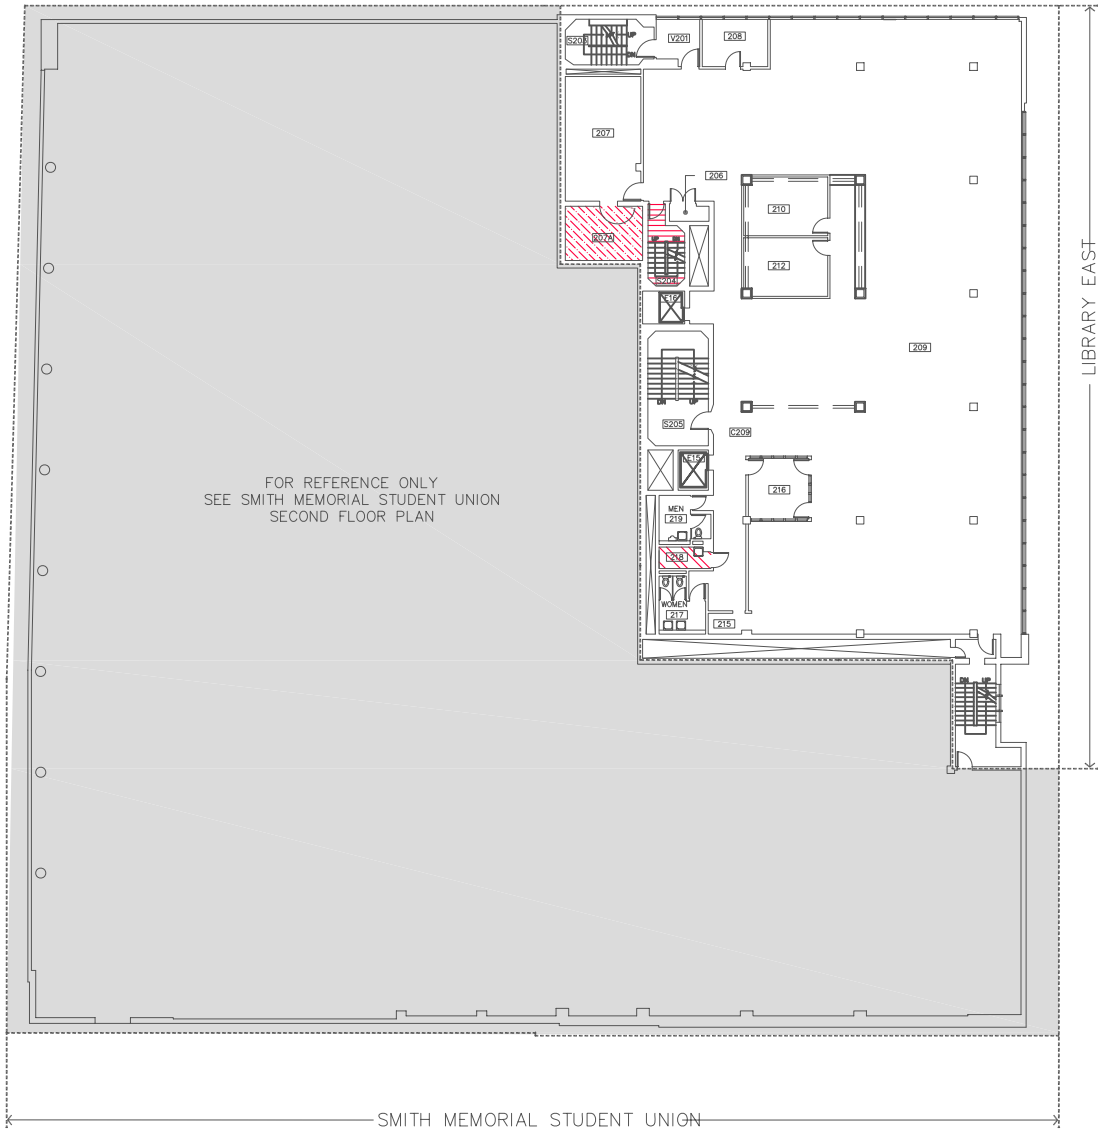
- Floor Tile, 12" x 12" Beige w/ Green Specks
 - Floor Tile, 9" x 9" Tan w/ White Streaks and Black Mastic
 - Floor Tile, 9" x 9" Orange w/ White Streaks and Black Mastic
 - Floor Tile, 9" x 9" Grey w/ White Streaks and Black Mastic
 - Floor Tile, 9" x 9" Black w/ Large White Streaks and Black Mastic
 - Floor Tile, 9" x 9" Green Streaked and Black Mastic
 - Floor Tile, 9" x 9" Dusty Rose and Black Mastic
 - Ceiling Tile, 2' x 4' Fissured w/ Pinholes - Drop
 - Cement Asbestos Board
- ACM not shown:
Drywall and Joint Compound
Rigid Pipe Insulation
Pipe Fitting Insulation
Duct Seam Tape

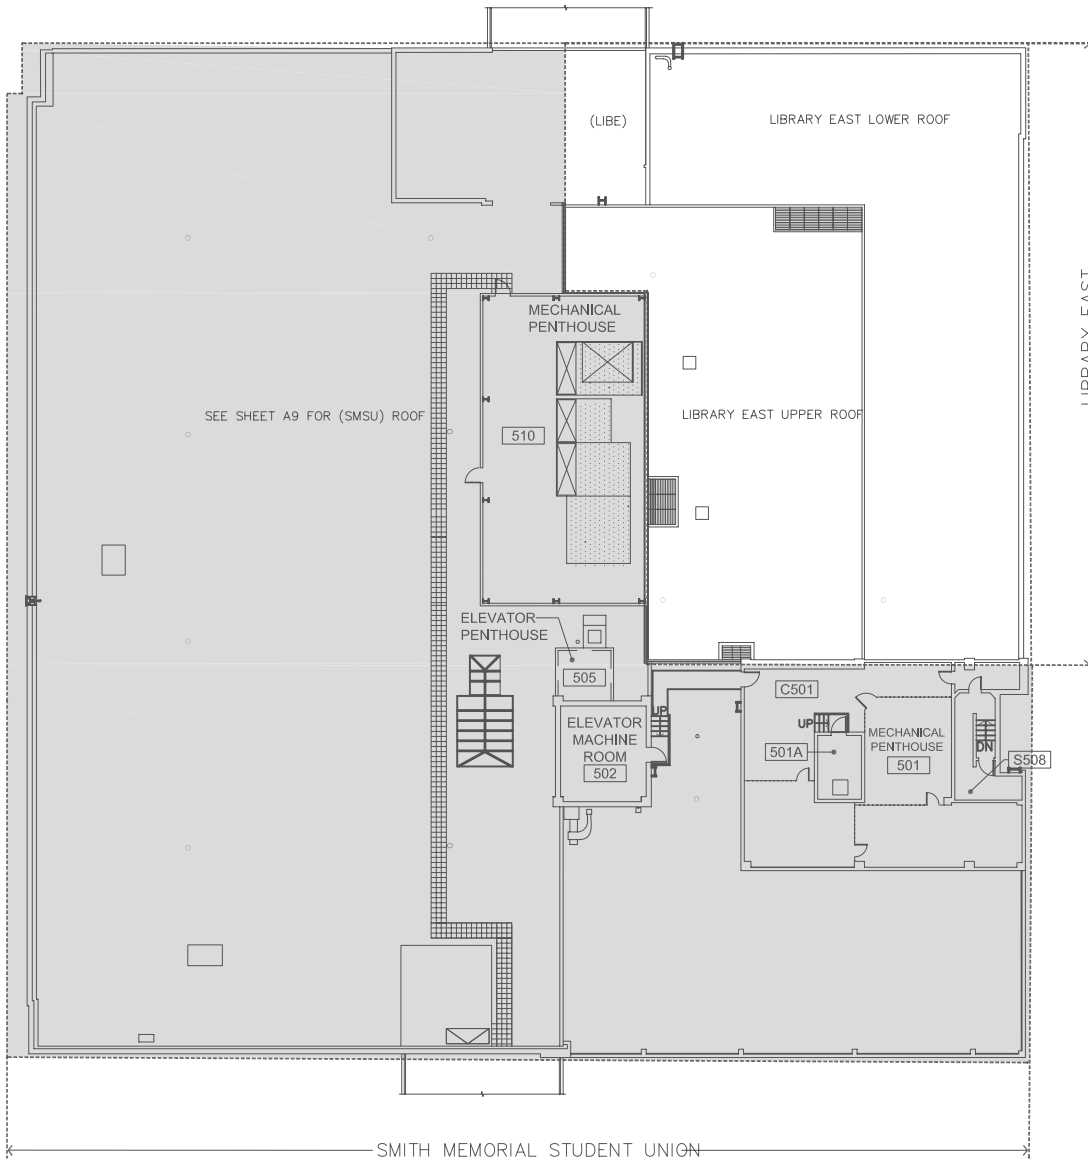
Library East
 Roof
 ACM Locations

-   Floor Tile, 12" x 12" Beige w/ Green Specks
-   Floor Tile, 9" x 9" Tan w/ White Streaks and Black Mastic
-   Floor Tile, 9" x 9" Orange w/ White Streaks and Black Mastic
-   Floor Tile, 9" x 9" Grey w/ White Streaks and Black Mastic
-   Floor Tile, 9" x 9" Black w/ Large White Streaks and Black Mastic
-   Floor Tile, 9" x 9" Green Streaked and Black Mastic
-   Floor Tile, 9" x 9" Dusty Rose and Black Mastic
-   Ceiling Tile, 2' x 4' Fissured w/ Pinholes - Drop
-   Cement Asbestos Board

ACM not shown:
 Drywall and Joint Compound
 Rigid Pipe Insulation
 Pipe Fitting Insulation
 Duct Seam Tape

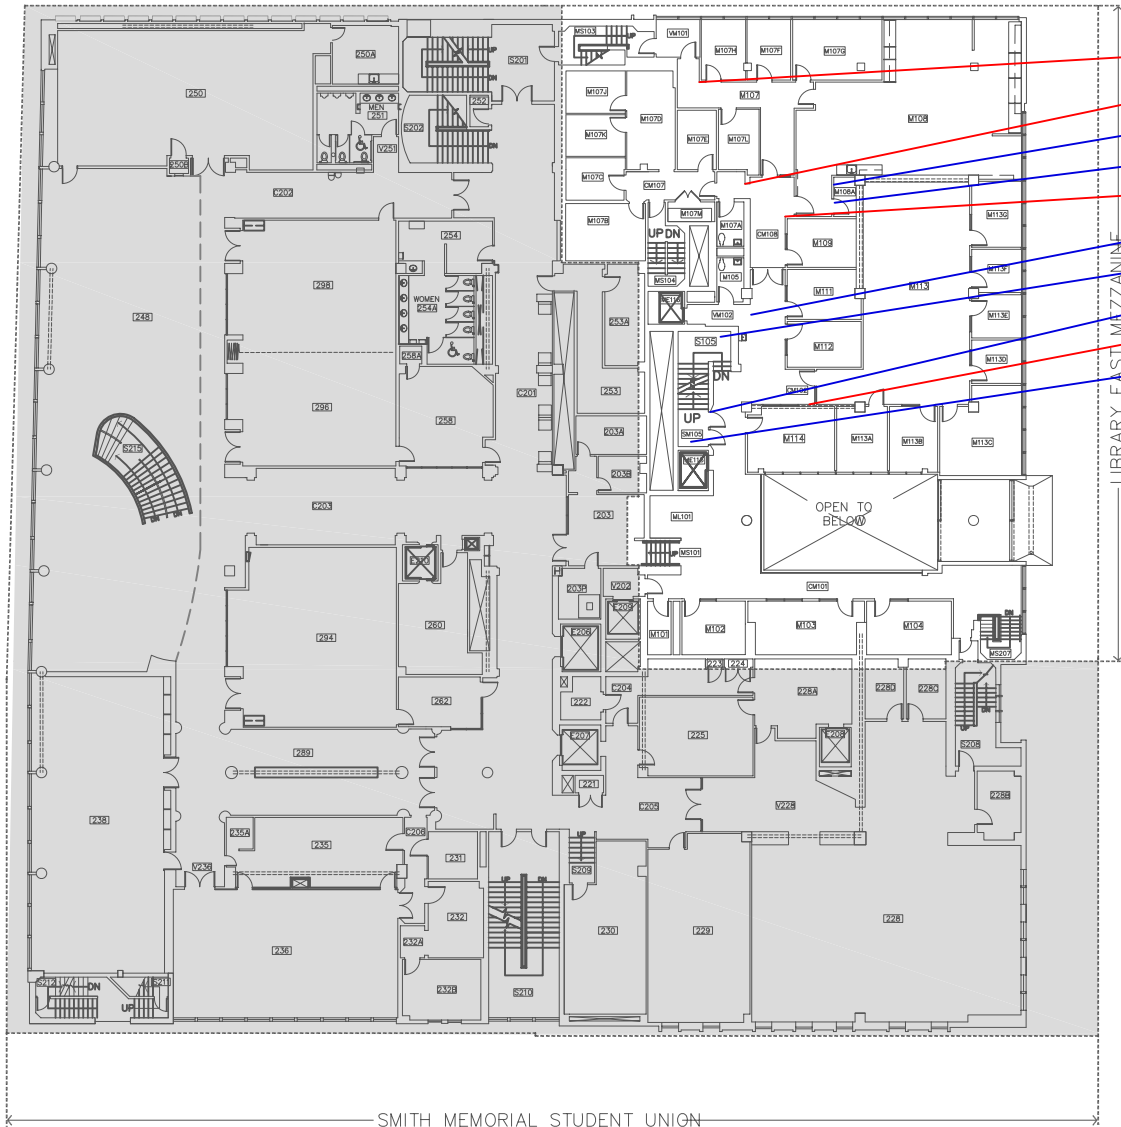
Library East
 1st Floor Mezzanine
 Sample Locations

- LIBE-05-DWJC-6*
- LIBE-05-DWJC-4*
- LIBE-14-CB-1
- LIBE-13-FT-1
- LIBE-05-DWJC-2*
- LIBE-12-FT-1
- LIBE-11-ST-1
- LIBE-06-PL-6
- LIBE-05-DWJC-3*
- LIBE-10-FT-1
