# ASBESTOS BUILDING INSPECTION

**EAST HALL  
632 SW HALL  
PORTLAND, OREGON 97201**

JUNE 30, 2008

FORENSIC ANALYTICAL PROJECT NO. PJ5551

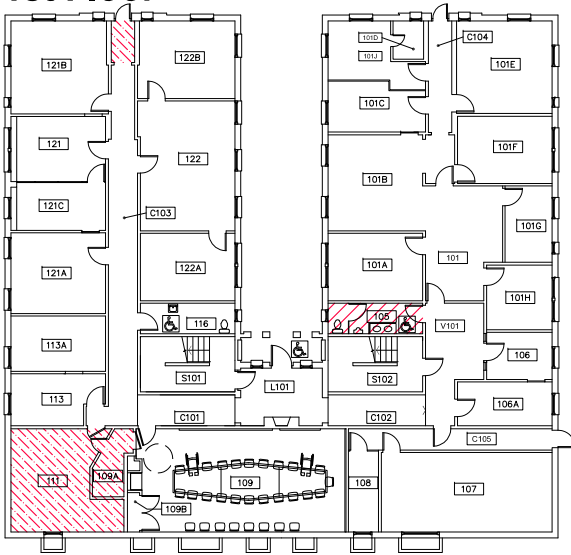
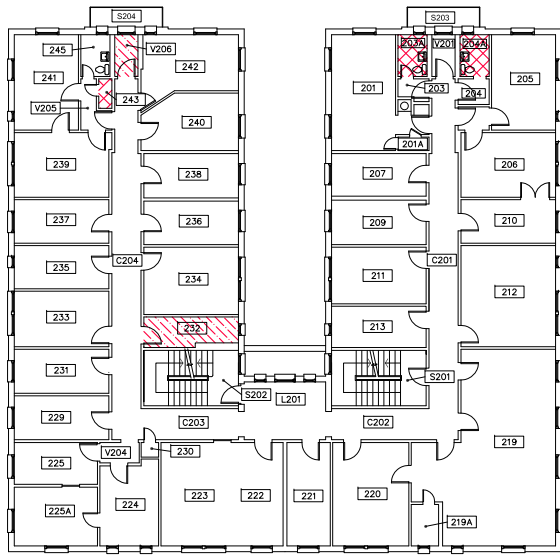
## East Hall 1st Floor & 2nd Floor ACM Locations

- Sheet Vinyl, Beige Pebble Pattern
- Floor Tile, 9" x 9" Tan Marbled, and Black mastic
- Sheet Vinyl, Red Pebble Pattern
- Ceiling Texture (Heavy and Knock-down)\*\*
- Floor Tile, 9" x 9" Off White w/ Grey Streaks, and Black mastic

ACM not shown:  
 Floor Tile under Carpet  
 Sink Undercoating, White  
 Aircell Pipe Insulation  
 Pipe Fitting Insulation

\*\* - This material contains a trace amount of asbestos

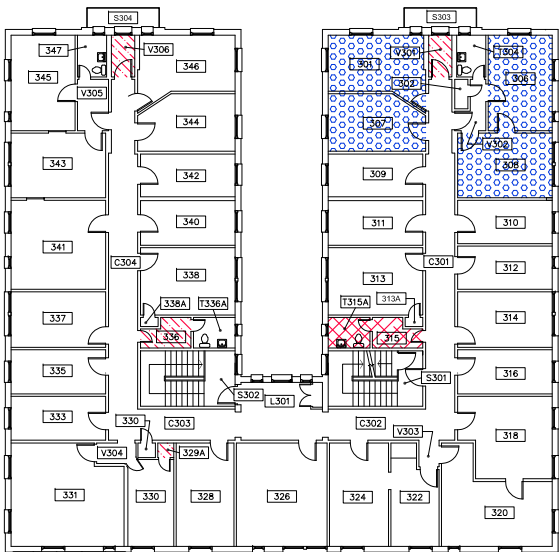
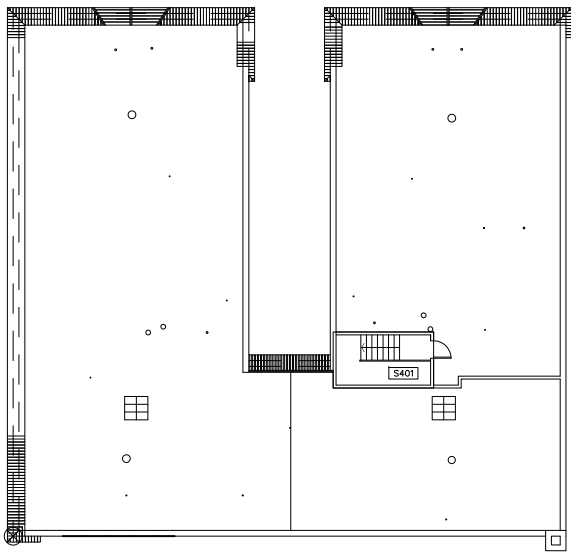
East Hall  
 3rd Floor & Roof Plan  
 ACM Locations

- Sheet Vinyl, Beige Pebble Pattern
- Floor Tile, 9" x 9" Tan Marbled, and Black mastic
- Sheet Vinyl, Red Pebble Pattern
- Ceiling Texture (Heavy and Knock-down)\*\*
- Floor Tile, 9" x 9" Off White w/ Grey Streaks, and Black mastic

ACM not shown:  
 Floor Tile under Carpet  
 Sink Undercoating, White  
 Aircell Pipe Insulation  
 Pipe Fitting Insulation

Roof Core samples of the roof were not collected at the request of PSU.

\*\* - This material contains a trace amount of asbestos
