Re: Focused Site Investigation  
1500 SW Chandler Avenue and 1707 SW Simpson Avenue, Bend, Oregon  
PBS Project No. 80599.000PR80599.000 Phase 0002

CHANDLER PROPERTY TEST PIT LOCATIONS

ROBINSON PROPERTY TEST PIT LOCATIONS

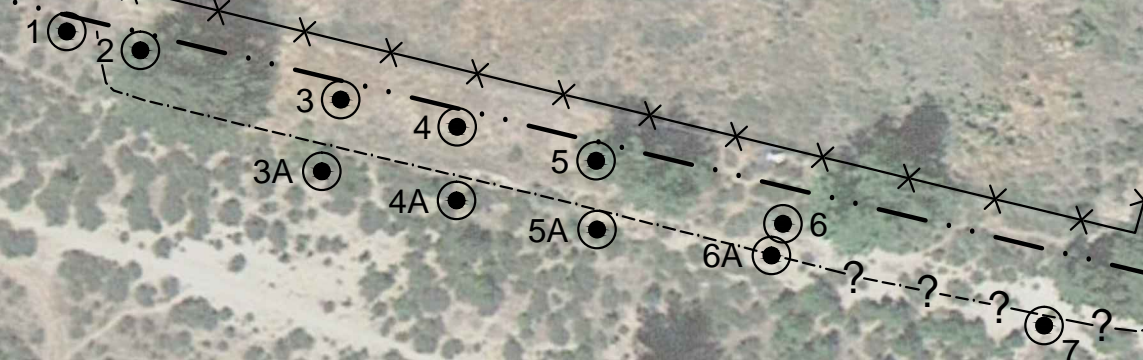
Eleven test pit locations were selected along the northern property boundary of the Chandler property (Figure 2). The existing chain-link fence and recently surveyed property boundary between Tax Lot 100 and the adjoining Demolition Landfill tax lot (TL 181206A000719) were available to use as reference points. The test pits were located in areas to assess beneath where apparent landfill cover soil had been placed and the surface topography indicated a possible extension of fill onto the Chandler property.

The test pits confirmed that solid waste extends into the northern edge of the Chandler property. Observed waste material included various metal, glass objects, ceramics, plastic, rubber, wire, and cables. The waste was encountered at depths ranging from 1.5 to 3.5 feet below ground surface (bgs). Test Pits TP-1, TP-3 thru TP-5 and TP-6A contained buried solid waste. Test Pits 3A thru 5A were excavated to estimate the horizontal extent of the waste south of test pits containing waste material. In general the waste is limited to within 20 feet of the property boundary (Figure 2). The remnants of a small berm that likely demarks the northern boundary of the former Brooks-Scanlon haul road appears to provide a good east-west delineation of the waste boundary. Test Pits TP-1, TP-6A and TP -7 were also used to further define the extent of buried waste on the Chandler Property. TP-6A contained a thin (less than 0.5 feet thick) layer of waste material at a depth of approximately 3 feet bgs. The waste zone pinched out to the south within the excavation. Test Pit TP-6 was excavated from the top of the fill berm and did not encounter any waste, but also was not able to fully penetrate the fill material vertically (9 ft bgs) or horizontally (8 ft into the center of the berm). Therefore, the extent of waste is estimated east of TP-6/TP-6A due to the significant amount of fill material placed along the property boundary associated with the removal of the former haul road bridge. The test pit information is summarized in Table 1 below.

Test pit explorations conducted along the northern portion of the Chandler Property adjacent to the Bend Demolition Landfill indicate that buried solid waste material is present along the property boundary. The waste material appears to have been placed in this area when the landfill was actively operating and when the former haul road was utilized by Brooks Scanlon. The identified waste appears to extend onto the Chandler Property a horizontal distance of approximately 20 feet as shown on Figure 2. Additionally, the waste appears to extend as much as 340 feet parallel to the northern property boundary of the Chandler Property. The eastern extent of the waste was not confirmed due to the large amount of fill material present in that area.

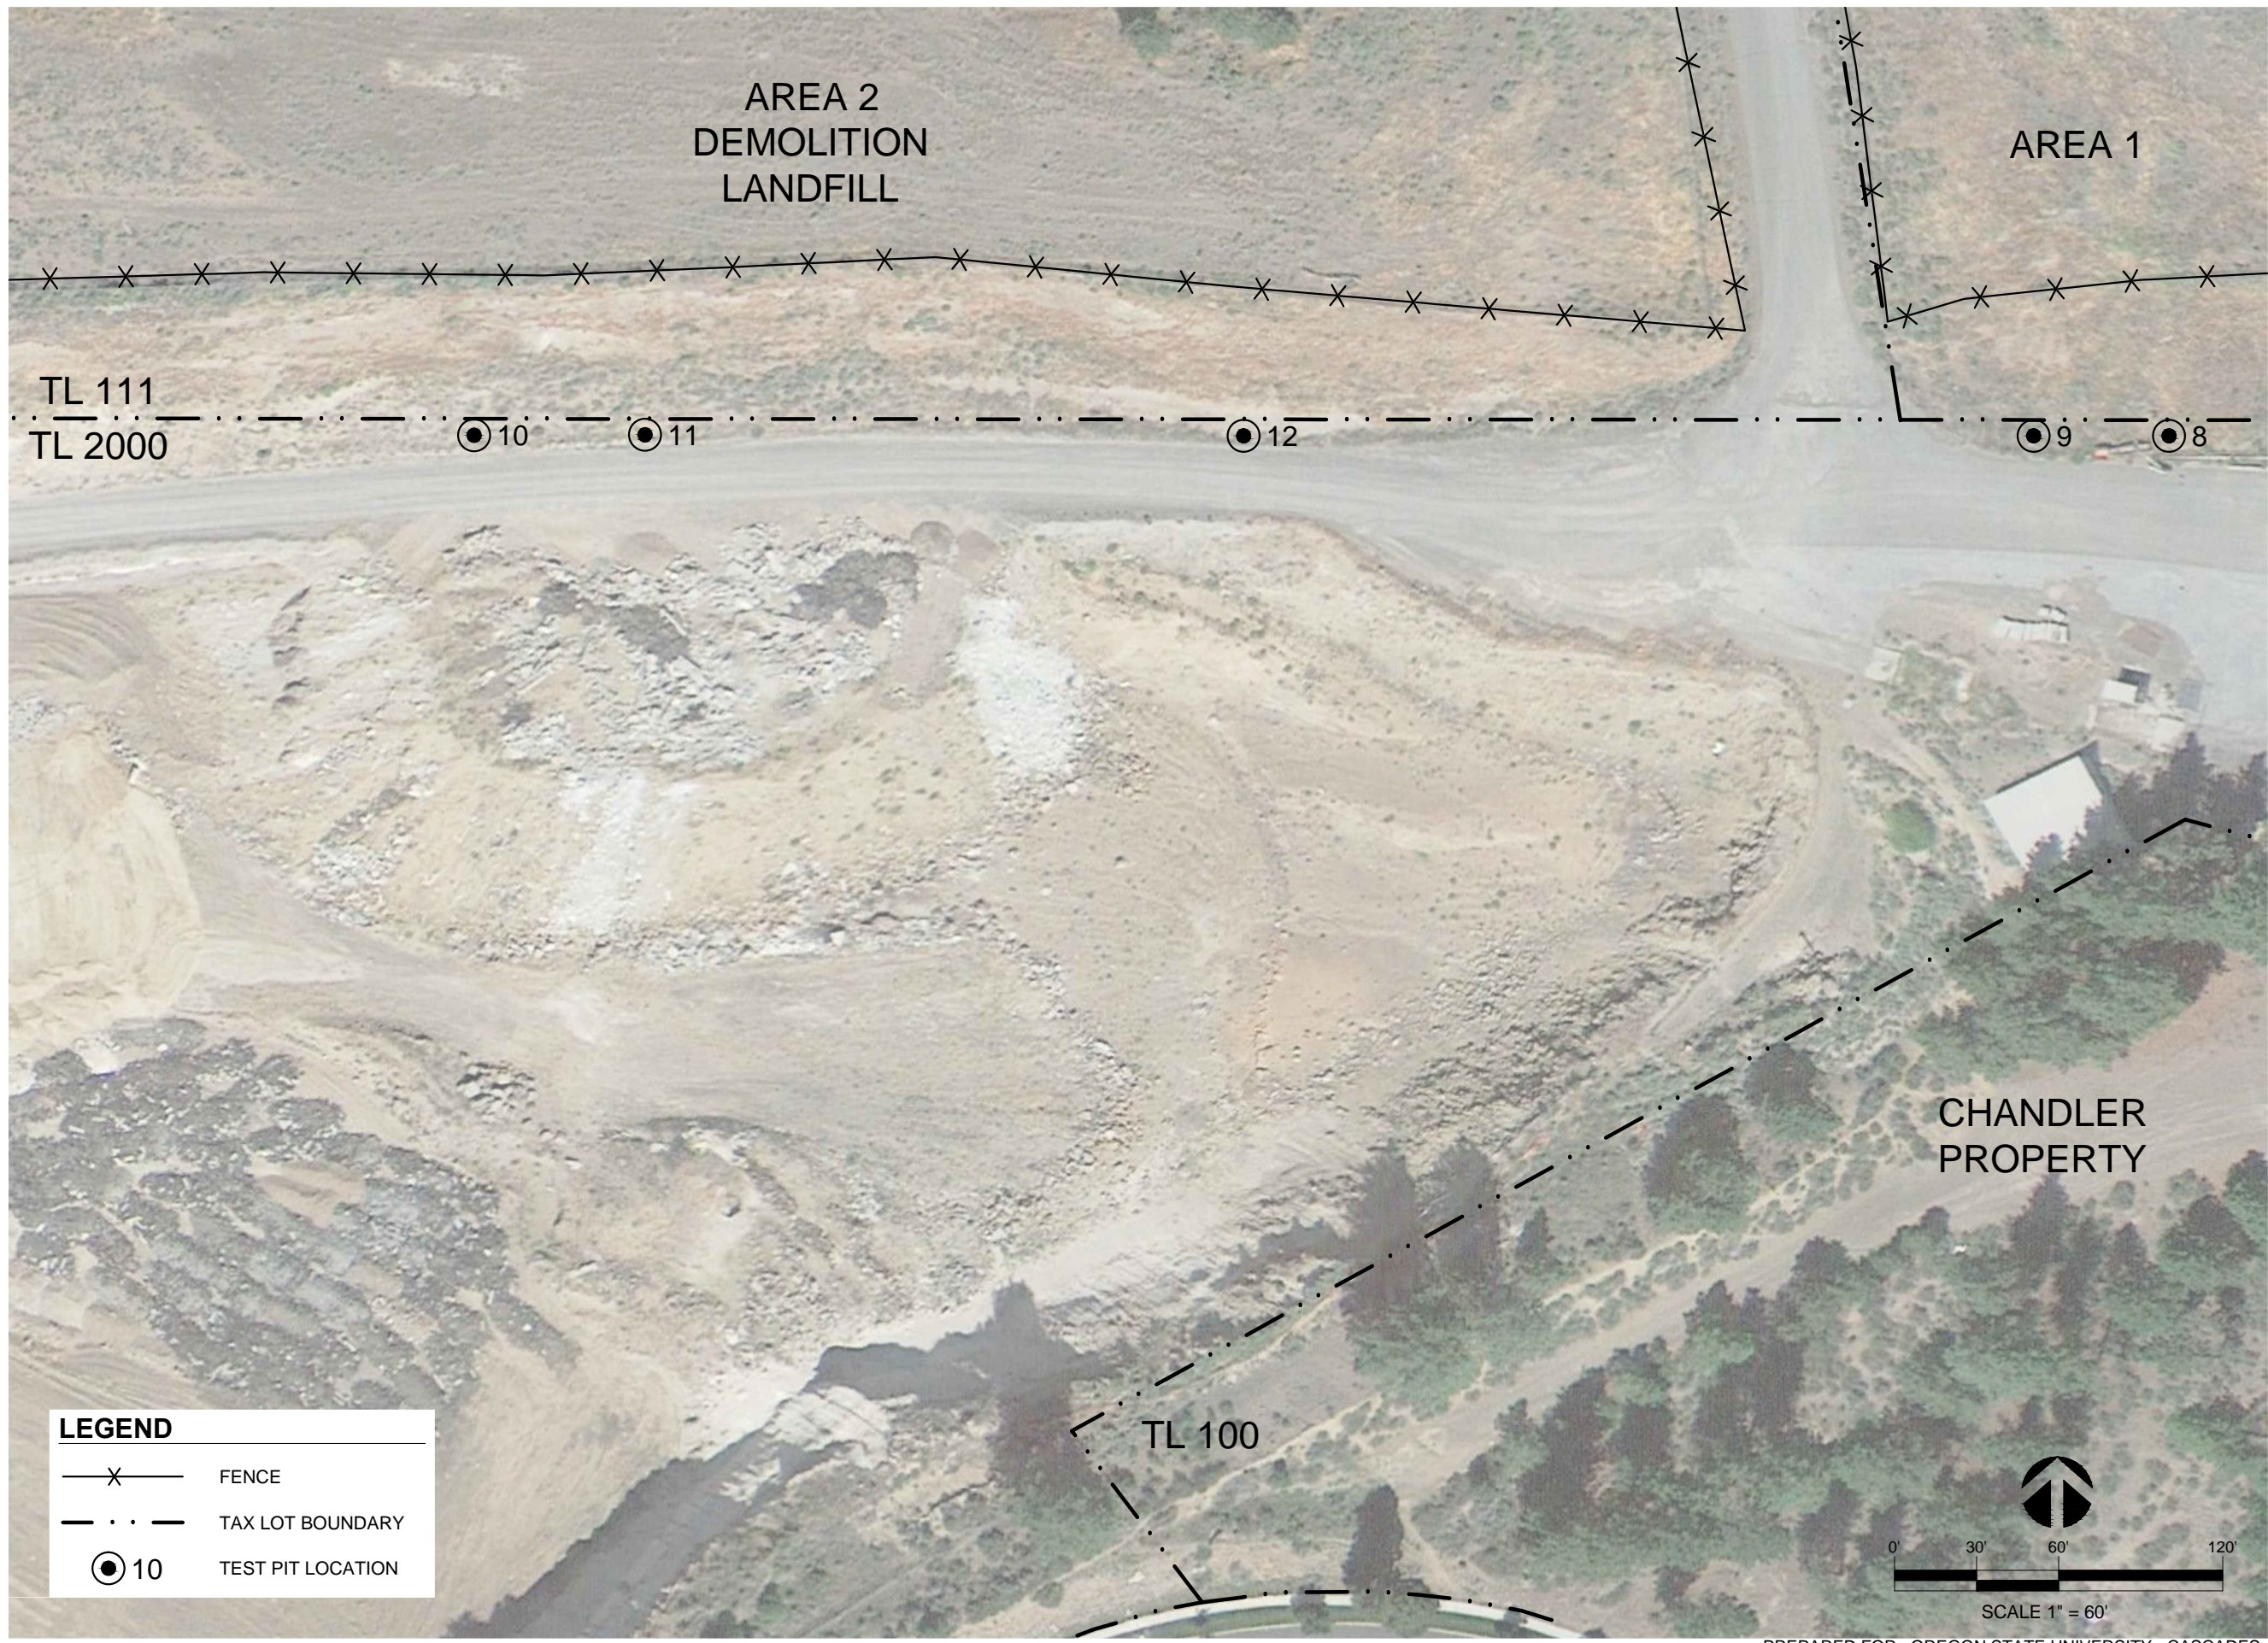
Five test pit locations were selected along the northern property boundary of the Robinson Property (Figure 3). The existing chain-link fence and recently surveyed property boundary between Tax Lot 2000 and the adjoining Demolition Landfill tax lots (TL 1812060000110 and TL 1812060000111) were available to use as reference points. There is a narrow area between the property boundary and the main access road on the Robinson Property where fill material is present. No solid waste was observed in the test pits (TP-8 through TP-12) excavated in this area to depths ranging from 4 to 6 feet bgs. The test pit data is summarized in Table 2 below.

Test pit explorations conducted along the northern portion of the Robinson Property adjacent to the landfill provide no evidence of solid waste material extending onto the property.
