*Pilot Study Report  
Deschutes County Construction  
Demolition Landfill  
Bend, Oregon*

Prepared for:  
Deschutes County

September 16, 2016  
2112-03

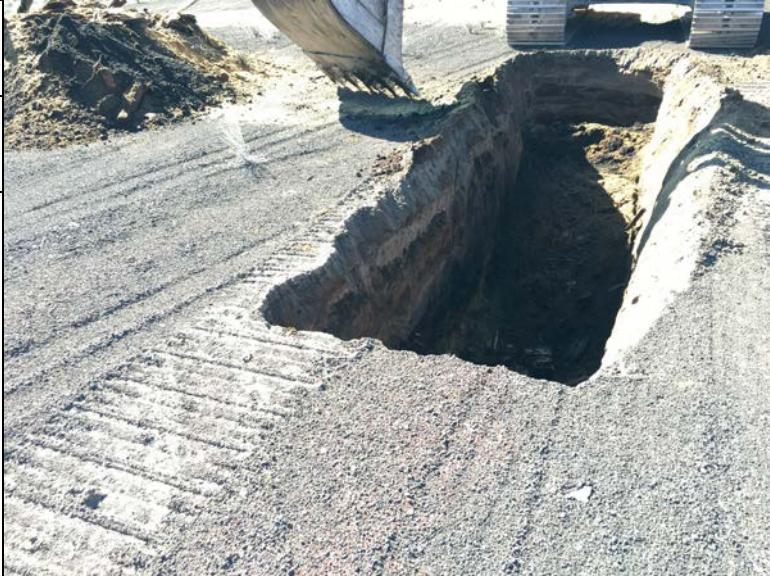
<b>Photo No:</b> 1

<b>Photo Date:</b> 4/18/16	
<b>Orientation:</b> --	
<b>Description:</b>  Typical excavation sequence: excavation to 23 feet.

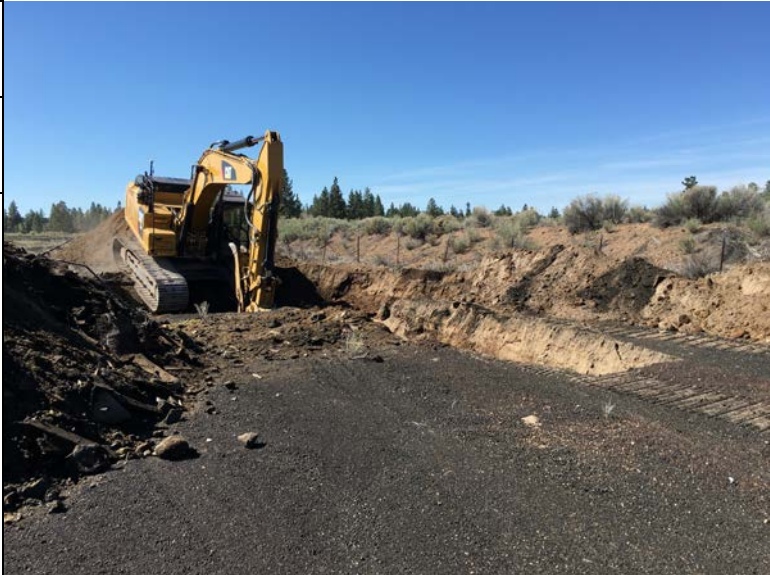
<b>Photo No:</b> 2

<b>Photo Date:</b> 4/18/16	
<b>Orientation:</b> South	
<b>Description:</b>  Typical excavation sequence: benching to 7 feet.

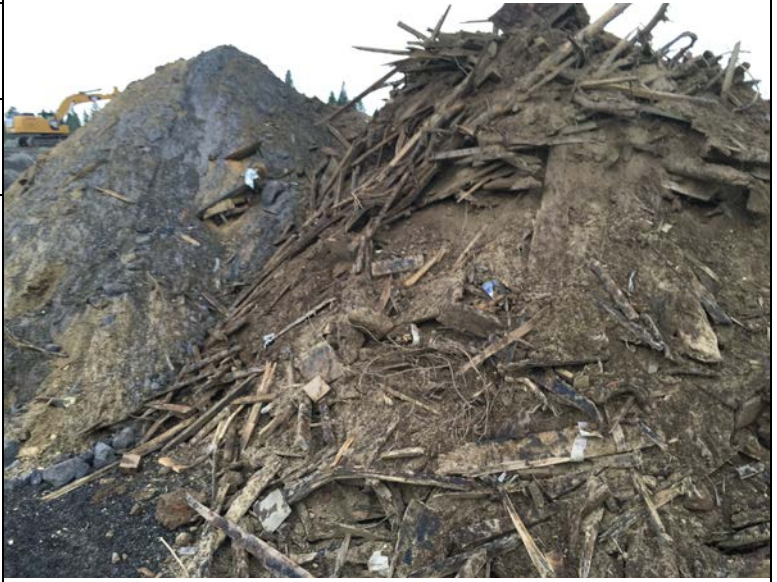
<b>Photo No:</b> 4	
<b>Photo Date:</b> 4/20/16

<b>Orientation:</b> --	
<b>Description:</b> Area 1 typical waste.

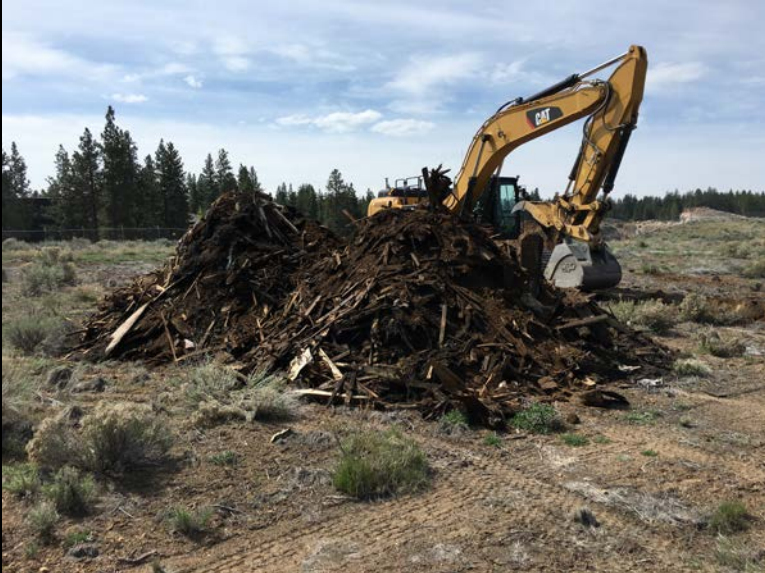
<b>Photo No:</b> 5

<b>Photo Date:</b> 4/20/16	
<b>Orientation:</b> South	
<b>Description:</b> Area 1 typical waste.

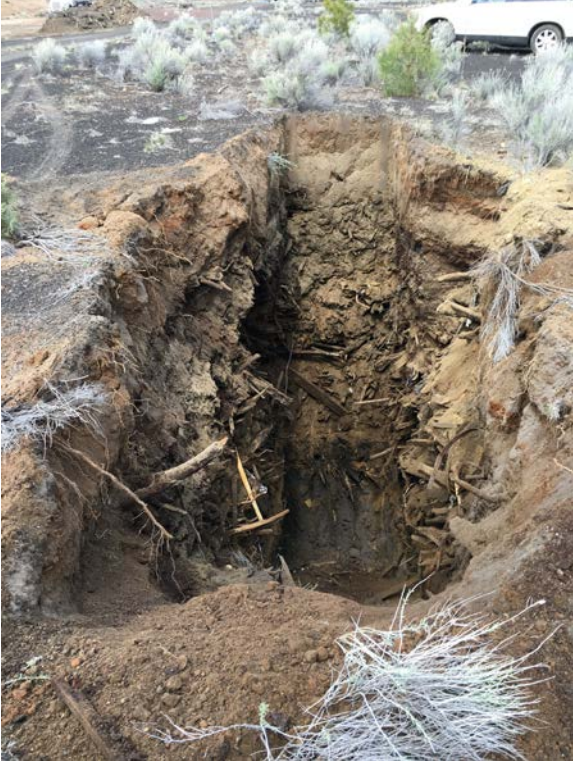
<b>Photo No:</b> 6

<b>Photo Date:</b> 4/20/16	
<b>Orientation:</b> North	
<b>Description:</b> Area 1 test pit profile.

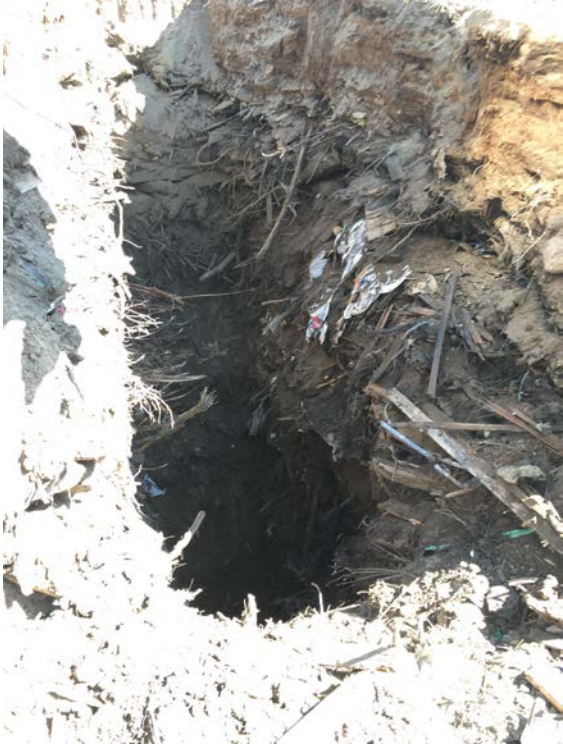
<b>Photo No:</b> 7

<b>Photo Date:</b> 4/25/16	
<b>Orientation:</b> --	
<b>Description:</b> Area 2 Test pit profile.

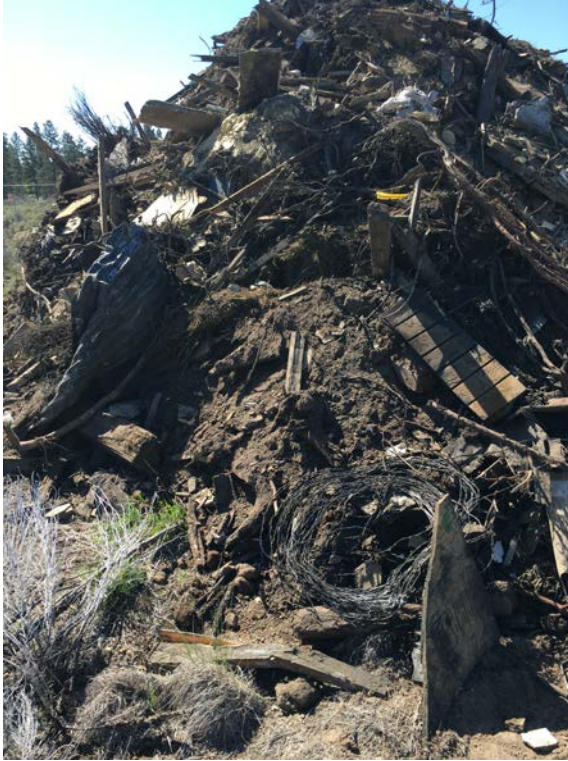
<b>Photo No:</b> 8

<b>Photo Date:</b> 4/25/16	
<b>Orientation:</b> --	
<b>Description:</b> Area 2 waste pile.

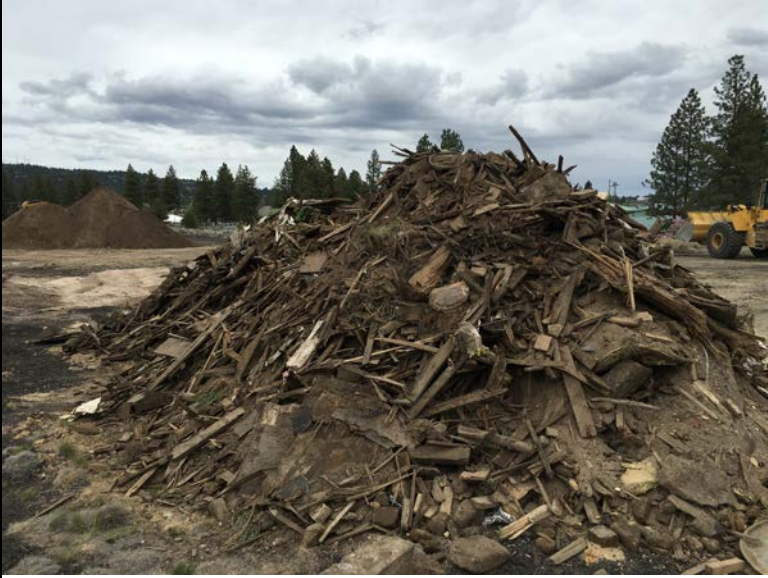
<b>Photo No:</b> 9

<b>Photo Date:</b> 4/22/16	
<b>Orientation:</b> --	
<b>Description:</b> Area 1 mixed waste for screening.

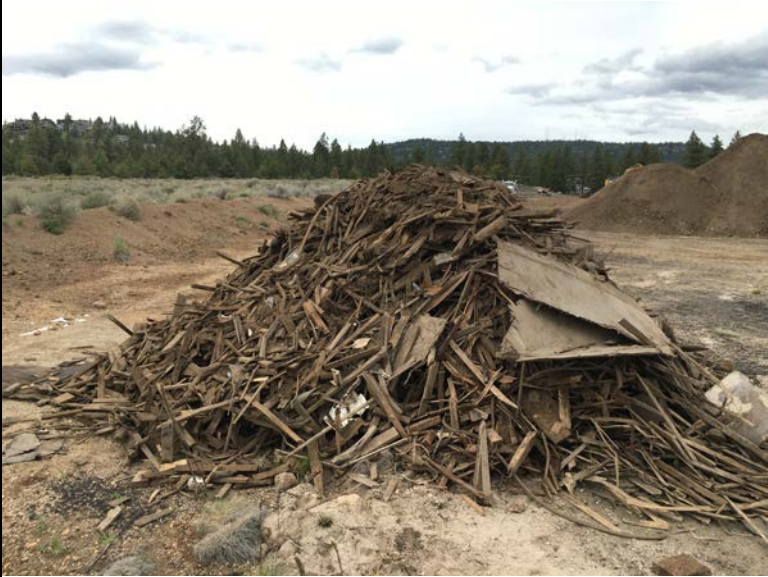
<b>Photo No:</b> 10

<b>Photo Date:</b> 4/22/16	
<b>Orientation:</b> North	
<b>Description:</b> Area 1 wood waste after screening.

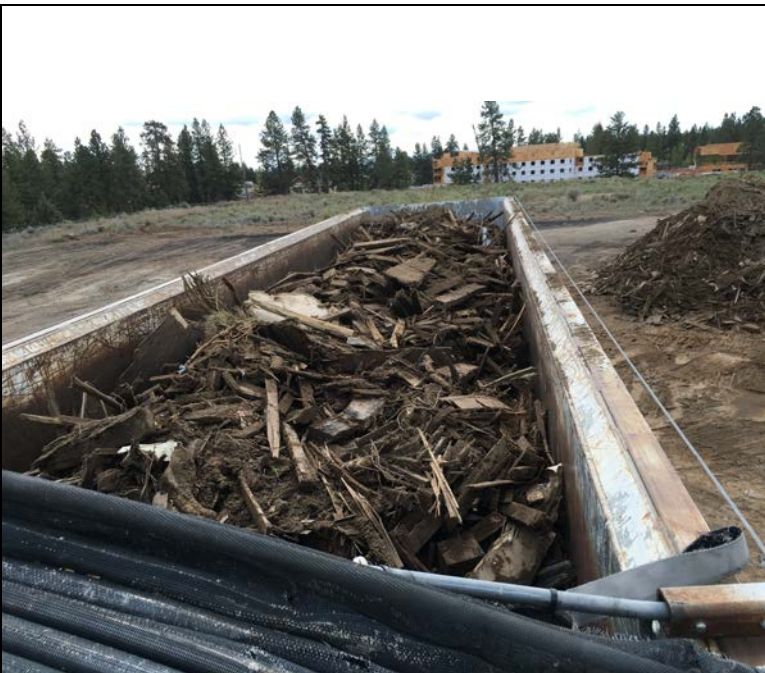
<b>Photo No:</b> 12

<b>Photo Date:</b> 4/27/16	
<b>Orientation:</b> South	
<b>Description:</b> Load of Area 1 wood waste for processing at MRF.

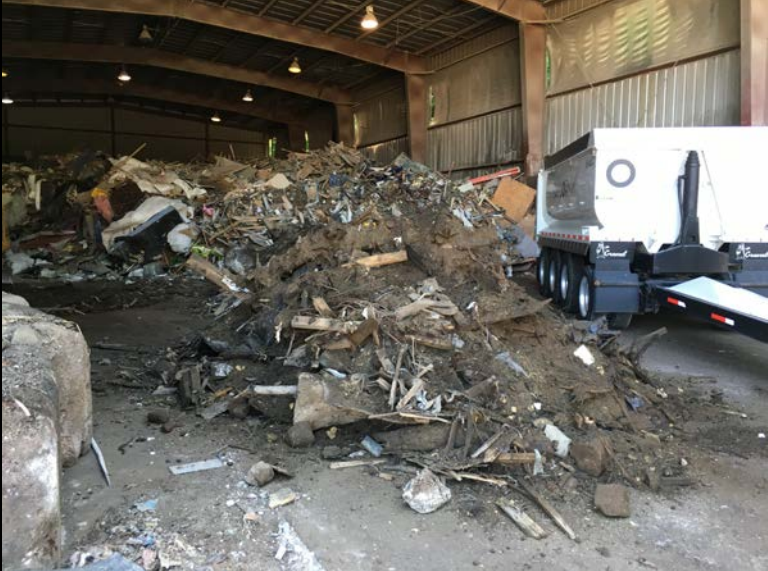
<b>Photo No:</b> 14	
<b>Photo Date:</b> 4/30/16

<b>Orientation:</b> --	
<b>Description:</b> Area 2 mixed waste at MRF.

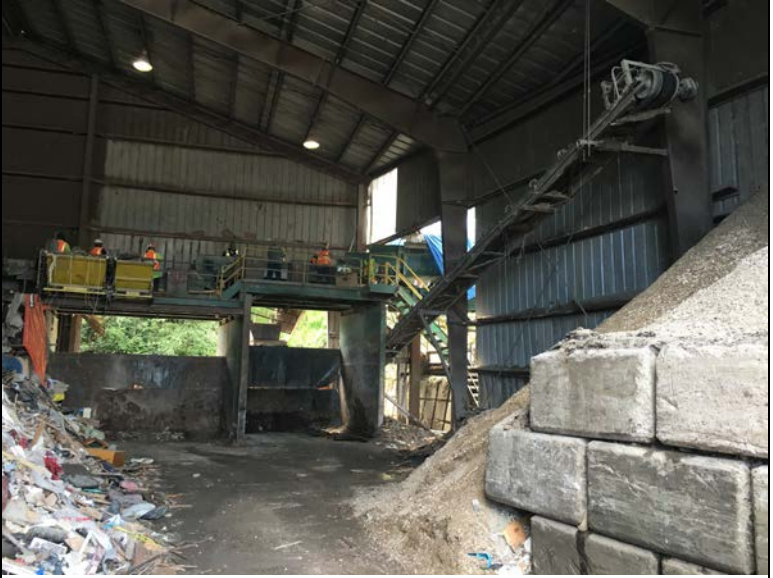
<b>Photo No:</b> 15	
<b>Photo Date:</b> 4/30/16

<b>Orientation:</b> --	
<b>Description:</b> MRF sorting line.

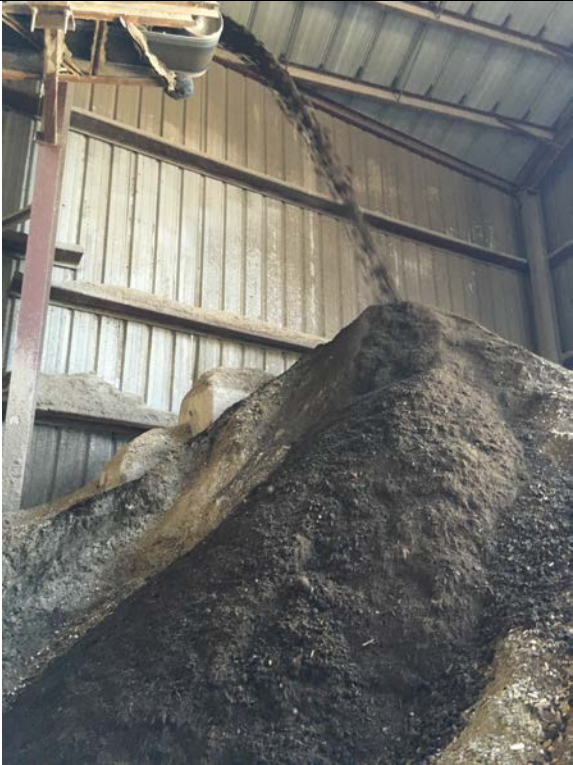
<b>Photo No:</b> 16

<b>Photo Date:</b> 4/30/16	
<b>Orientation:</b> --	
<b>Description:</b> Fines (< 1 inch).

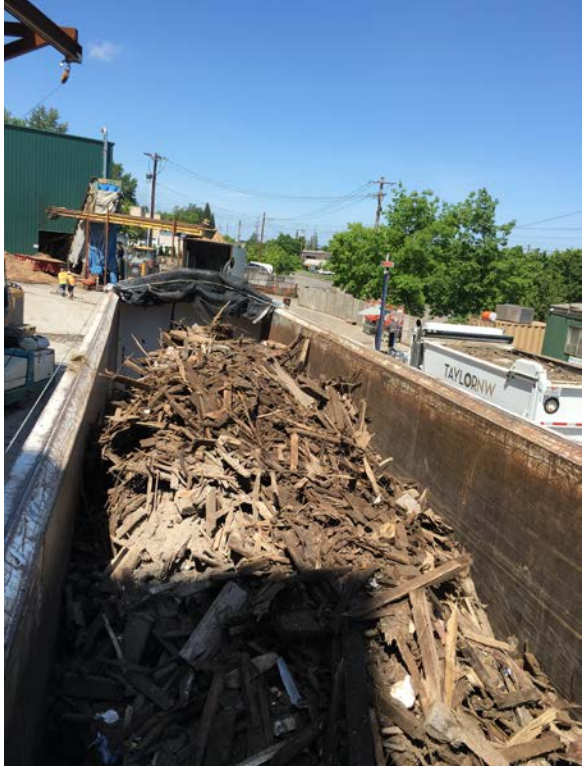
<b>Photo No:</b> 17

<b>Photo Date:</b> 4/30/16	
<b>Orientation:</b> --	
<b>Description:</b> Sorted wood waste loaded for transport to chipper.

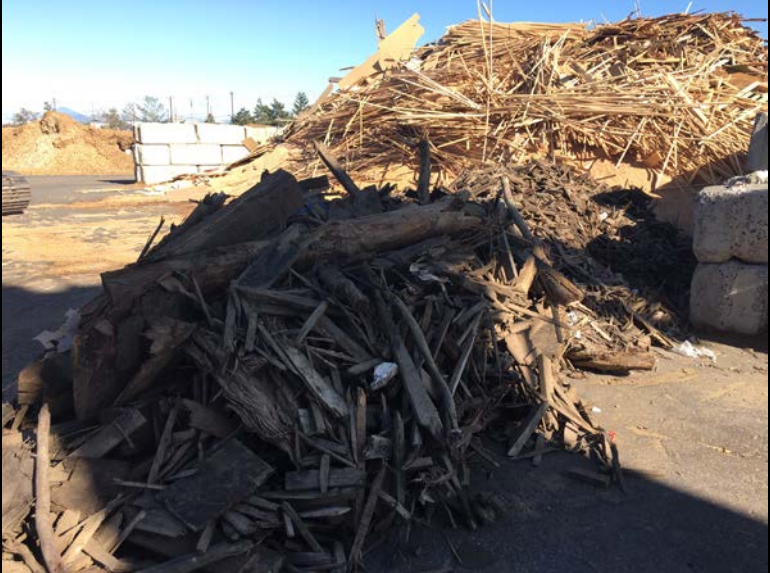
<b>Photo No:</b> 18

<b>Photo Date:</b> 5/9/16	
<b>Orientation:</b> --	
<b>Description:</b> Sorted wood waste at chipper.

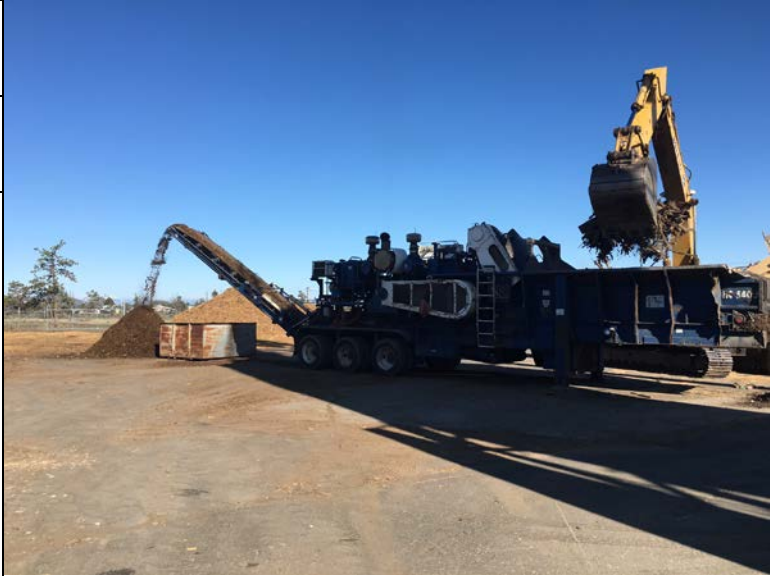
<b>Photo No:</b> 19	
<b>Photo Date:</b> 5/9/16

<b>Orientation:</b> --	
<b>Description:</b> Chipping process.
