Precision Analytical & Environmental Services

Client: **Oregon State University** -Location: **Wiegand Hall Warehouse**

Log # **20321**

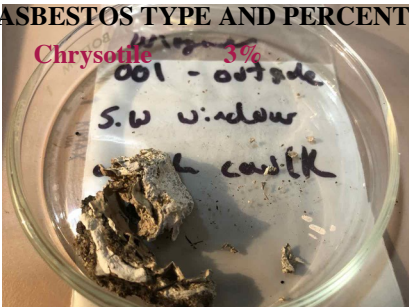
Sample #: 001 Caulk Outside SW Window	
Lab # 20321-1 Asbestos Containing Brittle	
MATERIAL DESCRIPTION: Window glazing compound is a white to tan, brittle putty composed of mineral grains, 3% chrysotile fiber bundles, and a small amount of cellulose fibers in a binder. Outer layers of paint not included in the analysis.	ASBESTOS TYPE AND PERCENT:

A petri dish containing a white to tan, brittle putty sample. Handwritten text on the dish reads "001 - outside S.W. window" and "3% chrysotile".
	% OTHER FIBERS: Cellulose 1 % NONFIBROUS COMPONENTS: Mineral fillers & binders 96
Sample #: 002 Caulk Outside SE Corner	
Lab # 20321-2 Asbestos Containing Brittle	
MATERIAL DESCRIPTION: White latex caulk over window glazing compound that white to tan, brittle putty composed of mineral grains, 1-2% chrysotile fiber bundles, and a small amount of cellulose fibers in a binder. Outer layers of paint include silver aluminum coating containing 1-2% chrysotile. Possible cross contamination of silver coating and glazing compound.	ASBESTOS TYPE AND PERCENT:

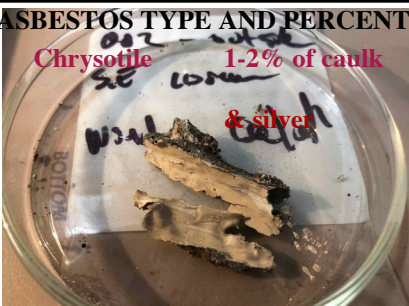
A petri dish containing a white latex caulk sample. Handwritten text on the dish reads "002 - outside SE corner" and "1-2% of caulk & silver".

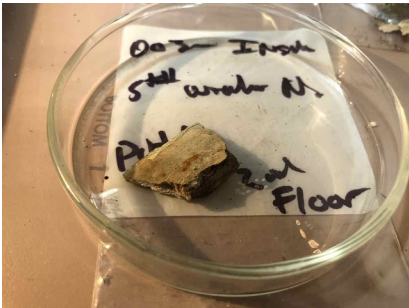
% OTHER FIBERS: Cellulose <1 % NONFIBROUS COMPONENTS: Mineral fillers & binders 98
Sample #: 003 Caulk Inside 2nd Fl., 5th Window N.	
Lab # 20321-3 No Asbestos Detected Brittle	
MATERIAL DESCRIPTION: Window glazing compound is a hard, white to tan putty composed of mineral grains and a small amount of cellulose fibers in a binder. Outer layer of tan paint.

A petri dish containing a hard, white to tan putty sample. Handwritten text on the dish reads "003 - Inside 5th window N." and "Floor".
	% OTHER FIBERS: Cellulose trace % NONFIBROUS COMPONENTS: Mineral fillers & binders ~100
Sample #: 004 Caulk Inside 2nd Fl., NW Window	
Lab # 20321-4 Asbestos Containing Brittle	
MATERIAL DESCRIPTION: Window glazing compound is a white to tan, brittle putty composed of mineral grains, 3% chrysotile fiber bundles, and a small amount of cellulose fibers in a binder. Outer layers of paint not included in the analysis.	ASBESTOS TYPE AND PERCENT:

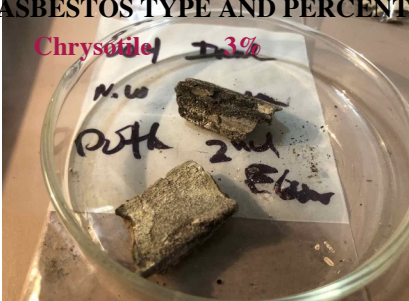
A petri dish containing a white to tan, brittle putty sample. Handwritten text on the dish reads "004 - Inside 2nd Fl. NW" and "3% chrysotile".

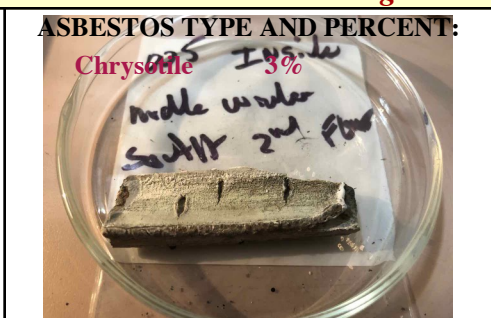
Sample #: **005** Putty **Inside 2nd Fl. Middle Window**

Lab # **20321-5** **Asbestos Containing** **Brittle**

MATERIAL DESCRIPTION:
Window glazing compound is a white to tan, brittle putty composed of mineral grains, 3% chrysotile fiber bundles, and a small amount of cellulose fibers in a binder. Outer layers of paint not included in the analysis.

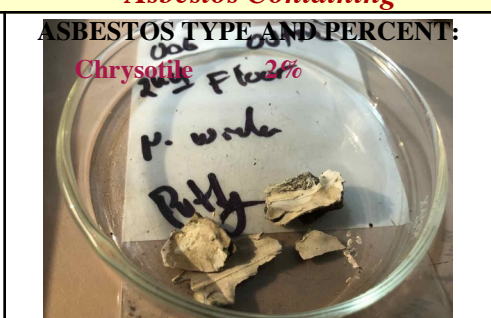
Sample #: **006** Putty **Outside 2nd Fl. North Window**

Lab # **20321-6** **Asbestos Containing** **Brittle**

MATERIAL DESCRIPTION:
Window glazing compound is a brpwm brittle putty composed of mineral grains, 2% chrysotile fiber bundles, and a small amount of cellulose fibers in a binder. Outer layers of paint not included in the analysis. Dirt mixed with the putty.

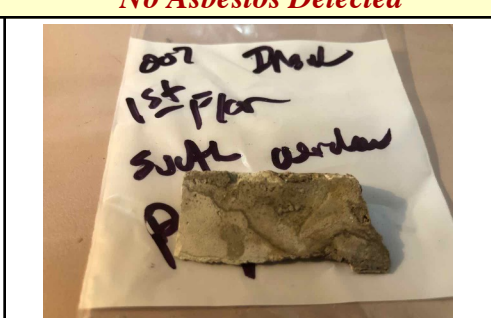
Sample #: **007** Putty **Inside 1st Fl. South Window**

Lab # **20321-7** **No Asbestos Detected** **Brittle**

MATERIAL DESCRIPTION:
Window glazing compound is a hard, white to tan putty composed of mineral grains and a small amount of cellulose fibers in a binder. Outer layer of tan paint.

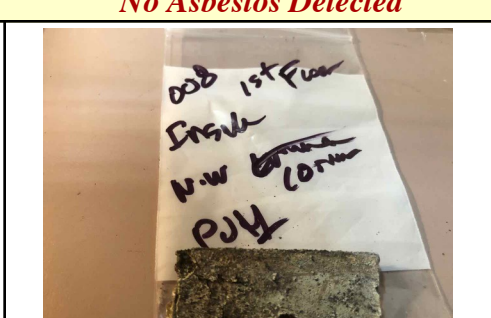
Sample #: **008** Putty **1st Fl. Inside NW Corner**

Lab # **20321-8** **No Asbestos Detected** **Brittle**

MATERIAL DESCRIPTION:
Window glazing compound is a hard, white to tan putty composed of mineral grains and a small amount of cellulose fibers in a binder. Outer layer of gray paint.
