# ASBESTOS BUILDING INSPECTION

**WEIGAND HALL  
3051 SW CAMPUS WAY  
CORVALLIS, OR 97331**

NOVEMBER 28, 2008

FORENSIC ANALYTICAL PROJECT NO. PJ6286

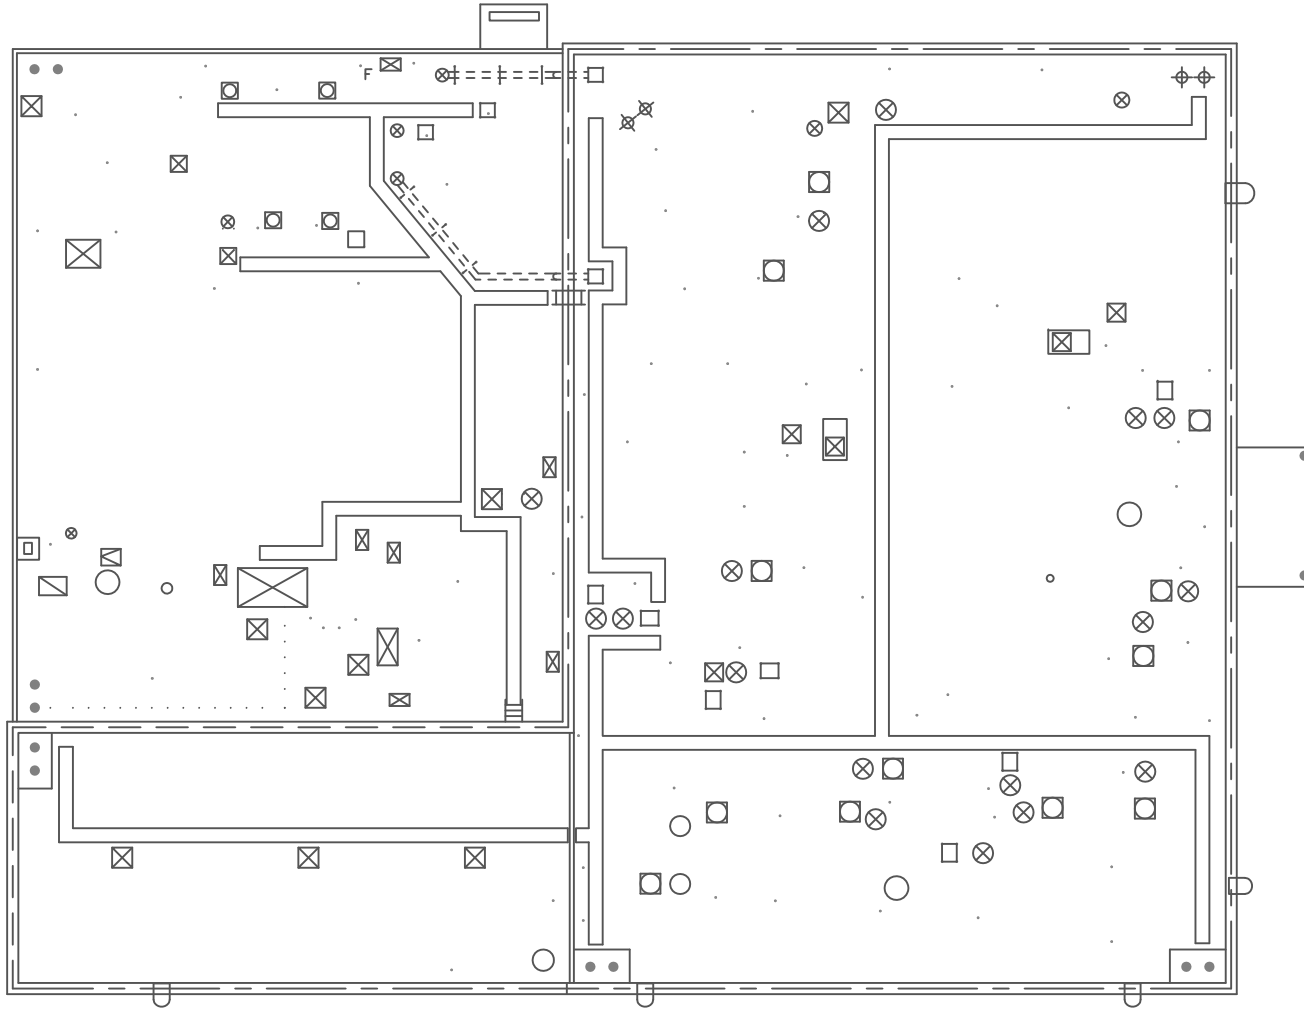
Wiegand Hall  
Roof Plan  
Sample Locations

No sample in this area
