PSU - STUDENT HEALTH & COUNSELING (SHAC)

1880 SW 6th AVENUE, PORTLAND, OREGON 97201
OWNER: PORTLAND STATE UNIVERSITY - FACILITIES AND PLANNING (FAP)
202 UNIVERSITY SERVICES BLDG - 617 SW MONTGOMERY
PORTLAND, OREGON 97201
CONTACT: KAY BYRNE 503-725-9837

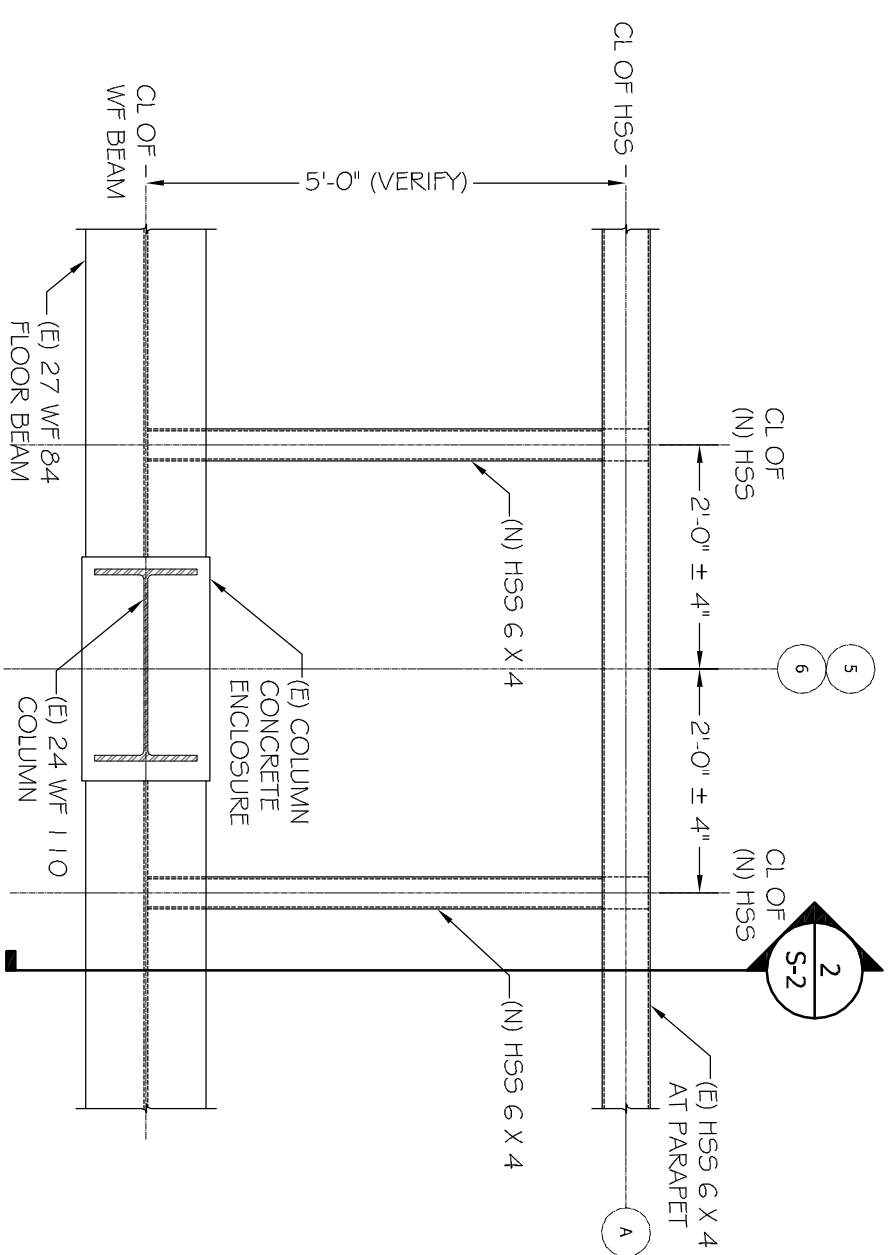
1 (N) PARAPET BRACE LOCATION @ 3RD FLOOR
S0.2 SCALE: 1"=1/2"
