**Report of
Supplemental Geologic Reconnaissance &
Preliminary Slope Stability Analysis for
Eastern Portion of
OSU Cascades 46-Acre Site
1707 & 1757 SW Simpson Avenue
Bend, Oregon**

CGT Project Number G1303959.B

May 21, 2014

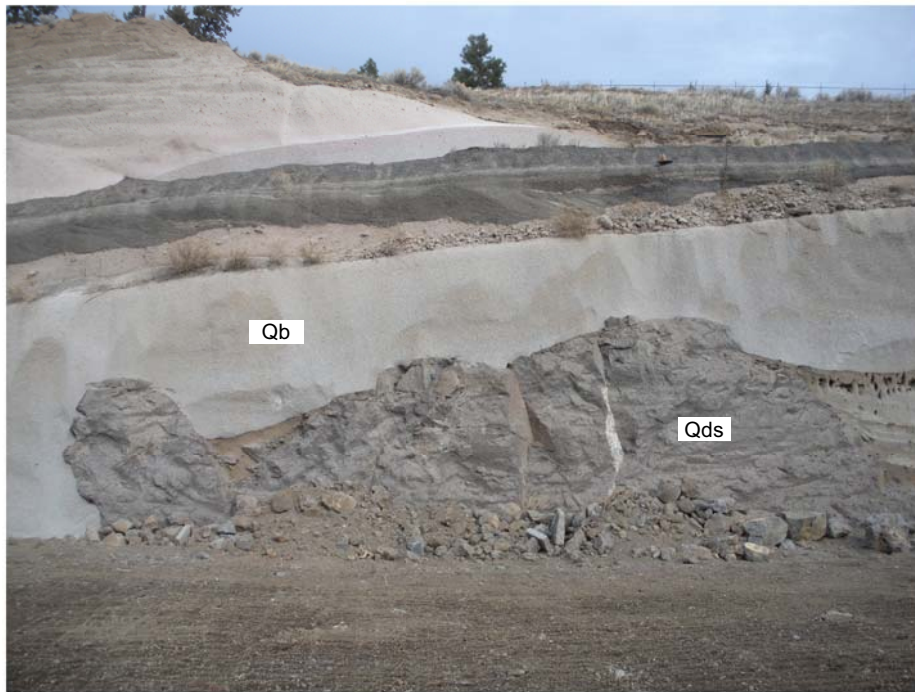
Photograph 2: Example of convoluted contact between unit Qb and Qds.

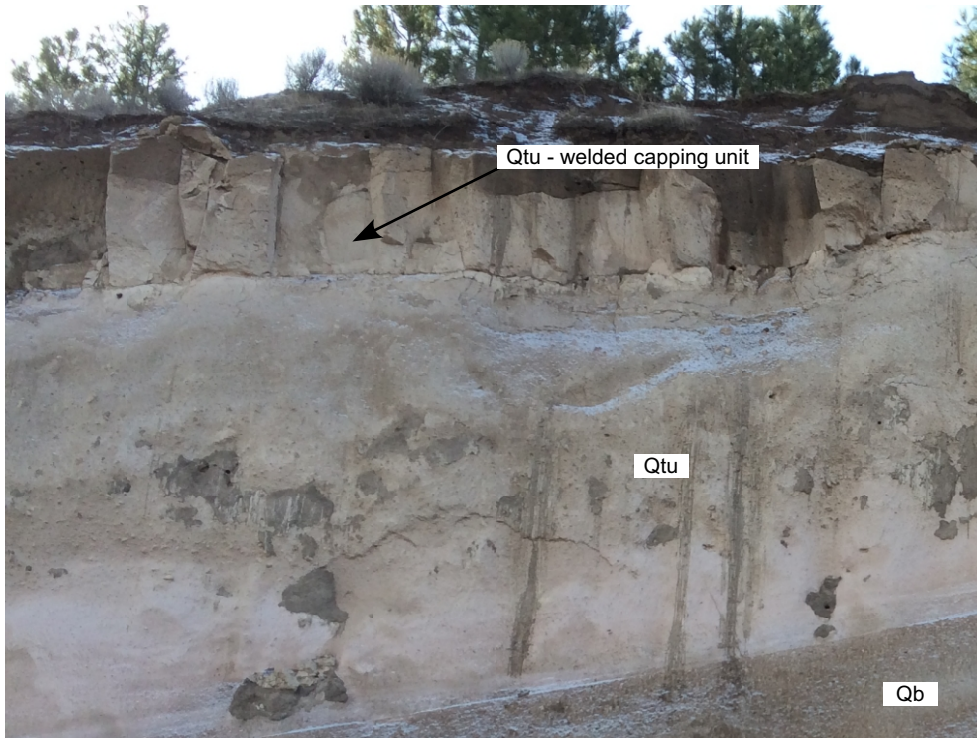
Photograph 3: Example of Qtu and columnar jointed, welded tuff capping unit.

The Tumalo tuff was generally extremely soft (R₀)⁶ to very soft (R₁) rock comprised of dry to moist, light gray to orange-brown, volcanic ash with varying amounts of pumice and fragments of welded tuff. The upper portion of the Tumalo tuff was welded, forming a medium hard (R₃) to hard (R₄), light brown, capping unit. The capping unit was generally on the order of 5 to 10 feet thick and displayed moderately developed, near-vertical, columnar jointing. Photograph 3 on Figure 3 shows a representative exposure of unit Q_{tu} and its capping unit.

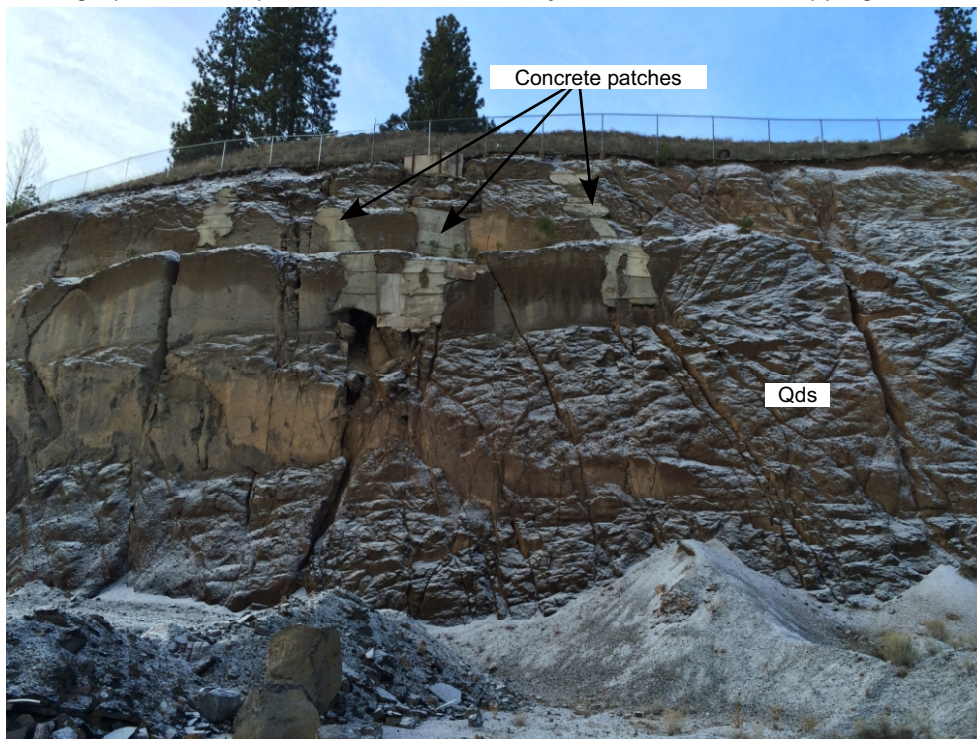
Photograph 4: Example of open joints and concrete patches in unit Qds.

Several open joints were observed within the south pit wall, near cross section J-J' (shown on Figure 1). Joint separation ranged from less than 1 inch to in excess of 1 foot, and the joints appeared to extend 5 to 10 feet (possibly more) into the slope. Adjacent rock also showed signs of intersecting joints and preferential erosion, forming rough blocks up to 10 to 20 feet or more in dimension. Several of the open joints had previously been filled with concrete. Anecdotally, we interpret this was done to help stabilize the individual blocks and reduce the risk of rockfall during operation of the pit. Photograph 4 on Figure 3 shows this area.

As described previously, numerous open joints were observed within the south pit wall, near cross section J-J'. Joint separation ranged from less than 1 inch to in excess of 1 foot, and the joints appeared to extend 5 to 10 feet (possibly more) into the slope. Adjacent rock also showed signs of intersecting joints and preferential erosion, forming rough blocks up to 10 to 20 feet or more in dimension. As indicated in Section 5.2.2, the lack of data regarding the rock structure in this area precluded quantitative stability analysis.

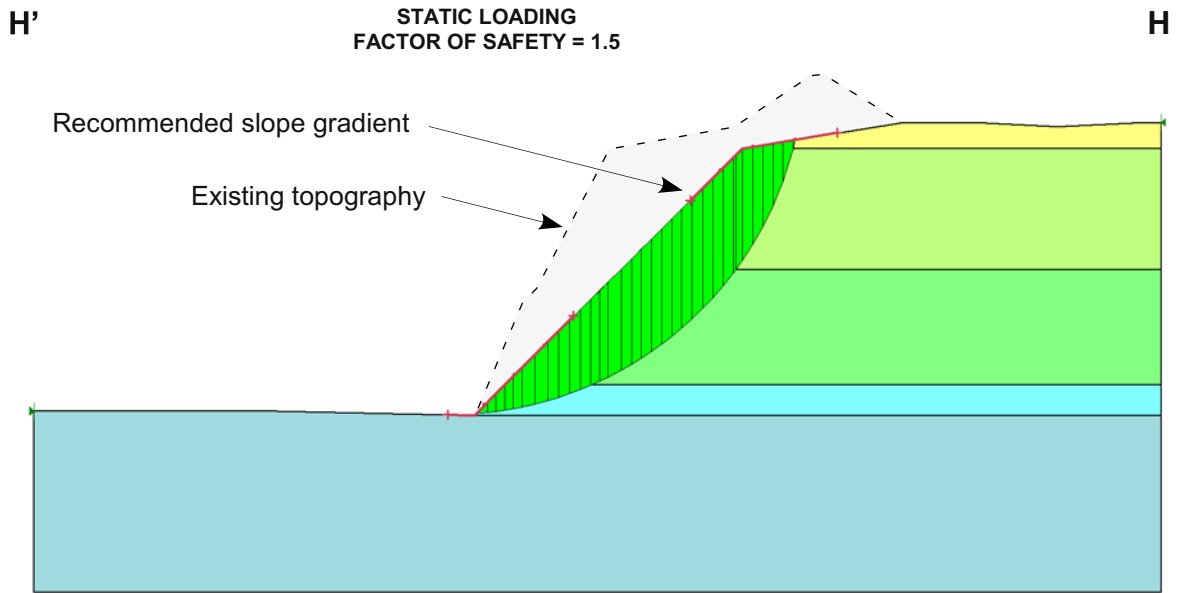
FIGURE 4

**EASTERN PORTION OF OSU CASCADES 46-ACRE SITE - BEND, OREGON
SLOPE STABILITY PROFILE H-H'**

Incorporating the maximum allowable gradients for slope materials discussed in Section 5.6.1, we performed slope stability analyses along four cross sections (H-H', I-I', L-L', and N-N'). The locations of the cross sections are shown on Figure 1. The results of our analyses for the modeled conditions are presented in Table 3. Graphical outputs of each of the conditions analyzed are presented in Figures 4 through 7.

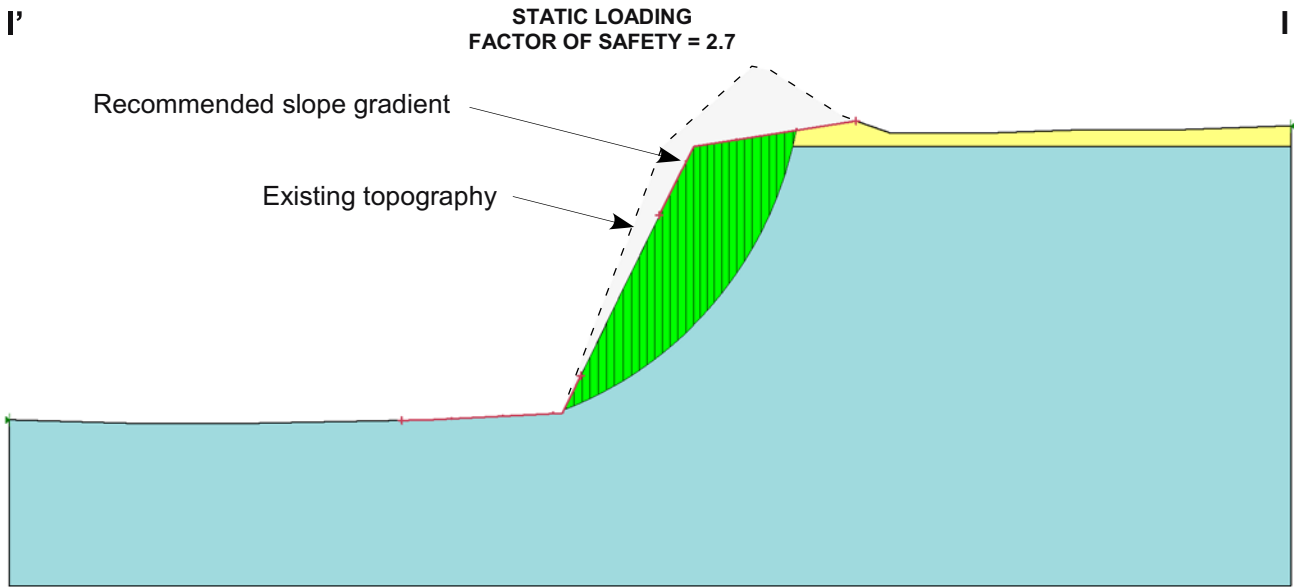
FIGURE 5

**EASTERN PORTION OF OSU CASCADES 46-ACRE SITE - BEND, OREGON
SLOPE STABILITY PROFILE I-I'**
