# Phase I Environmental Site Assessment

Robinson/4R Equipment Pumice Mine Property  
1707 & 1757 SW Simpson Avenue  
Bend, Oregon 97702

October 2013  
Project No. 80607.000

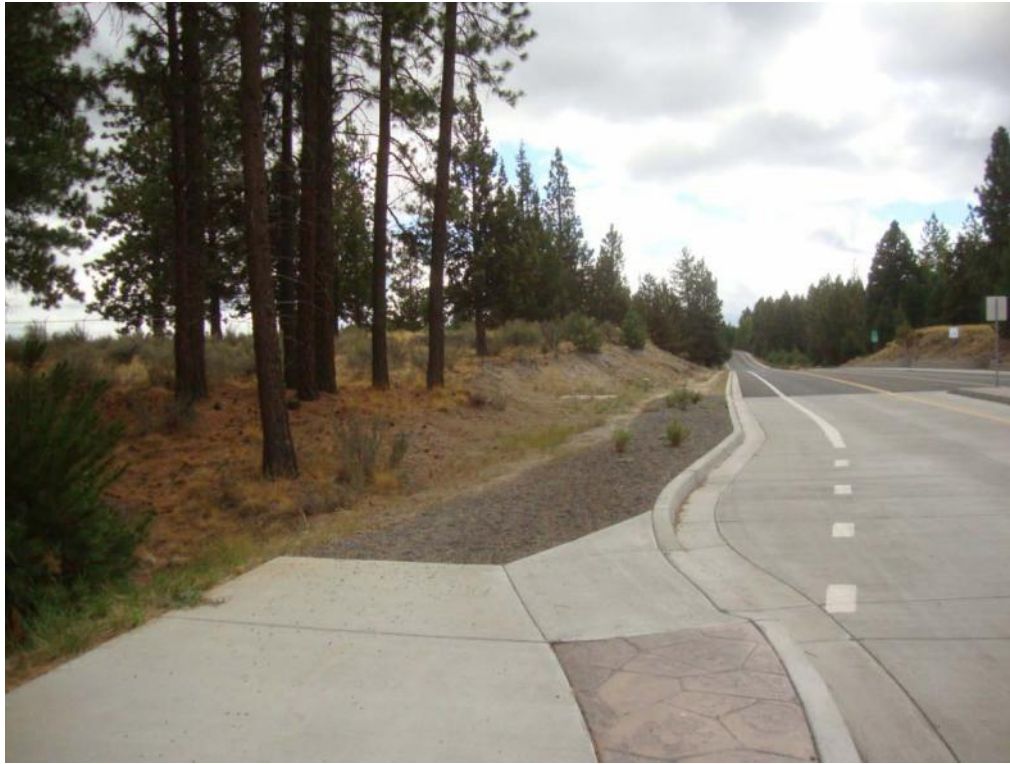
PHOTO 1: View from near the northwest property corner looking southerly along a portion of the west property boundary. NW Mount Washington Drive is on the right.

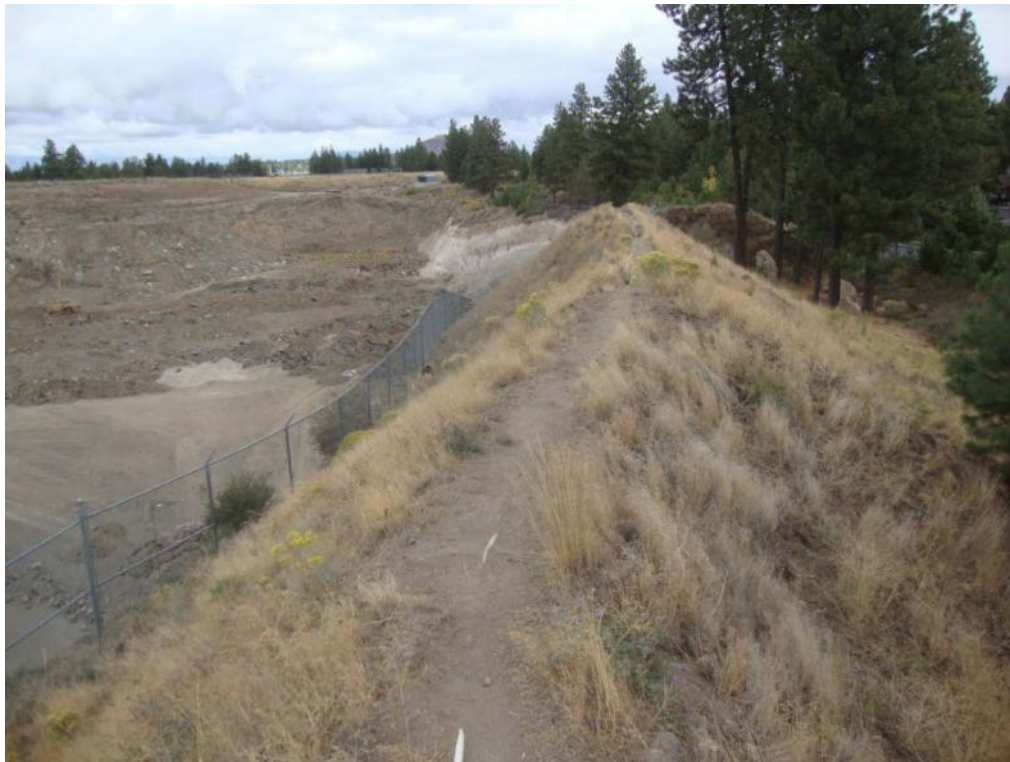
PHOTO 2: View of the earthen berm/trail located along portions of the south property Boundary, looking easterly. The former pumice quarry is on the left.

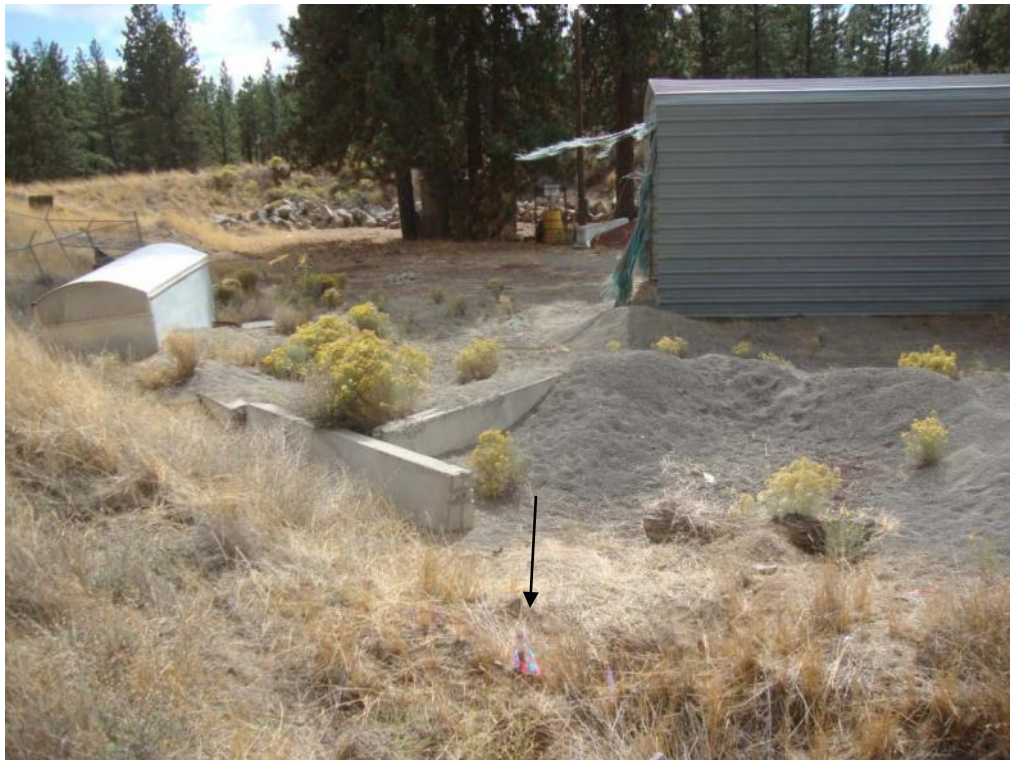
This structure is reportedly owned by the *subject property* owner but was observed to be located on the east adjoining property. The structure was formerly utilized as a dynamite storage shed and is wood framed with metal siding and roofing over a wood foundation.

PHOTO 4: View from near the northeast property corner looking southerly. Note the property boundary marker in the foreground and the former dynamite storage shed and stored materials on the adjacent county property to the left.

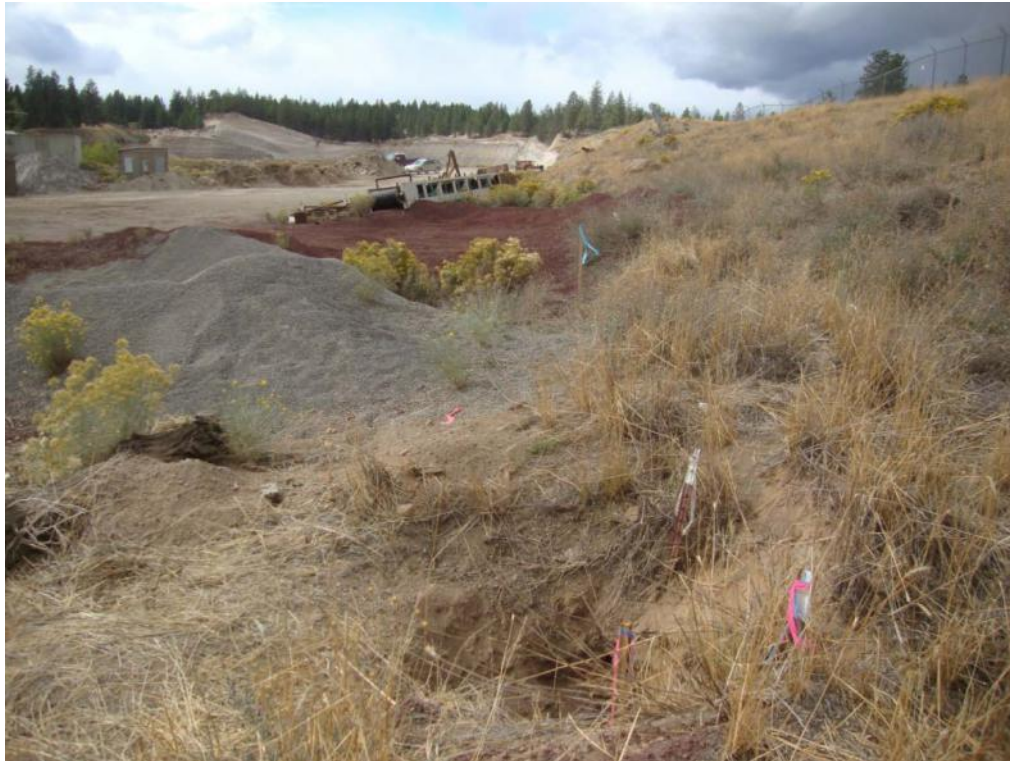
PHOTO 5: View from near the northeast property corner looking westerly along the northern property boundary.

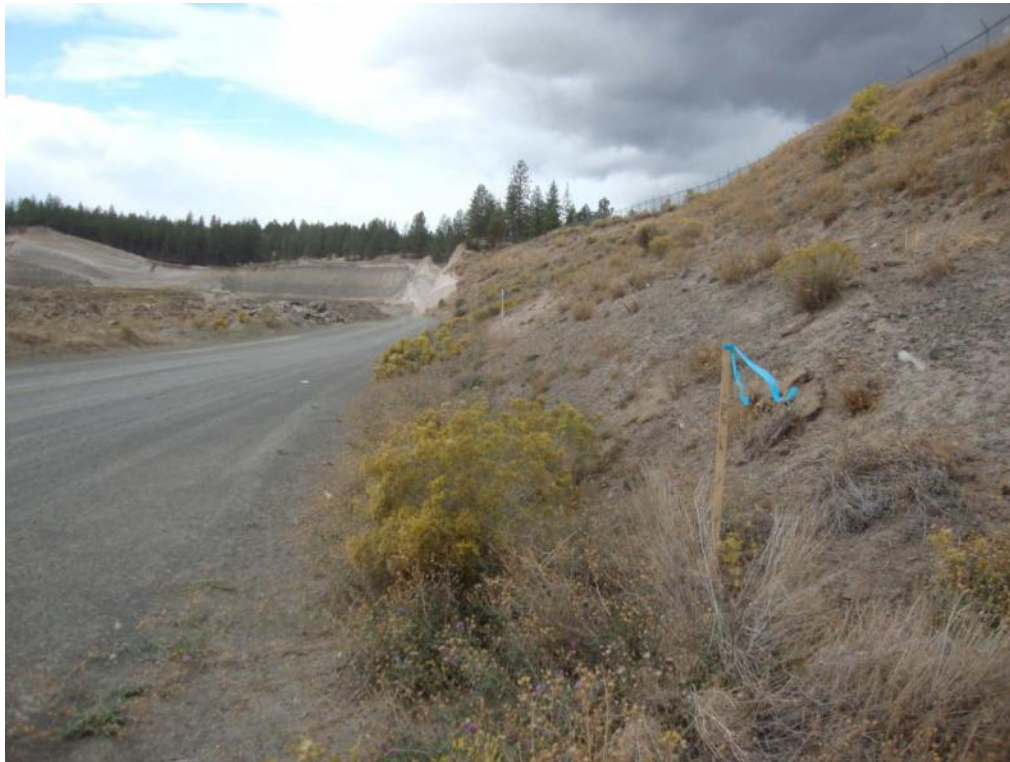
PBS observed minor amounts of wood waste, plastics, and metal banding on a small portion of the north property bank (south landfill boundary), located to the west of the north access road. PBS was unable to determine if the observed waste material originates from the north adjacent landfill.

PHOTO 6: View from near the north site access road looking westerly along a portion of the north property boundary. Note a presumed area of observed landfill cover material encroachment between the flagging and the quarry access road.

- If the client wishes to evaluate the subsurface conditions in the areas of observed landfill cover along portions of the northeast property boundary, a subsurface investigation including geophysical assessments and/or exploratory excavations could be performed.
- All imported backfill should meet the DEQ definition of Clean Fill and be properly documented.
- The ASTs with residual fluids and the partially buried steel drum and 5-gallon bucket containing an unknown dark fluid should be properly removed. The areas of observed surficial staining inside the steel drum should be characterized, removed, and properly disposed. Additionally, the area beneath the containers should be inspected during removal to verify that there have been no releases to the underlying soils.

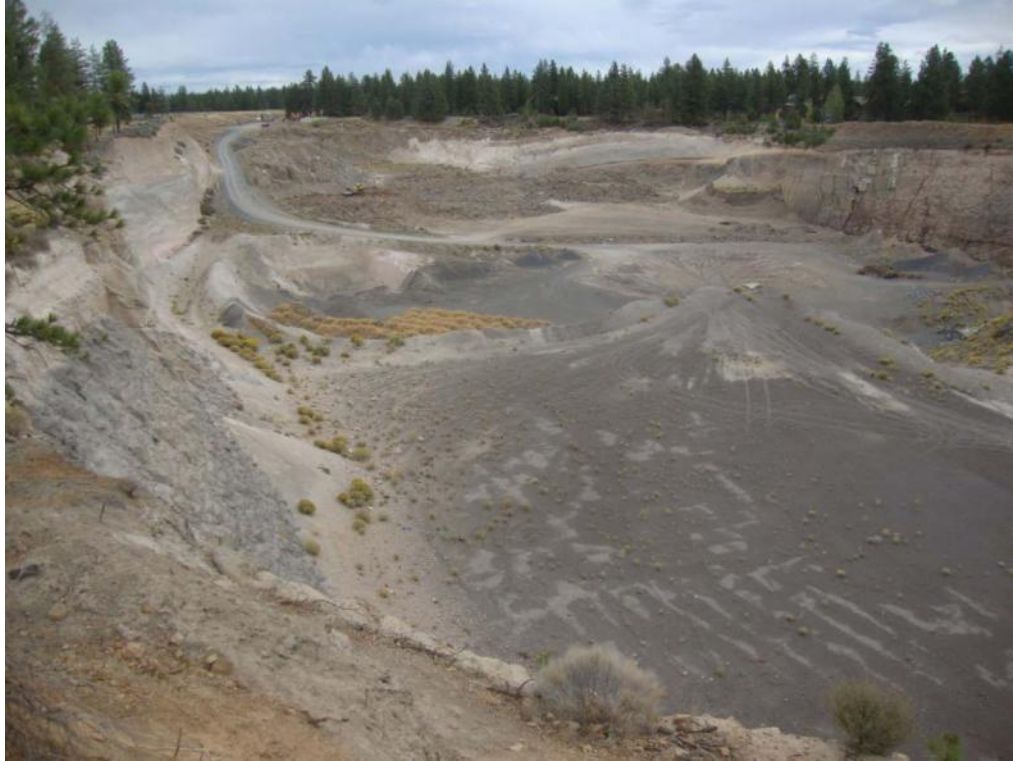
PHOTO 7: View from near the northwest extent of the quarry looking easterly along the northern pit wall. Note the quarry access road in the background.

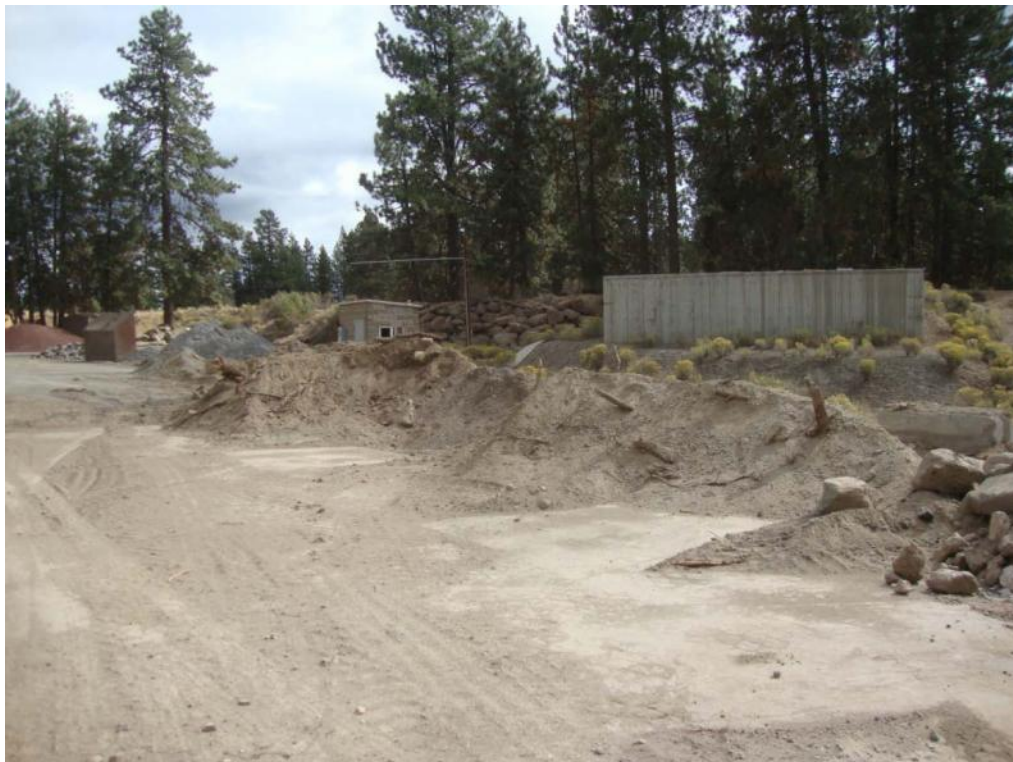
PHOTO 8: View of the former scale house area located in the eastern portion of the *subject property*. Note the soil mounds with organics, rocks, and concrete in the foreground and the cistern to the right.

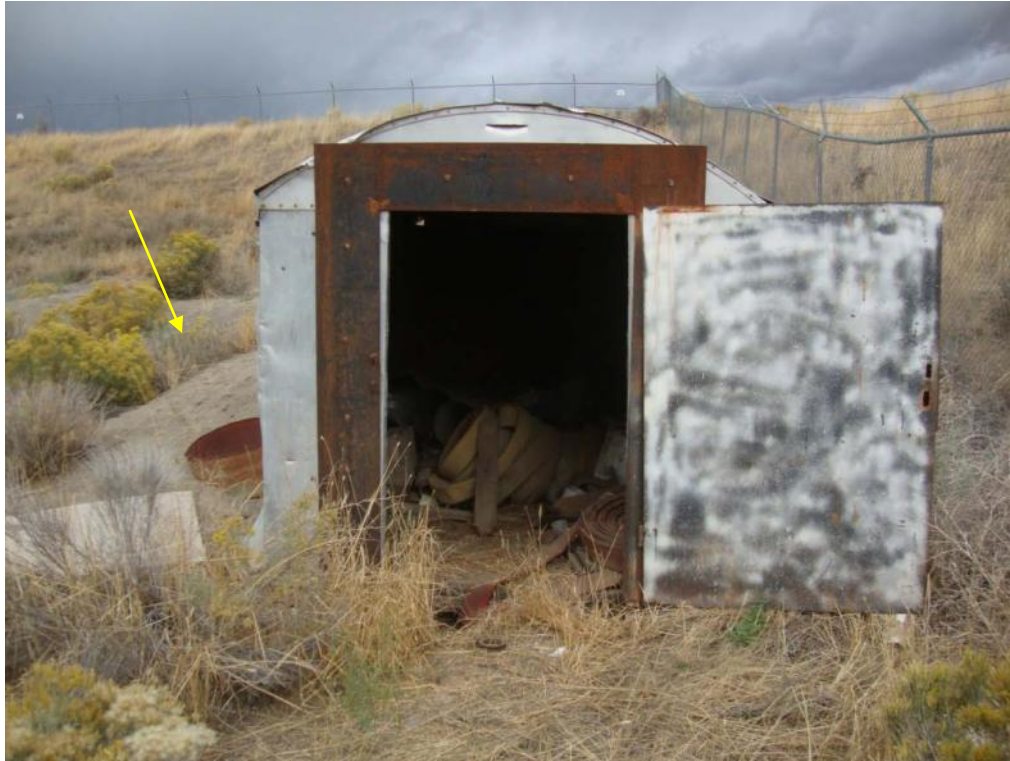
A partially buried drum was observed on the west side of the former dynamite storage shed owned by 4-R Equipment and located on the eastern adjacent Deschutes County property.

A covered 5-gallon bucket containing an unknown dark fluid was observed partially buried inside the drum surrounded by lightly stained soils. Mr. Robinson stated that he has no knowledge of why the drum and 5-gallon bucket are there or where they originated.

PHOTO 9: View of the former dynamite storage and partially buried drum. Note the shed, drum, and other staged materials have encroached onto the eastern (Deschutes County) property.

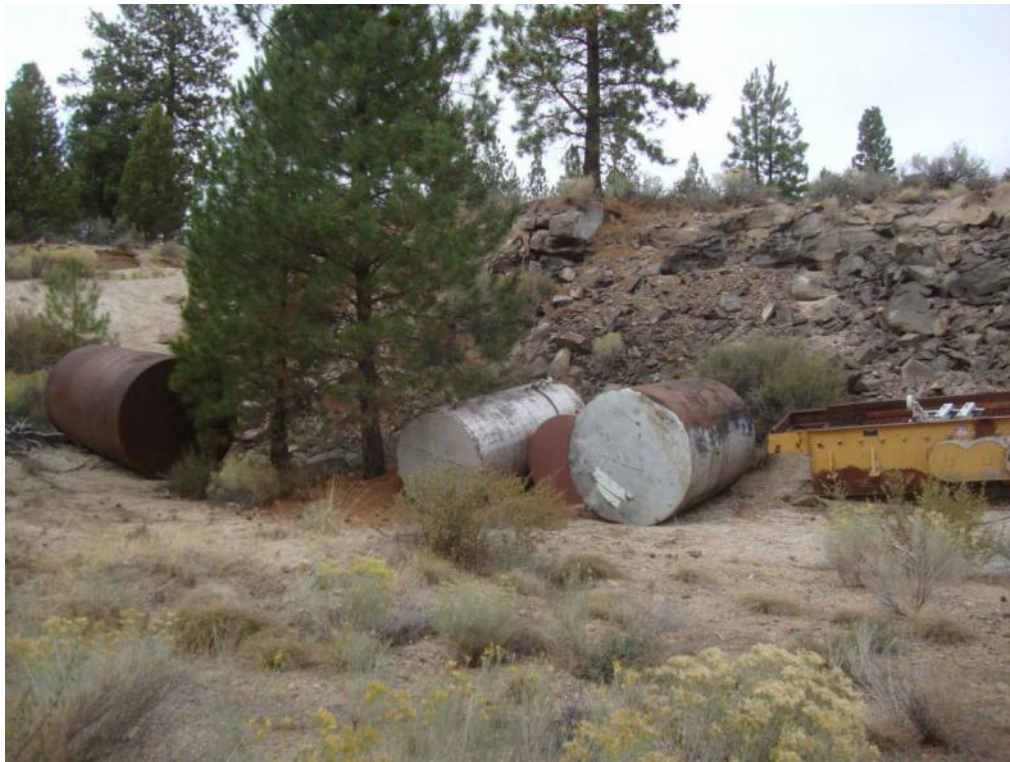
Four steel ASTs and an empty heating oil tank (HOT) were observed resting on the ground surface adjacent to the former Robinson construction materials storage area in the northwestern portion of the property. The estimated AST sizes ranged from approximately 750 to 6,300 gallons. According to Ron Robinson, the *subject property* owner, the observed storage tanks were reportedly brought onsite empty from various off-site locations for storage and have never been used for fuel storage onsite. No significant staining was noted adjacent to the tanks during the site reconnaissance; however, two of the ASTs were observed to contain minor amounts of residual fluid with light petroleum odors emanating from the tank vents.

PHOTO 10: View from the south showing the four staged ASTs placed on the ground surface in the northwest portion of the *subject property*.

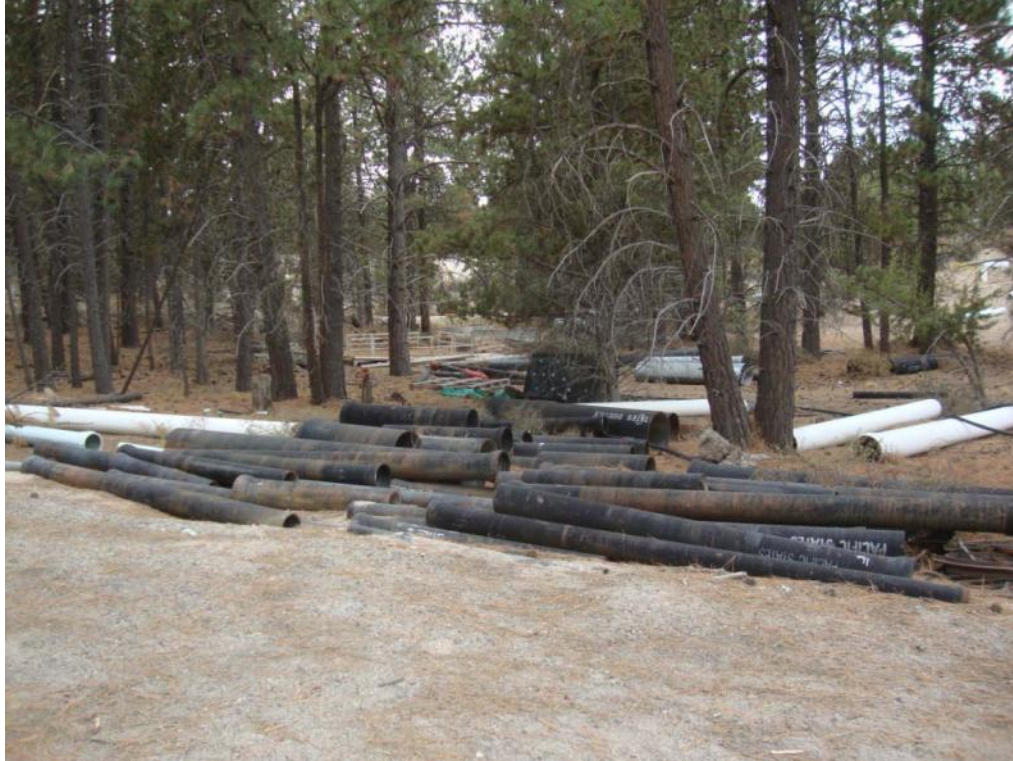
PHOTO 11: View of a portion of the former Robinson Construction material storage area located in the western quadrant of the site.

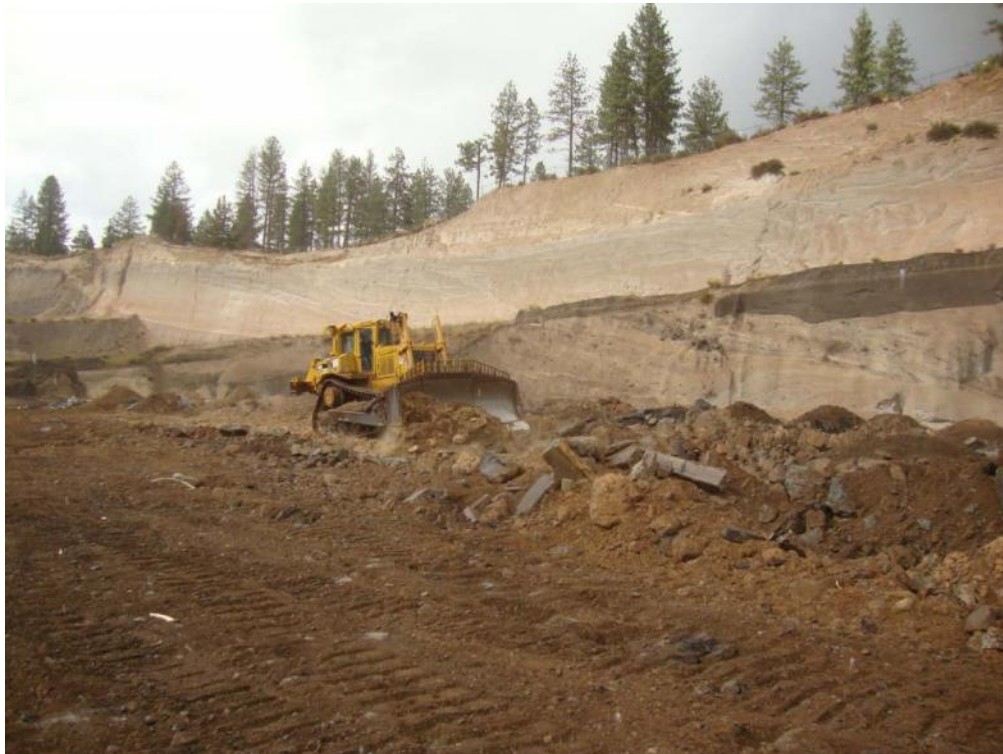
PHOTO 12: View of current backfilling and leveling activities being conducted in the eastern portion of the pit.
