REQUEST FOR PROPOSALS

No. 2014-0529

ARCHITECTURAL SERVICES

McNeal Pavilion Renovation and New Student Recreation Center

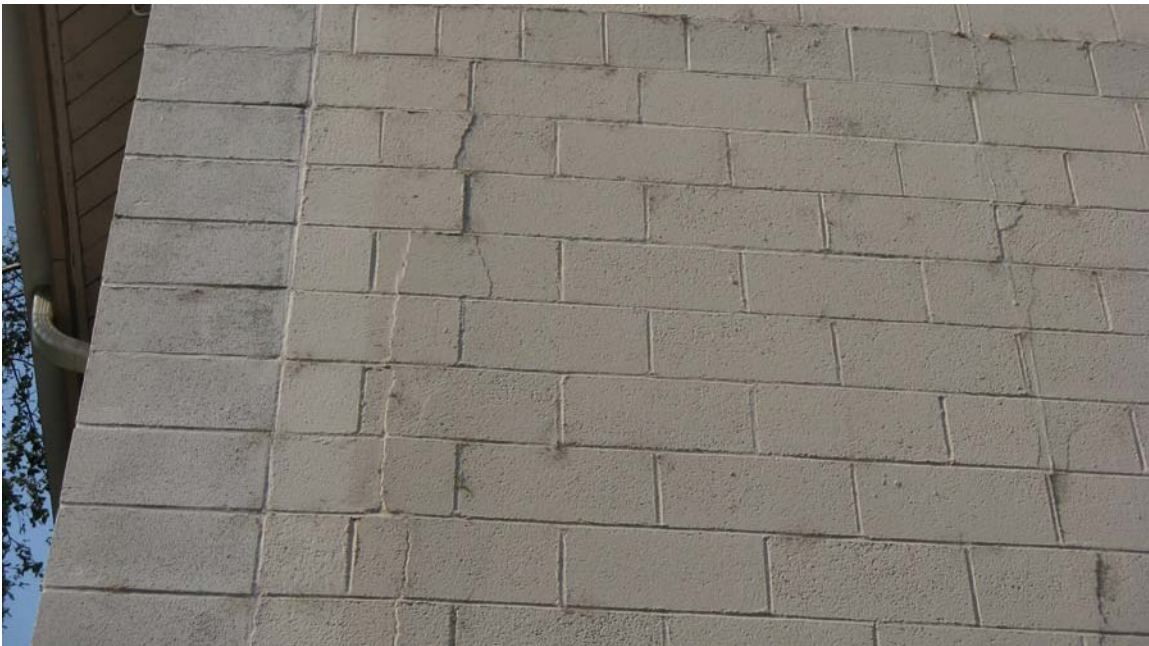
Figure 1: South West Wall Exterior Damage

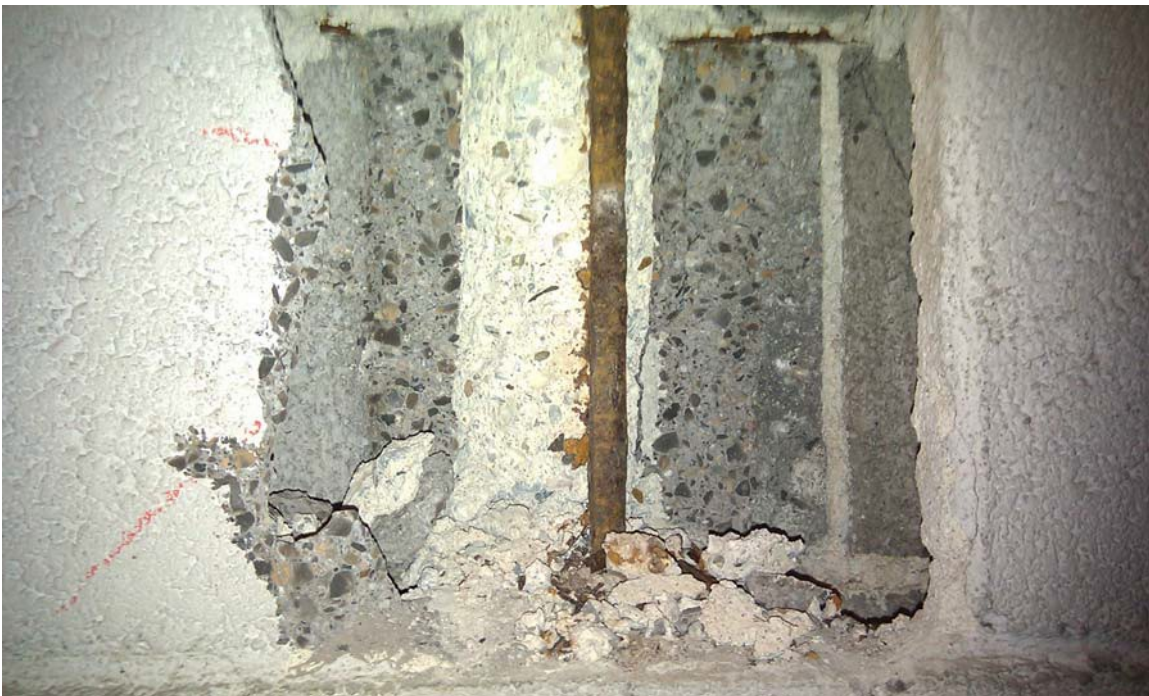
Figure 2: Corroded Steel within Wall

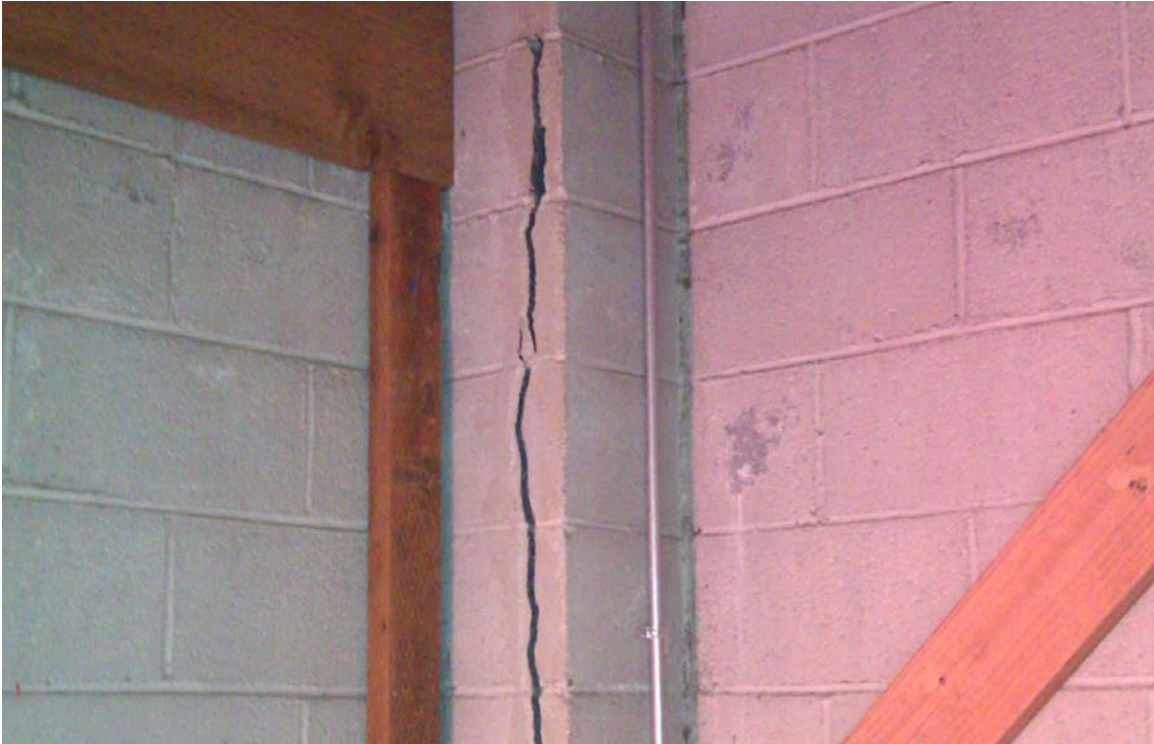
Figure 3: South West Wall Damage at Pilaster

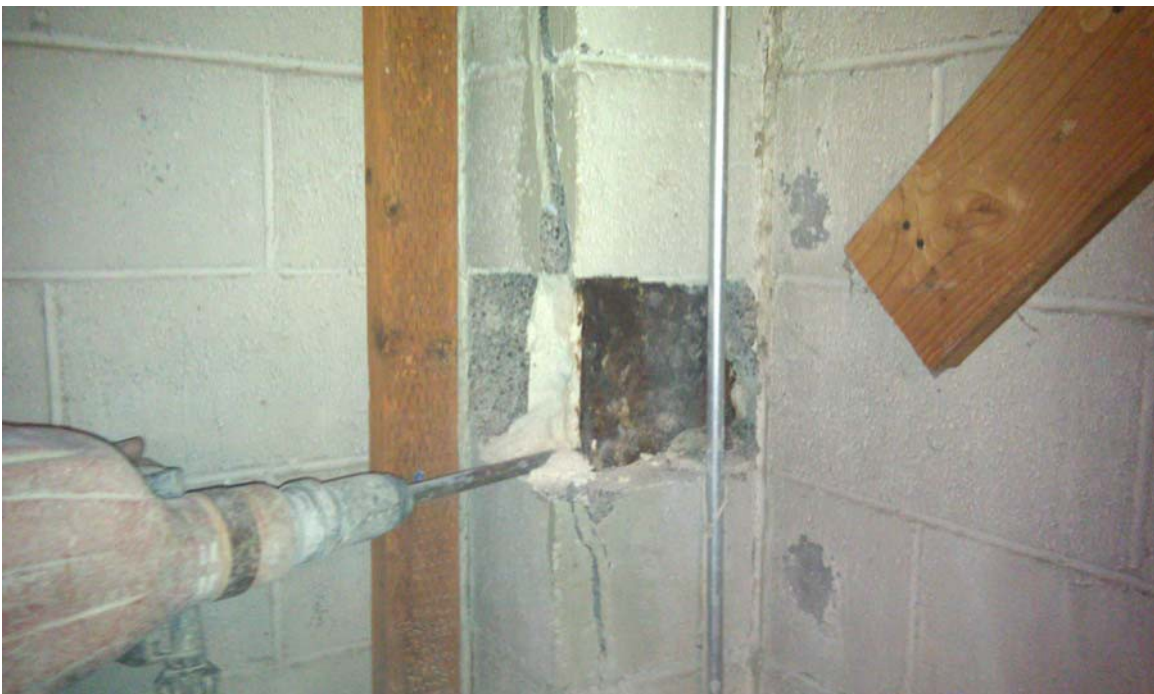
Figure 4: Corroded Steel Column within Pilaster

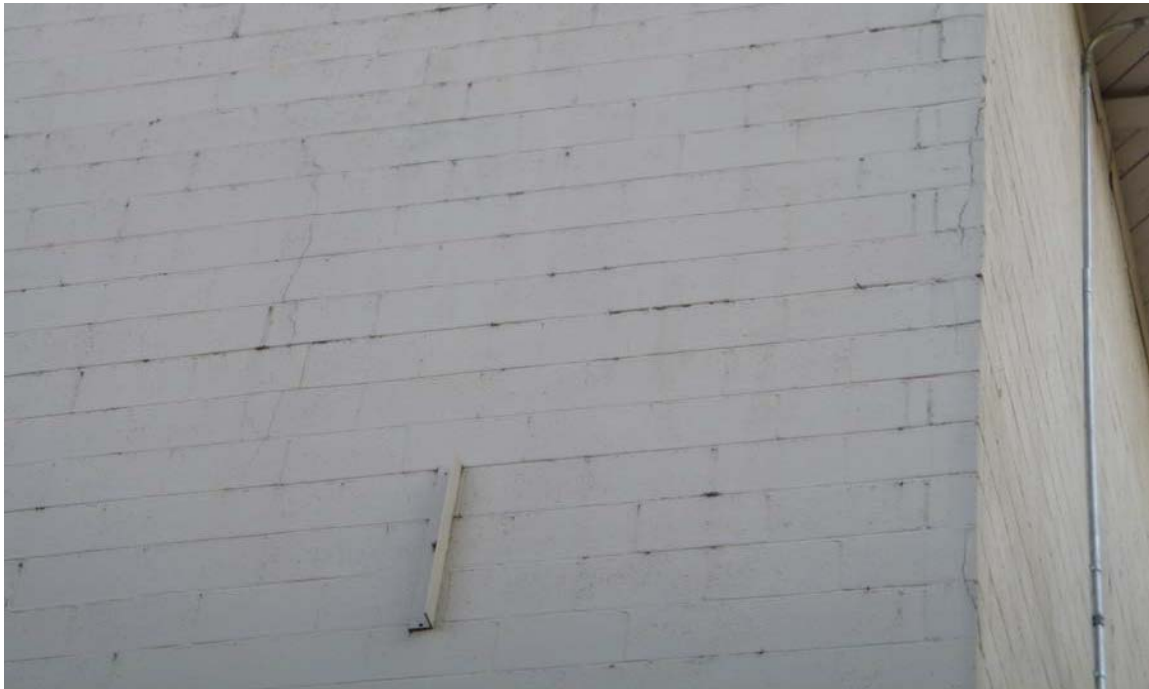
Figure 5: North West Exterior Wall Condition

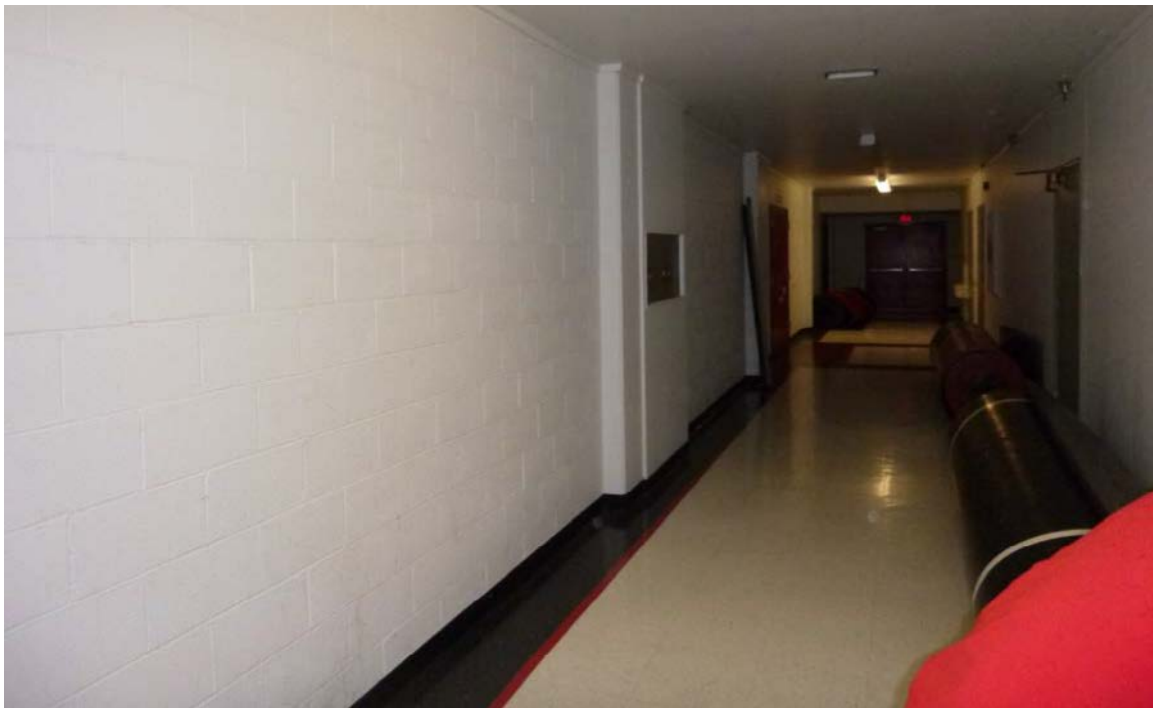
Figure 6: Interior Wall Condition

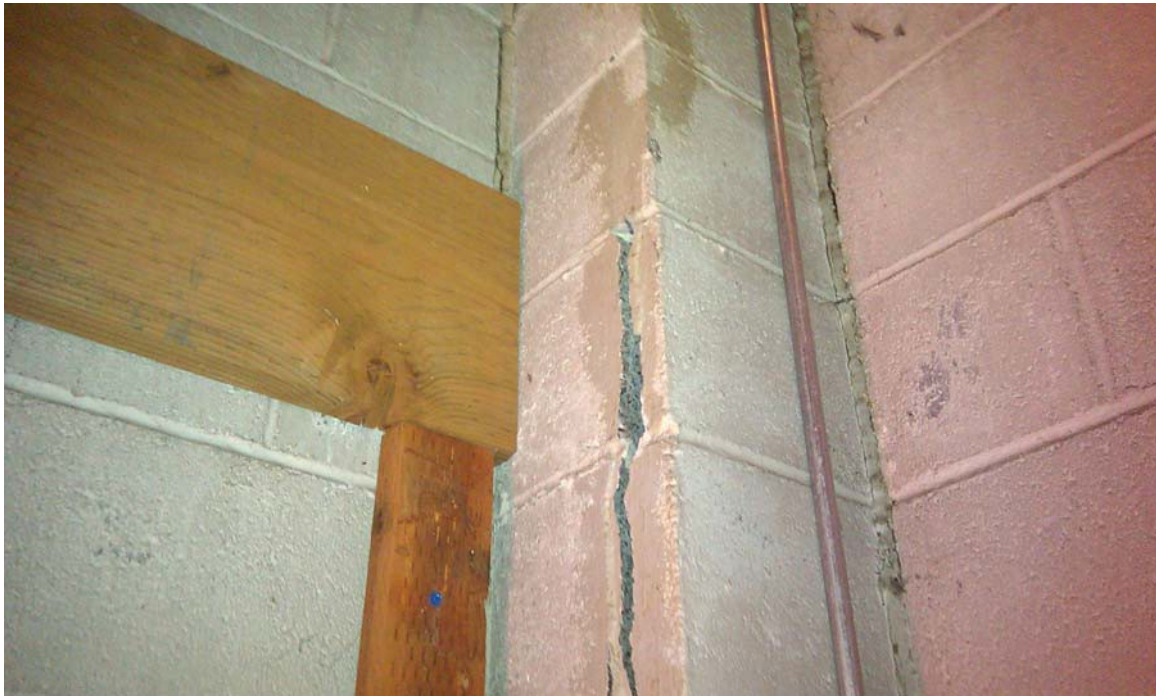
Figure 7: Repair at Damaged Area

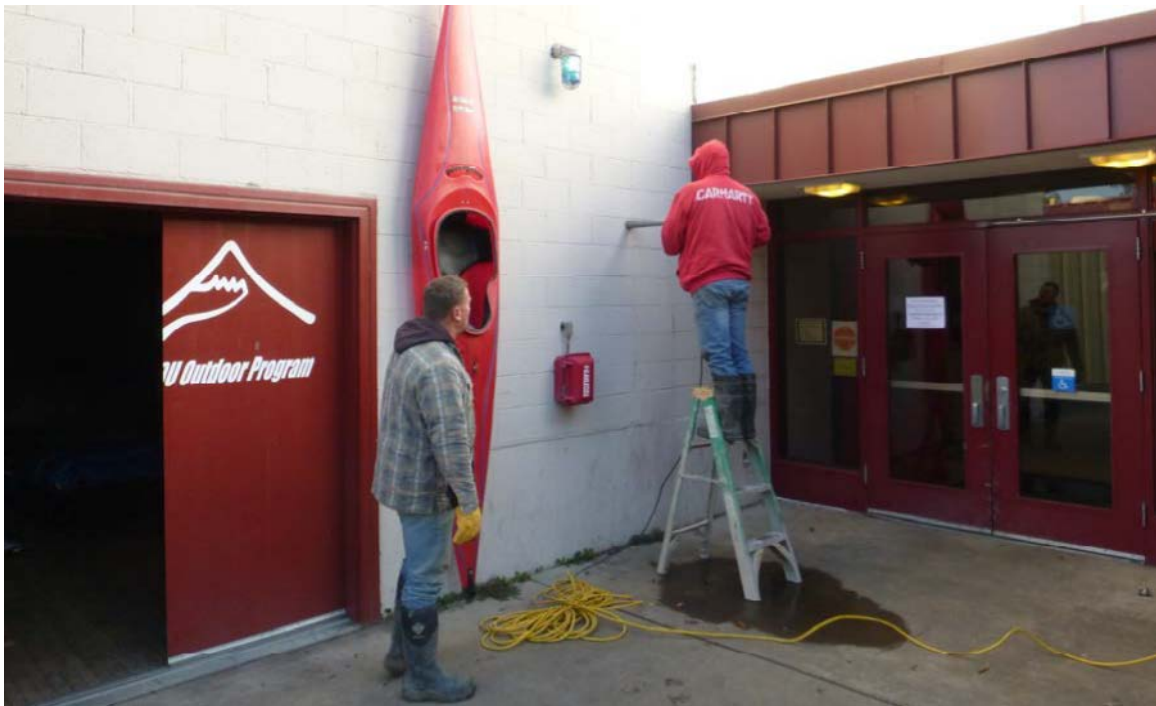
Figure 8: 2" Core Sample at South West Wall

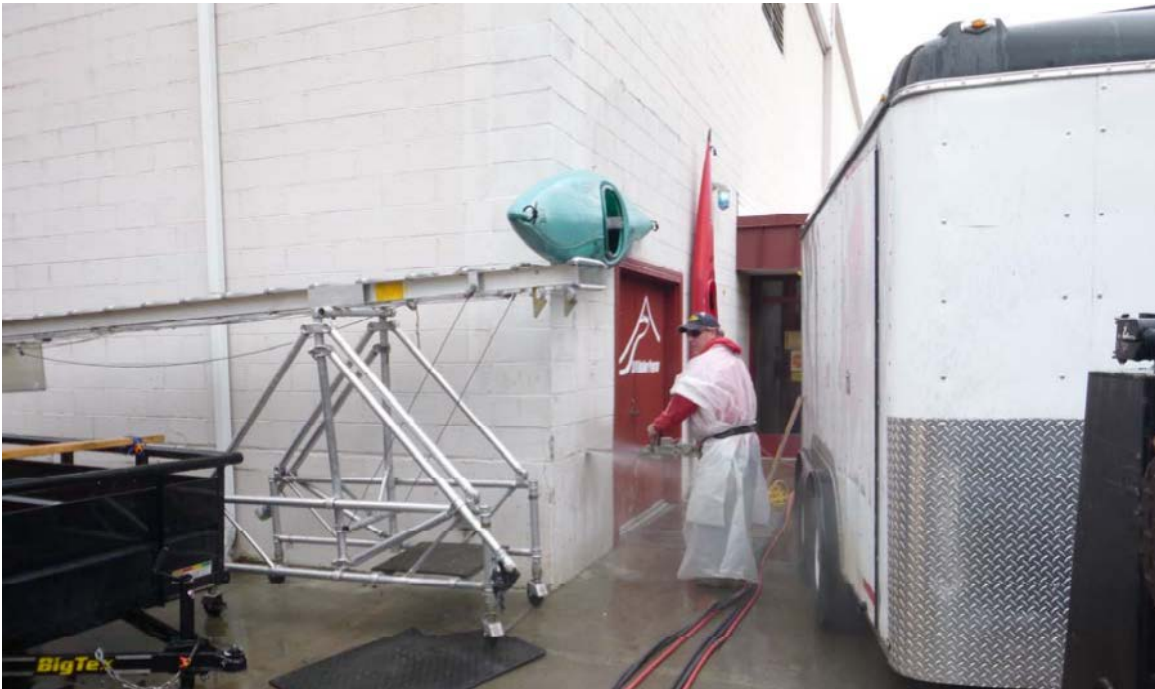
Figure 9: Exterior Assembly Sample

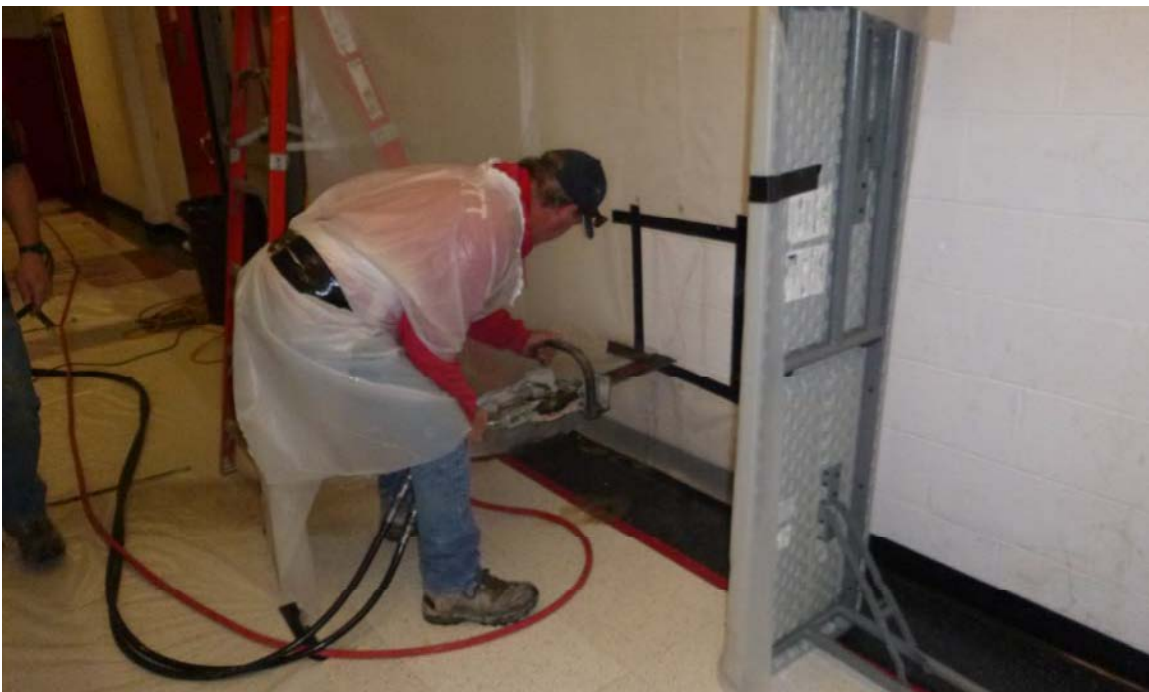
Figure 10: Interior Assembly Sample

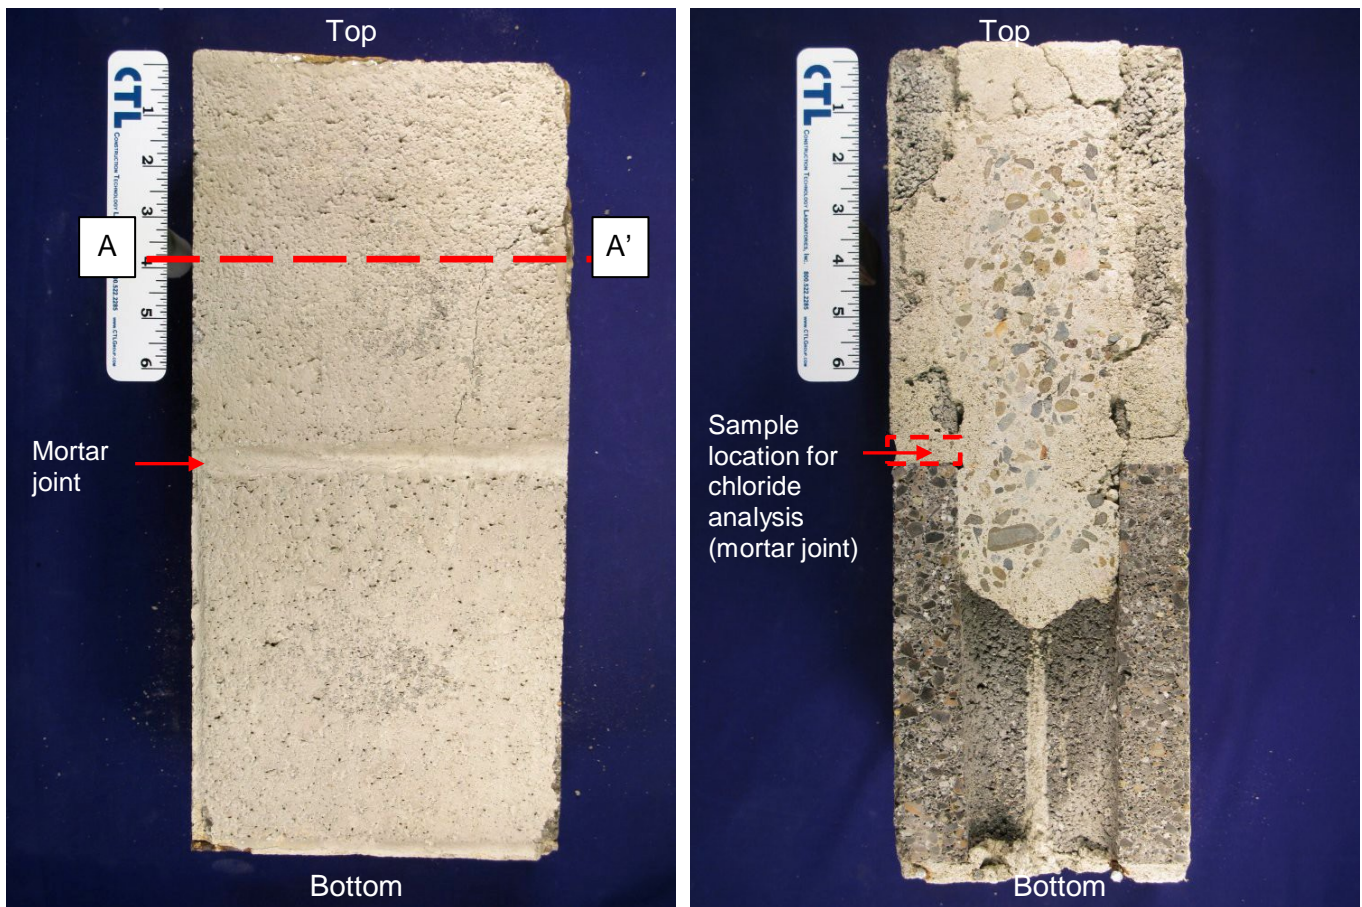
1a. Front surface. The saw-cut section along A-A' is shown in Fig. 3a.

1b. Side view. The red box designates location where mortar sample was taken for chloride analysis.

Fig. 1 Sample EXTERIOR as received for examination. The top and bottom surfaces of the sample are shown in Figures 1c and 1d, respectively. Scale is in inches.

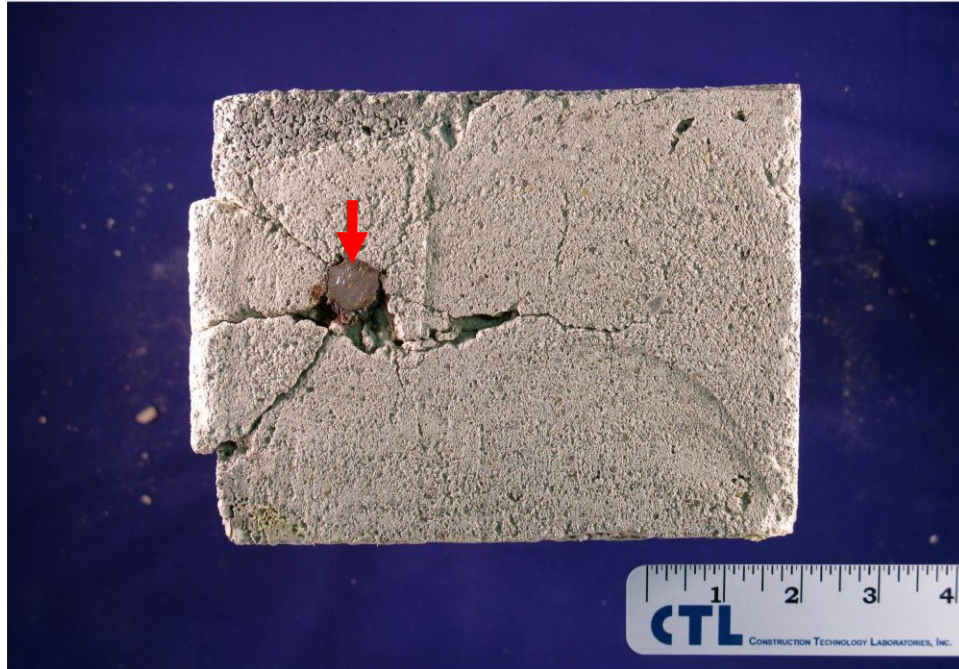
1c. Top surface showing cracks extending radially from a corroded reinforcing bar (arrow). The surface is covered with joint mortar.

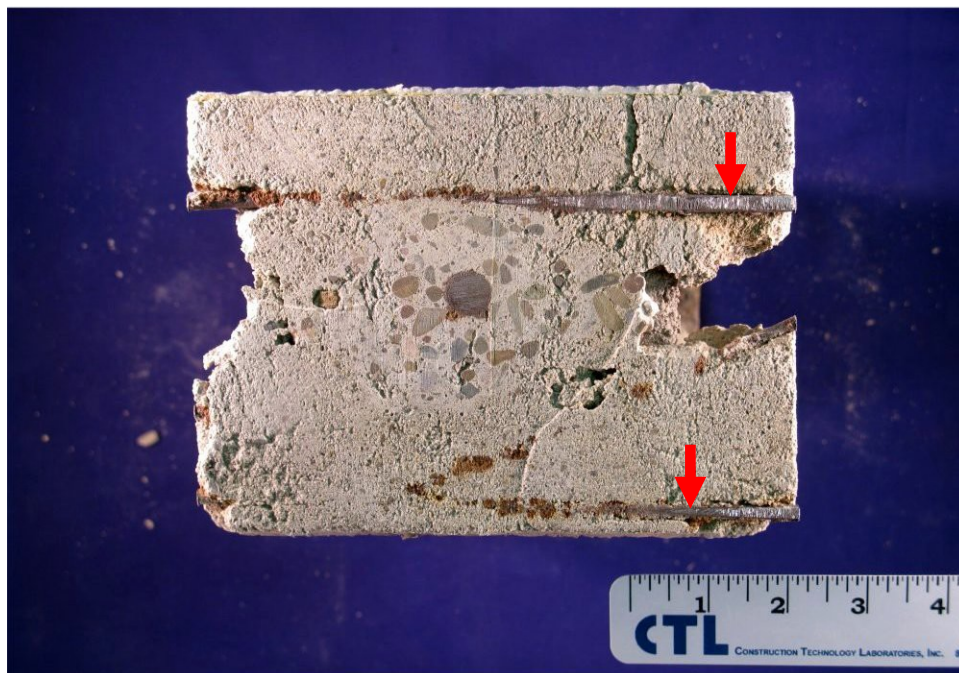
1d. Bottom surface showing a steel wire tie (arrows) partially embedded in joint mortar. The tie exhibits brown surface rusting.

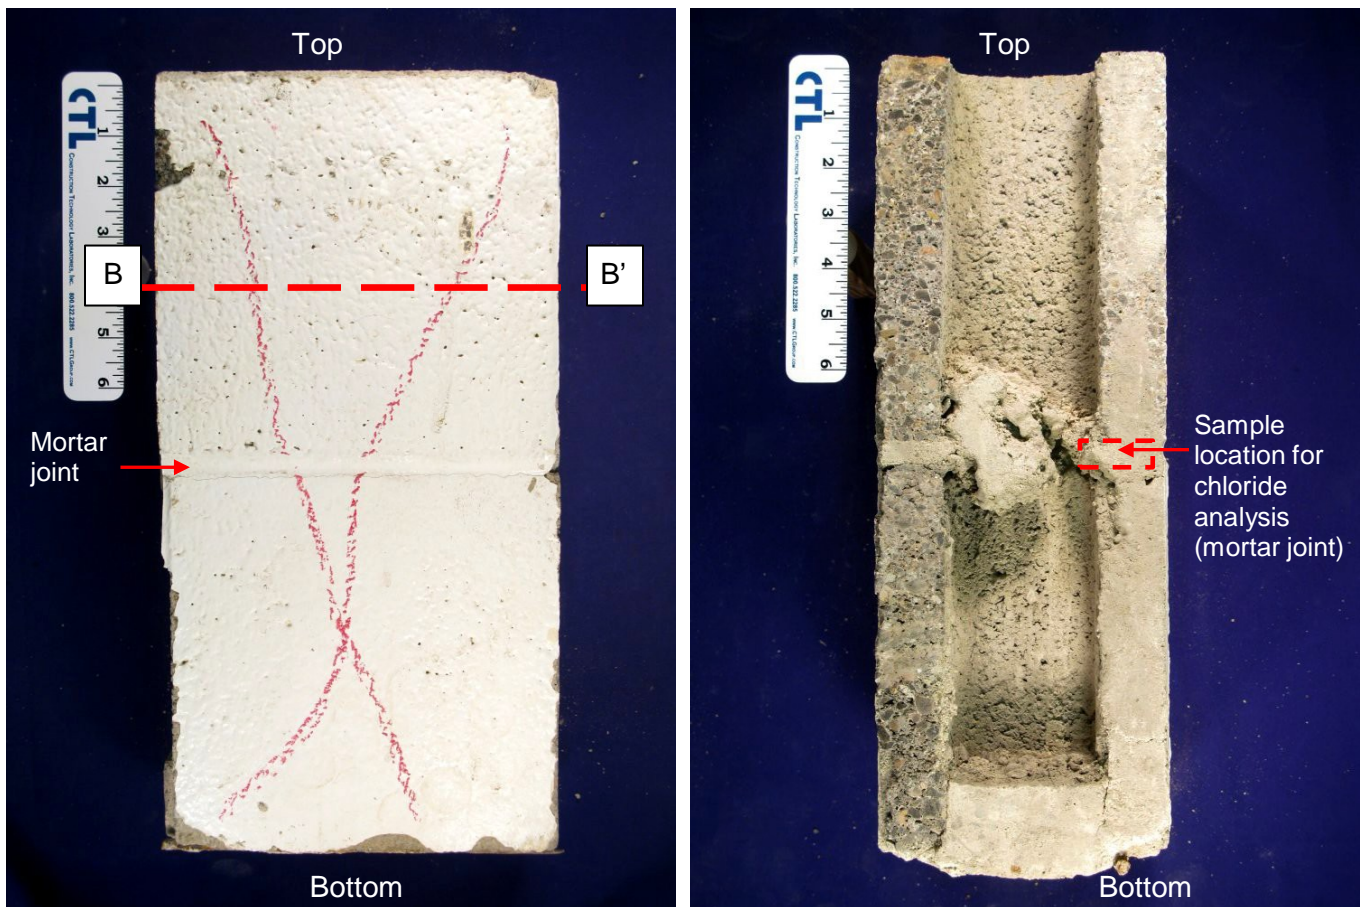
2a. Front surface. The saw-cut section along B-B' is shown in Fig. 3b.

Fig. 2 Sample INTERIOR as received for examination. The top and bottom surfaces are shown in Figure 2c and 2d, respectively. Scale is in inches.

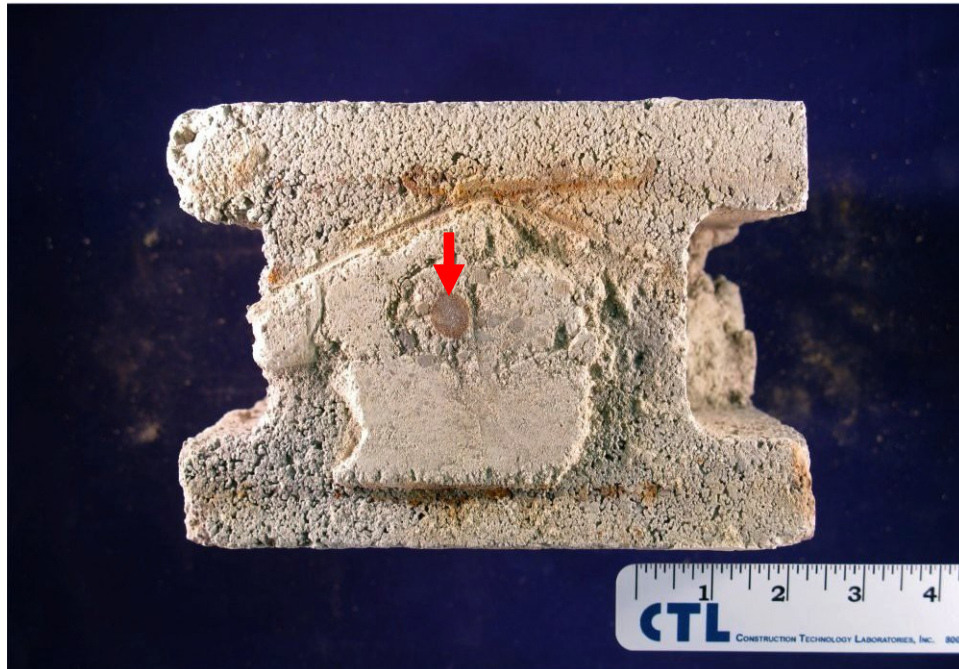
2c. Top surface, locally covered with joint mortar. Arrow designates a reinforcing steel bar. The rebar exhibits no visible corrosion.

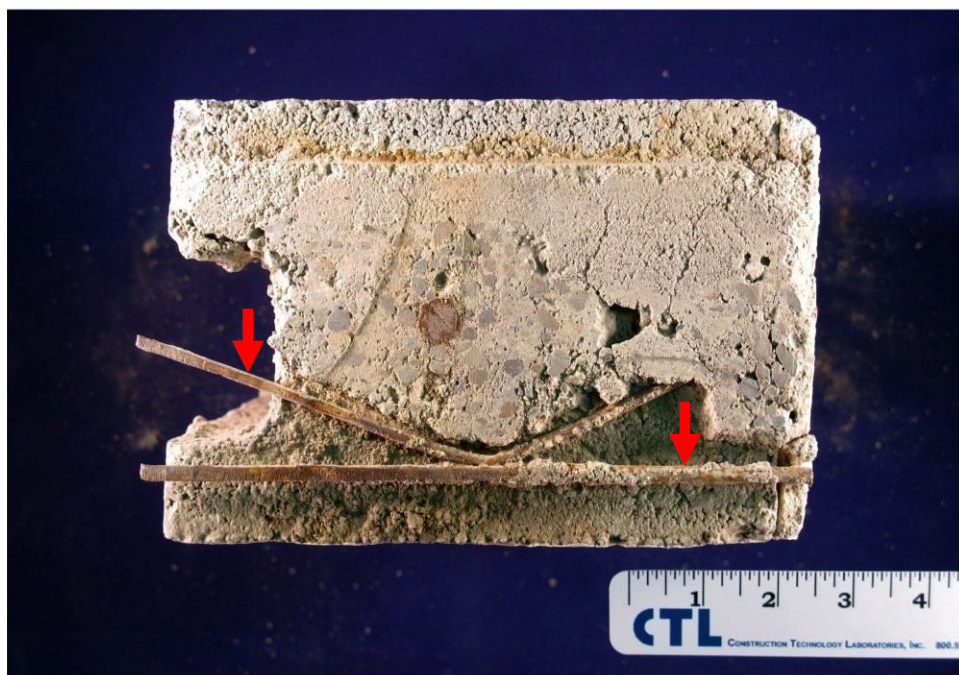
2d. Bottom surface showing a steel wire tie (arrows) partially embedded in joint mortar. The tie exhibits brown surface rusting.

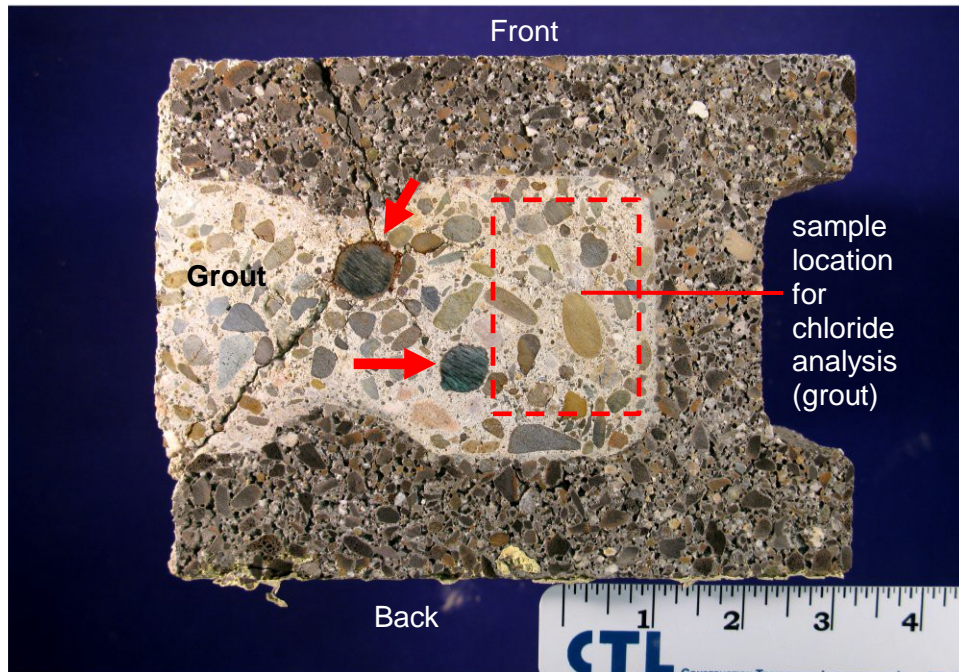
3a. Sample EXTERIOR. A few cracks extend radially from the corroded reinforcing steel bar.

Fig. 3 Saw-cut sections of the samples along A-A' and B-B' designated in Figs. 1a and 2a, respectively. Arrows indicate reinforcing steel bars embedded in the grout. The red boxes designate locations where sub-samples were taken for chloride analysis. Scale is in inches.

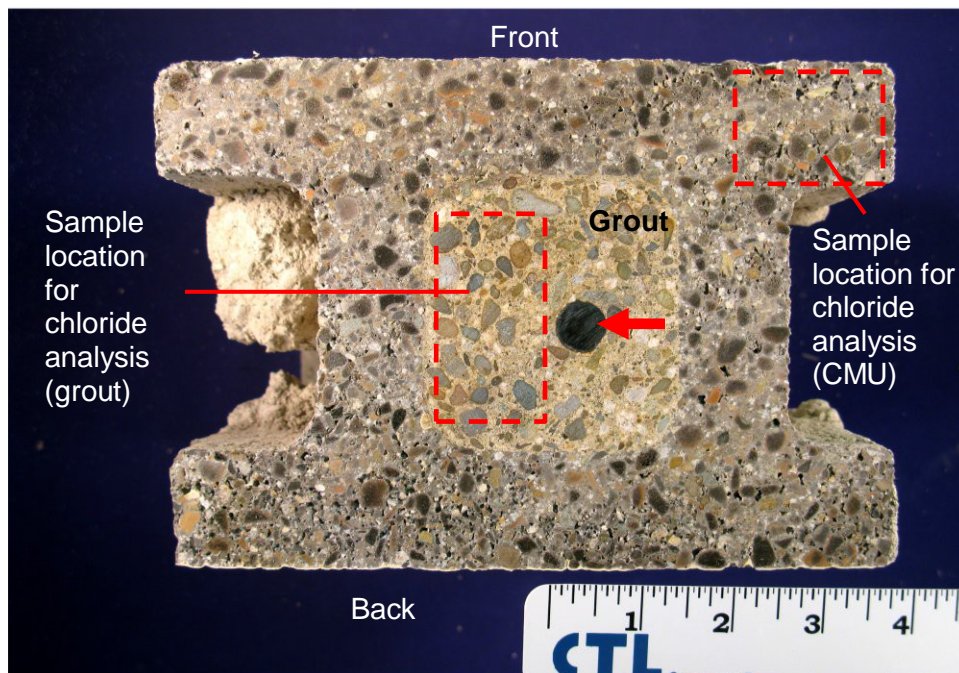
3b. Sample INTERIOR. No cracks are observed.

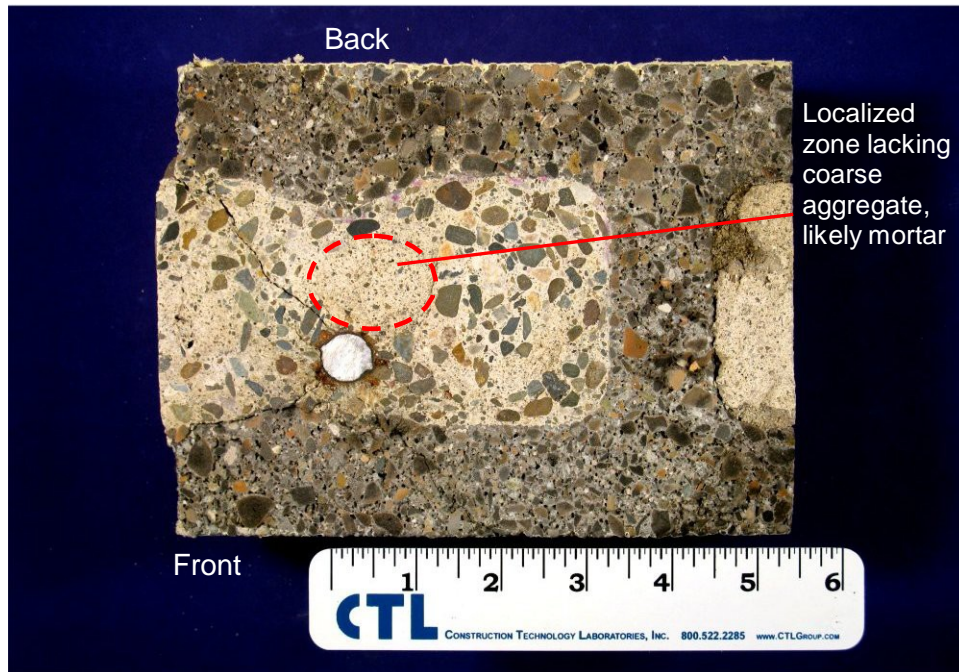
4a. Sample EXTERIOR. A few cracks extend radially from the corroded reinforcing steel bar.

Fig. 4 Saw-cut sections of the samples treated with a pH indicator solution (phenolphthalein). The solution imparts a deep magenta stain to high pH, non-carbonated paste. Absence of color change indicates that the grout is fully carbonated through the width of the cells. Scale is in inches.

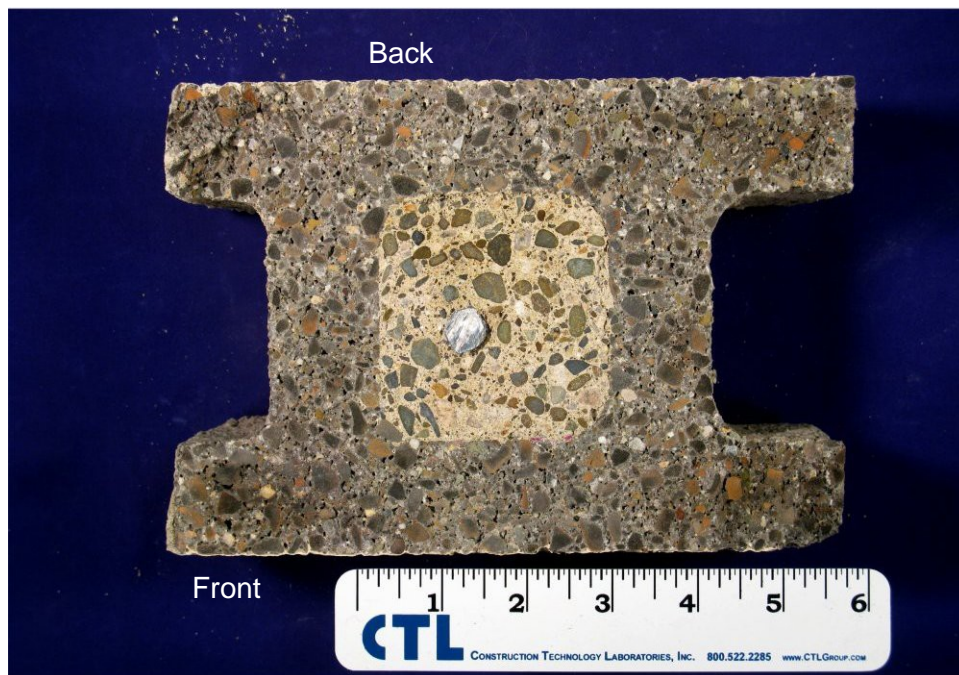
4b. Sample INTERIOR. No cracks are observed.

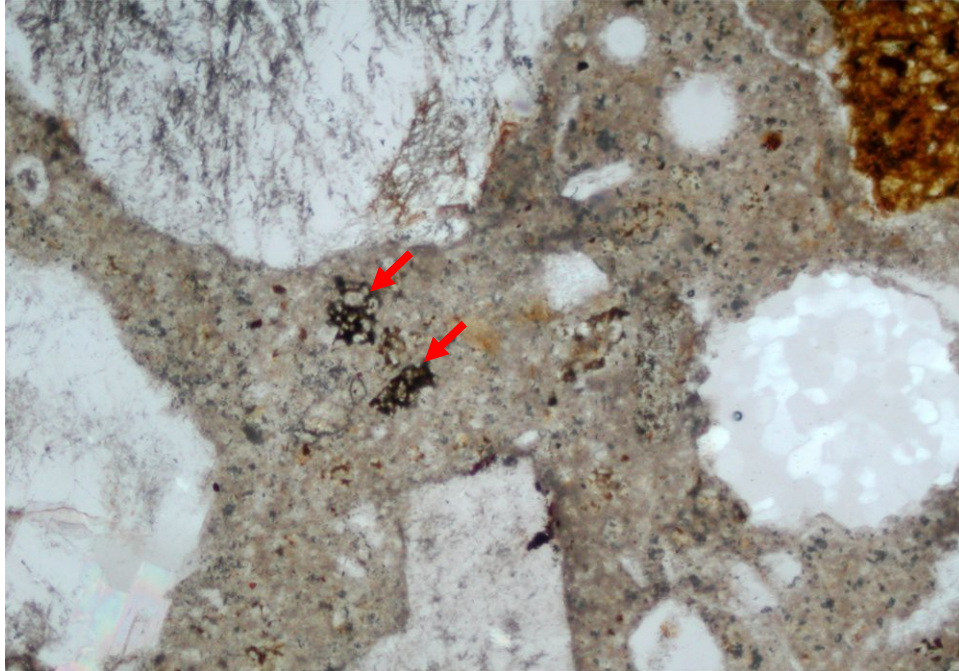
5a. Plane-polarized light. Arrows designate relicts of hydrated portland cement particles in the paste.

Fig. 5 Thin-section photomicrograph showing the hardened paste of the grout in Sample EXTERIOR. Field of view is approximately 0.05 in.

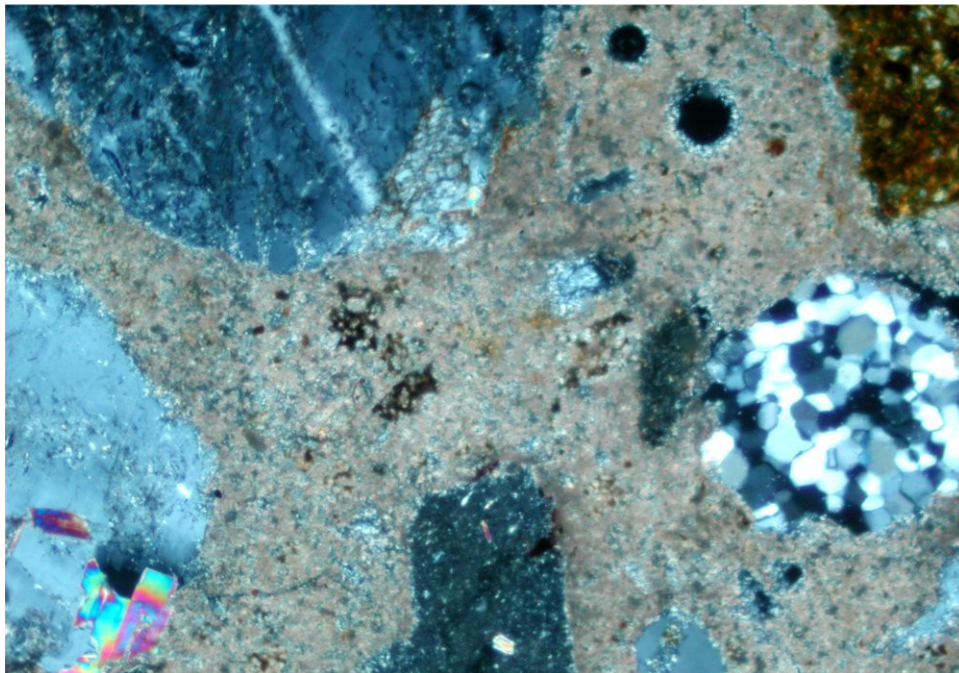
5b. The same field; cross-polarized light. The bright paste coloration is due to carbonation.

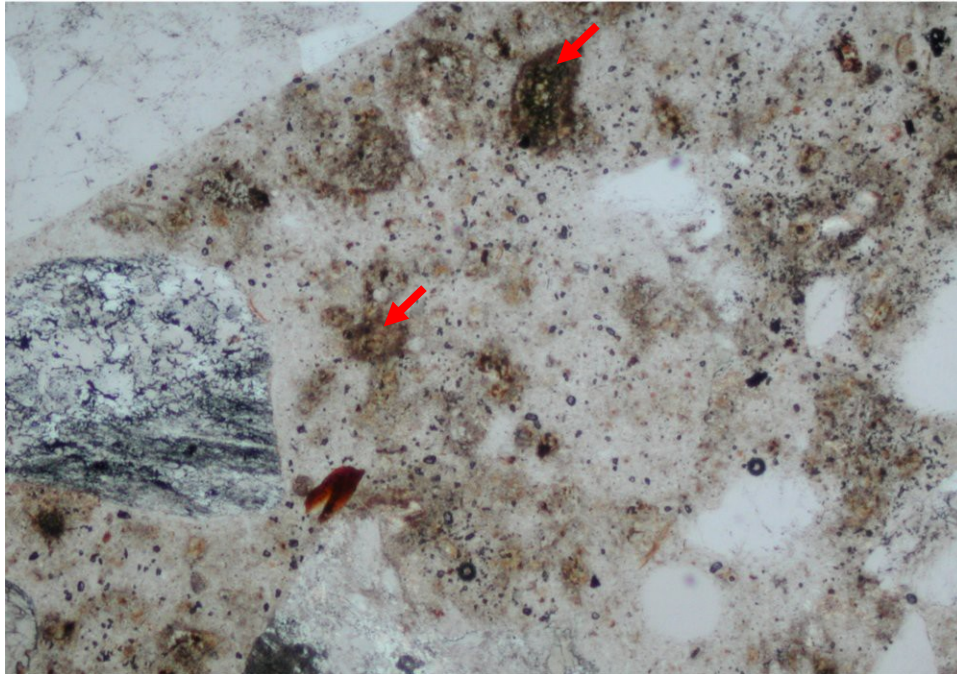
6a. Plane-polarized light. Arrows designate residual and relict portland cement particles in the paste.

Fig. 6 Thin-section photomicrograph showing the hardened paste of the grout in Sample INTERIOR. Field of view is approximately 0.05 in.

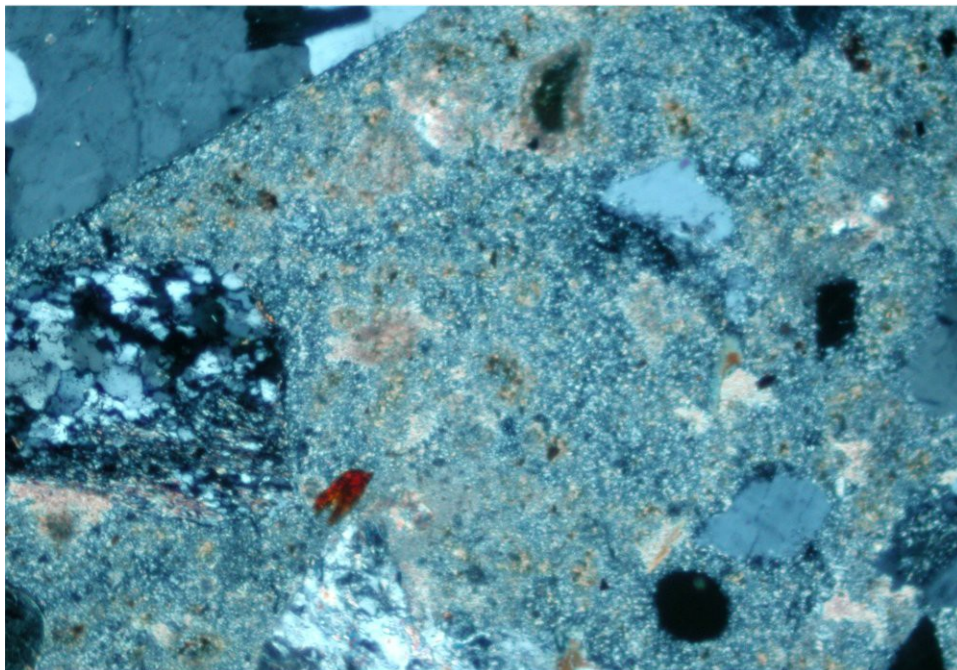
6b. The same field; cross-polarized light. The bright paste coloration is due to carbonation.

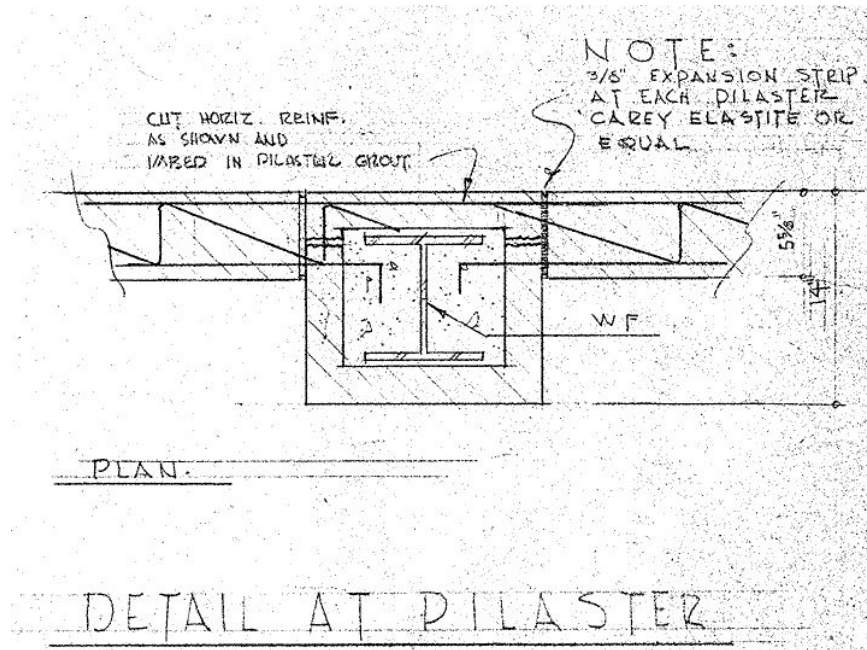
Figure 2.2 – Steel Column Detail

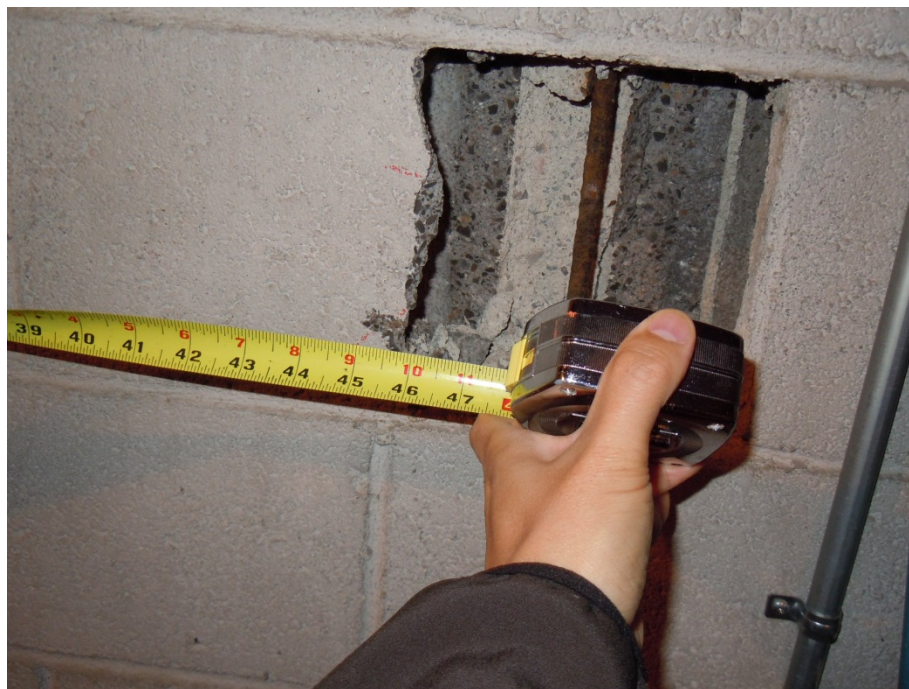
Figure 3.5 – Vertical Cracks Spaced at Four Feet

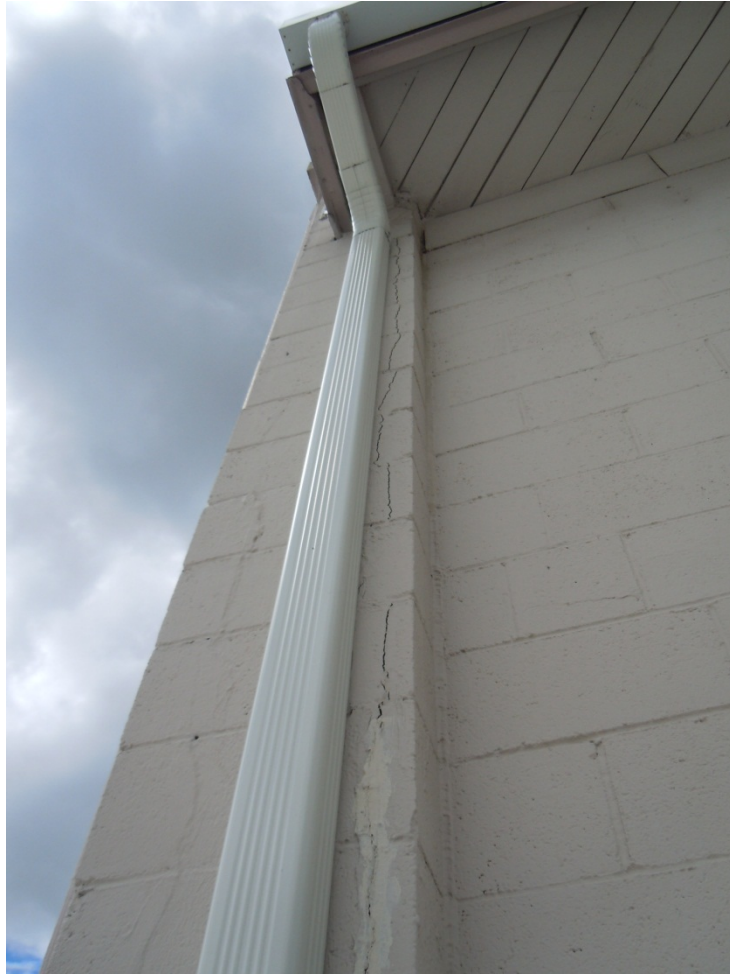
Figure 3.6 – Vertical Cracks at Southeast Corner of Gymnasium

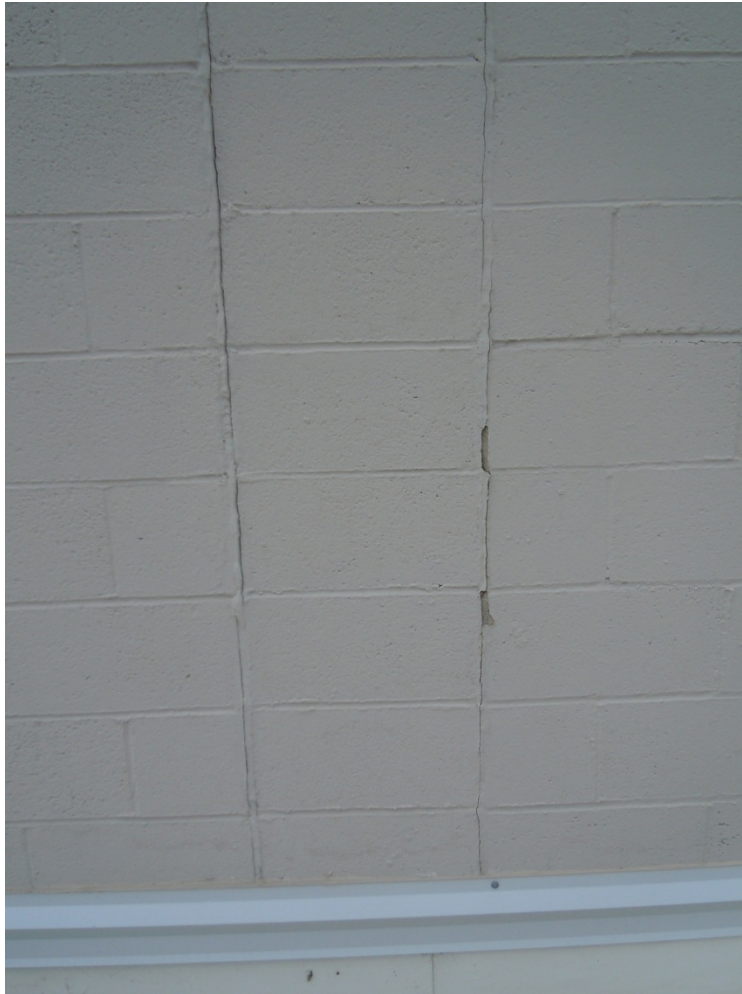
Figure 3.7 – Expansion Joint at Each Side of Masonry Pier

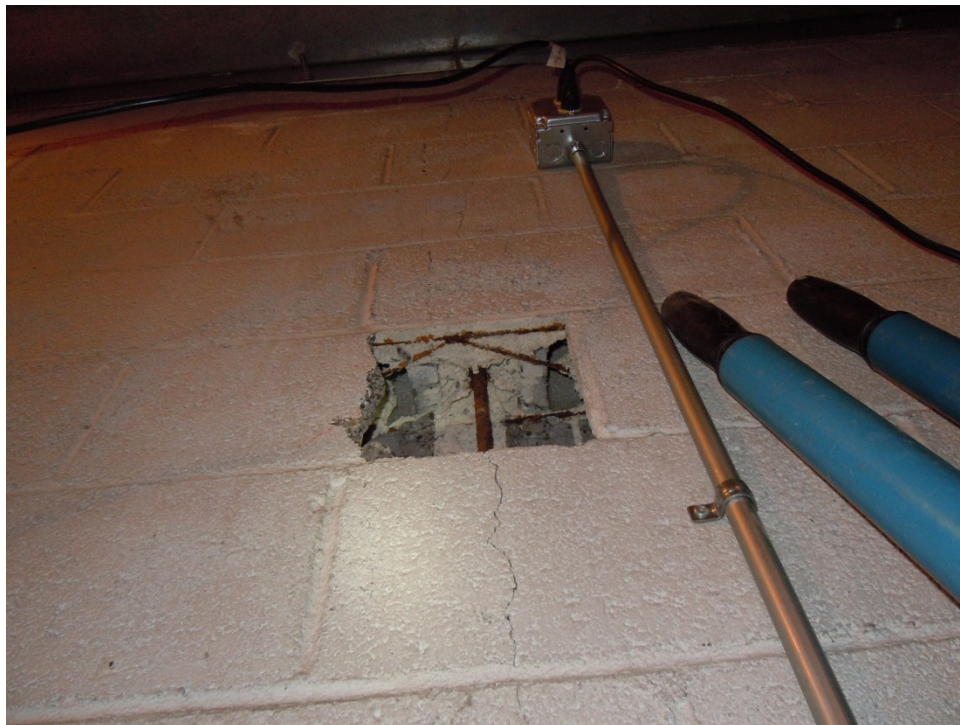
Figure 3.9 – Horizontal K-web Reinforcing in Storage Room

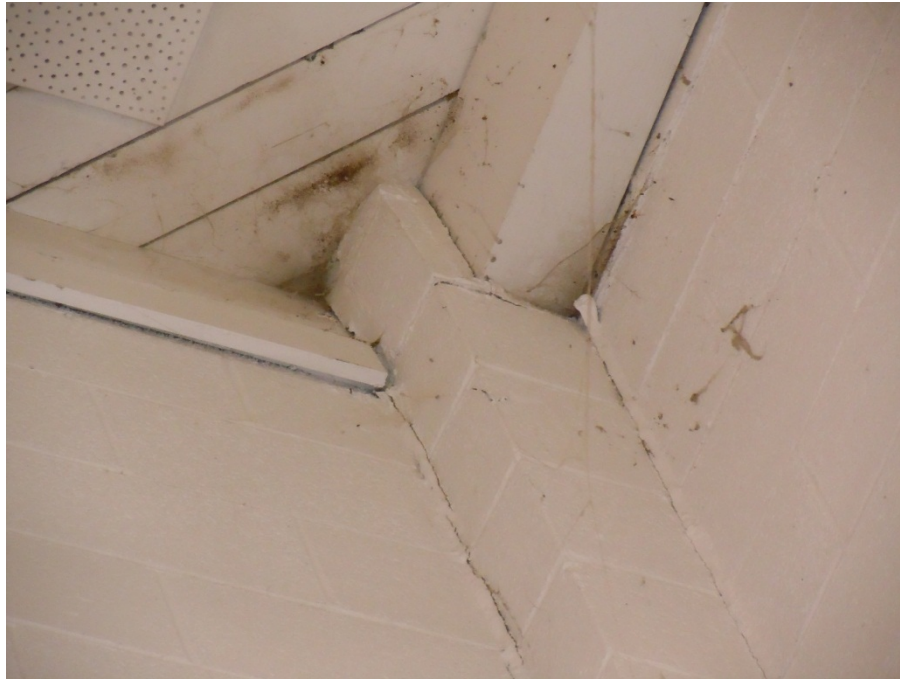
Figure 3.12 – Moisture at Top of Southeast Column
