REQUEST FOR PROPOSALS

No. 2014-0529

ARCHITECTURAL SERVICES

McNeal Pavilion Renovation and New Student Recreation Center

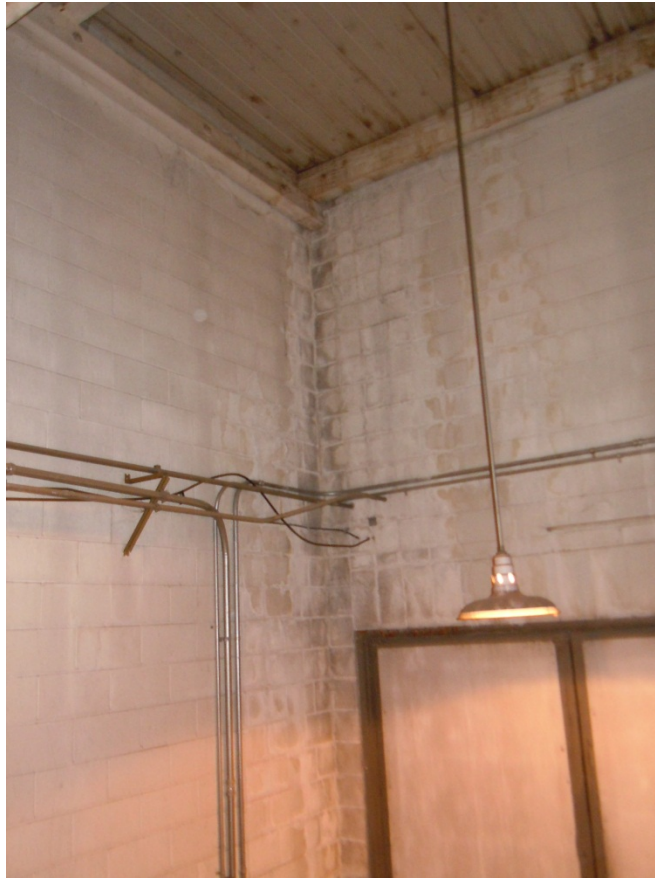
Figure 3.17 – Missing Pilaster in Boiler Room

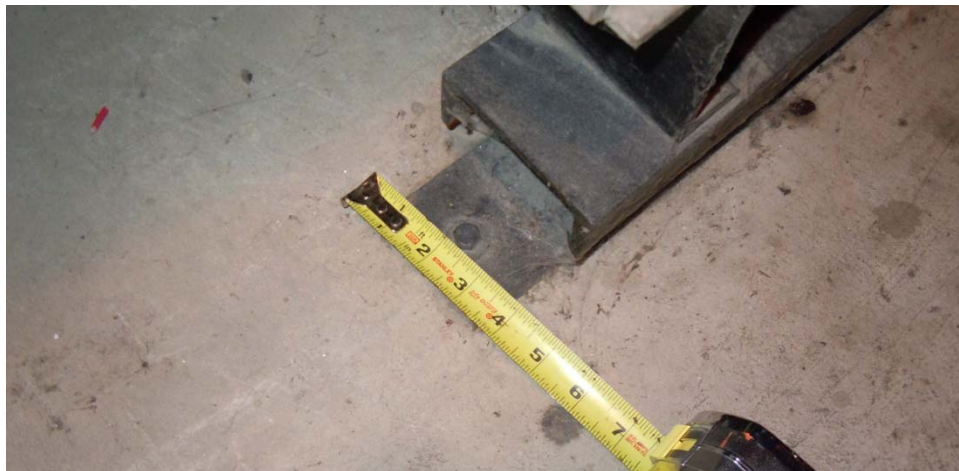
Figure 3.18 – Minimal Equipment Anchorage

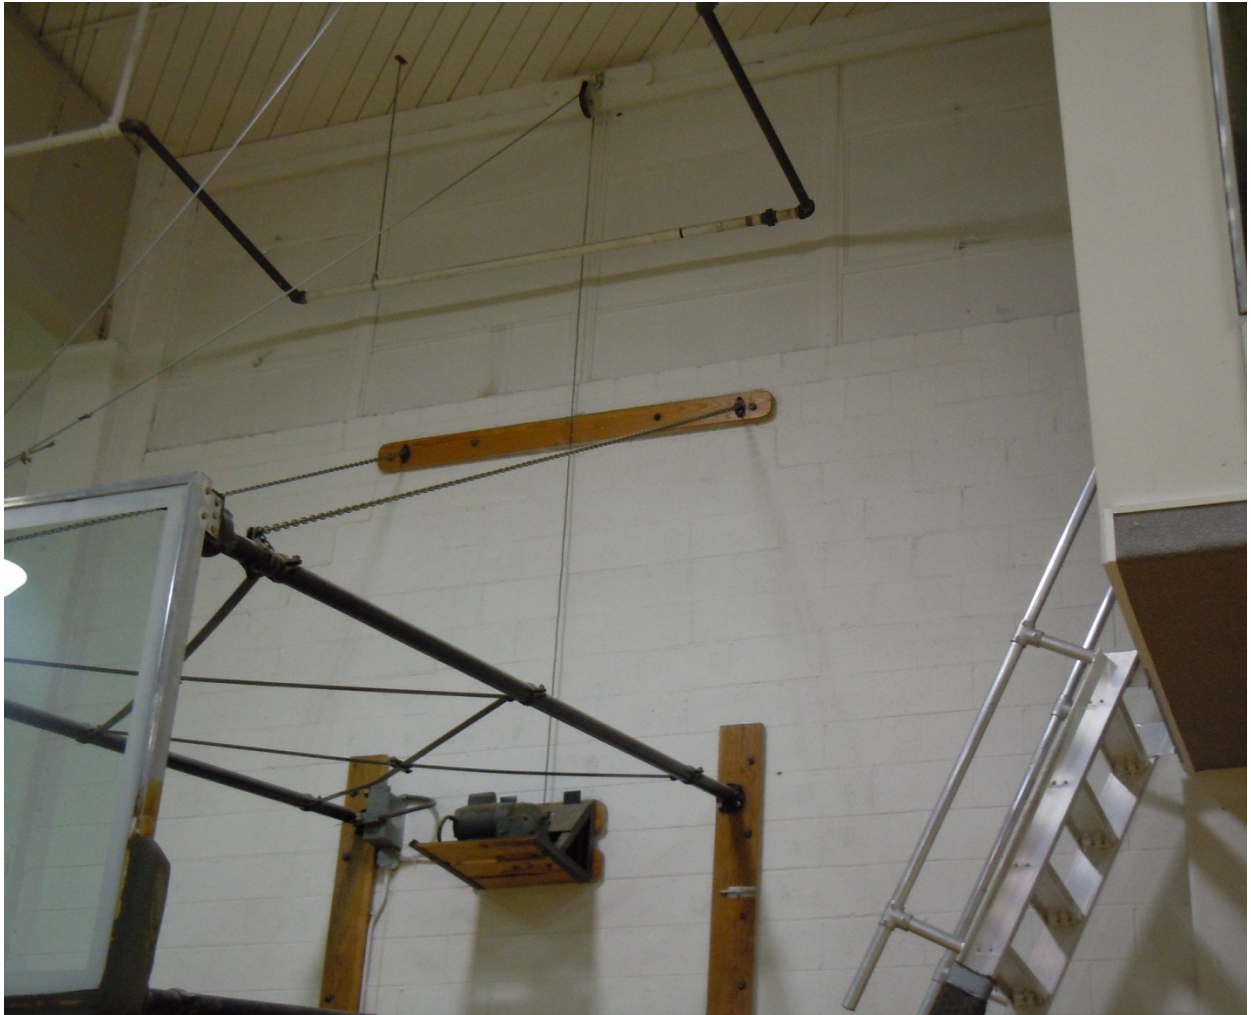
Figure 3.19 – Diagonal Cracks at Basketball Hoop

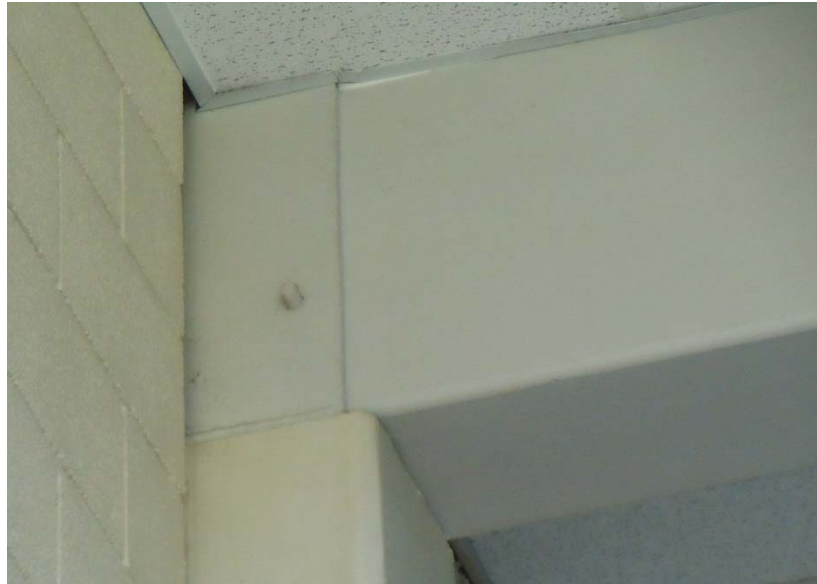
Figure 3.20 – Missing Nut in Pool Area

- Only minor rusting was noted in the pool area at the northeast corner of the building. However, a missing nut at a beam to pilaster connection was noted as shown in **Figure 3.20**. An investigation of the pool building construction is recommended.

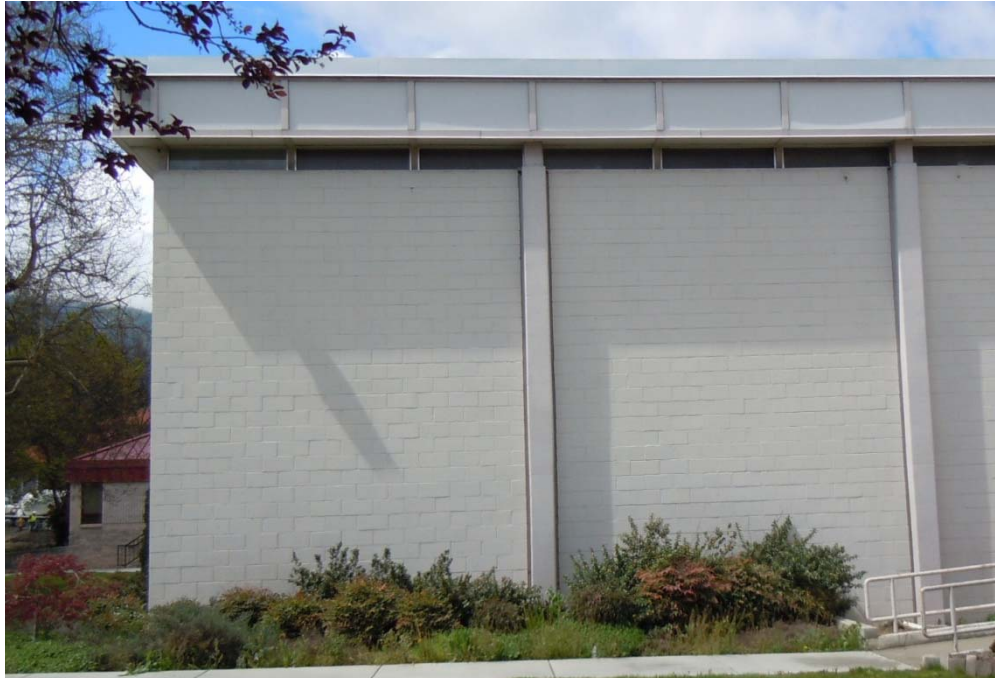
Figure 3.21 – Windows as Southeast Indoor Basketball Court

- A significant number of windows were observed between the top of the wall and the roof at the indoor basketball court at the southeast corner of the building, as shown in **Figure 3.21**. These windows disconnect the roof from the masonry walls, with only the columns extending from the wall up to the roof. If not properly designed, detailed and constructed, the portion of columns between the walls and the roof will experience significant damage during a seismic event.

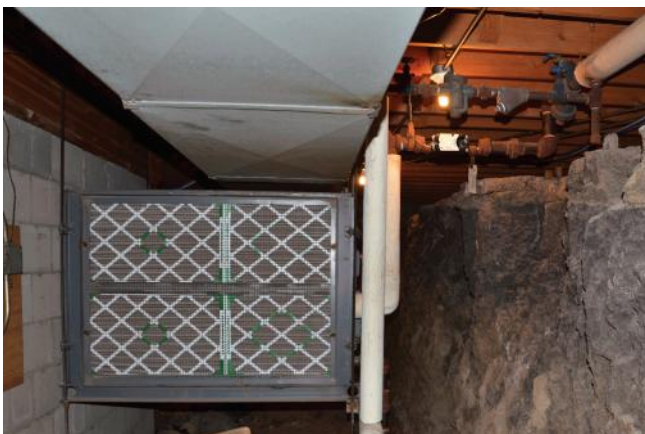
Air filters next to unexcavated basement

- Pool chemicals kept in unventilated basement storage rooms.
- Corroded pipes
- Steam piping failures
- Air filters located next to unexcavated dirt basement
- Plumbing fixtures at the end of their useful life that do not meet current low flow water codes
- Electrical panels and equipment located in the pool chemical room, which has high humidity and a corrosive atmosphere.
- No emergency power source.
- Incomplete fire suppression system
- Multiple under-lighted spaces
- Malfunctioning electronic latches on some doors, resulting in unsecure doors
- No dedicated signal pathway
