DEMOLITION LANDFILL REMEDIATION —ENGINEERING DUE DILIGENCE

OSU-CASCADES

Prepared for
OREGON STATE UNIVERSITY

OSU-CASCADES
November 14, 2016
Project No. 1290.01.01

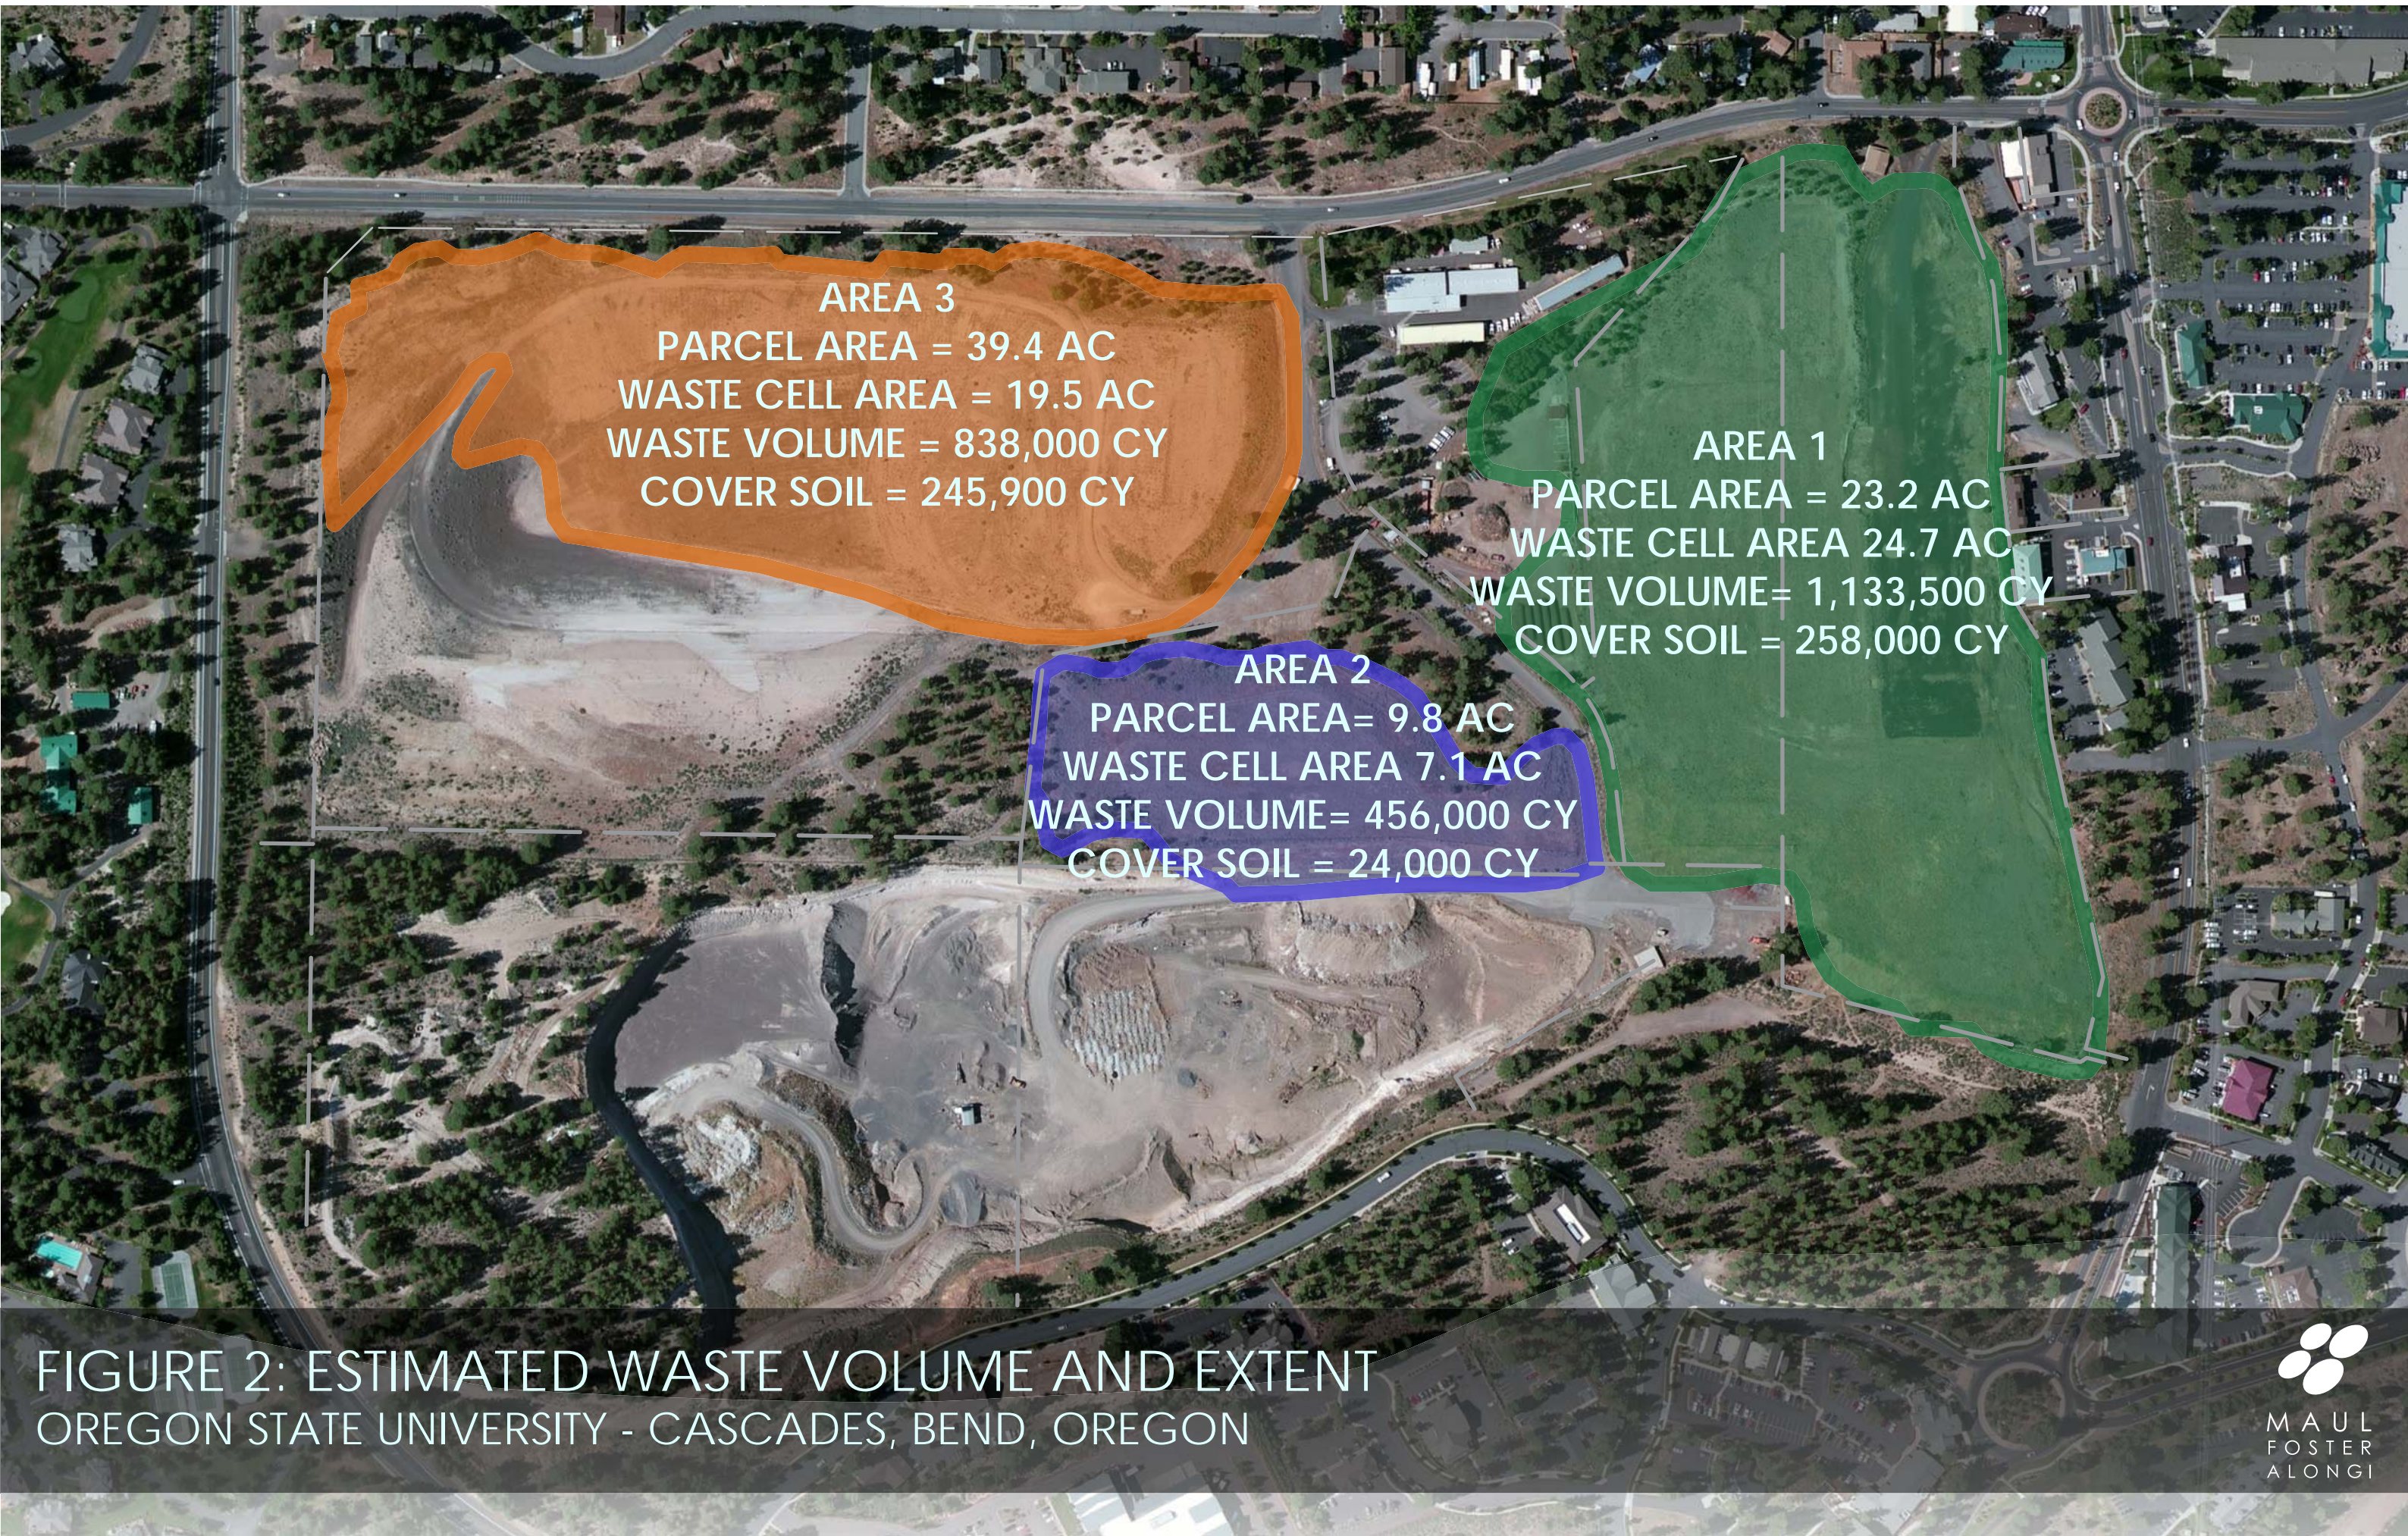
FIGURE 2: ESTIMATED WASTE VOLUME AND EXTENT
OREGON STATE UNIVERSITY - CASCADES, BEND, OREGON

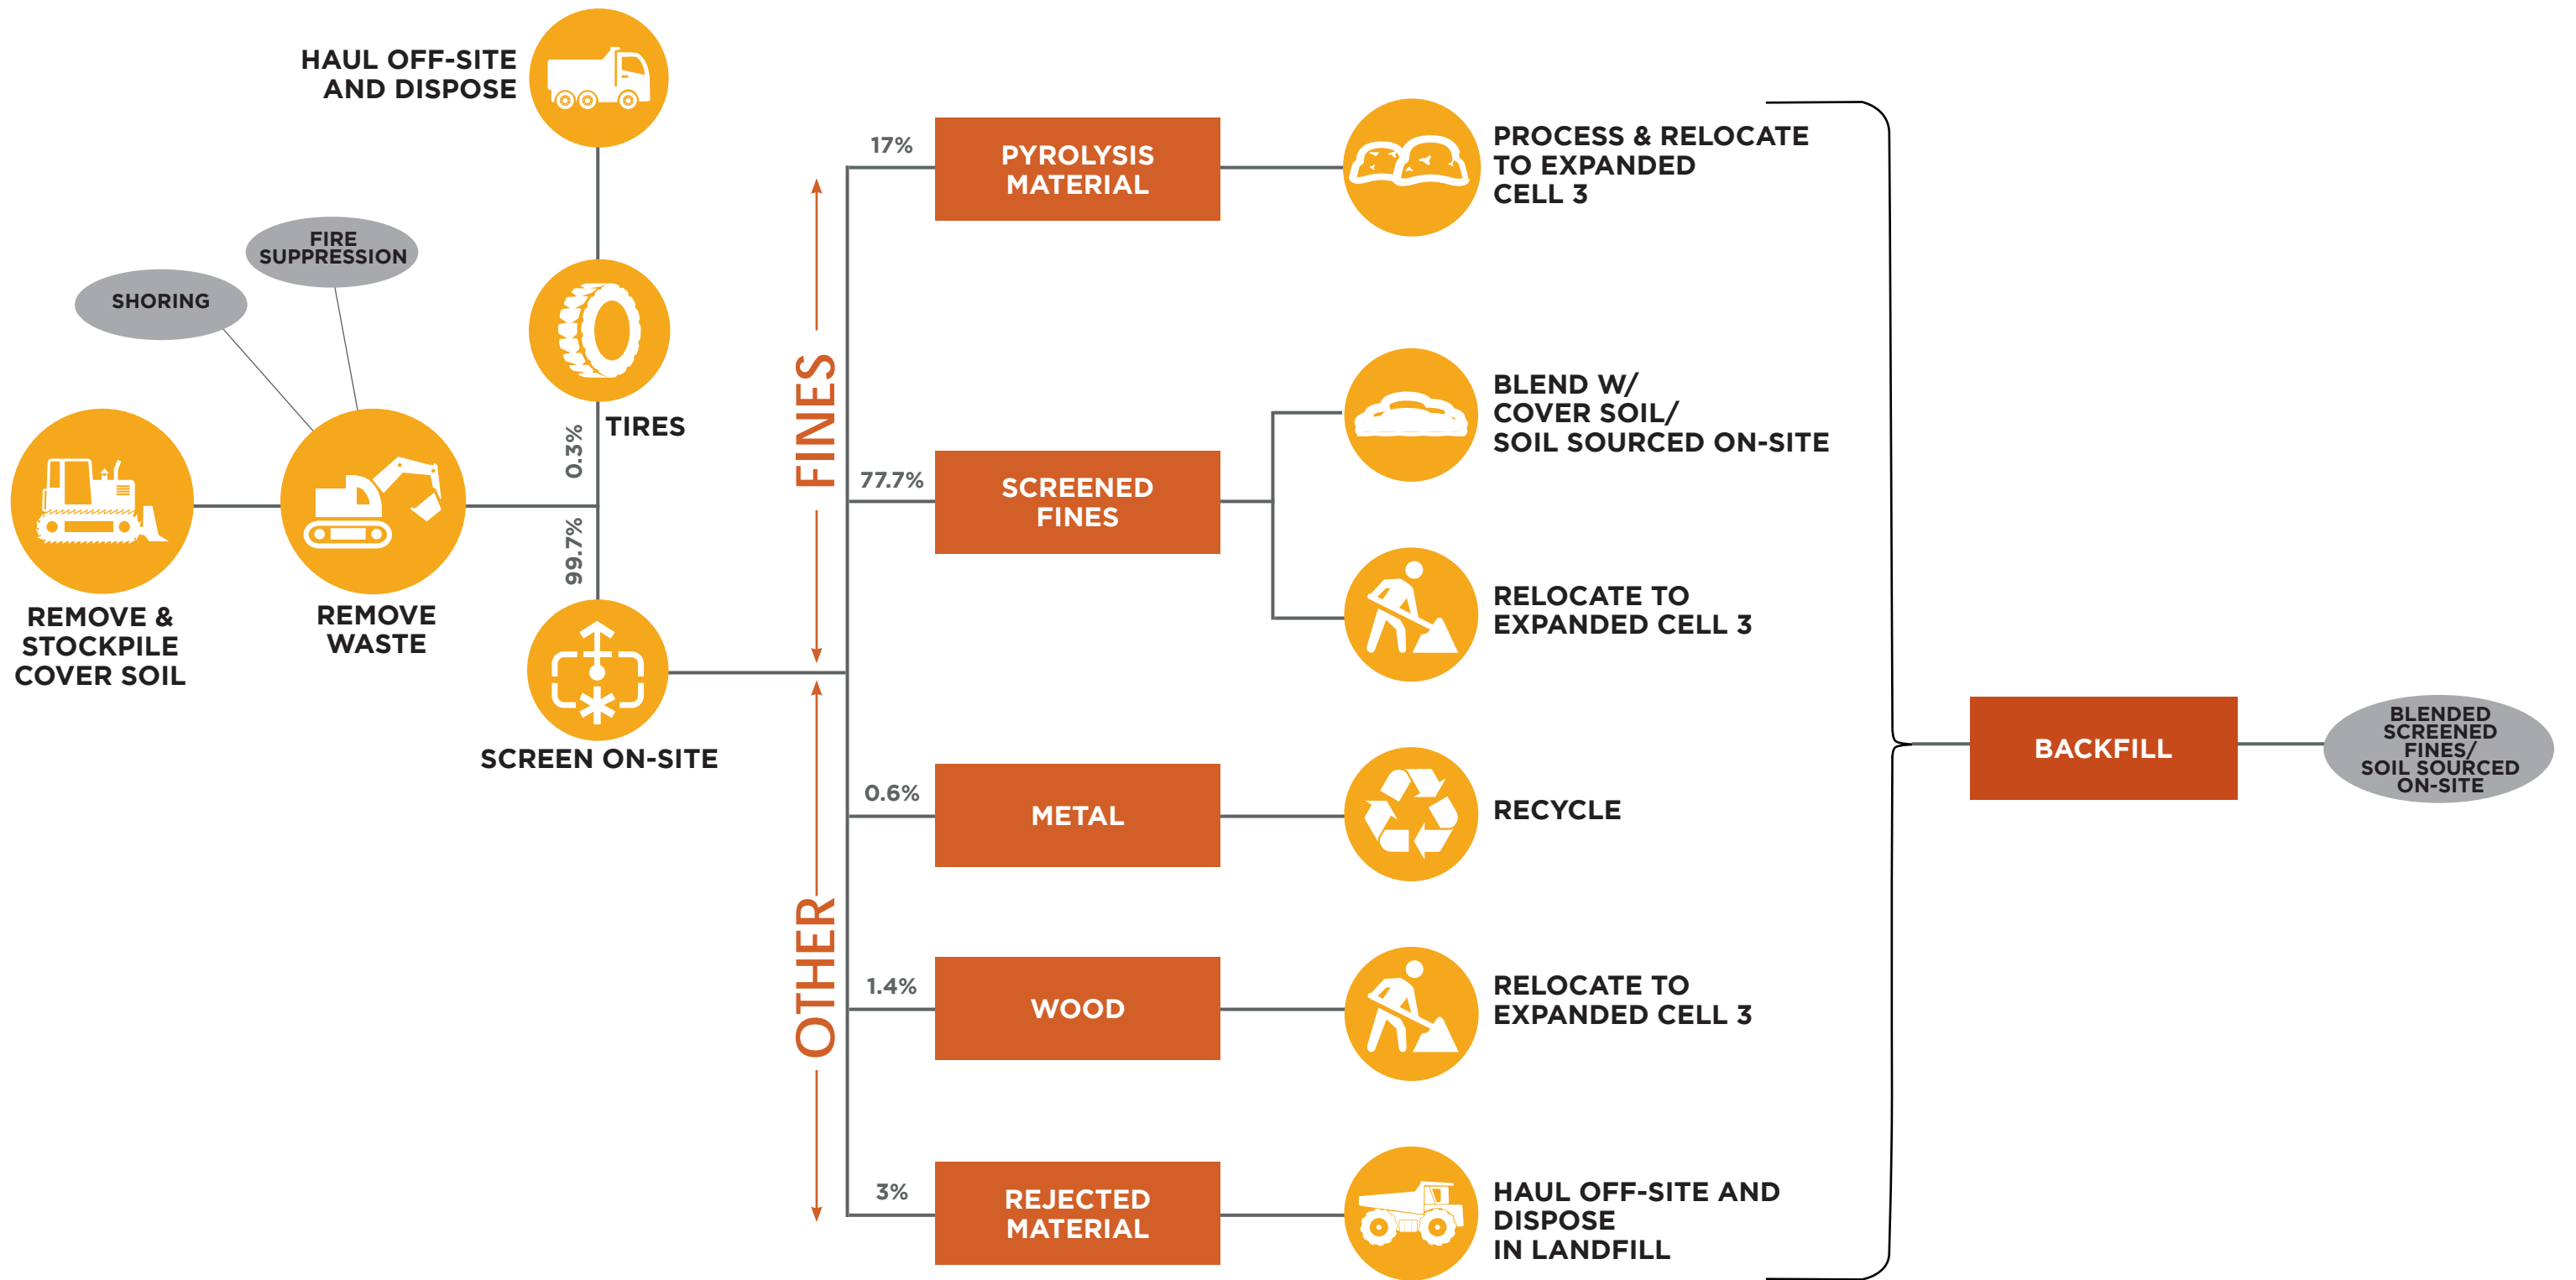
FIGURE 3: CELL 1 - REMEDIATION APPROACH
 OREGON STATE UNIVERSITY - CASCADES, BEND, OREGON

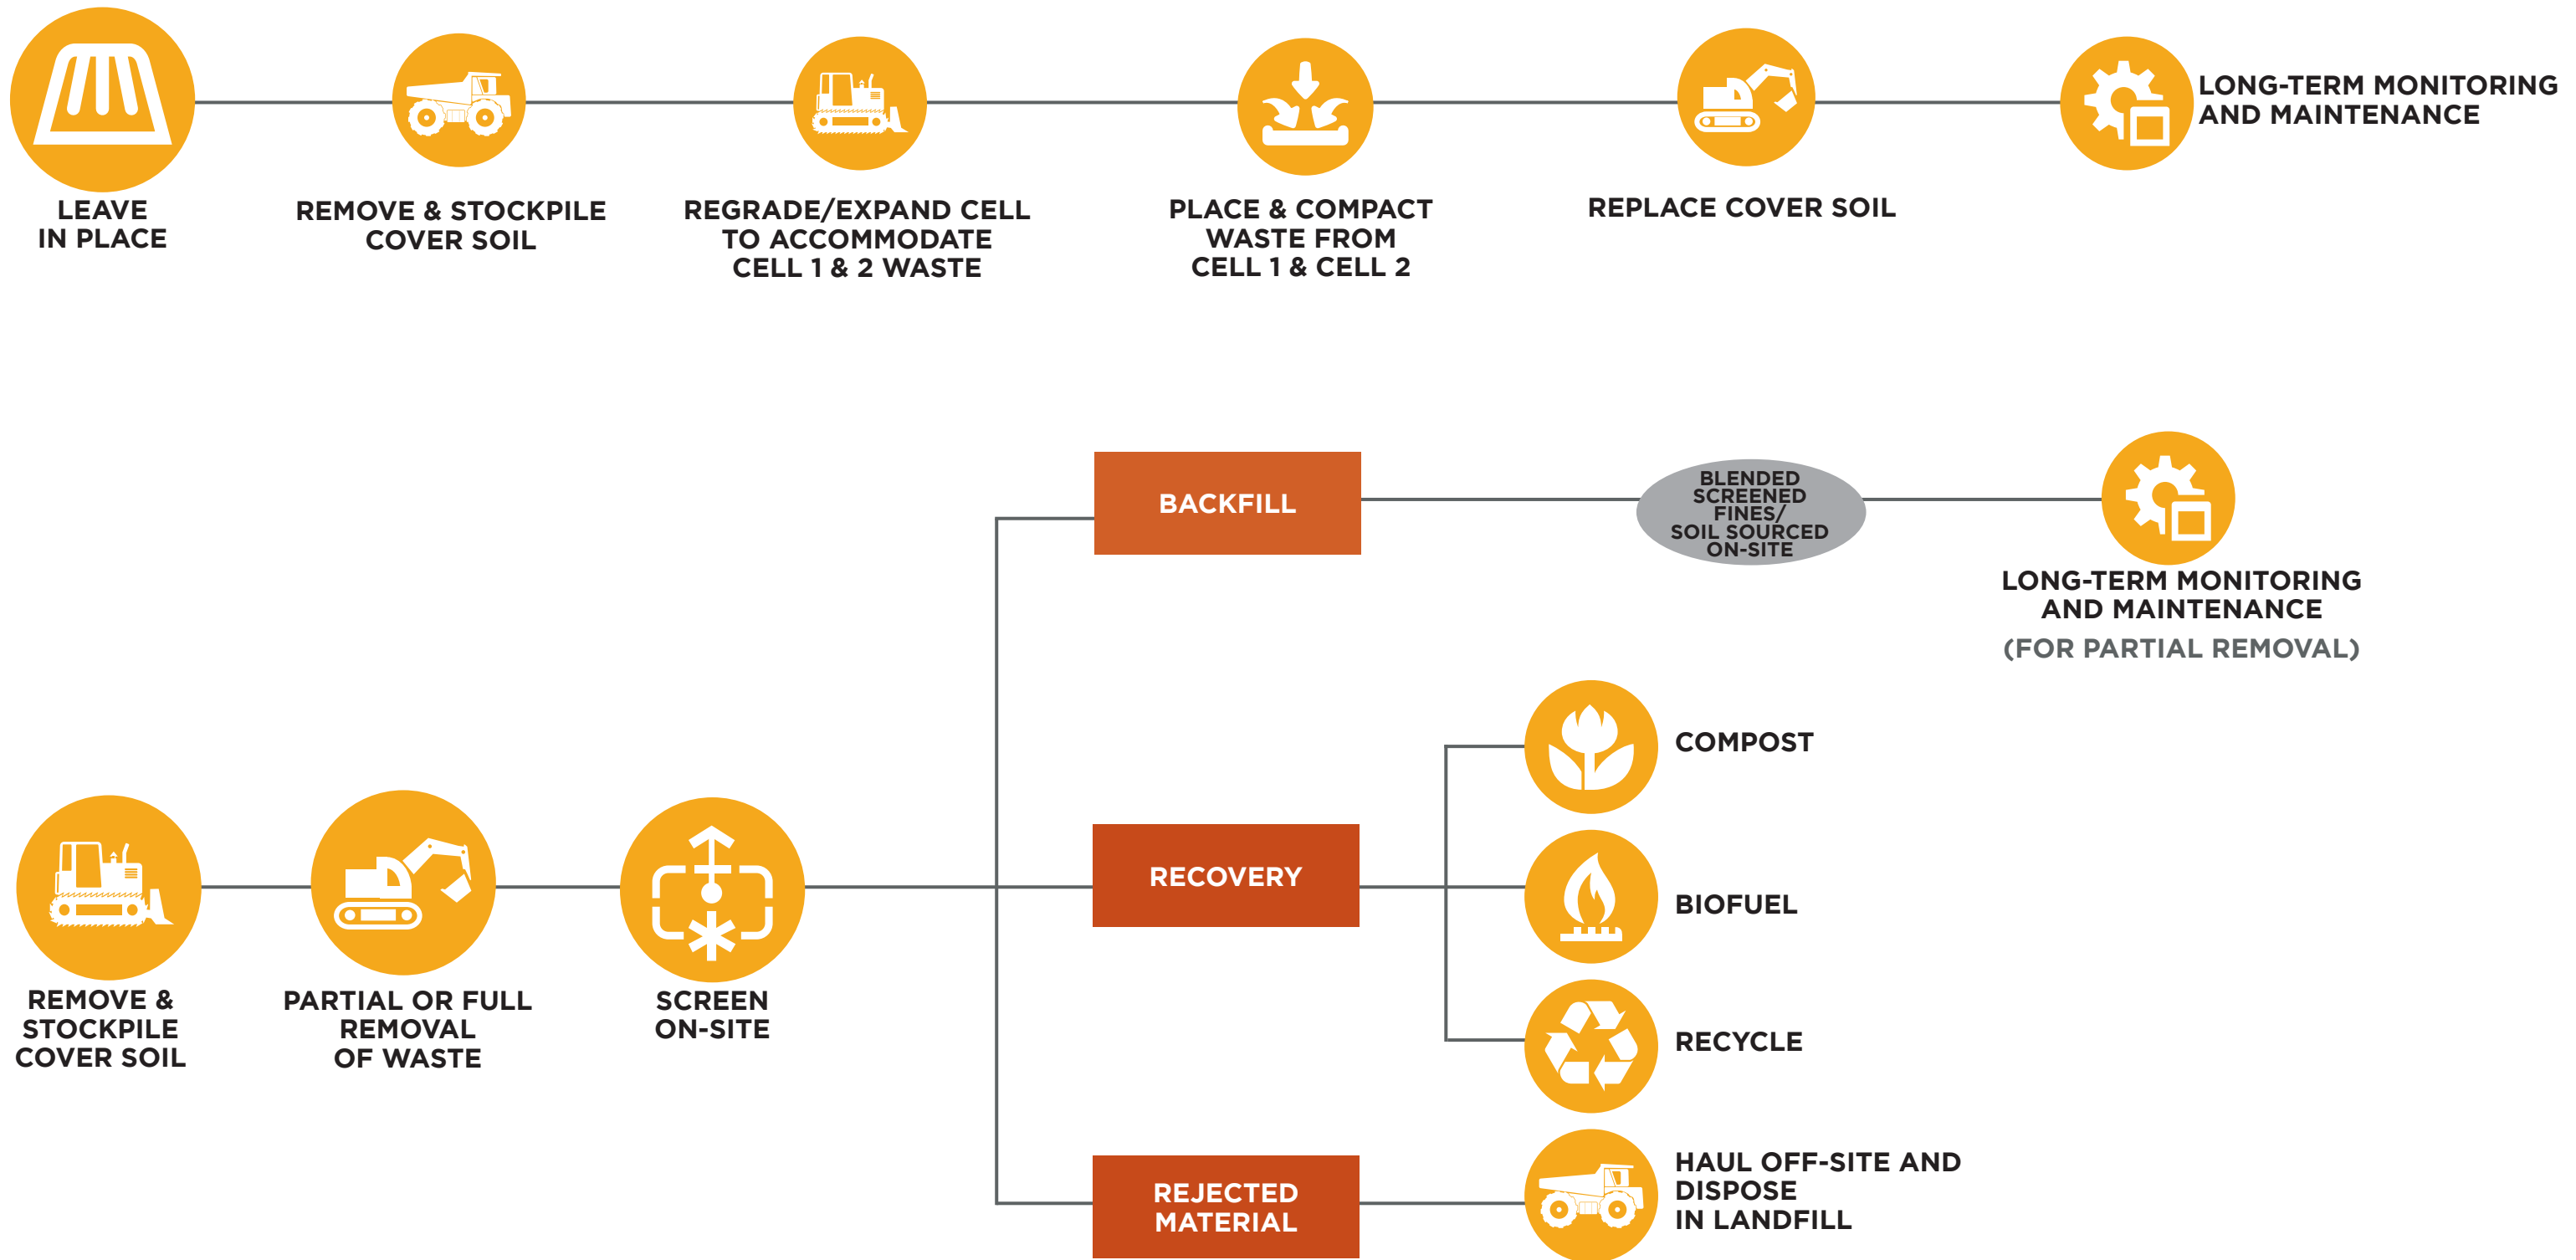
FIGURE 5: CELL 3 - REMEDIATION APPROACH
 OREGON STATE UNIVERSITY - CASCADES, BEND, OREGON

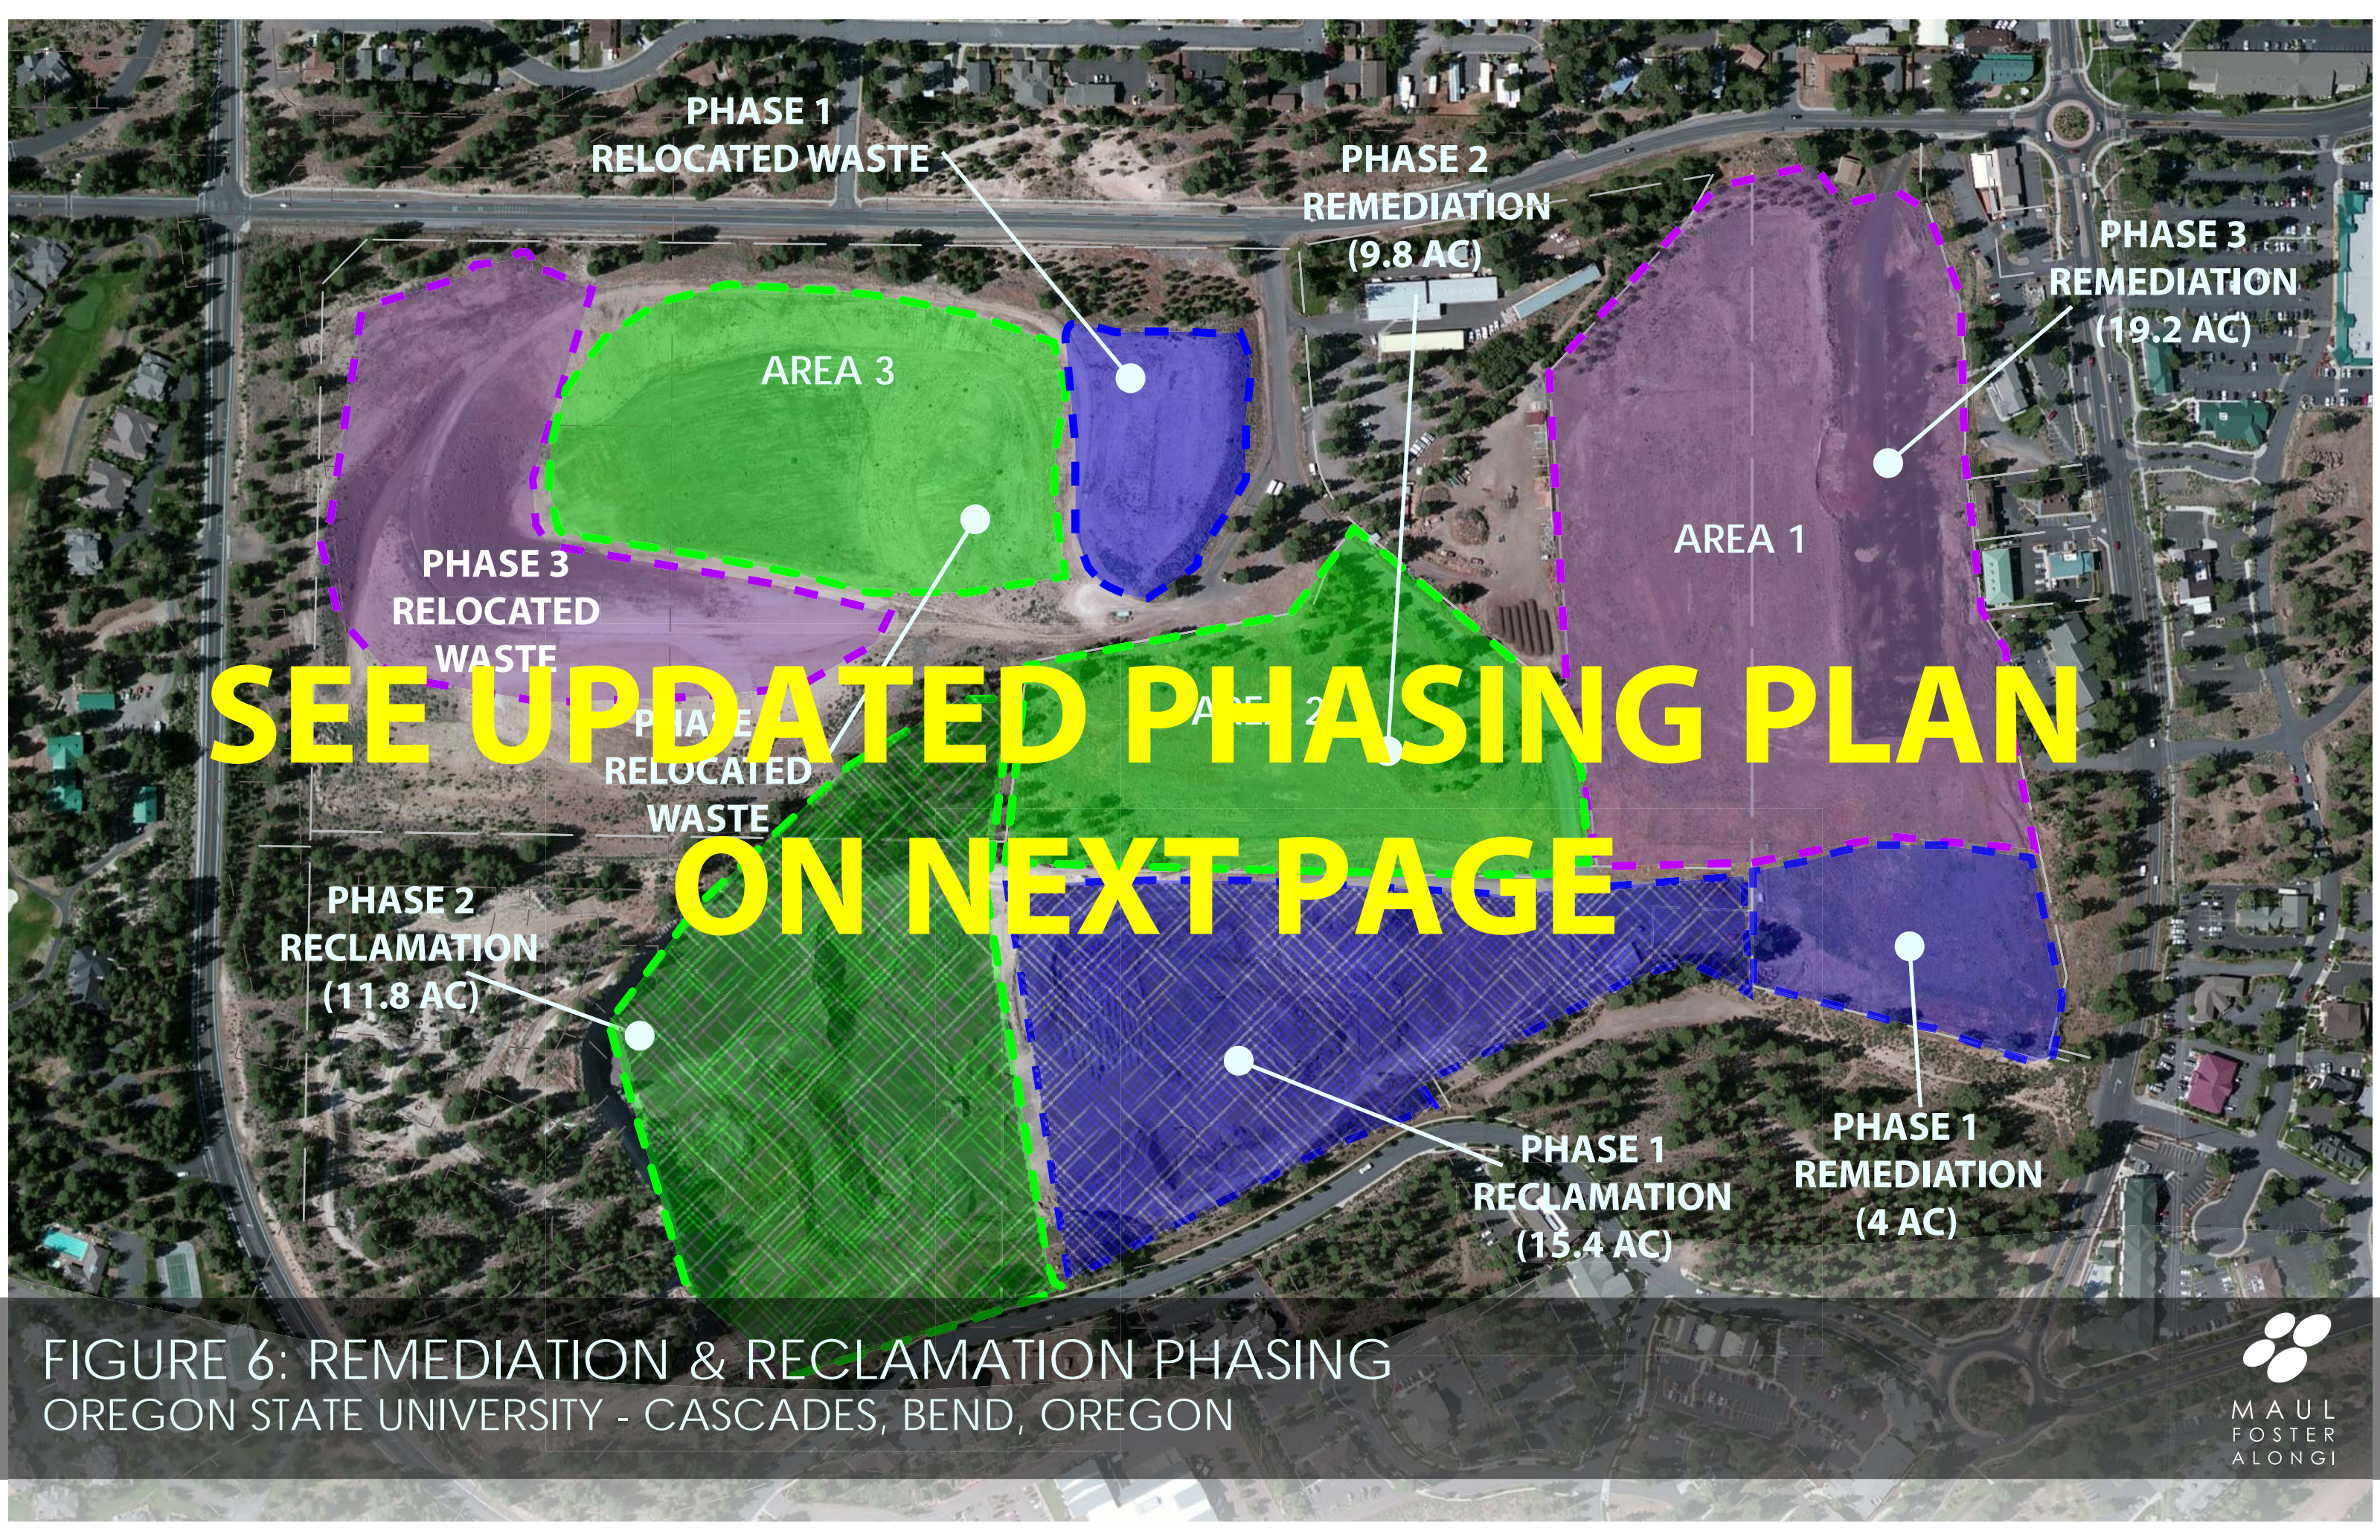
PHASE 1
RELOCATED WASTE

PHASE 2
REMEDICATION
(9.8 AC)

PHASE 1
REMEDICATION
(4 AC)

FIGURE 6: REMEDIATION & RECLAMATION PHASING
OREGON STATE UNIVERSITY - CASCADES, BEND, OREGON

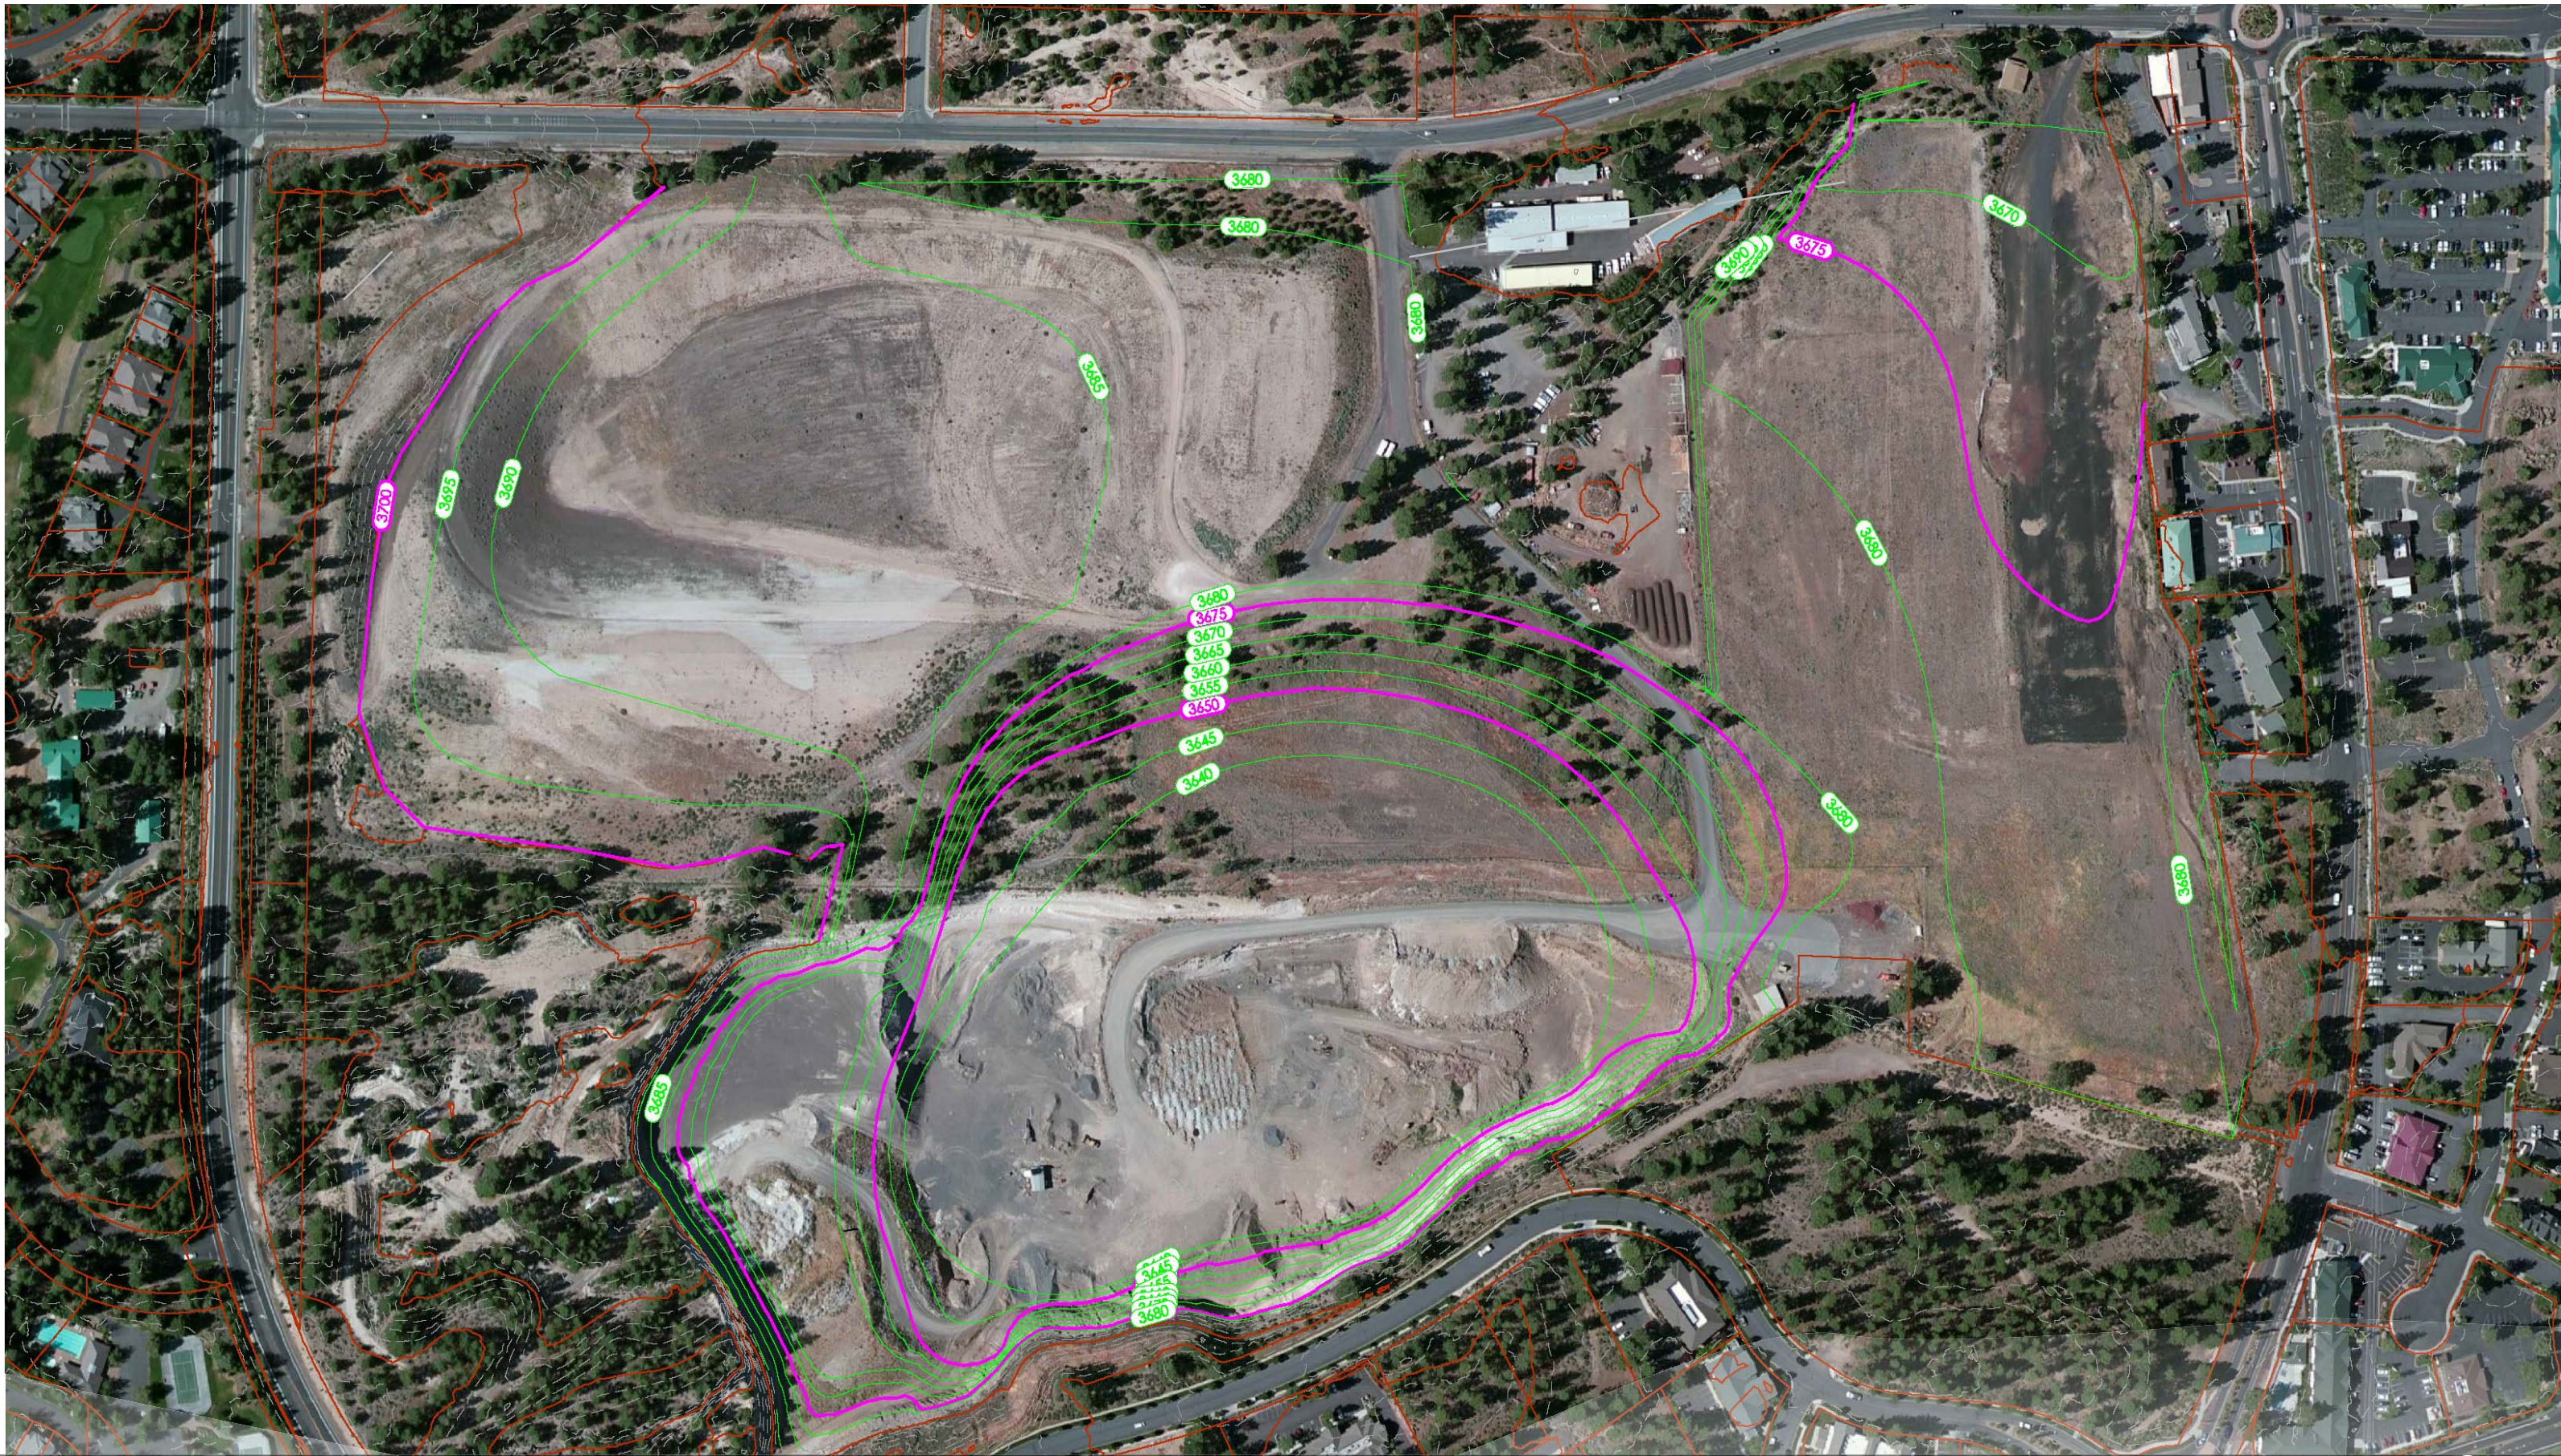
FIGURE 7: CONCEPTUAL GRADING SCHEME
OREGON STATE UNIVERSITY - CASCADES, BEND, OREGON
