Oregon State University
Construction Contract Administration
Request for Qualifications #194360
Demolition Landfill Remedial Action Planning, Remediation Design and Pumice Mine Site Reclamation Design

ADDENDUM NO. 2

**Report of
Supplemental Geologic Reconnaissance &
Preliminary Slope Stability Analysis for
Eastern Portion of
OSU Cascades 46-Acre Site
1707 & 1757 SW Simpson Avenue
Bend, Oregon**

CGT Project Number G1303959.B

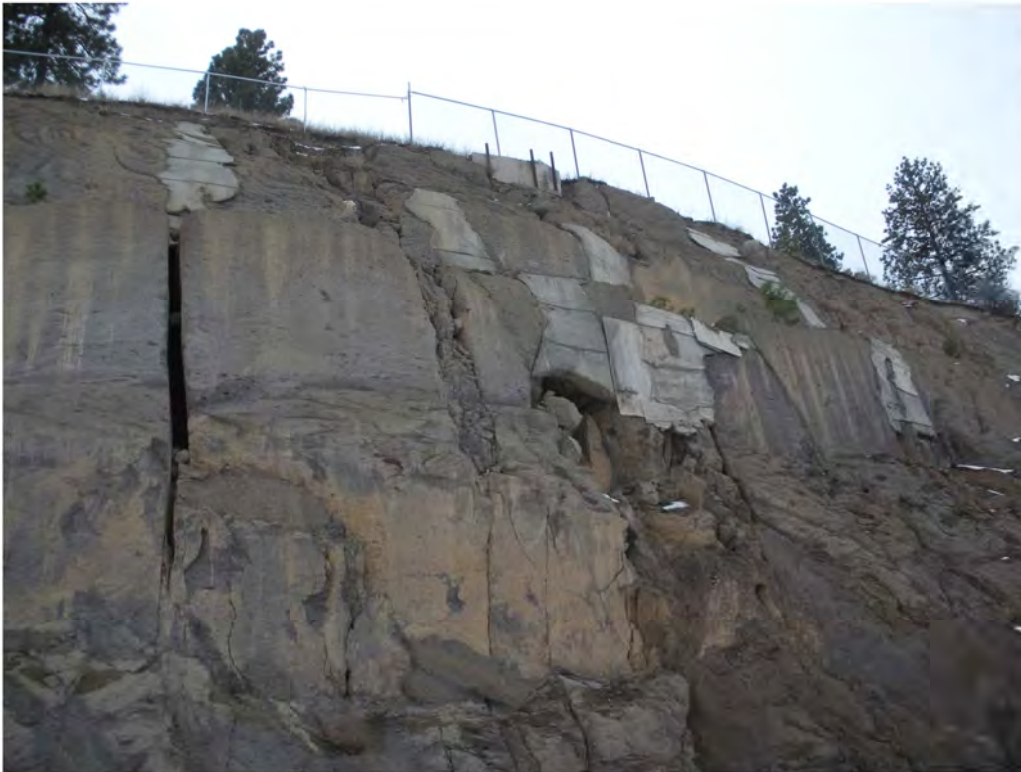
Photograph 13:
Showing extensive
jointing and concrete
patching.

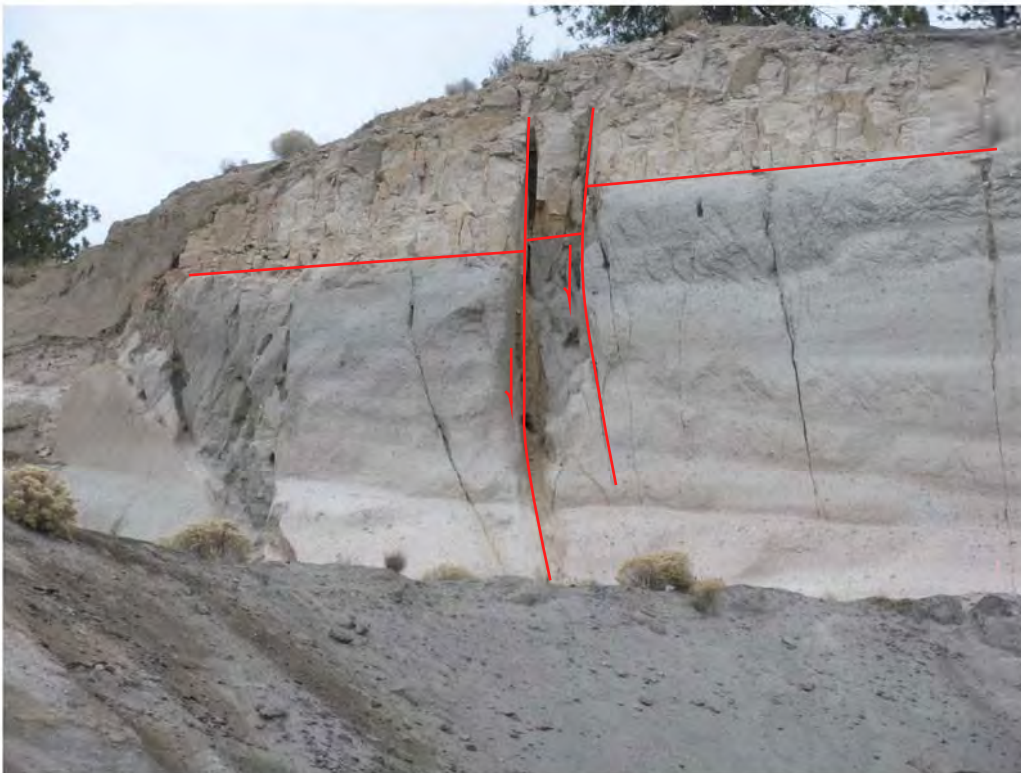
Photograph 14:
Showing example of
observed faulting. Red
lines indicate fault
traces, geologic contact
marker, and relative
offset.
