LIMITED ASBESTOS SURVEY

**BRITT HALL ROOMS 311, 314, 314 (A-G)
1170 SISKIYOU BLVD., ASHLAND, OREGON**

SOUTHERN OREGON UNIVERSITY

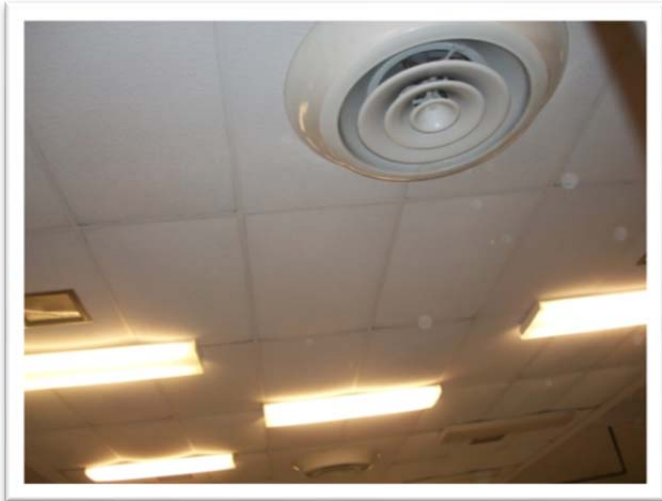
Sample 14-072A.1, Ceiling Tile, Non-ACM

Sample Layers	Asbestos Content
Brown Semi-Fibrous Material	ND
Composite Non-Asbestos Content:	75% Cellulose
Sample Composite Homogeneity:	Good

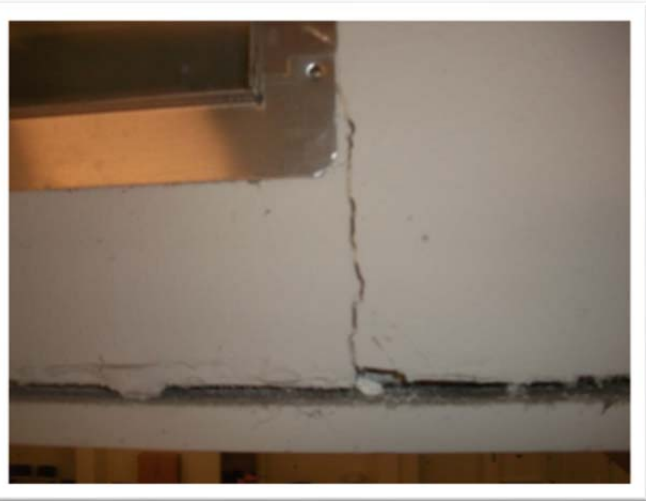
Sample 14-072A.2, Drywall/Mud, Non-ACM

Sample Layers	Asbestos Content
White Drywall with Brown Paper	ND
White Compound	ND
Composite Non-Asbestos Content:	10% Cellulose
Sample Composite Homogeneity:	Good

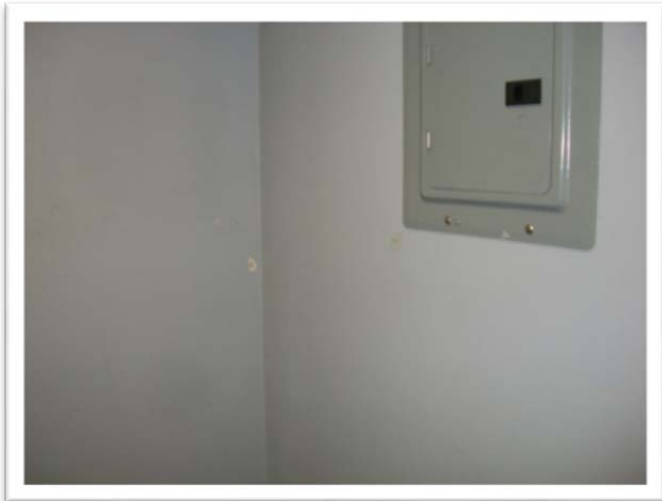
Sample 14-072A.3, Wall Materials, Non-ACM

Sample Layers	Asbestos Content
White Drywall with Brown Paper	ND
White Compound	ND
Composite Non-Asbestos Content:	10% Cellulose
Sample Composite Homogeneity:	Good

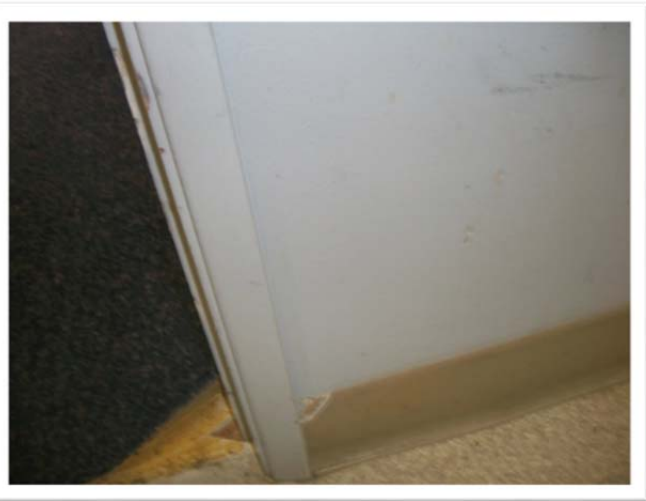
Sample 14-072A.4, Cove Base, Non-ACM

Sample Layers	Asbestos Content
Gray Baseboard	ND
Sample Composite Homogeneity:	Good

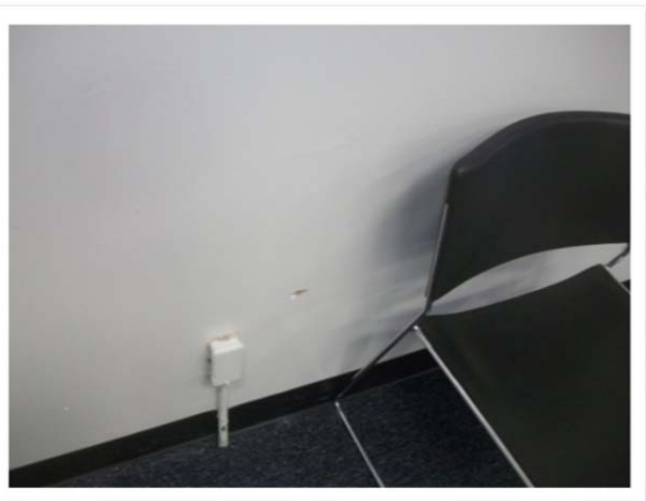
Sample 14-072A.7, Wall Materials, Non-ACM

Sample Layers	Asbestos Content
White Drywall with Brown Paper	ND
Composite Non-Asbestos Content:	10% Cellulose
Sample Composite Homogeneity: Good

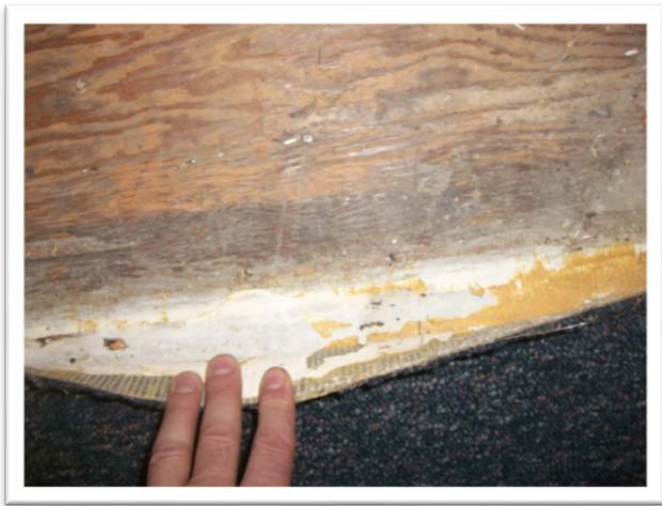
Sample 14-072A.8, Carpet Glue/Cmpd, Non-ACM

Sample Layers	Asbestos Content
Yellow Mastic	ND
Sample Composite Homogeneity: Moderate

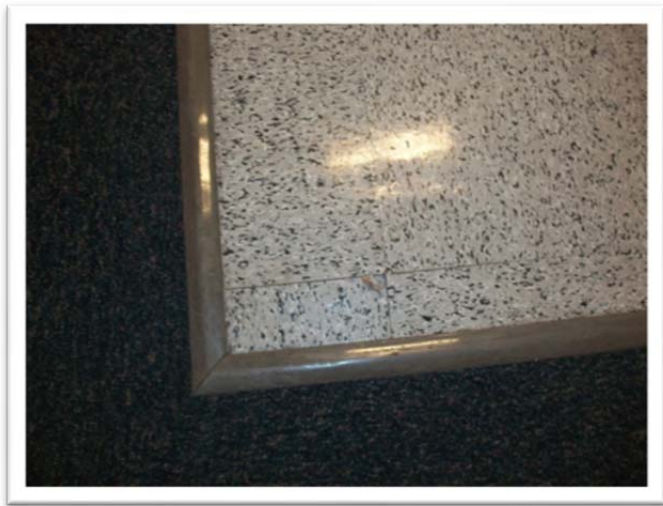
Sample 14-072A.9, Floor Tile (Top), Non-ACM
Sample 14-072A.10, Gray Floor (2nd), Non-ACM

Sample Layers	Asbestos Content
Light Gray Floor Tile	ND
Sample Composite Homogeneity: Good

Sample Layers	Asbestos Content
Light Gray Floor Tile	ND
Gray Mastic	ND
Sample Composite Homogeneity: Good

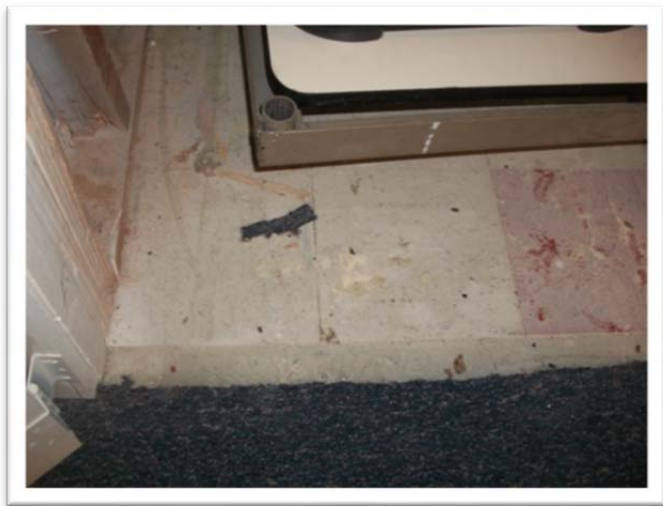
Asbestos was reported in the 9" floor tile under the stage in Room 311. Floor tile remnants (assumed asbestos) were noted under the carpet at the threshold to Room 314E. Assumed asbestos floor tile may have been previously removed from Room 314 prior to installation of current floor tile and carpet. Mr. McNamara indicated the floor tile beneath the stage in Room 311 would not be impacted during renovation activities. All other samples submitted for analysis were reported none detected for asbestos.

Sample 14-072A.12, 9" Floor Tile, ACM

Sample Layers	Asbestos Content
Light Gray Floor Tile	3% Chrysotile
Dark Gray Mastic	ND
Sample Composite Homogeneity: Good

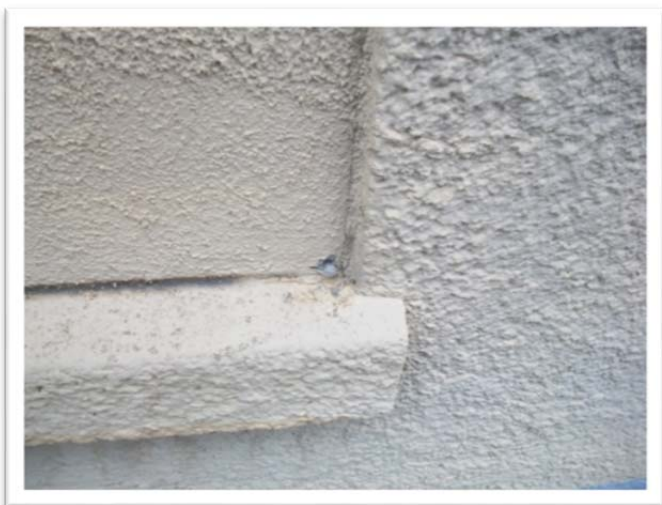
Sample 14-072A.13, Cement/Texture, Non-ACM

Sample Layers	Asbestos Content
Gray Cementitious Material	ND
Sample Composite Homogeneity: Good

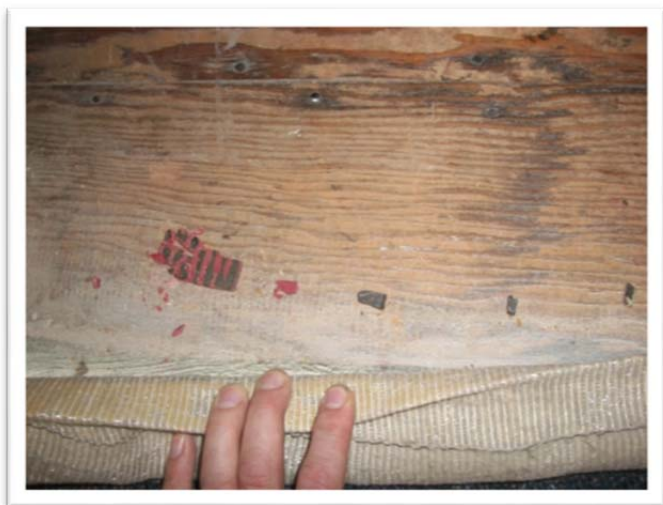
Comments: Friability of a sample does not indicate presence or absence of asbestos. Floor tile remnants noted under carpet at threshold to Room 314E. Plywood noted beneath all flooring sample locations.

Assumed Asbestos Floor Tile, Room 314E Threshold

The floor tile remnants under the carpet at Room 314E should be removed by a licensed asbestos abatement contractor or appropriate SOU trained staff with HEPA vacuum prior to renovation activities. If additional areas of floor tile remnants are uncovered during carpet removal, a licensed abatement contractor should be retained to perform the removal work. If materials not sampled in this survey are uncovered during renovation activities, a sample(s) should be collected and analyzed for asbestos content.
