RICHARDSON HALL CHILLER AND CONTROLS REPLACEMENT CM/GC

ADDENDUM NO. 2

Richardson Hall HVAC Upgrades

OSU Richardson Hall Chiller Plant and HVAC Upgrades

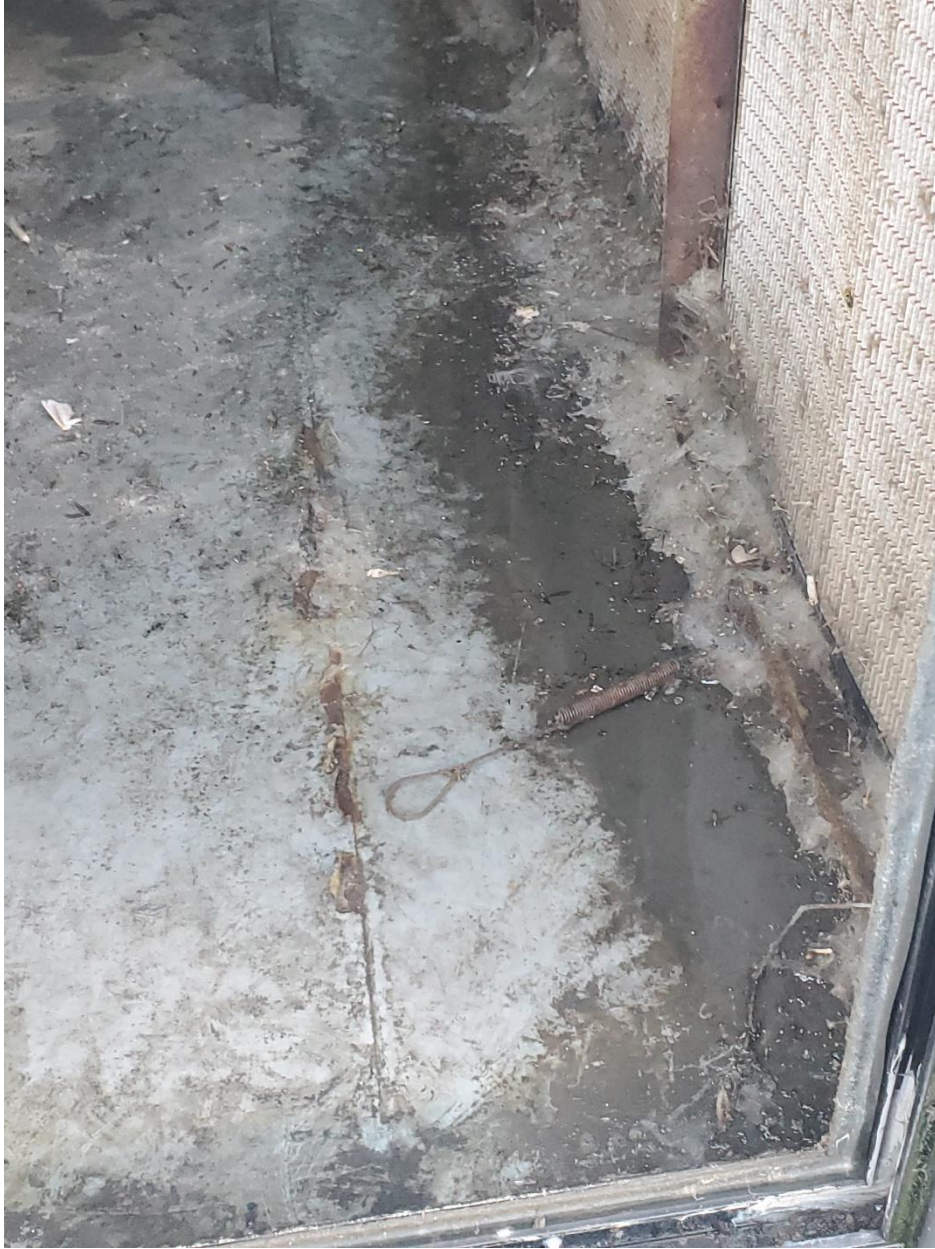
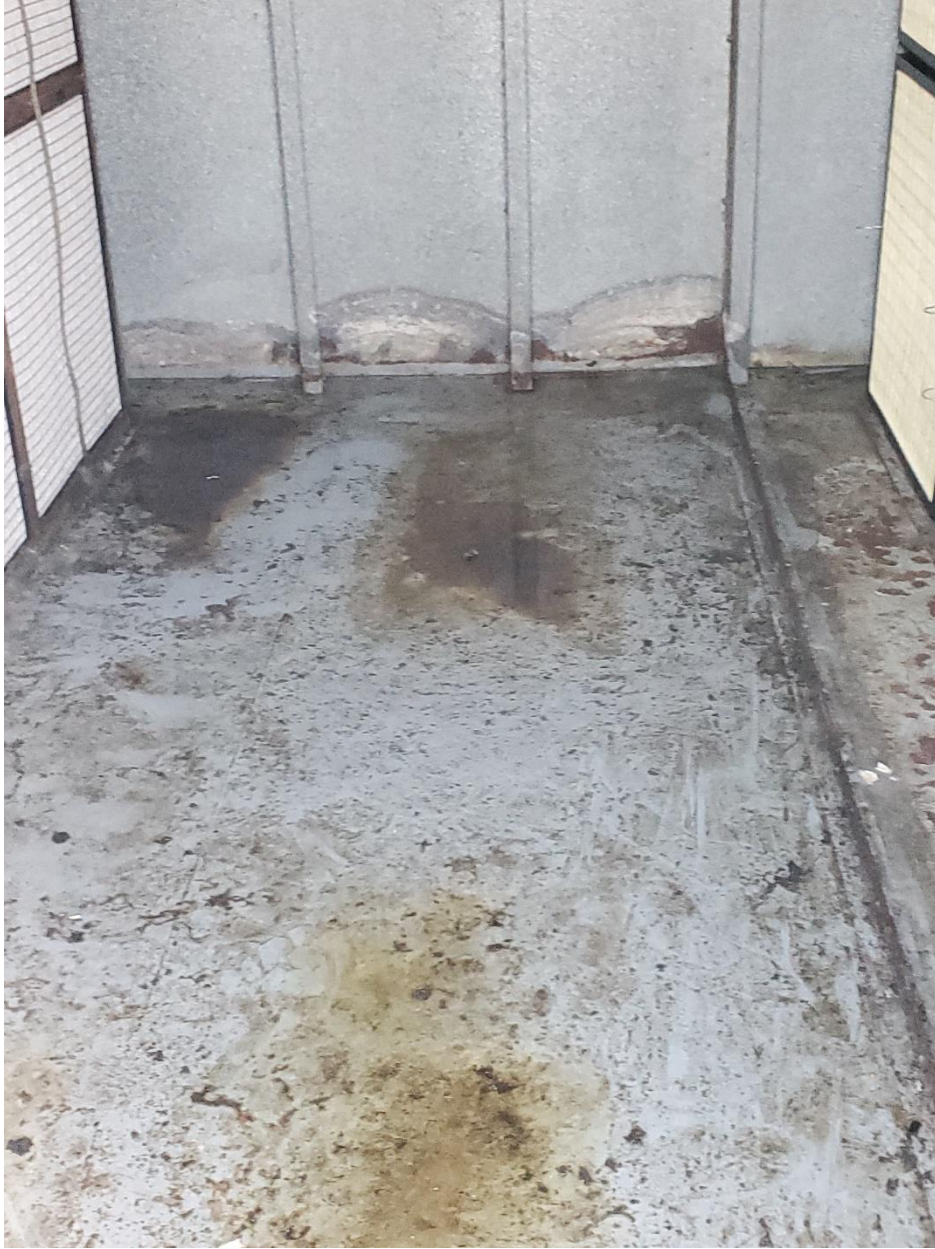
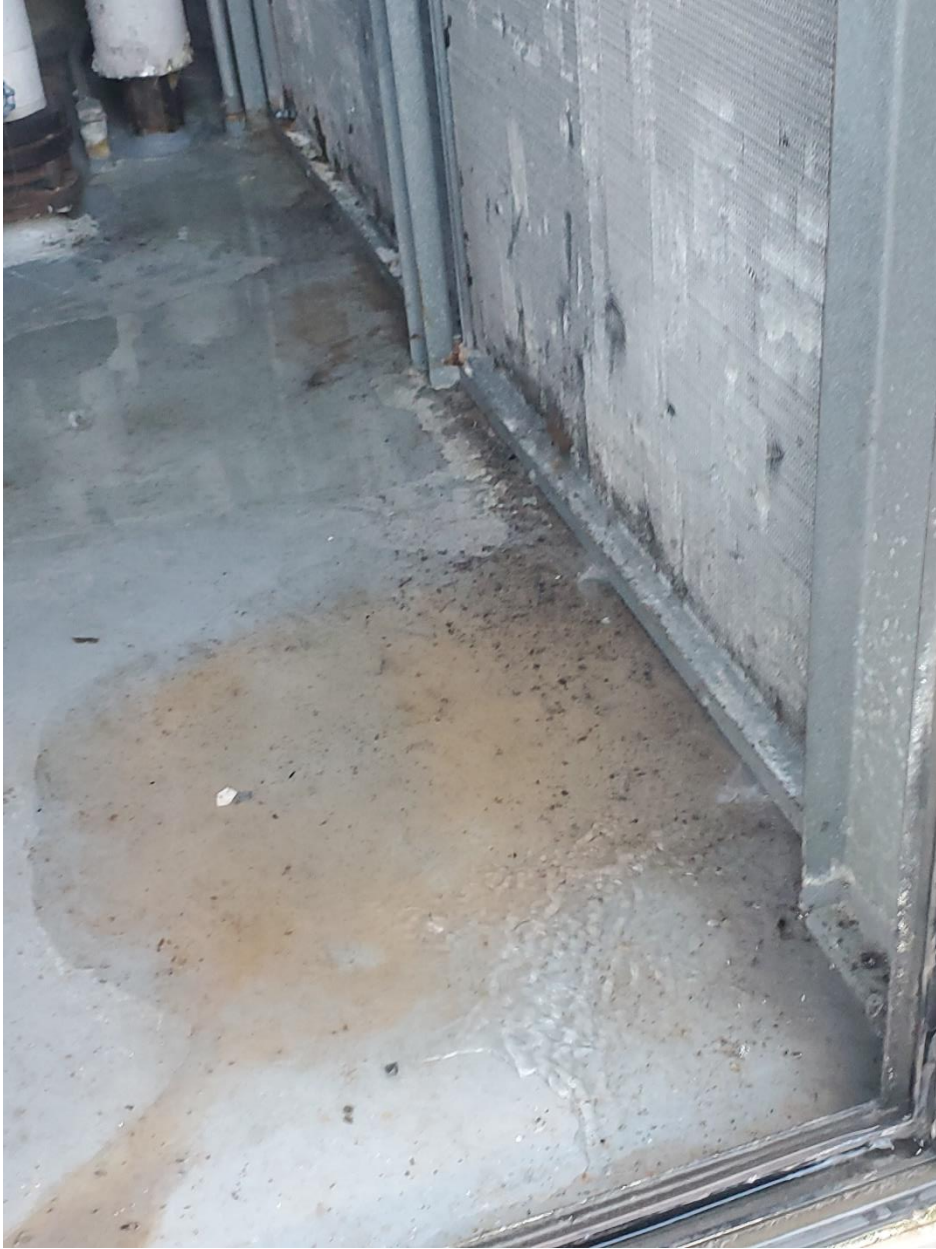
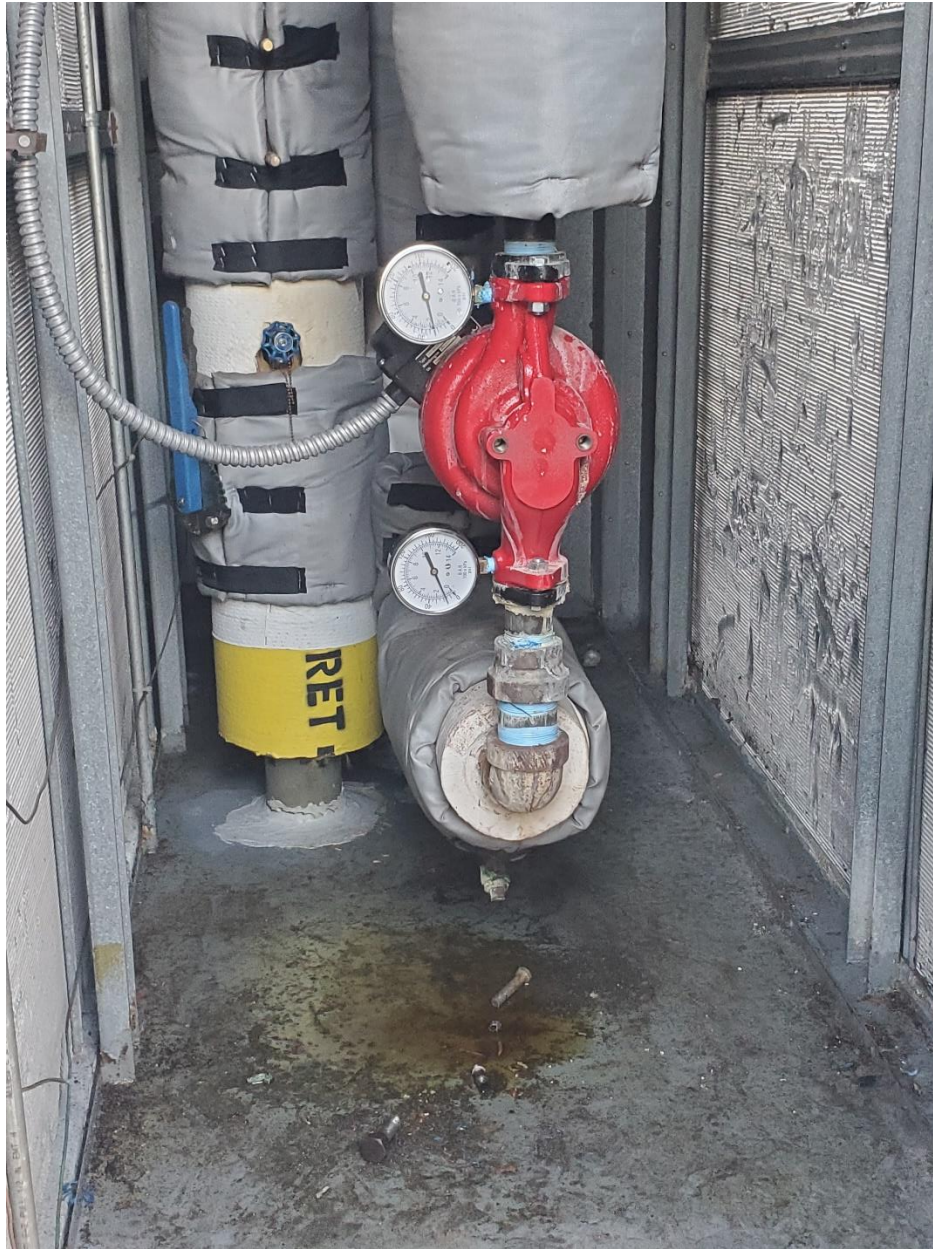
- Air handling units were installed in 1999 and have exceeded the expected service life of 25 years as suggested by ASHRAE Standards.
- Air handling unit AHU-1 has water inside many of the fan compartments. It is unclear where the water is entering the unit. Given the amount and location of the water, it is likely that the source is the outside air intake. It is more probable that the water is entering from casing leaks or through door seals. A significant amount of corrosion is occurring on the floors, casing, filter frames, and coil frames. Efforts have been made to coat the unit floor to prevent corrosion. This seems to have provided some benefit, but the water intrusion continues.

Photo 1: AHU-1 Outside Air Intake Plenum

Photo 2: AHU-1 Filter Plenum

Photo 3: AHU-1 Heat Recovery Coil Plenum

Photo 4: AHU-1 Heating Coil Plenum

- The run-around heat recovery system has been shut down due to loss of hydronic fluid from the piping system. No leaks were identified in the pipe, and OSU Facilities staff believe fluid loss is due to the temperature and pressure relief valve discharging resulting from pressure fluctuations.
- Laboratory spaces are reportedly too hot in most locations for a majority of the year. Unreliable operation of the chilled water system has significantly contributed to this issue. However, issues with the AHU-1 heat recovery systems, operation of laboratory air valves, and DDC controls affect space temperature control.
- During a recent period, there were high temperature complaints on the third floor due to failed zone reheat valves. When the system was false loaded by running hot water in the summer, some of the reheat coil valves did not shut, and rooms got too warm. This was

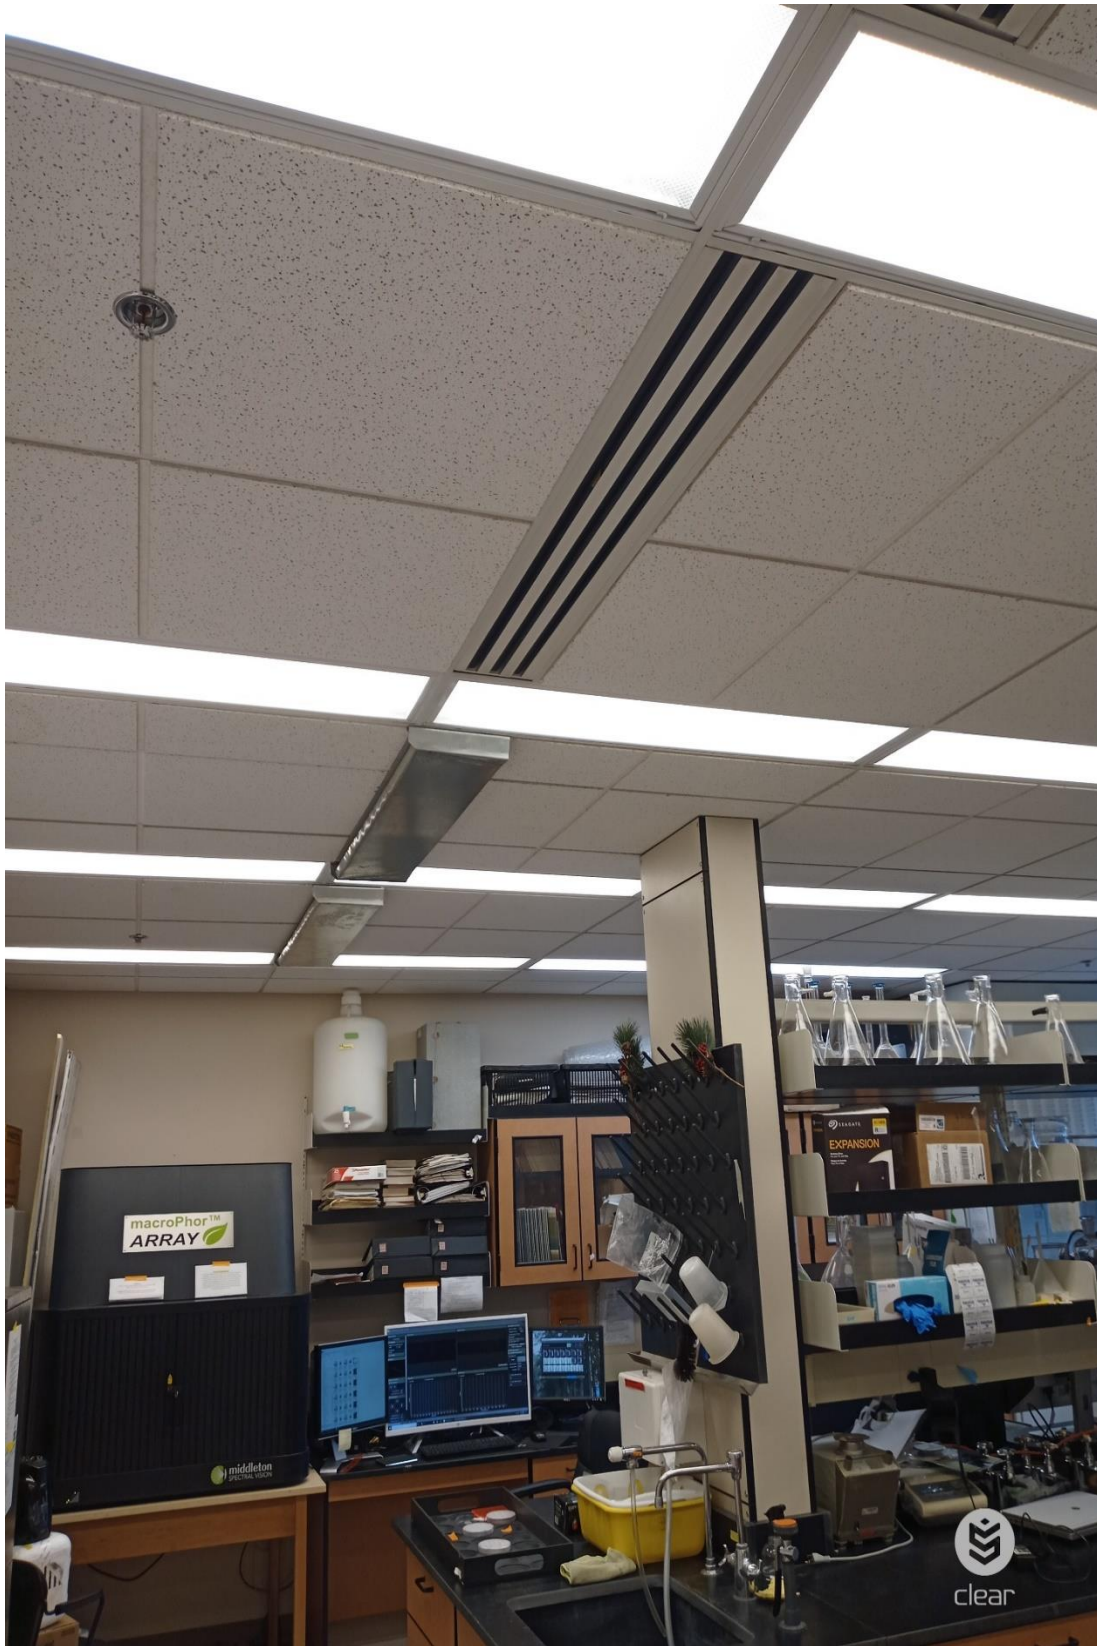
- Supply diffusers in laboratories are linear slot type. These diffusers discharge air at relatively high velocity and create undesirable air currents. Some diffusers have covers to redirect airflow. The slot diffusers may be short circuiting into the exhaust inlet in some locations.

Photo 5: Linear Slot Diffusers in Laboratories

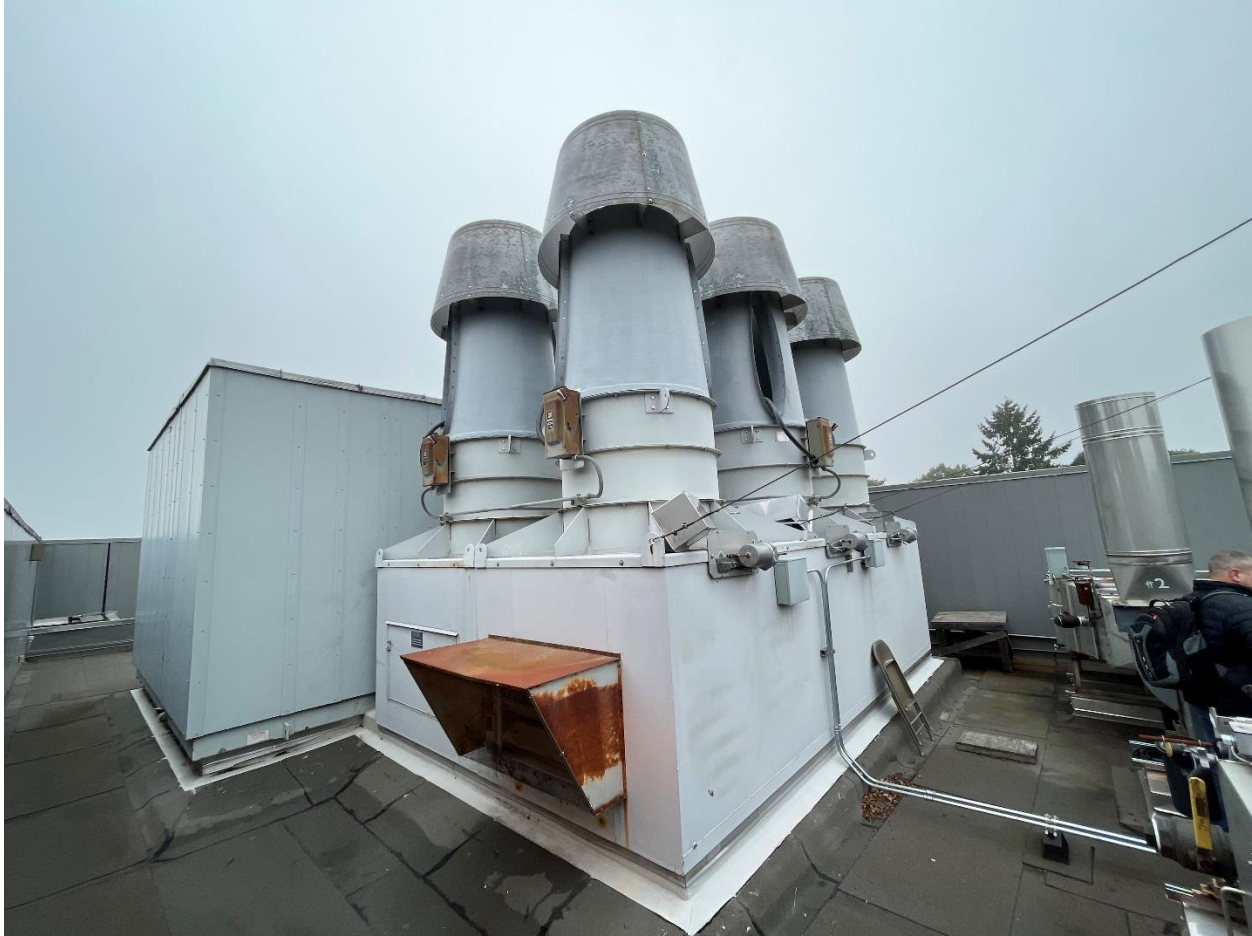
- Air handling units and most exhaust fans were installed in 1999 and have exceeded the expected service life of 25 years as suggested by ASHRAE Standards.
- Exhaust fan EF-1D is not operational. The unit currently has no standby capacity if another exhaust fan fails.
- EF-1 exhaust fan isolation dampers are reportedly in poor condition and are unreliable. Some do not function.
- EF-1 unit housing and equipment components are showing signs of rust and corrosion.

Photo 6: Exhaust Fan EF-1

- The EF-1 heat recovery coils do not appear to have air filters upstream to protect the coil from fouling. No filters are shown on the as-built plans upstream of the heat recovery coil in the exhaust plenum. No filter access doors were observed on the unit casing.

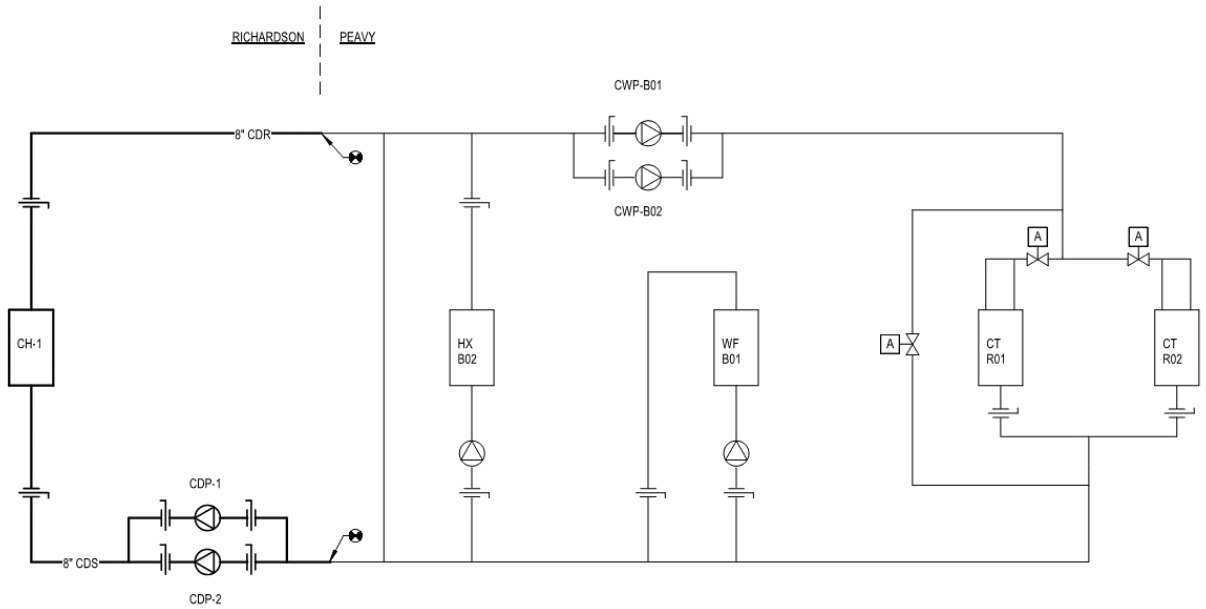
Figure 4: Richardson/Peavy Hall Condenser Water System

The condenser water piping system will be replaced within the Richardson Hall chiller room for the new chiller layout. The condenser water piping connecting to the Peavy Hall condenser water system will remain. See Figure 4 below.

The existing condenser water pump is past its expected service life and should be replaced with two base-mounted condenser water pumps. Each pump will be sized for 100% of the condenser water flow for redundancy.

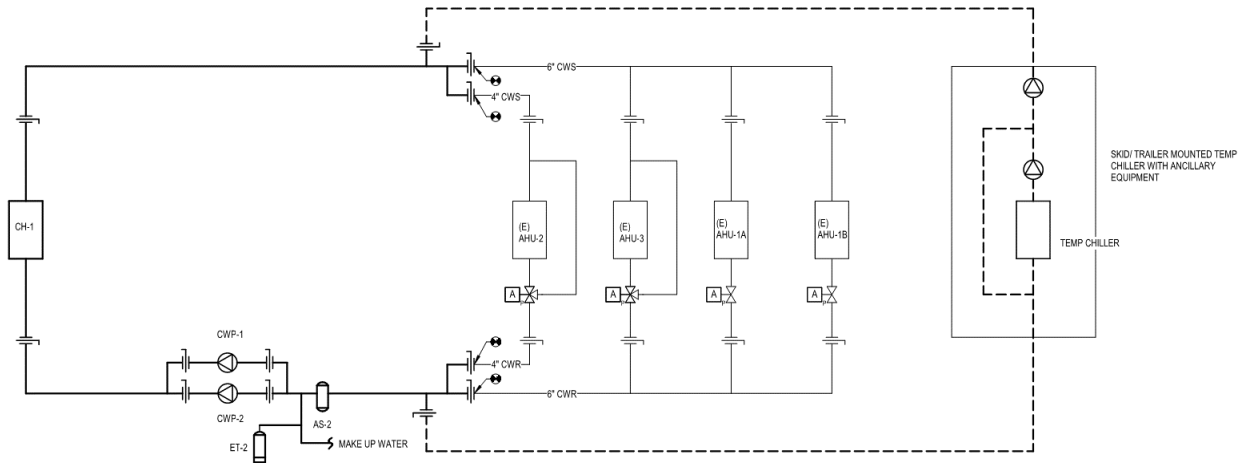
Figure 3 Richardson Hall Chilled Water Diagram

New 6-inch diameter chilled water supply and return piping will be provided for connecting to a temporary air-cooled chiller.

- Chilled water piping will be Schedule 40 ASTM A53 steel with mechanical couplings.

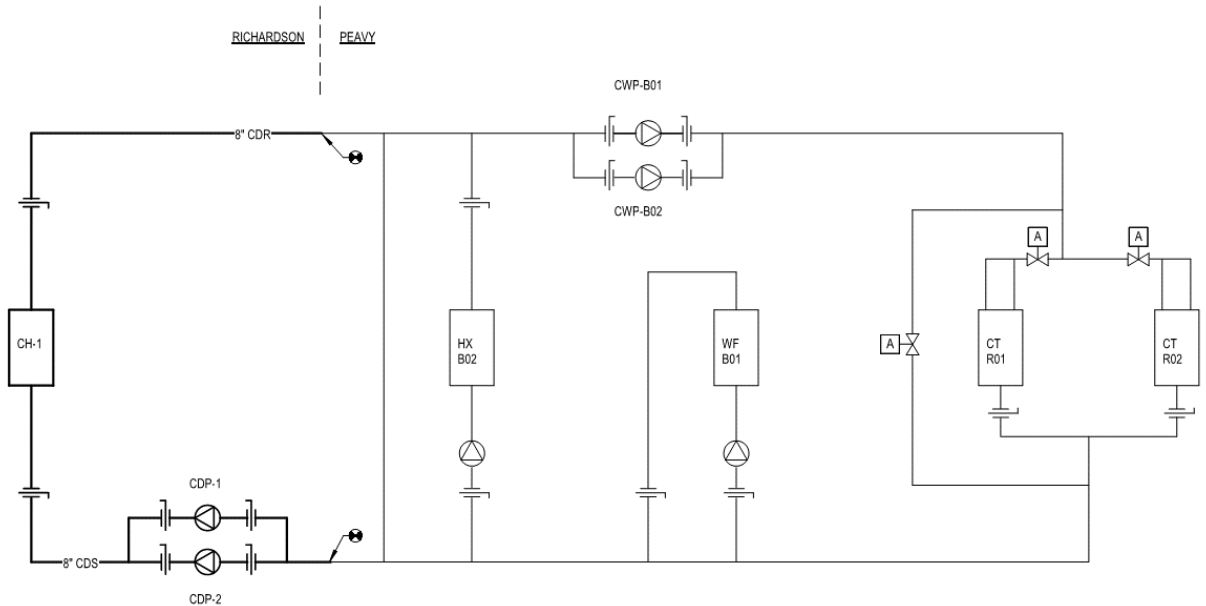
Figure 4 Richardson/Peavy Hall Condenser Water System

The 8-inch diameter condenser water supply and return piping will be replaced throughout the Richardson Hall chiller room. New 8-inch condenser water supply and return piping will connect to the existing piping at the north wall of the chiller room.

- Piping will be Schedule 40 ASTM A53 steel with mechanical joints.
