# ASBESTOS BUILDING INSPECTION

**GRADUATE SCHOOL OF EDUCATION  
615 SW HARRISON STREET  
PORTLAND, OREGON 97201**

JULY 11, 2008

FORENSIC ANALYTICAL PROJECT NO. PJ5552

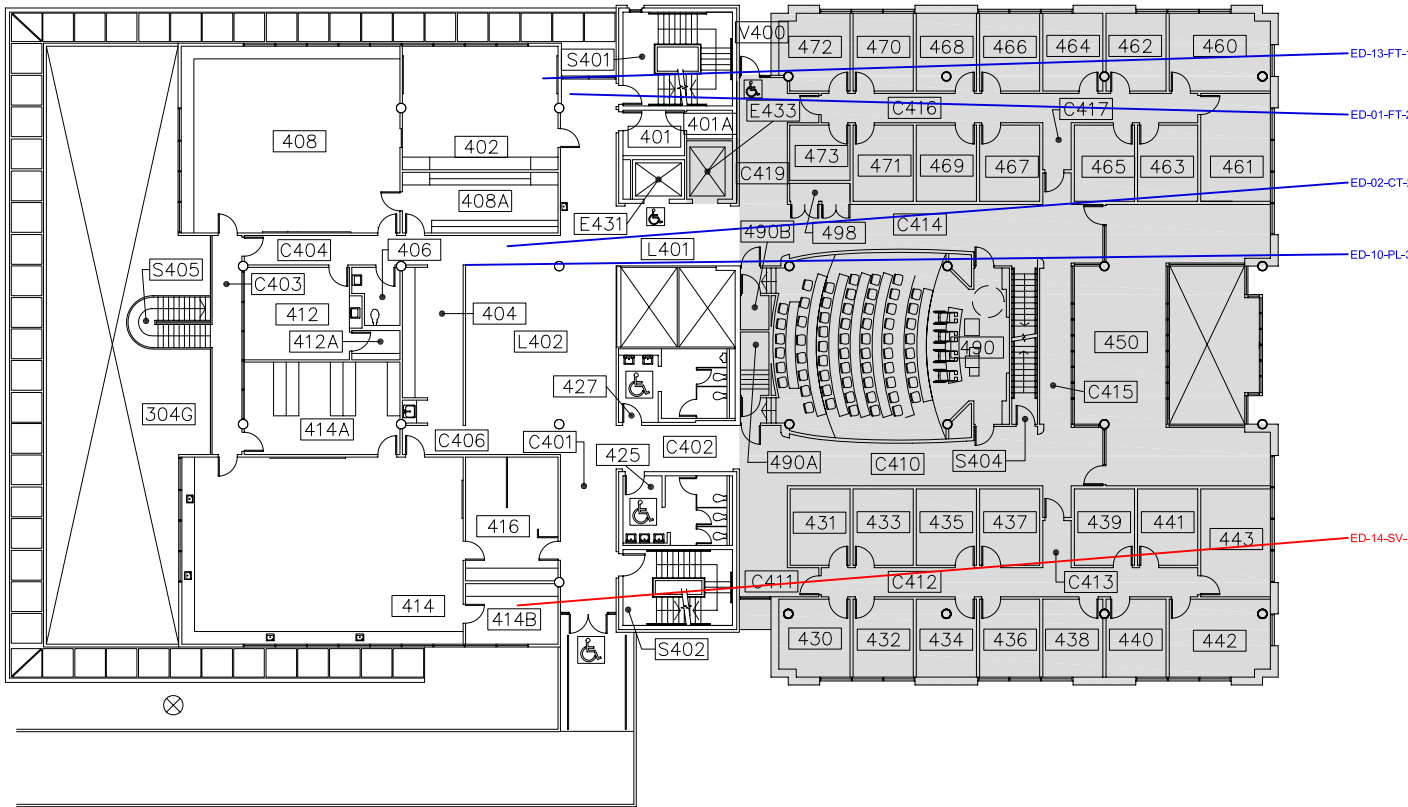
Graduate School of Education  
4th Floor  
Sample Locations

\* - This sample is part of a set in which one of the samples tested positive for asbestos.  
 \*\* - This sample contained a trace amount of asbestos.

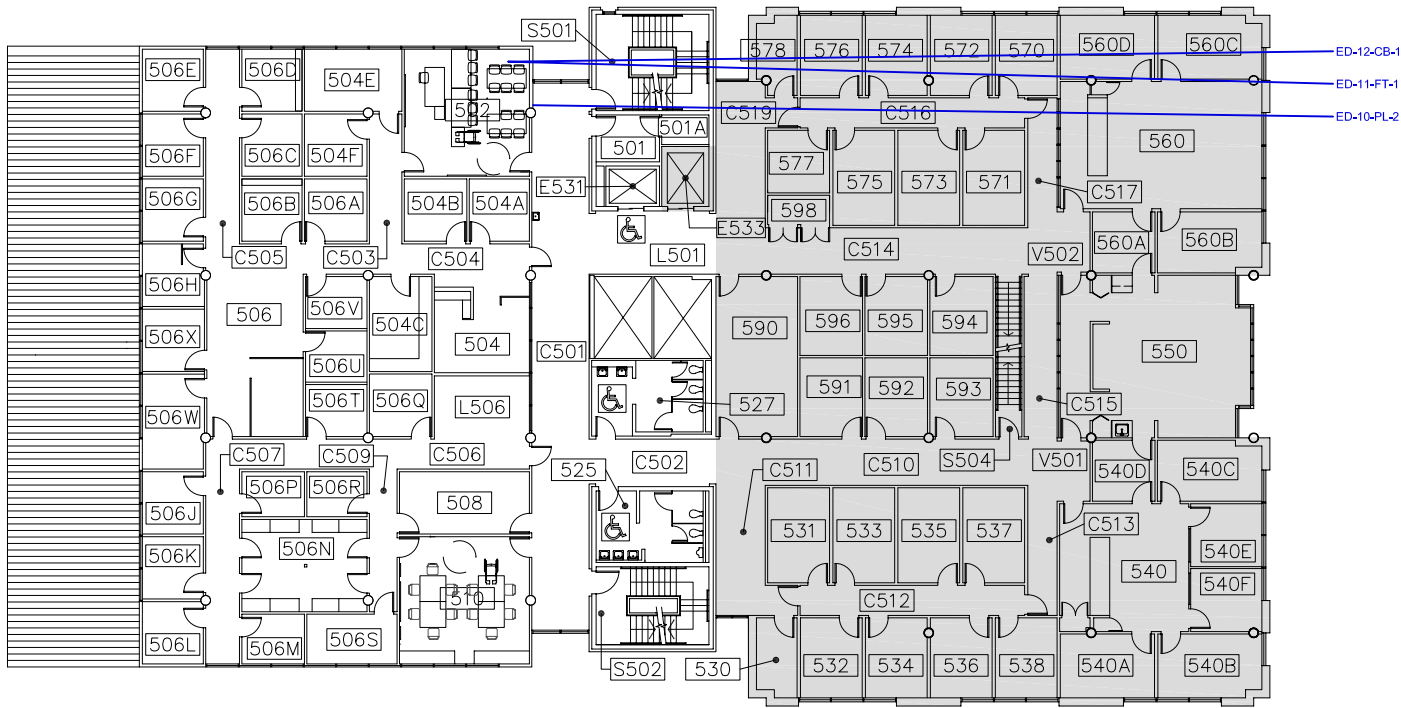
# 5th Floor

\* - This sample is part of a set in which one of the samples tested positive for asbestos.  
\*\* - This sample contained a trace amount of asbestos.
