ASBESTOS BUILDING INSPECTION

**LIBRARY EAST
1825 SW BROADWAY
PORTLAND, OREGON 97201**

JUNE 23, 2008

FORENSIC ANALYTICAL PROJECT NO. PJ5592

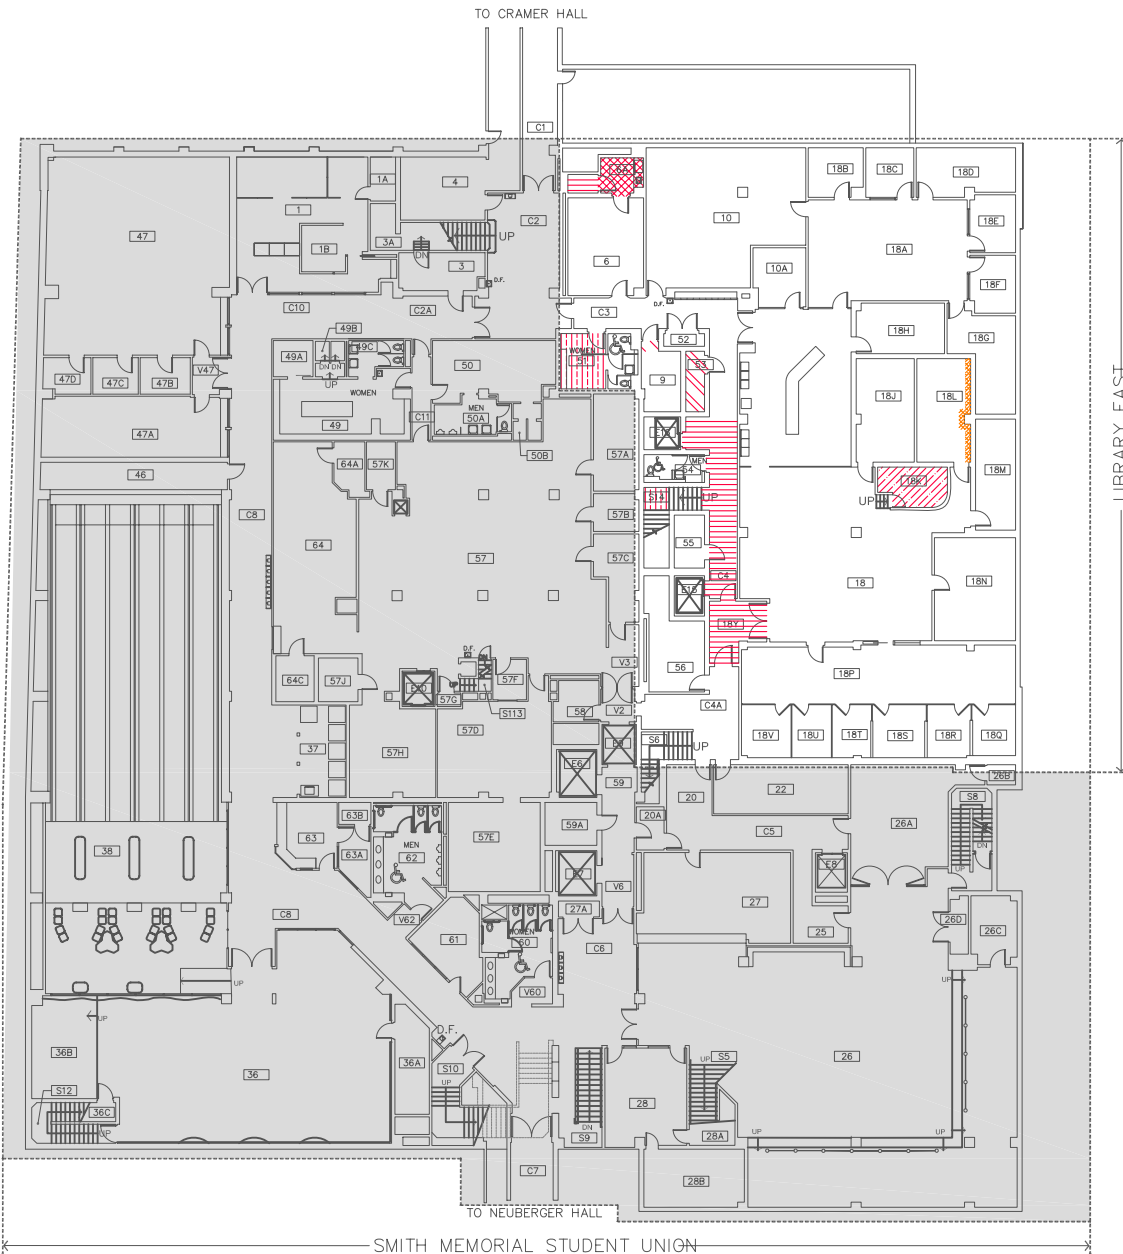
- Floor Tile, 12" x 12" Beige w/ Green Specks
 - Floor Tile, 9" x 9" Tan w/ White Streaks and Black Mastic
 - Floor Tile, 9" x 9" Orange w/ White Streaks and Black Mastic
 - Floor Tile, 9" x 9" Grey w/ White Streaks and Black Mastic
 - Floor Tile, 9" x 9" Black w/ Large White Streaks and Black Mastic
 - Floor Tile, 9" x 9" Green Streaked and Black Mastic
 - Floor Tile, 9" x 9" Dusty Rose and Black Mastic
 - Ceiling Tile, 2' x 4' Fissured w/ Pinholes - Drop
 - Cement Asbestos Board
- ACM not shown:
 Drywall and Joint Compound
 Rigid Pipe Insulation
 Pipe Fitting Insulation
 Duct Seam Tape

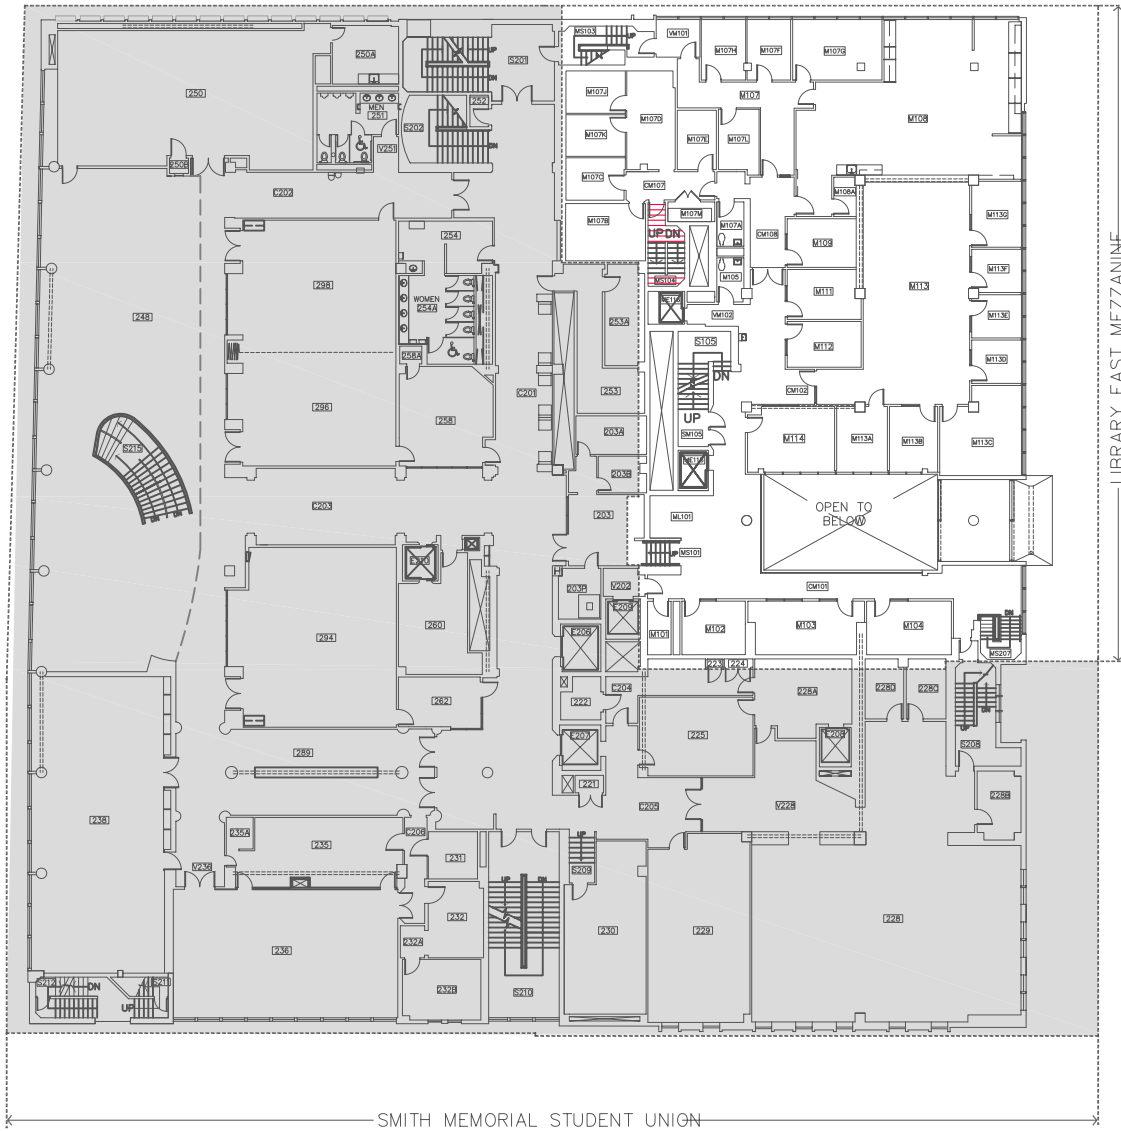
- Floor Tile, 12" x 12" Beige w/ Green Specks
- Floor Tile, 9" x 9" Tan w/ White Streaks and Black Mastic
- Floor Tile, 9" x 9" Orange w/ White Streaks and Black Mastic
- Floor Tile, 9" x 9" Grey w/ White Streaks and Black Mastic
- Floor Tile, 9" x 9" Black w/ Large White Streaks and Black Mastic
- Floor Tile, 9" x 9" Green Streaked and Black Mastic
- Floor Tile, 9" x 9" Dusty Rose and Black Mastic
- Ceiling Tile, 2' x 4' Fissured w/ Pinholes - Drop
- Cement Asbestos Board

ACM not shown:
 Drywall and Joint Compound
 Rigid Pipe Insulation
 Pipe Fitting Insulation
 Duct Seam Tape

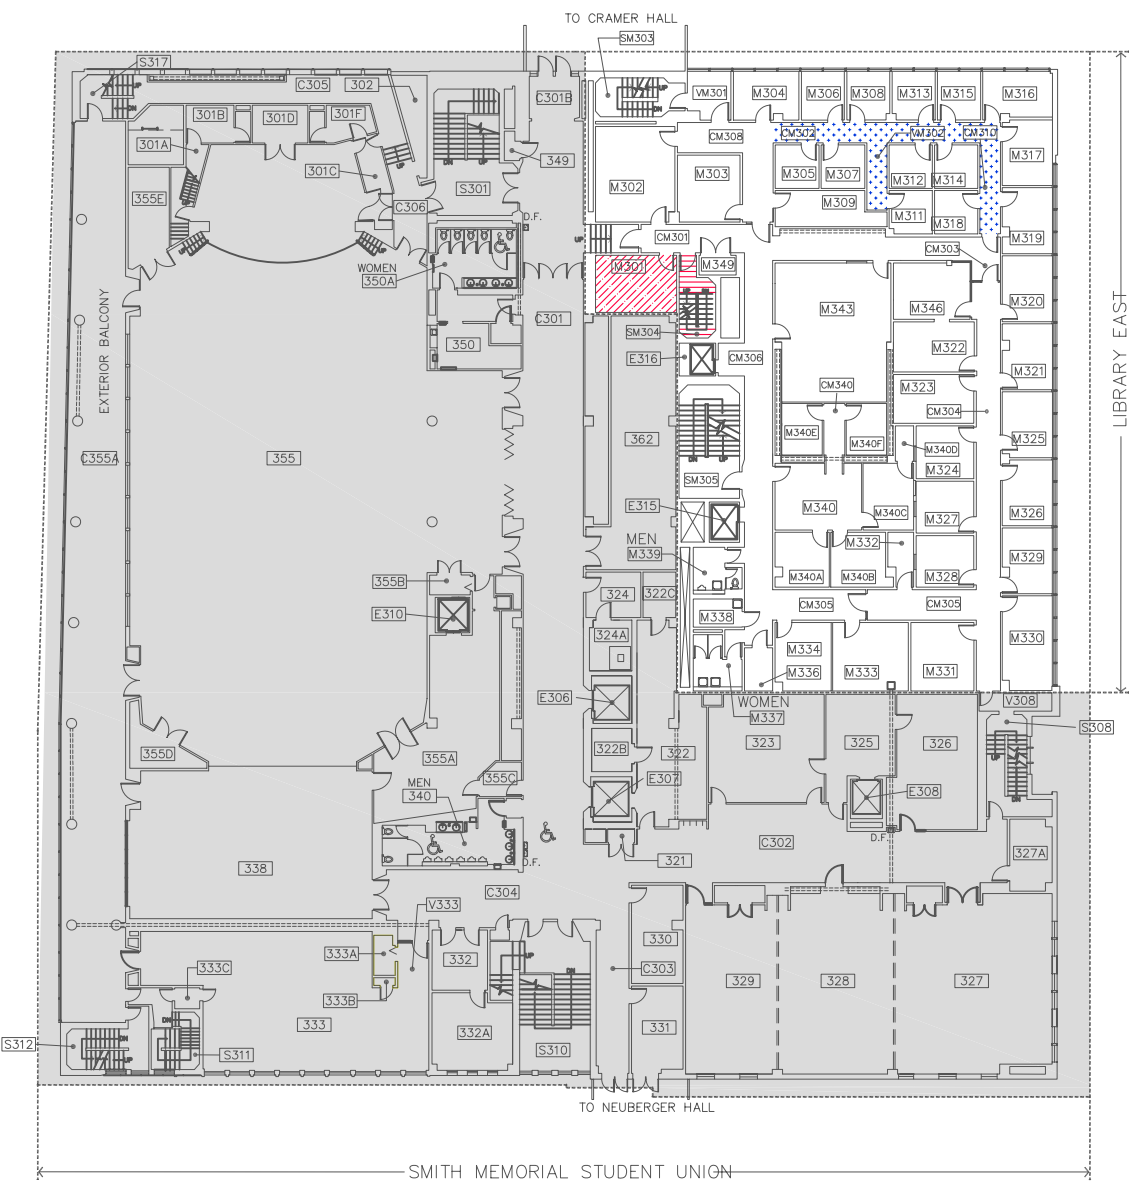
Ceiling Tile, 2' x 4' Fissured w/ Pinholes - Drop
 -

Cement Asbestos Board
- ACM not shown:
Drywall and Joint Compound
Rigid Pipe Insulation
Pipe Fitting Insulation
Duct Seam Tape

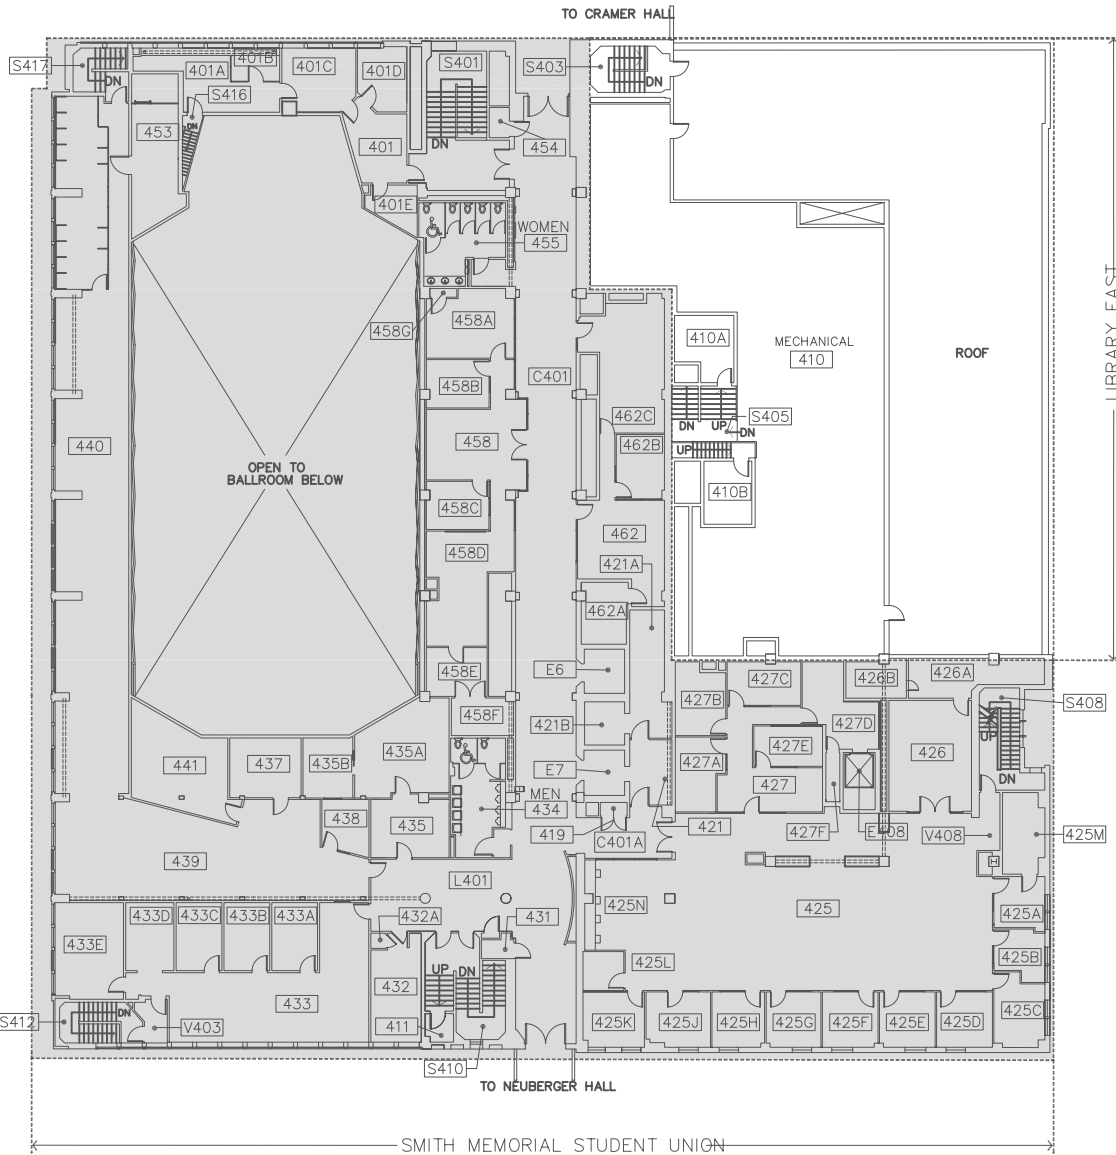
- Floor Tile, 12" x 12" Beige w/ Green Specks
 - Floor Tile, 9" x 9" Tan w/ White Streaks and Black Mastic
 - Floor Tile, 9" x 9" Orange w/ White Streaks and Black Mastic
 - Floor Tile, 9" x 9" Grey w/ White Streaks and Black Mastic
 - Floor Tile, 9" x 9" Black w/ Large White Streaks and Black Mastic
 - Floor Tile, 9" x 9" Green Streaked and Black Mastic
 - Floor Tile, 9" x 9" Dusty Rose and Black Mastic
 - Ceiling Tile, 2" x 4" Fissured w/ Pinholes - Drop
 - Cement Asbestos Board
- ACM not shown:
 Drywall and Joint Compound
 Rigid Pipe Insulation
 Pipe Fitting Insulation
 Duct Seam Tape
