*Pilot Study Report  
Deschutes County Construction  
Demolition Landfill  
Bend, Oregon*

Prepared for:  
Deschutes County

September 16, 2016  
2112-03

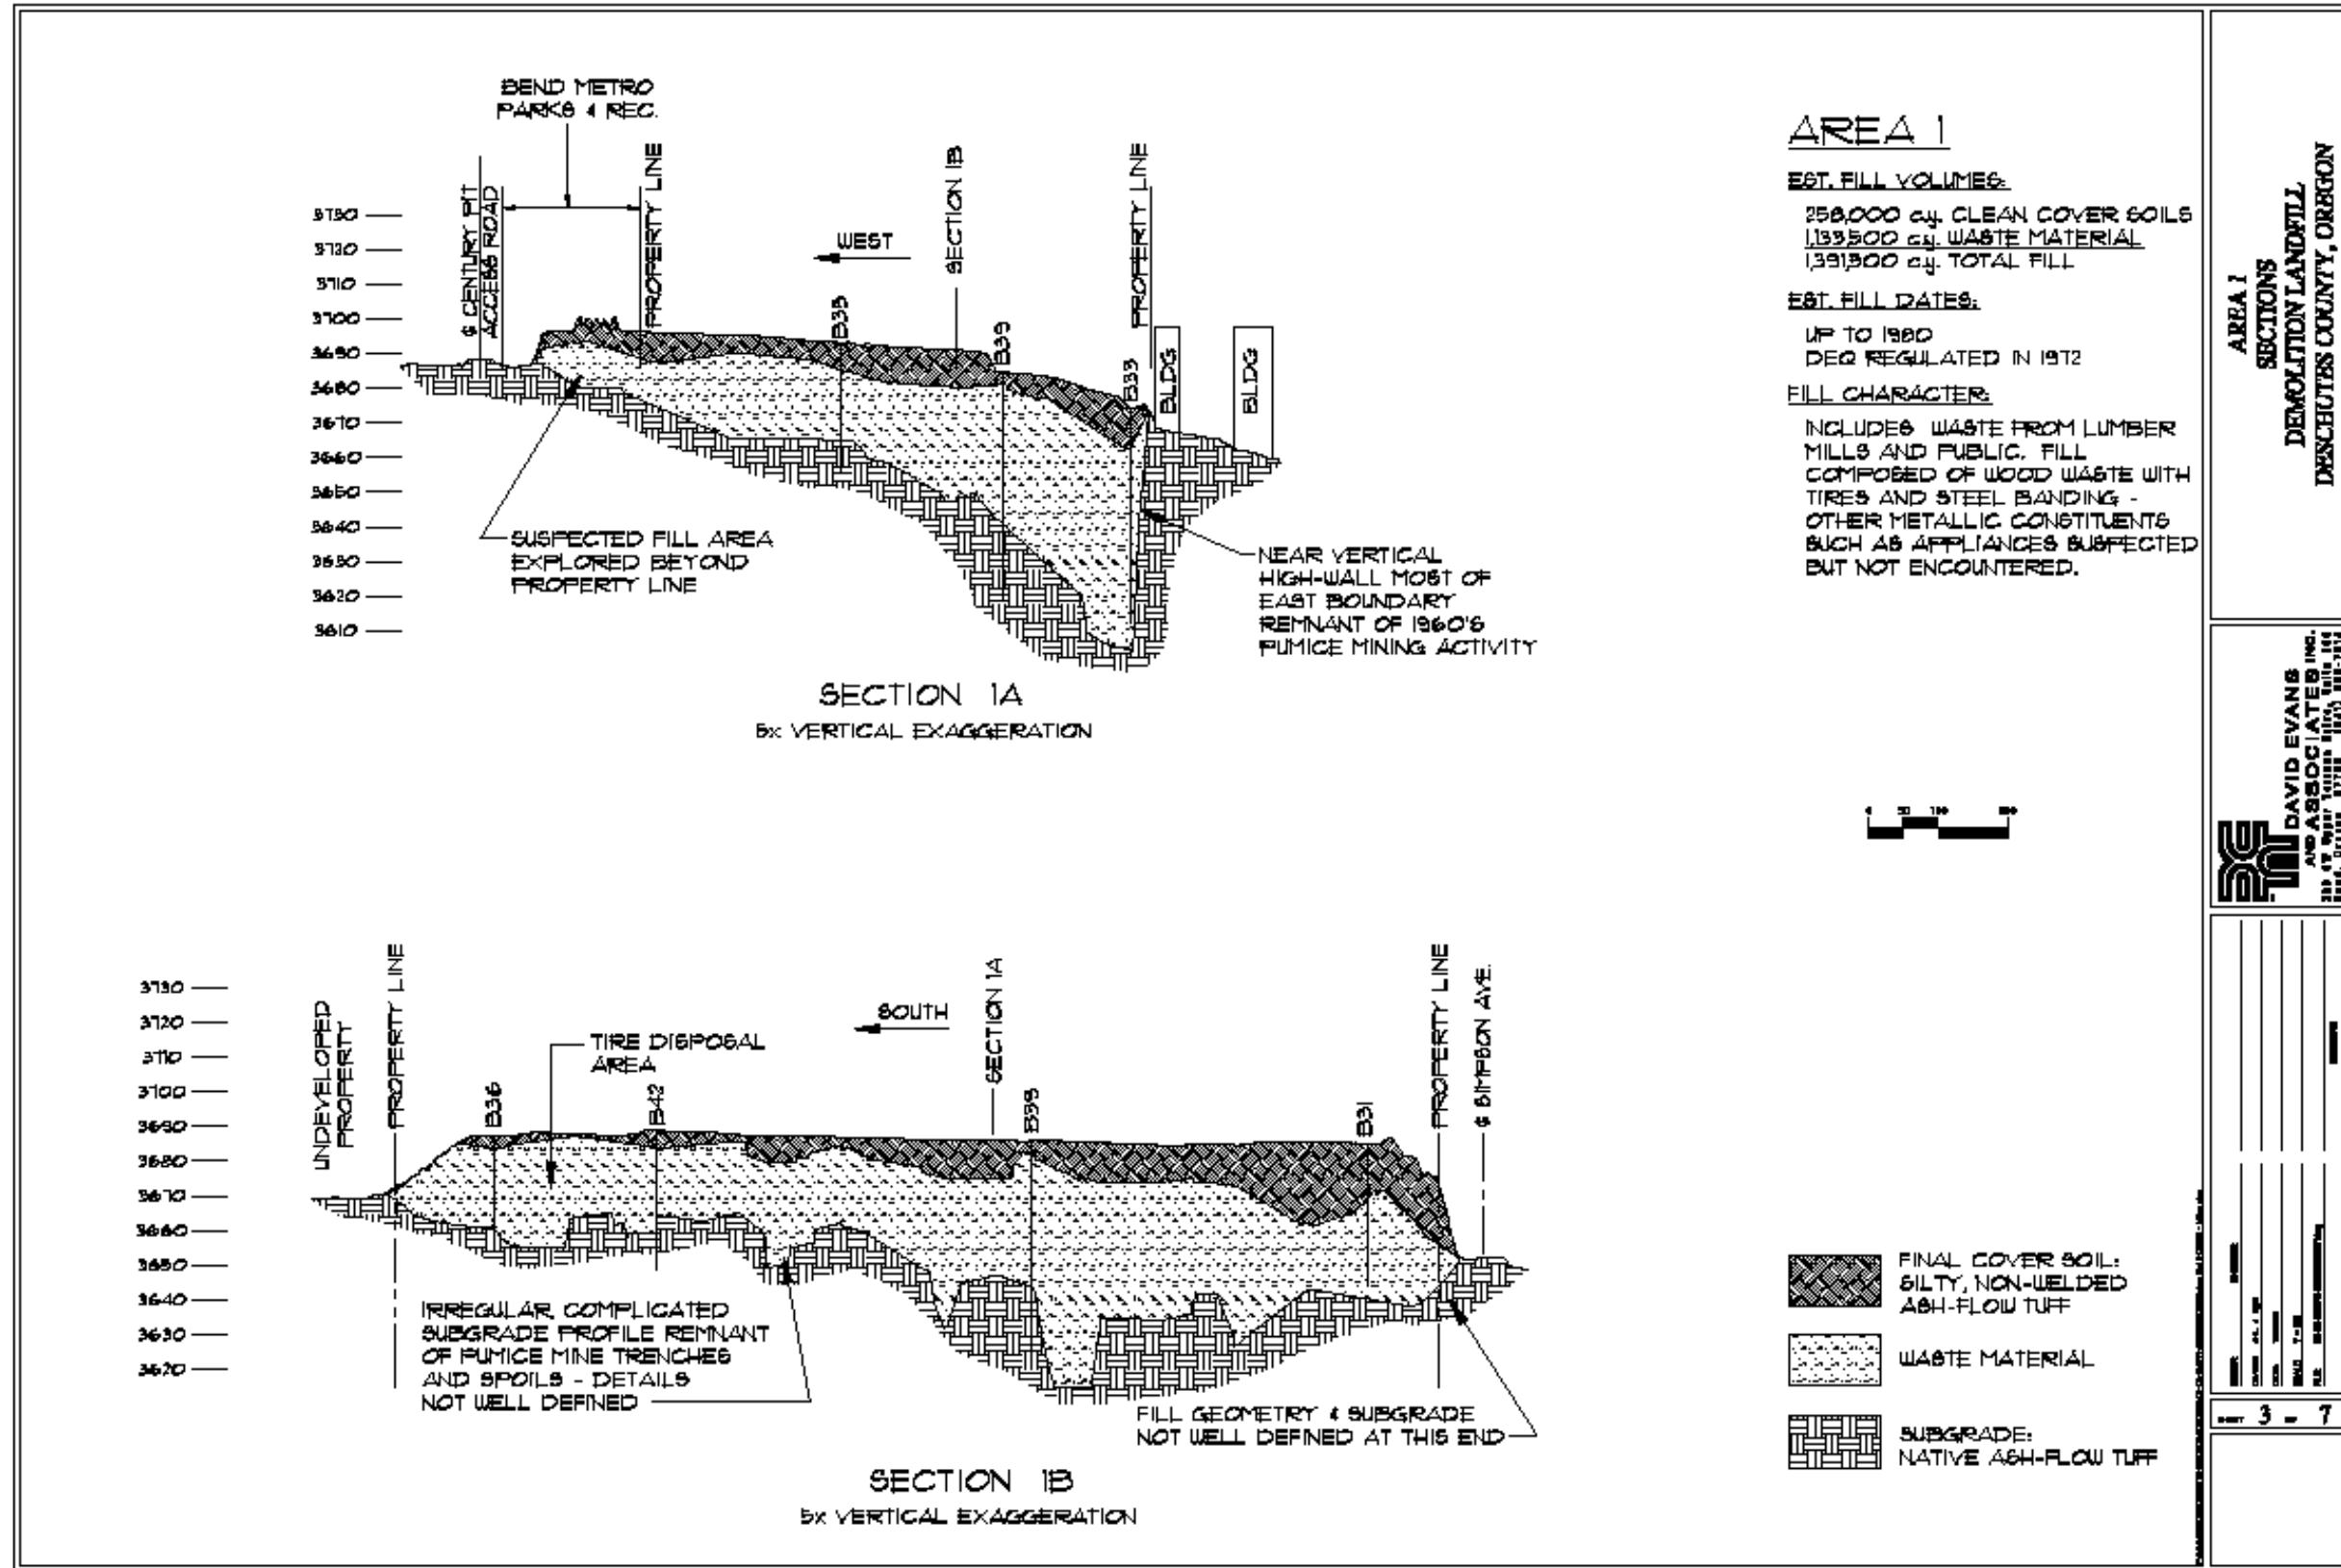
Figure 6-1 - Estimate of Area 1 Fill Volumes with Sectional Cuts

**Area 1 – Estimated and Observed Waste Distribution**

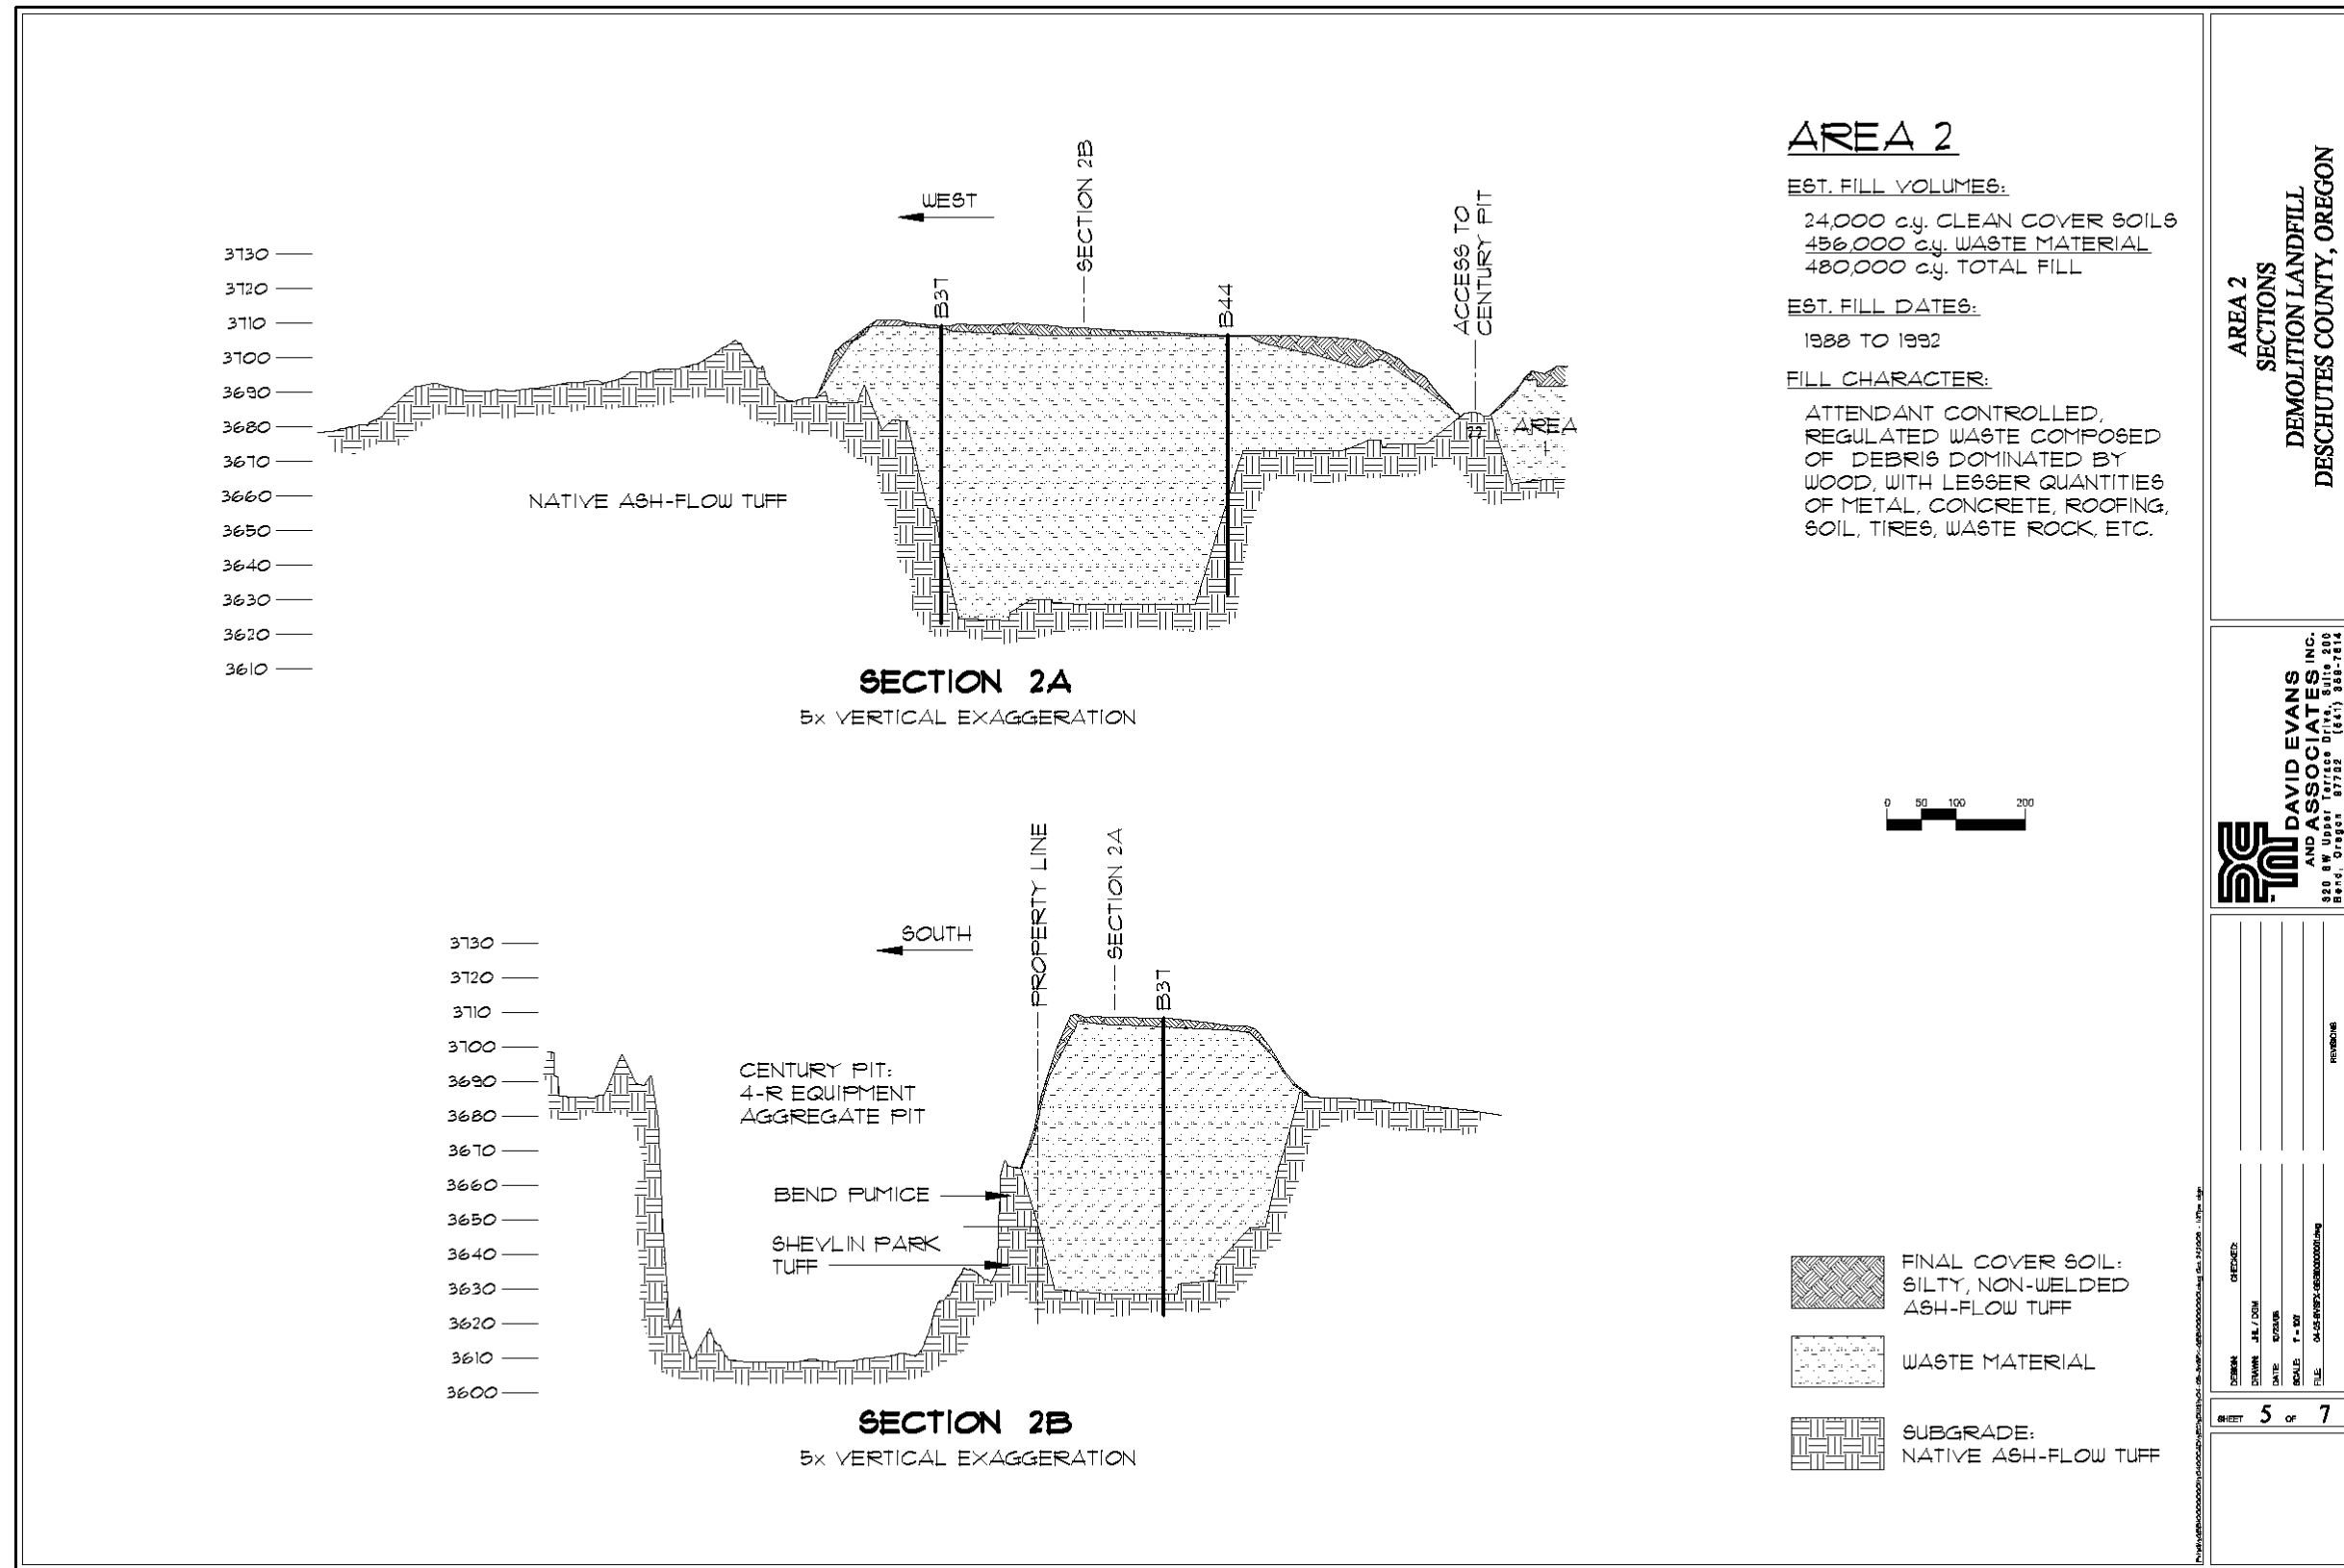
Figure 6-2 - Estimate of Area 2 Fill Volumes with Sectional Cuts

**Area 2 – Estimated and Observed Waste Distribution**
