# ASBESTOS BUILDING INSPECTION

**WEIGAND HALL  
3051 SW CAMPUS WAY  
CORVALLIS, OR 97331**

NOVEMBER 28, 2008

FORENSIC ANALYTICAL PROJECT NO. PJ6286

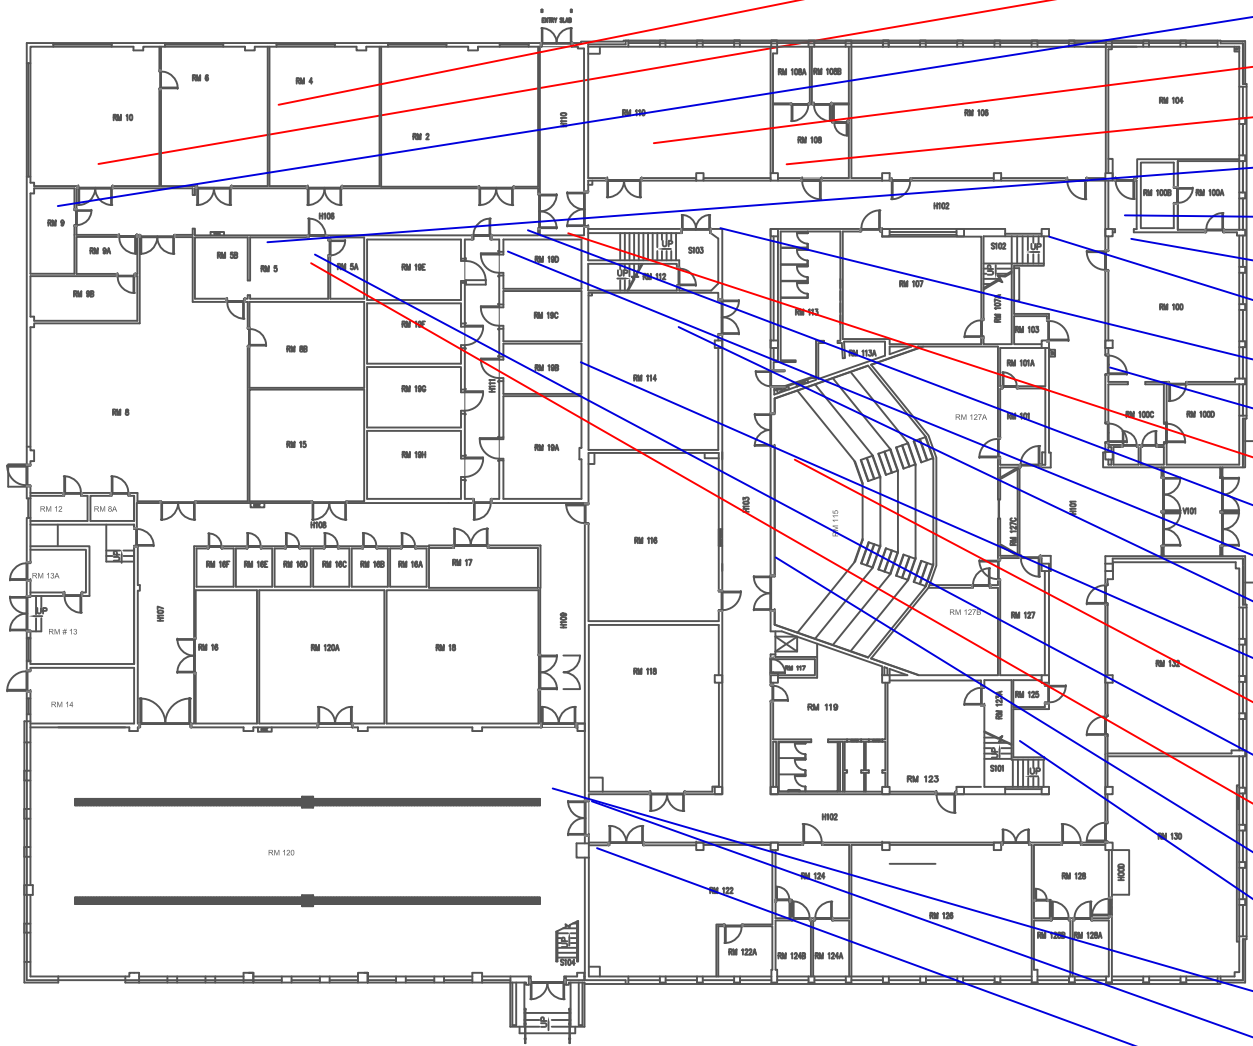
# 1st Floor

- Wgnd-19-SU-1
- Wgnd-14-SU-1
- Wgnd-15-CT-1
- Wgnd-08-SU-1
- Wgnd-07-FT-1
- Wgnd-13-CT-1
- Wgnd-04-CT-1
- Wgnd-05-CT-1
- Wgnd-01-CB-1
- Wgnd-03-PL-1
- Wgnd-02-CM-1
- Wgnd-06-FT-1
- Wgnd-09-FT-1
- Wgnd-18-BF-1
- Wgnd-12-CT-1
- Wgnd-16-MAS-1
- Wgnd-11-FT-1
- Wgnd-03-PL-2
- Wgnd-10-FT-1
- Wgnd-03-PL-3
- Wgnd-28-FT-1
- Wgnd-17-FM-1
- Wgnd-03-PL-7
- Wgnd-29-FM-1
