UNIVERSITY OF OREGON

HENDRICKS HALL EXTERIOR RESTORATION PROJECT 2013

EUGENE, OREGON

SODERSTROM ARCHITECTS
 1200 NW Naito Parkway, Suite 410, Portland, Oregon 97209
 503.228.5617
 www.sdra.com

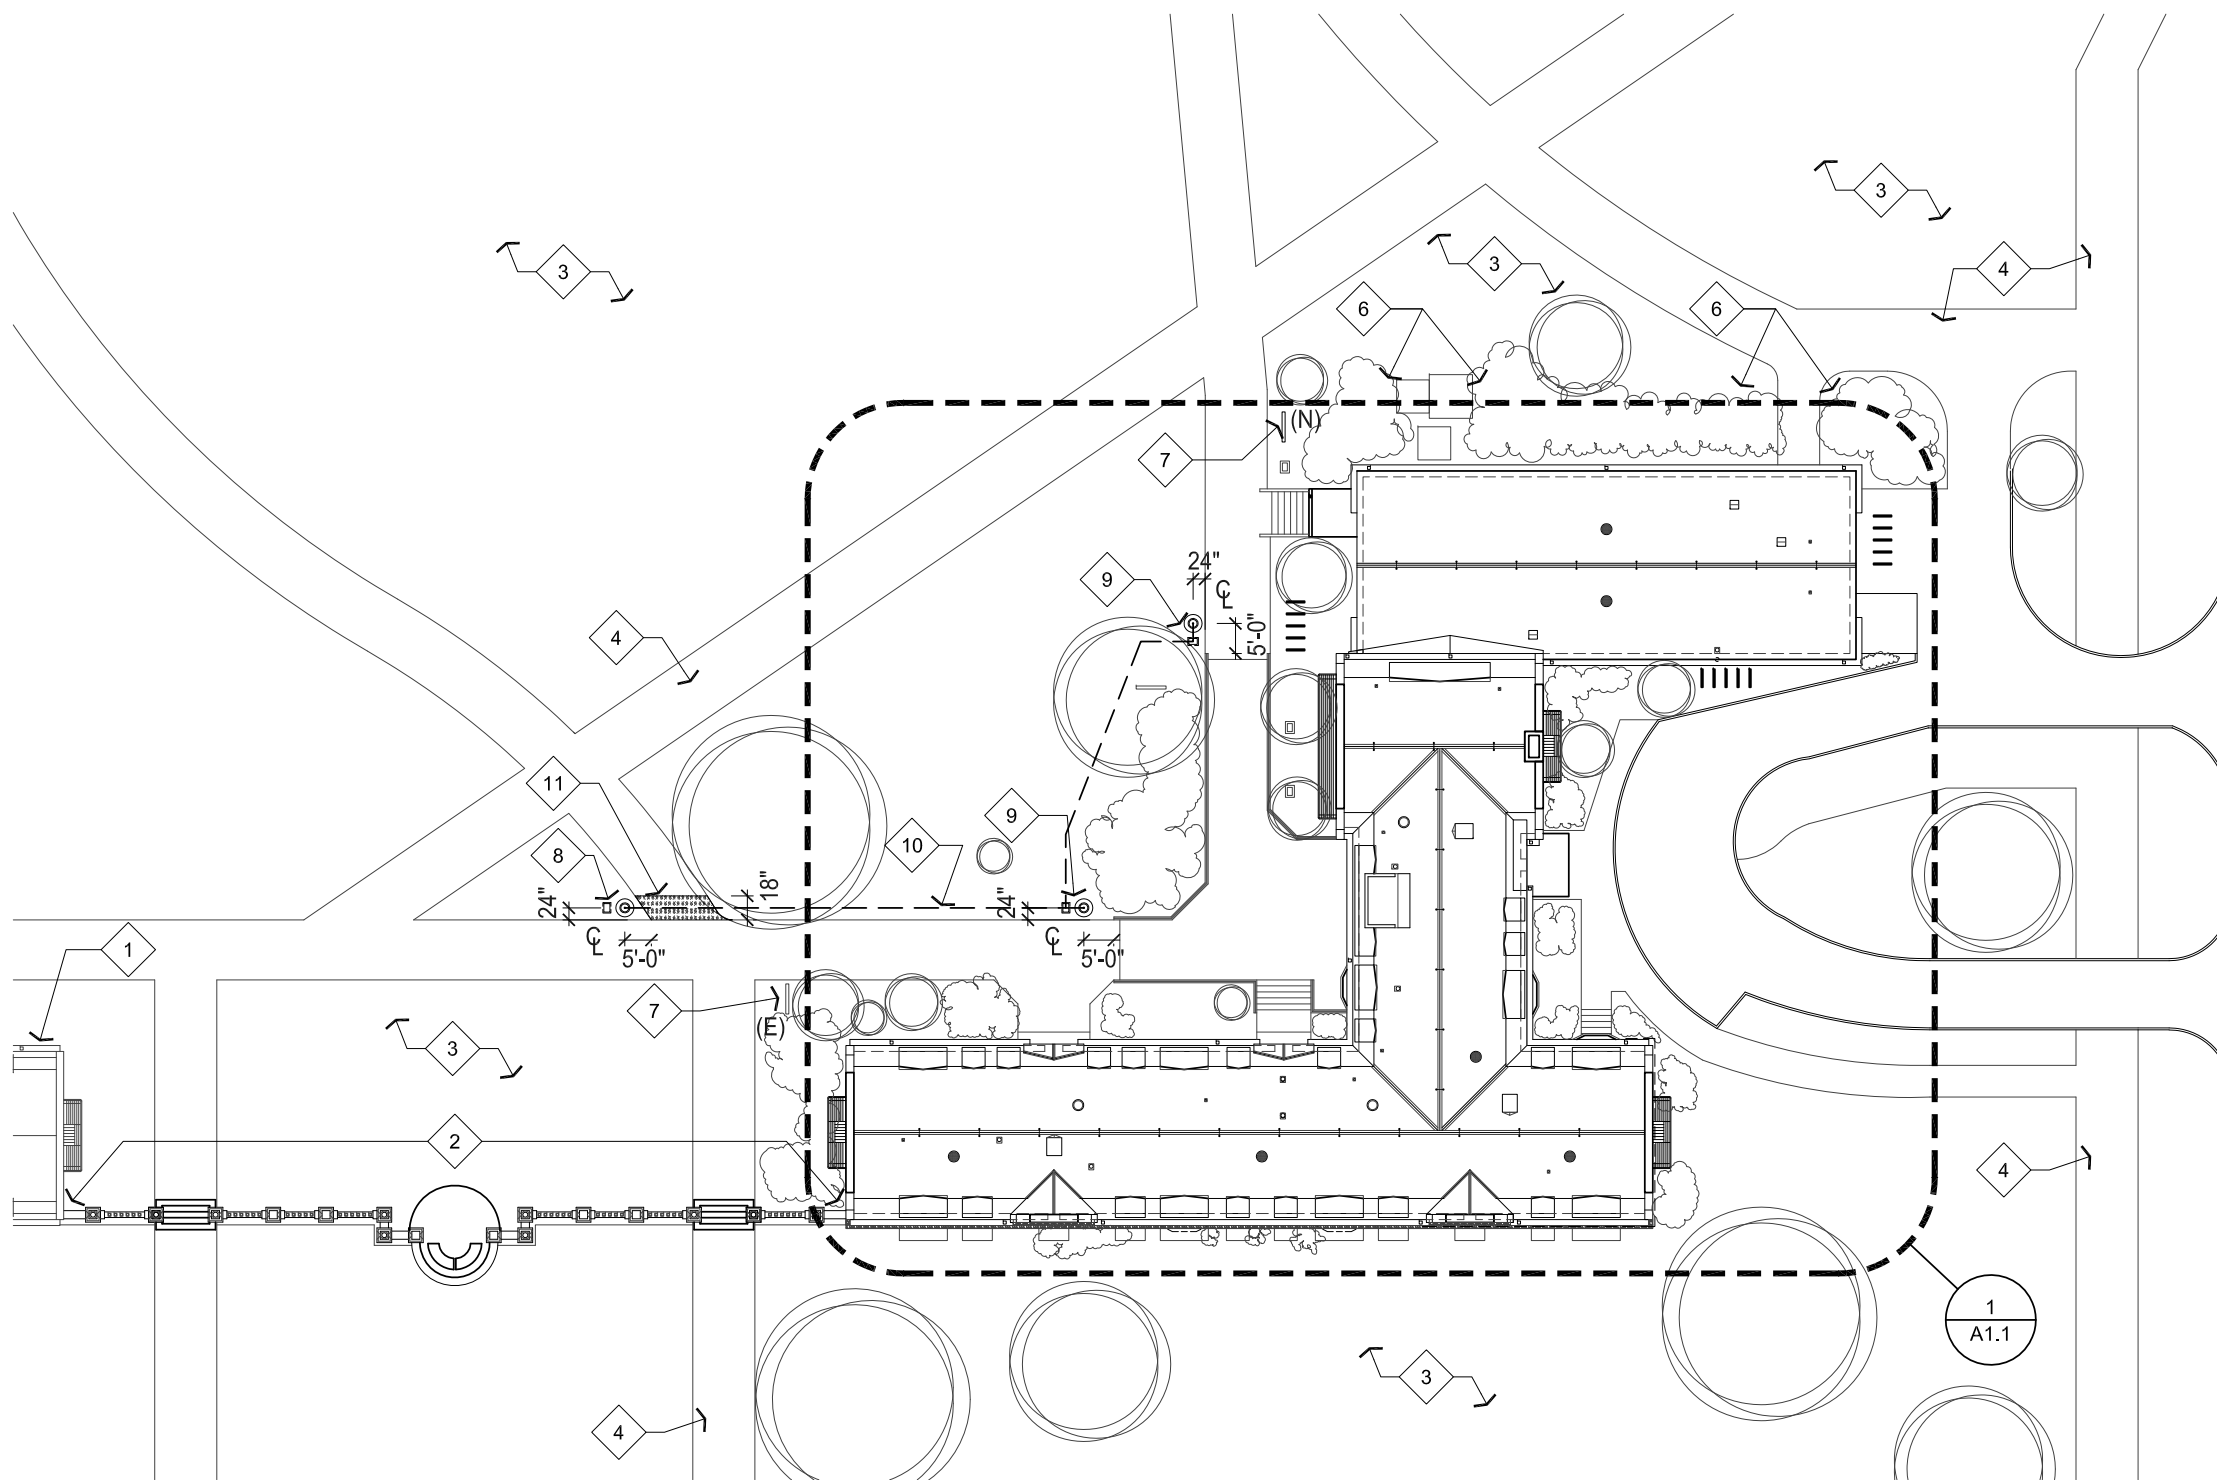
1 OVERALL SITE PLAN
 1/32" = 1'-0"

- 1 SUSAN CAMPBELL HALL
- 2 ADD ALTERNATE #1 - GARDEN WALL - REFER TO SHEET A2 FOR PLAN
- 3 LANDSCAPING, N.I.C.
- 4 SIDEWALK, N.I.C.
- 5 DRIVEWAY, N.I.C.
- 6 ENHANCED LANDSCAPE BUFFER AT TRASH DUMPSTER AND AIR UNITS BY OWNER, N.I.C., COORDINATE WITH OWNER

- 7 EXISTING WOOD HENDRICKS SIGN, N.I.C.; TO BE RELOCATED BY OWNER'S EXTERIORS TEAM FROM WEST OF BUILDING TO NW CORNER OF NORTH BUILDING
- 8 EXISTING LAMP POST AND J-BOX TO BE REMOVED AND REPLACED WITH NEW. SEE ADD ALTERNATE #3.

- 9 NEW LAMP POST AND J-BOX; SEE ADD ALTERNATE #3.
- 10 NEW CONDUIT RUNS FOR POWER TO NEW LAMP POST (DASHED LINE); CONNECT POWER RUNS FROM EXISTING LAMP POST TO BE REPLACED; COORDINATE WITH OWNER'S EXTERIORS TEAM TO PROTECT LANDSCAPING PRIOR TO INSTALLATION. SEE ADD ALTERNATE #3.

ADD ALTERNATE NO.3: REMOVE AND DISPOSE OF THE EXSITING LAMP POST, FOOTING, AND ADJACENT J-BOX. PROTECT EXISTING WIRING AT J-BOX FOR NEW LAMP POST. INSTALL THREE (3) NEW LAMP POSTS; ONE (1) AT EXISTING LOCATION AND TWO (2) ADJACENT TO RAMP. PROVIDE ALL APPROPRIATE MATERIALS SUCH AS BUT NOT LIMITED TO; CONCRETE FOOTING, CONDUIT, WIRING, AND J-BOX AS NOTED IN THE SPECIFICATION. REFER TO DRAWING SHEET A1 FOR LOCATIONS AND SPECIFICATION FOR SHOP DRAWINGS.

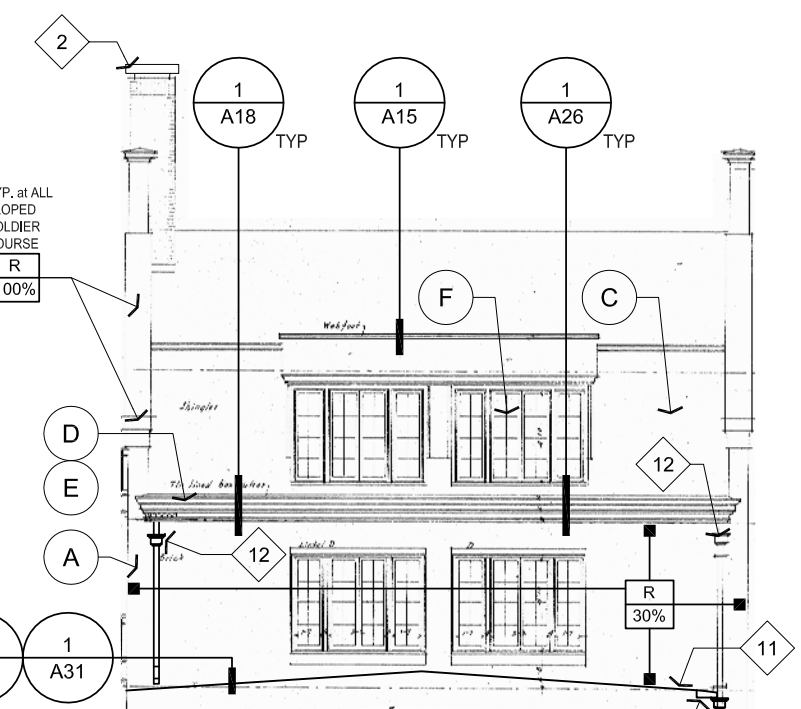
2 PARTIAL NORTH ELEVATION
 3/32" = 1'-0"
 (N) COPPER SCUPPER/DIVERTER FROM (N) CRICKET TO (N) LEADER BOX

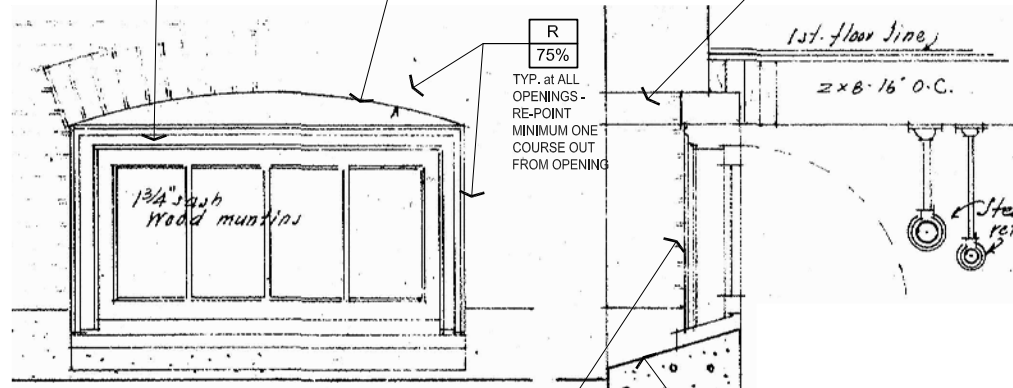
3 BASEMENT WINDOW ELEV./ SECT.
N.T.S.

METAL SCREEN; SCRAPE, PREP, PRIME AND PAINT TO MATCH WOOD TRIM COLOR.

REPAIR BROKEN OR CRACK CONCRETE SILLS

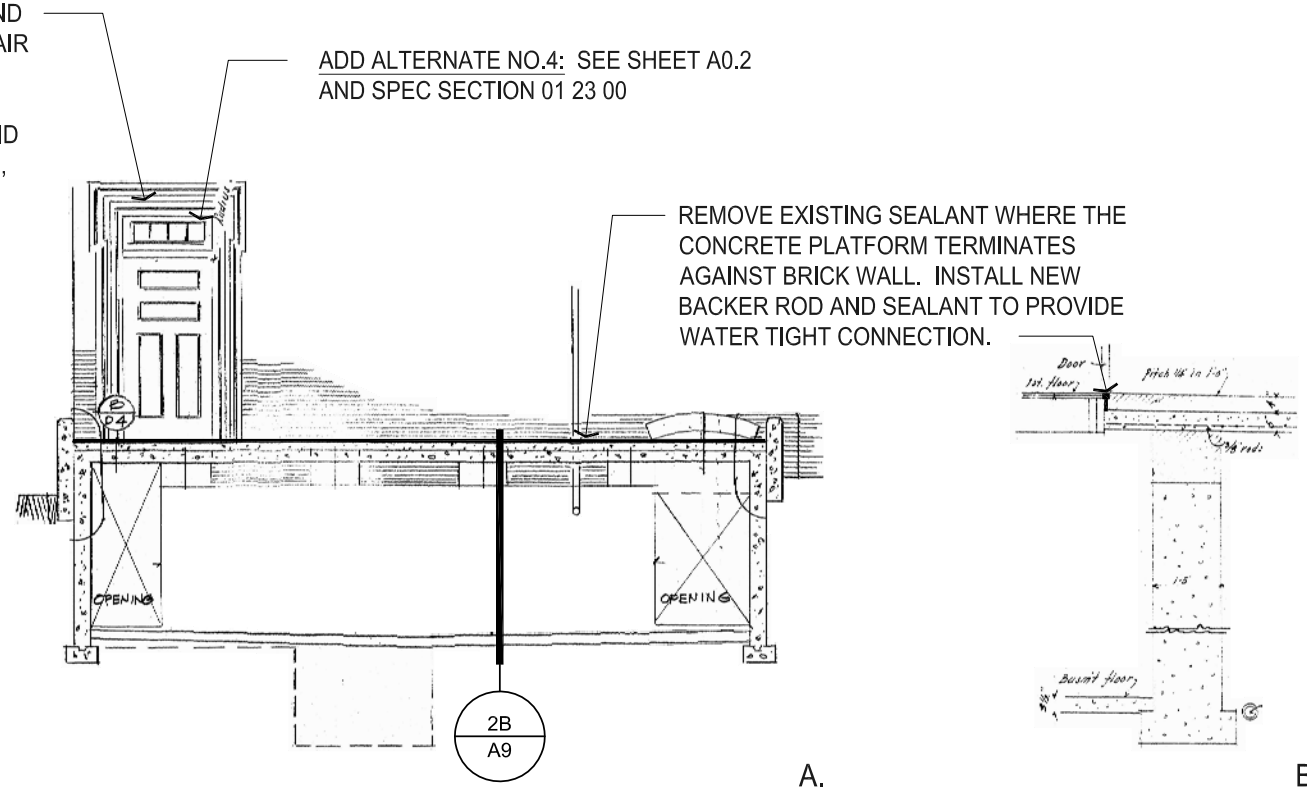
2 RAISED WALK AT BRICK WALL
1/4" = 1'-0"

EXISTING WOOD DOOR AND WOOD DOOR WELL. REPAIR OR REPLACE ANY DETERIORATED WOOD, REPAIR DOOR TO FILL VOID AROUND FRAME; SCRAPE, PREP, PRIME AND PAINT.

REPAIR AND REPLACE ALL DETERIORATED WOOD; SCRAPE, PREP, PRIME AND PAINT.

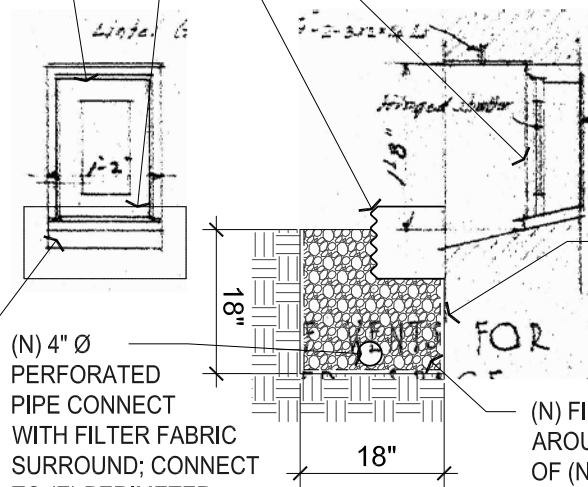
(N) 4" Ø PERFORATED PIPE CONNECT WITH FILTER FABRIC SURROUND; CONNECT TO (E) PERIMETER FOUNDATION DRAIN

(N) FILTER FABRIC AROUND PERIMETER OF (N) 3/4" CRUSHED ROCK BACKFILL

- 16 EXCAVATE 18" W X18" D TRENCH ALONG ENTIRE LENGTH OF SOUTH FACING FOUNDATION WALL; (N) 4" Ø PERFORATED PIPE AND BACKFILL WITH 3/4" CRUSHED ROCK, SEE DETAIL 4/A9

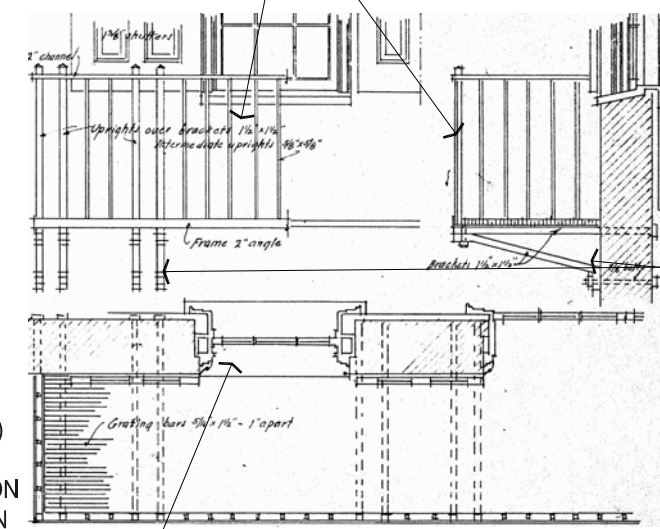
5 LIVING ROOM BALCONY
1/4" = 1'-0"

EXISTING METAL BALCONY, SCRAPE, PREP, PRIME AND PAINT TO MATCH WOOD TRIM COLOR.

WINDOW AND WINDOW WELL UNDER METAL BALCONY; REPAIR AND REPLACE ALL BROKEN OR LOOSE BRICK; REPAIR AND REPLACE ALL DETERIORATED WOOD; SCRAPE, PREP, PRIME AND PAINT.

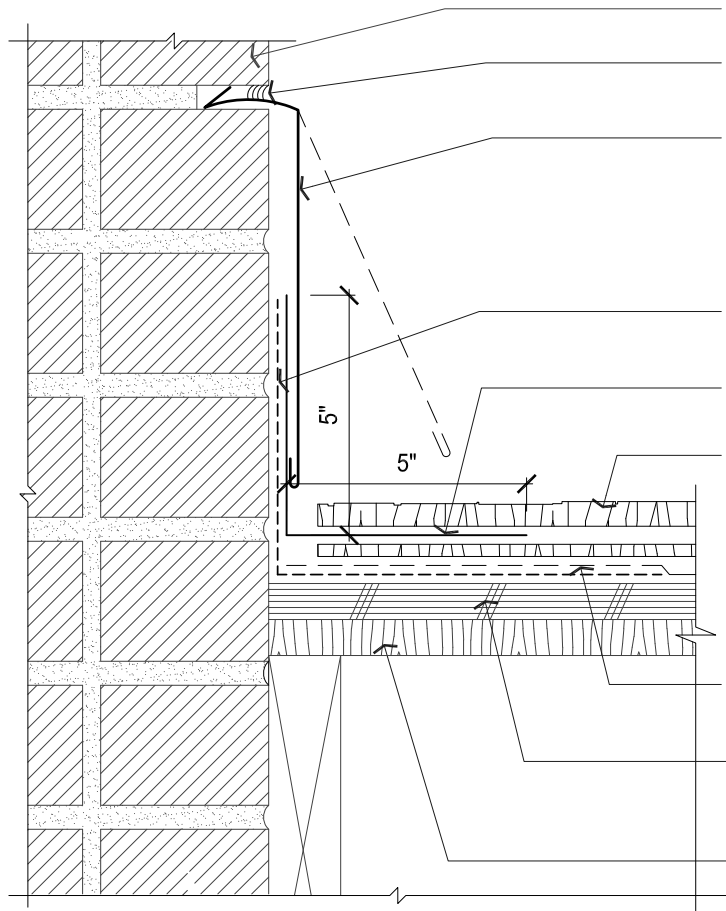
EXISTING MASONRY WALL

REMOVE EXISTING MORTAR, INSTALL NEW SEALANT

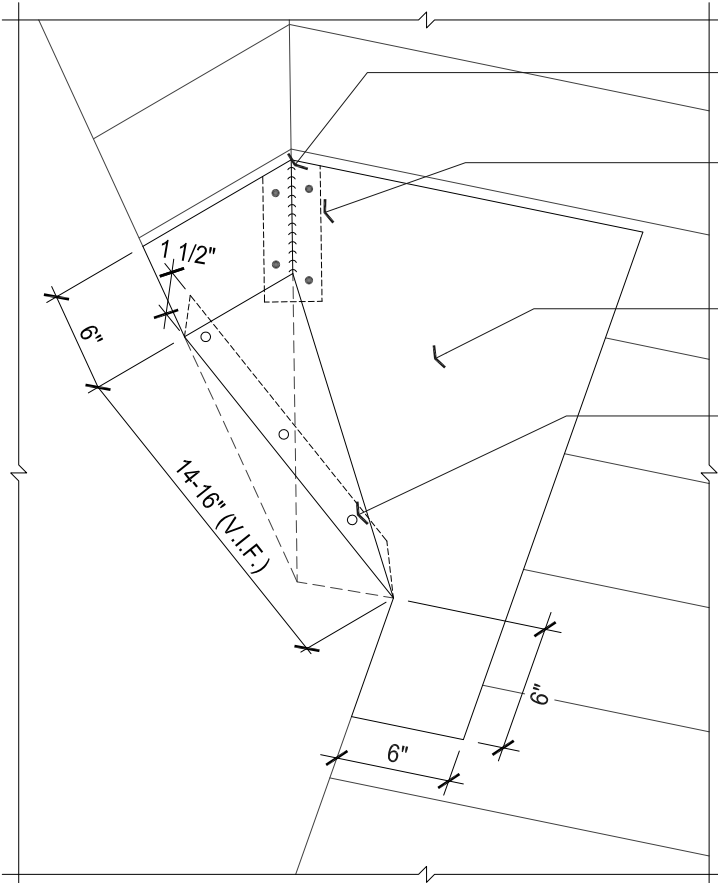
SOLDER AT SEAM

NEW COPPER GUSSET BEHIND WITH POP RIVETS. APPLY SEALANT TO RIVET HEADS.

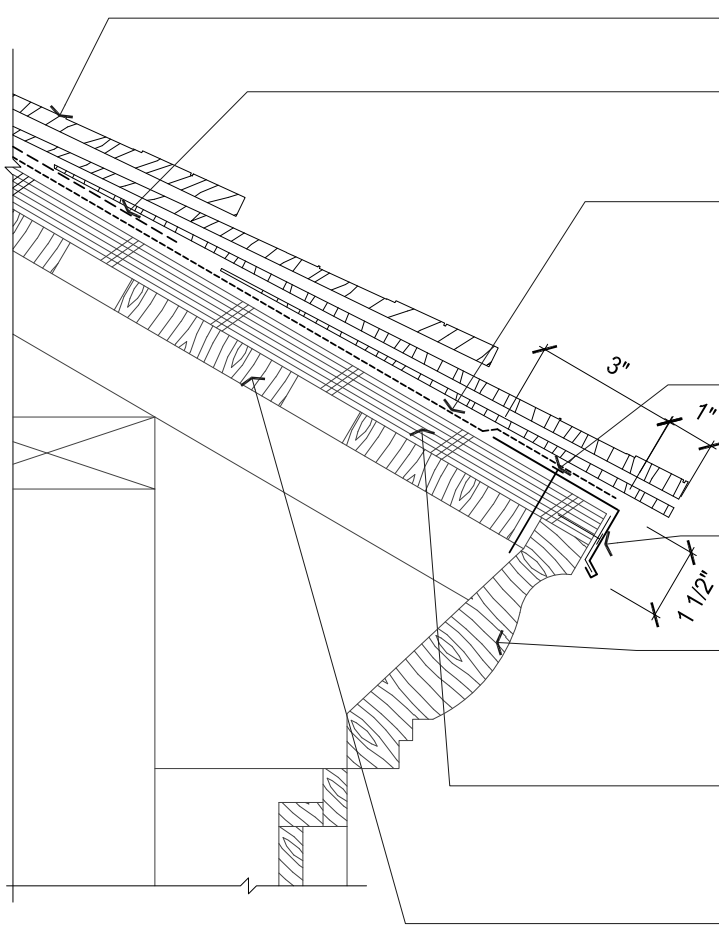
NEW FIRE TREATED CEDAR SHINGLES

NEW 30# BUILDING PAPER LAPPED OVER SELF ADHESIVE MEMBRANE

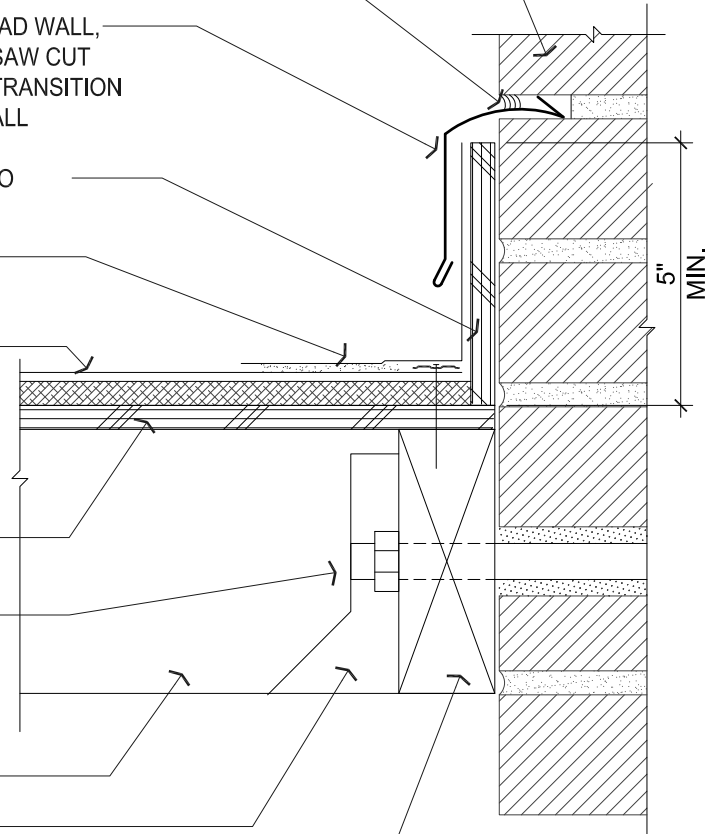
1

NEW SIMPSON 'U26' JOIST HANGER

NEW 3X6 LEDGER ANCHORED TO BRICK WALL

CRICKET TERMINATION AT BRICK

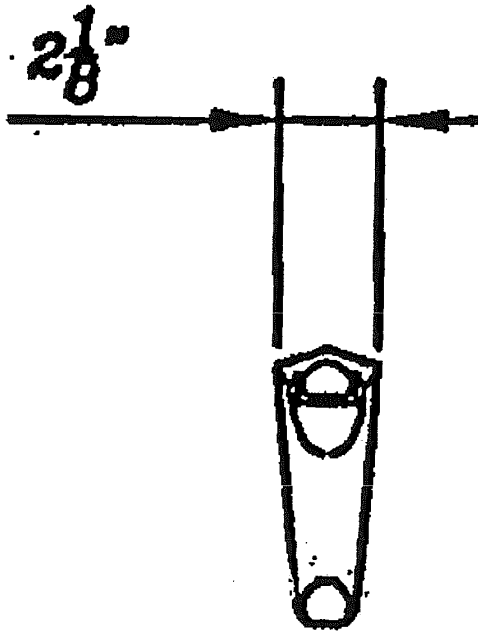
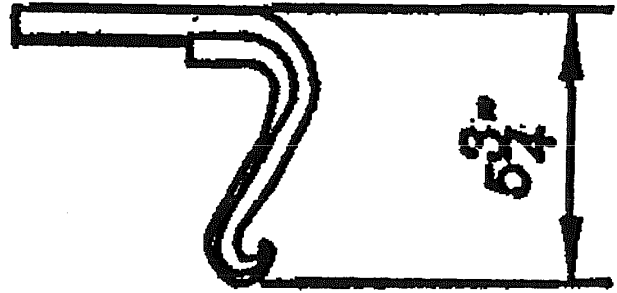
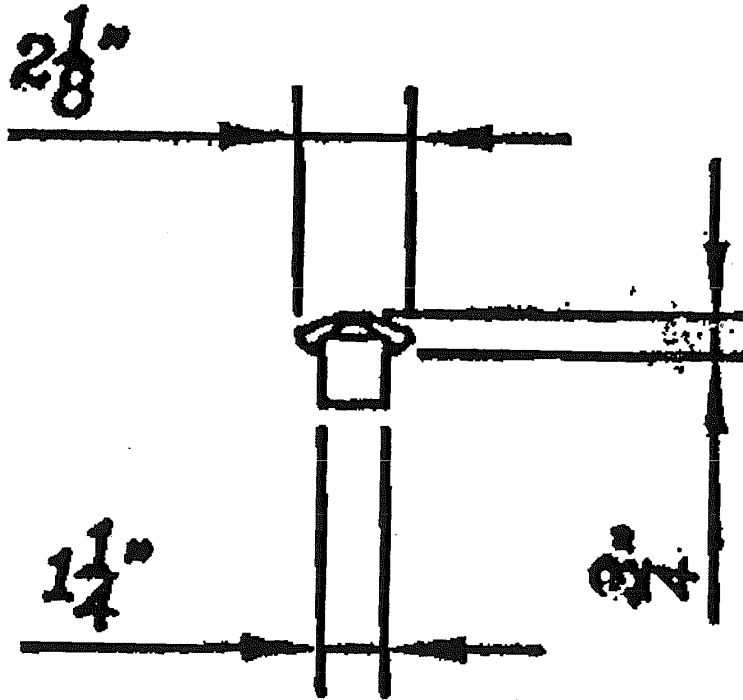
1

NOTE :
 FOLLOW UO CAMPUS STANDARD
 HANDRAIL DESIGN FOR HISTORIC
 BUILDING, MARCH 2012

POWDER-COATED BLACK FINISH TO
 MATCH SUSAN CAMPBELL

UO HANDRAIL DESIGN STANDARD

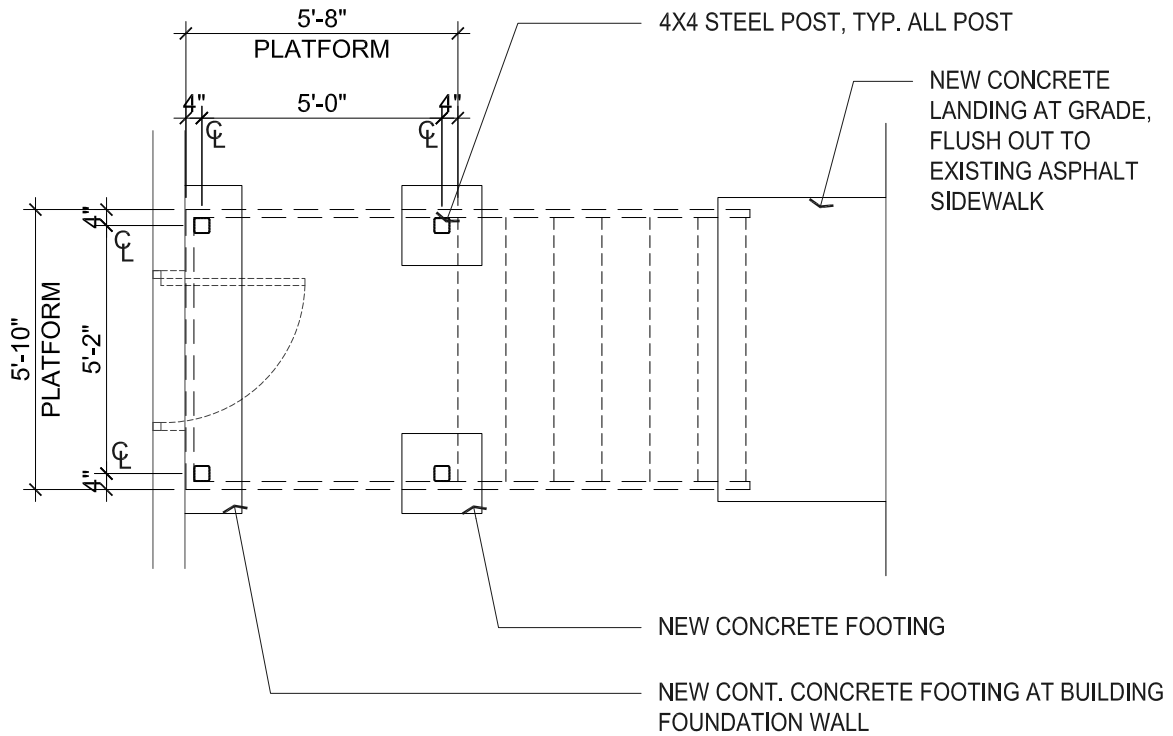
1

ADD ALTERNATE #2 NEW EXT. STAIR FOOTING PLAN

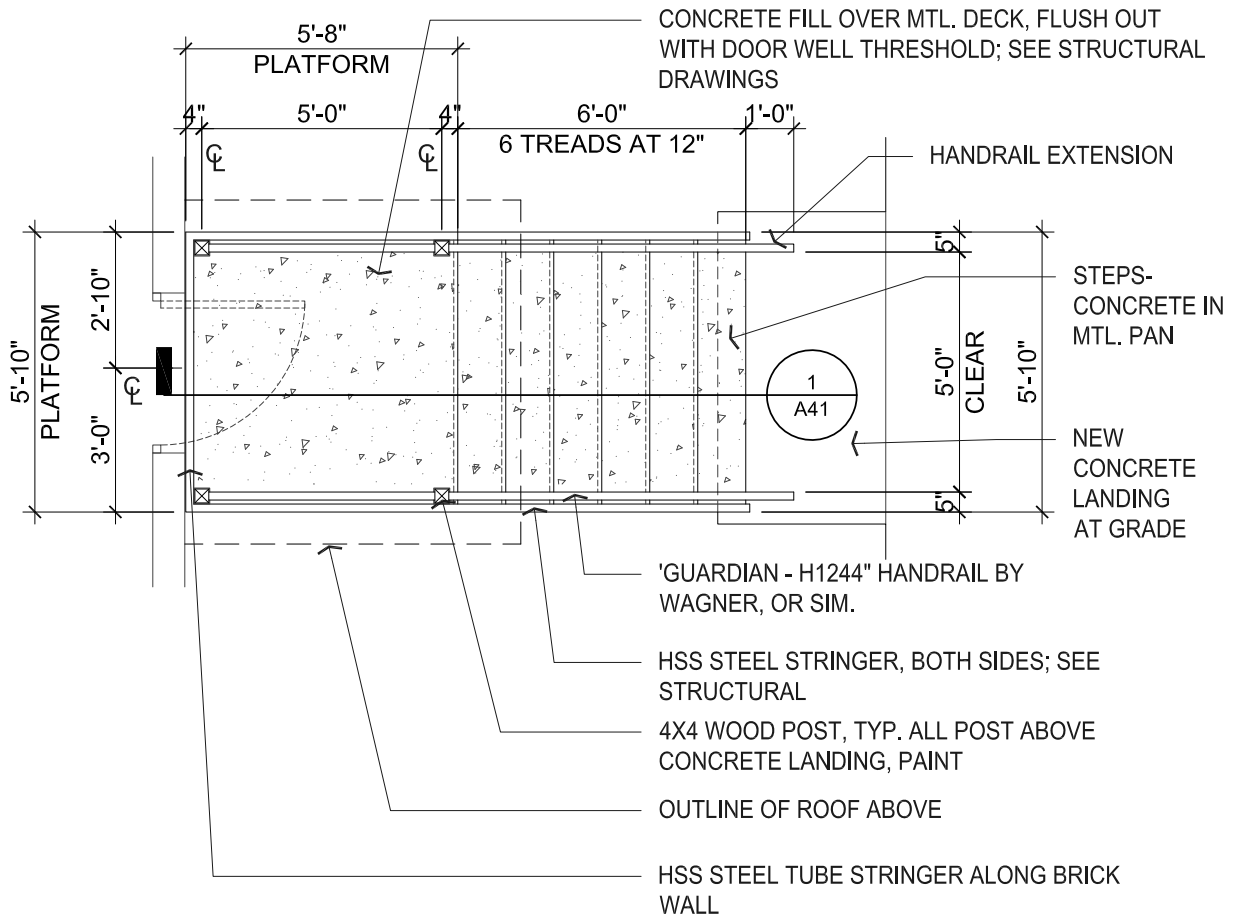
1

ADD ALTERNATE #2 NEW EXT. STAIR PLAN

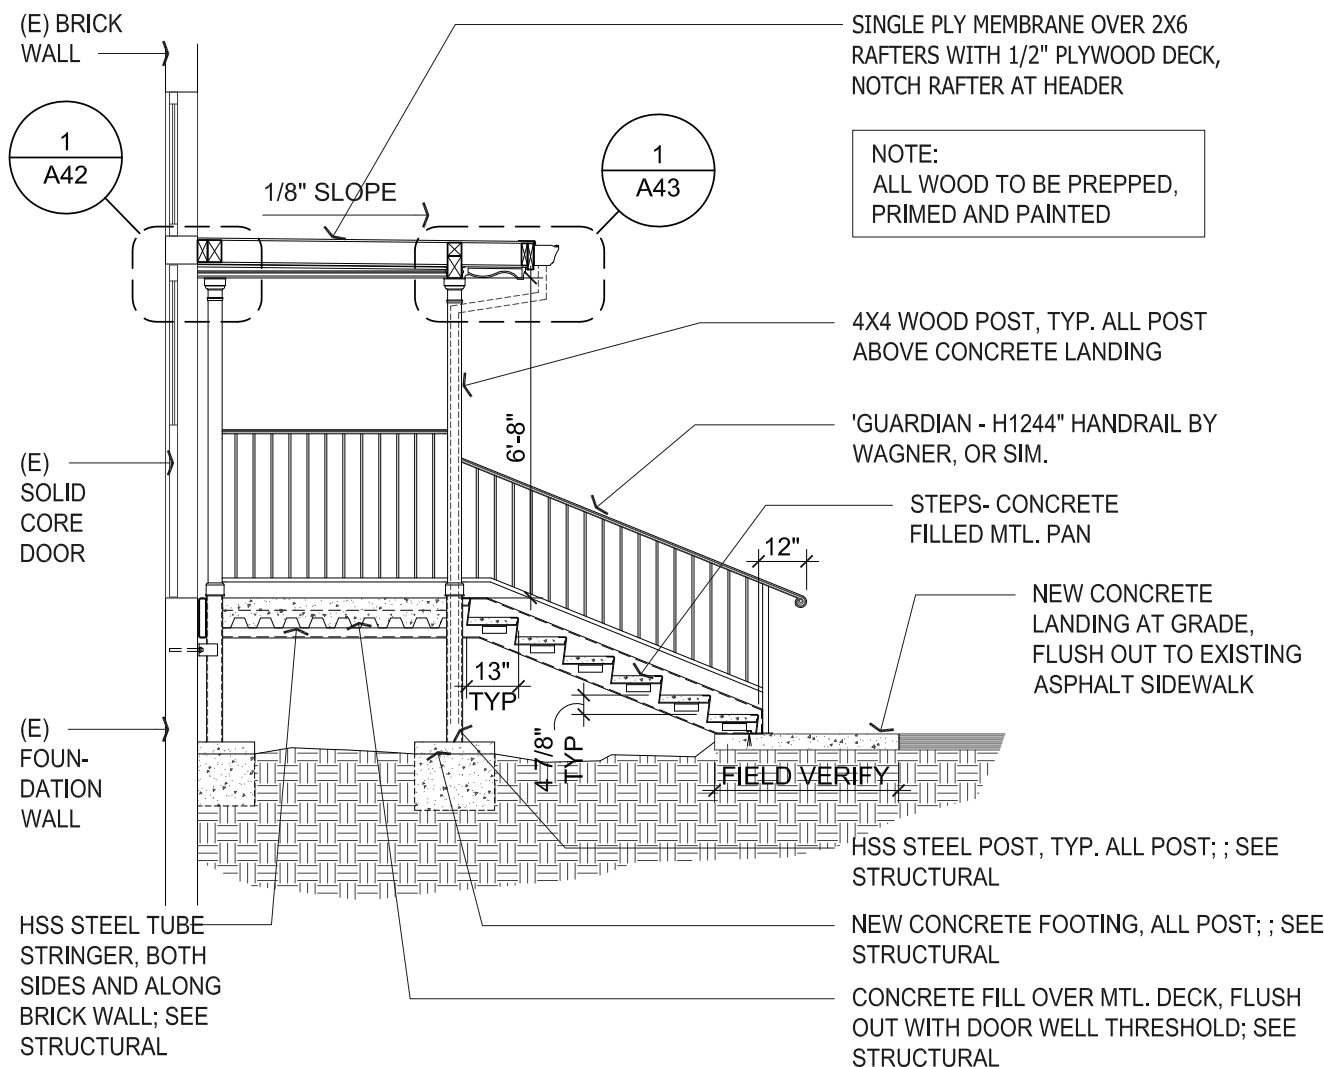
1

ADD ALTERNATE #2 NEW EXT. STAIR SECTION

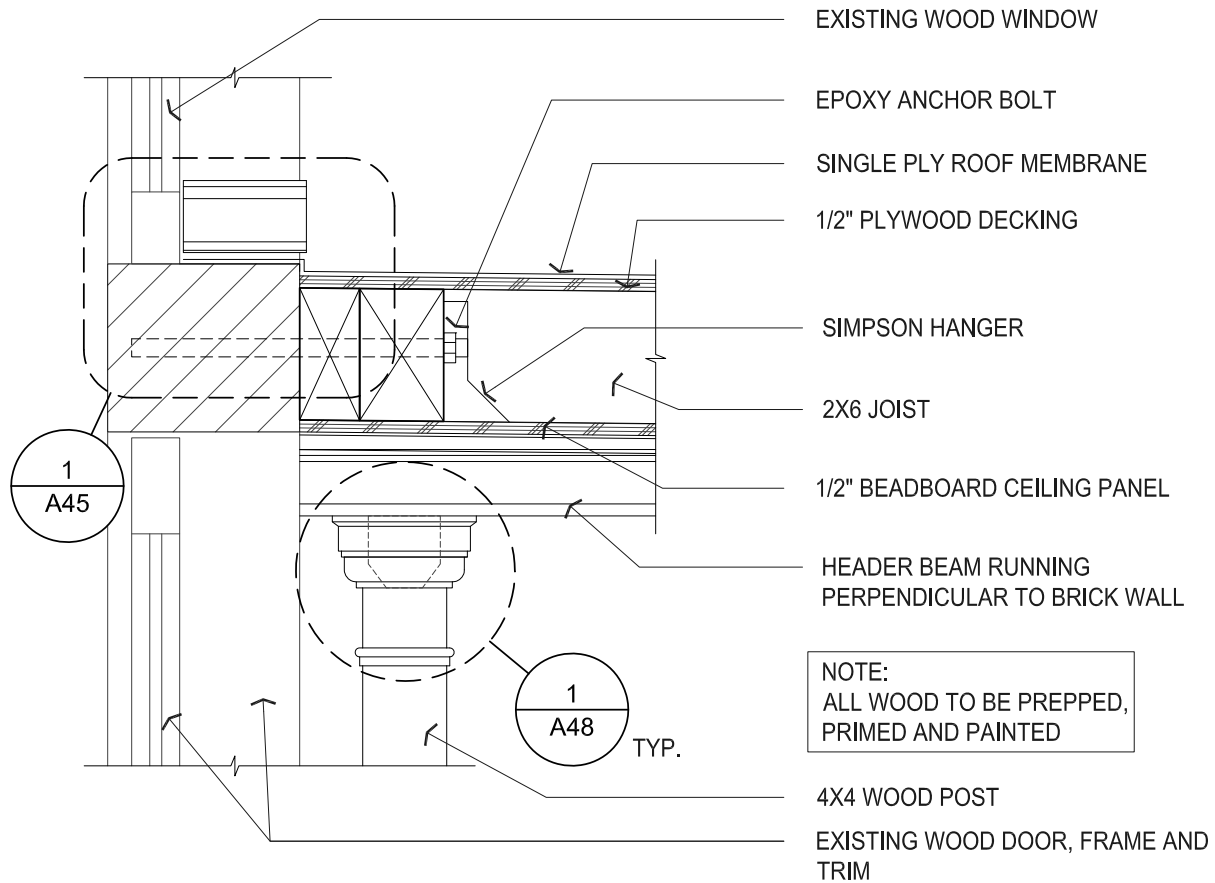
1

ADD ALTERNATE #2 STAIR CANOPY AT HEAD WALL

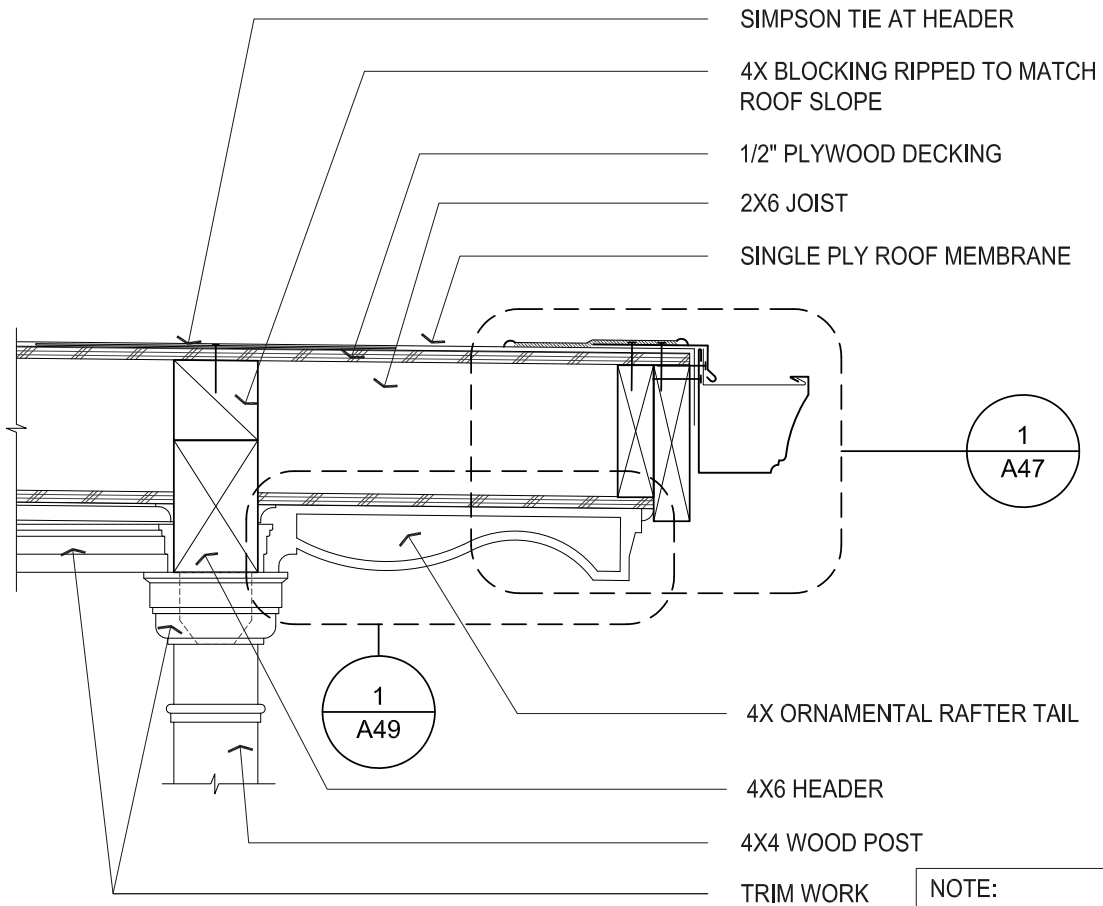
NOTE:
ALL WOOD TO BE
PREPPED, PRIMED
AND PAINTED

ADD ALTERNATE #2 EAVE AT NEW STAIR CANOPY

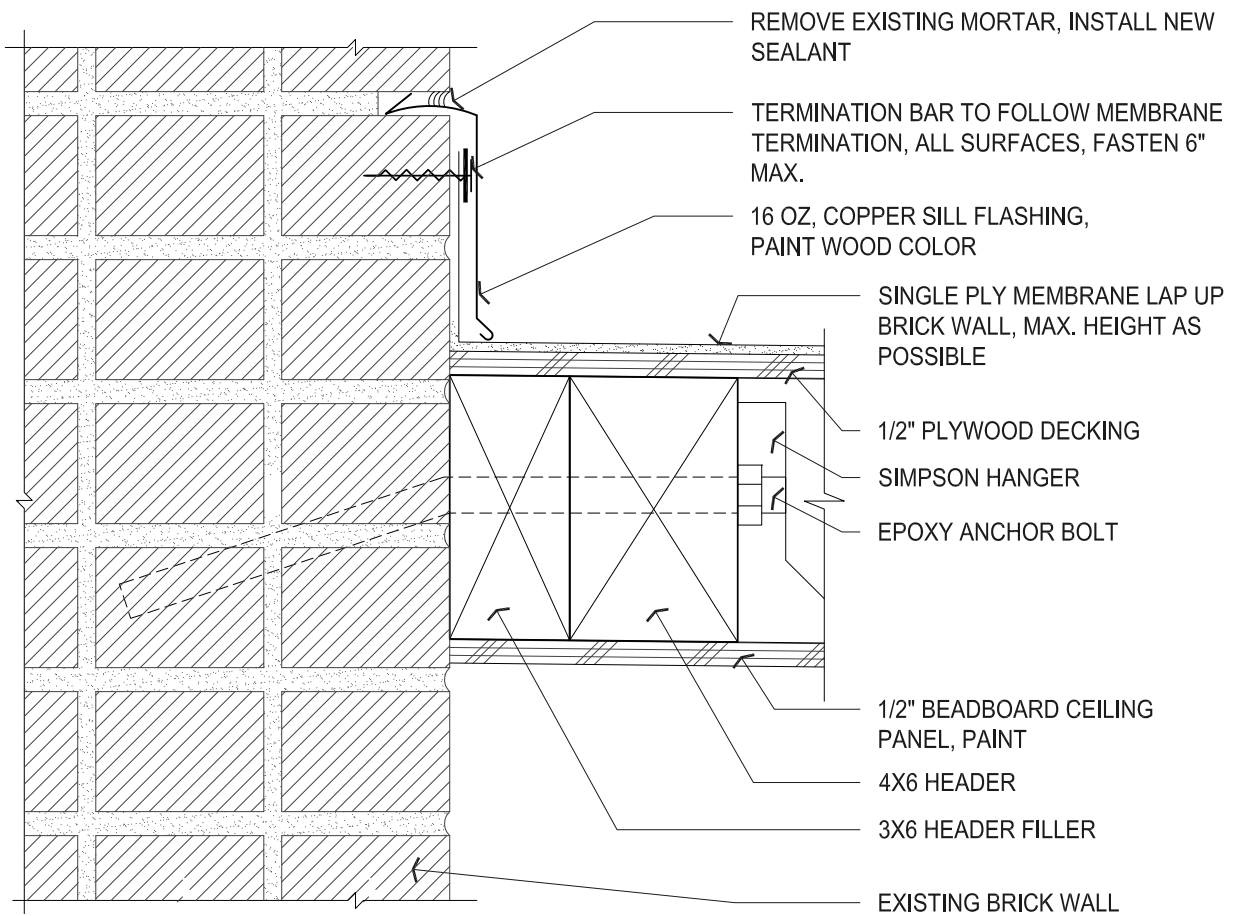
1

ADD ALTERNATE #2 FLASHING AT HEAD WALL

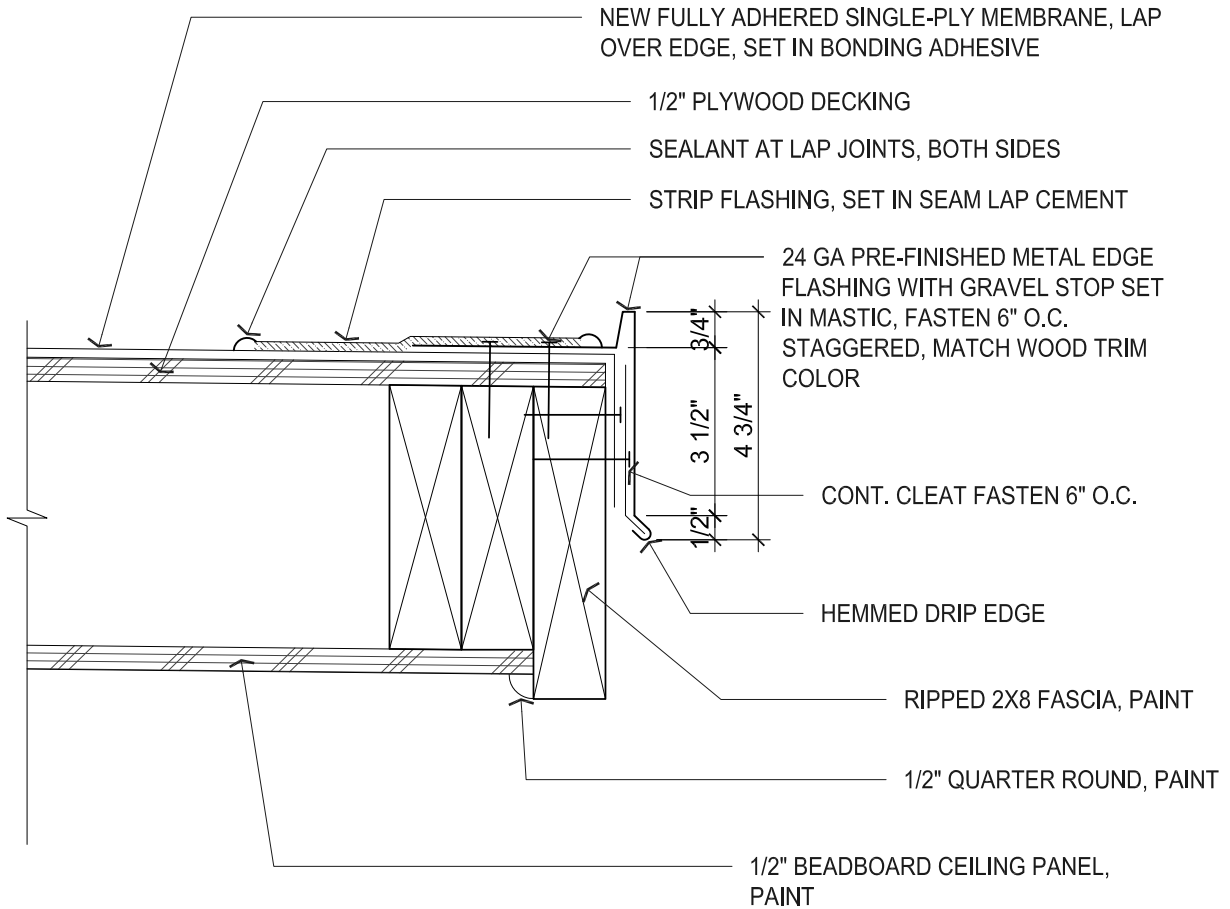
1

ADD ALTERNATE #2 EDGE FLASHING AT RAKE

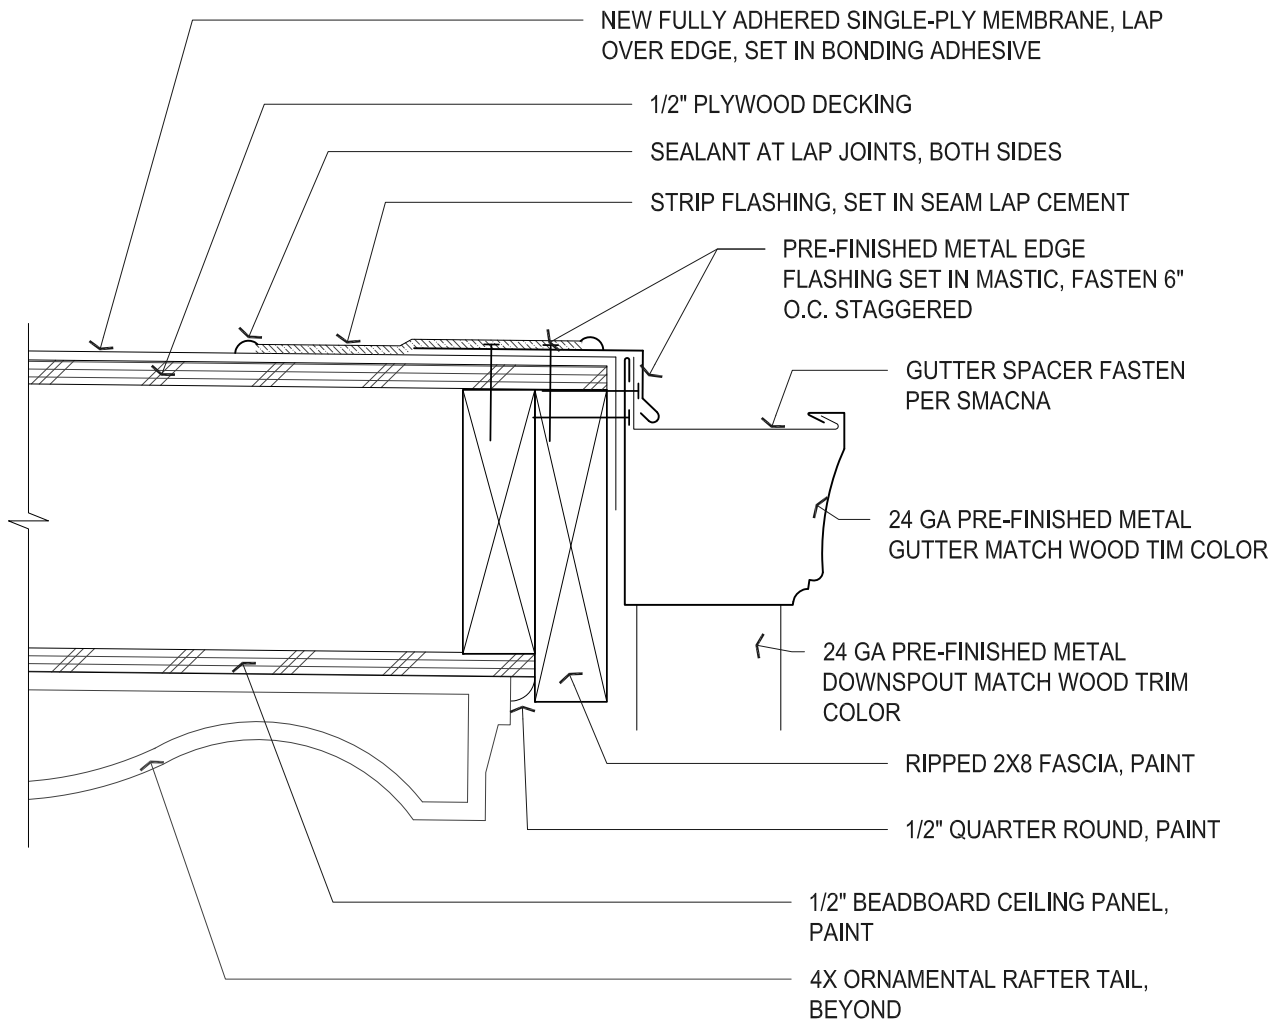
1

ADD ALTERNATE #2 GUTTER AT EAVE

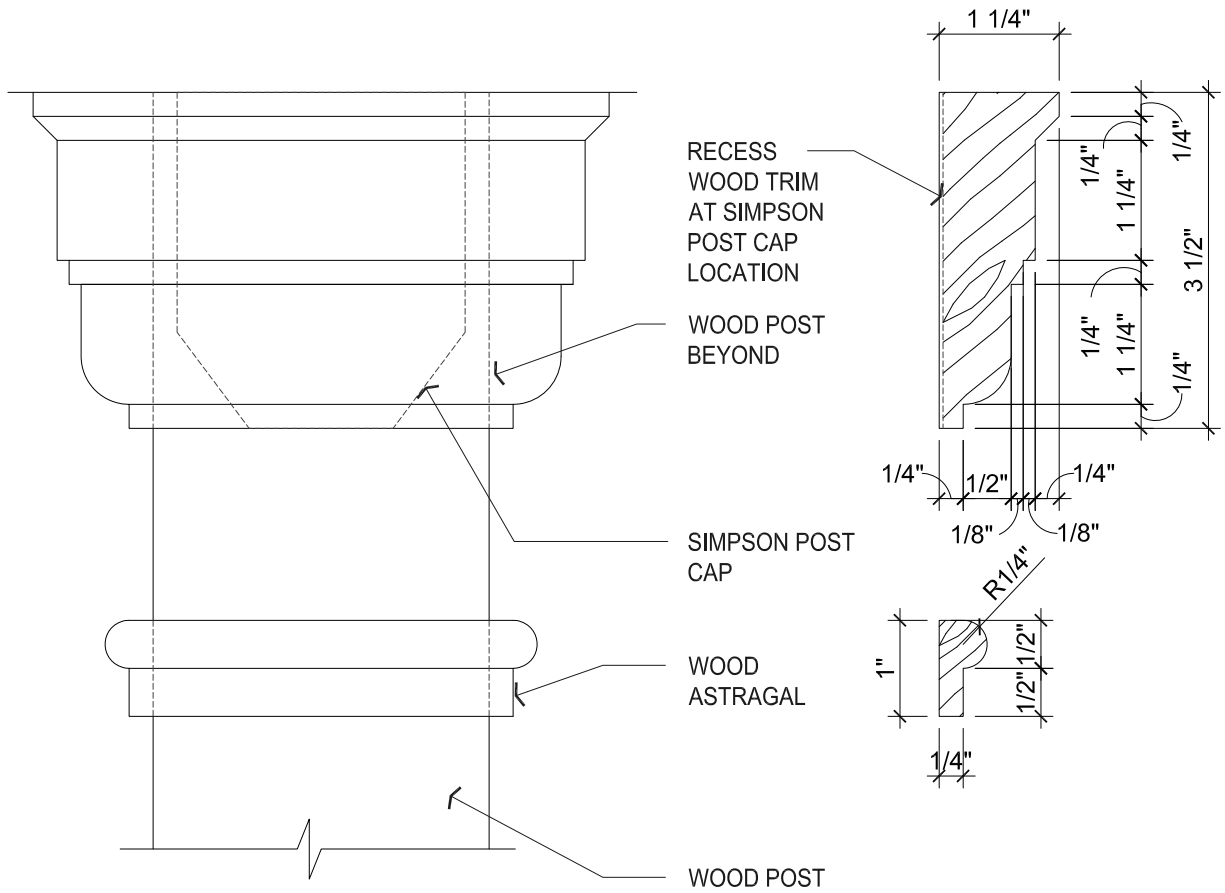
1

ADD ALTERNATE #2 WOOD TRIM CAPITAL AT POST

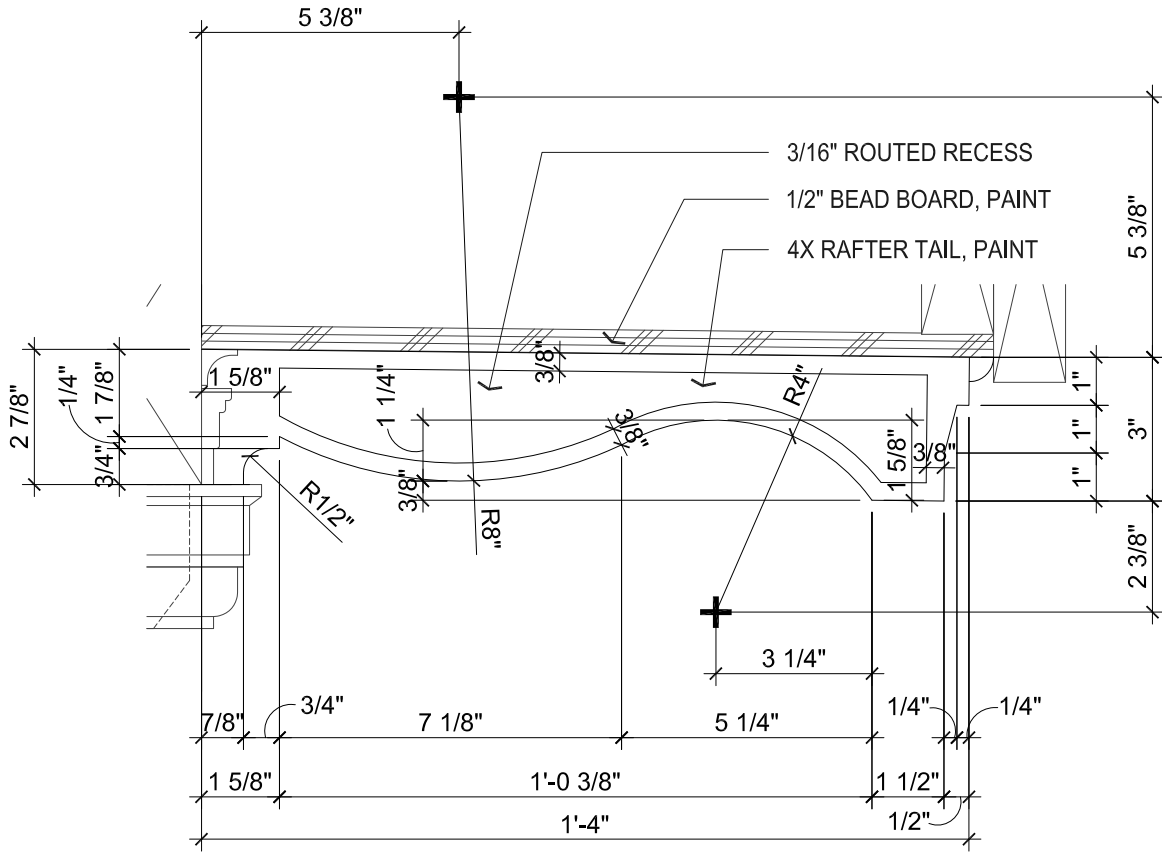
1

ADD ALTERNATE #2 ORNAMENTAL RAFTER TAIL

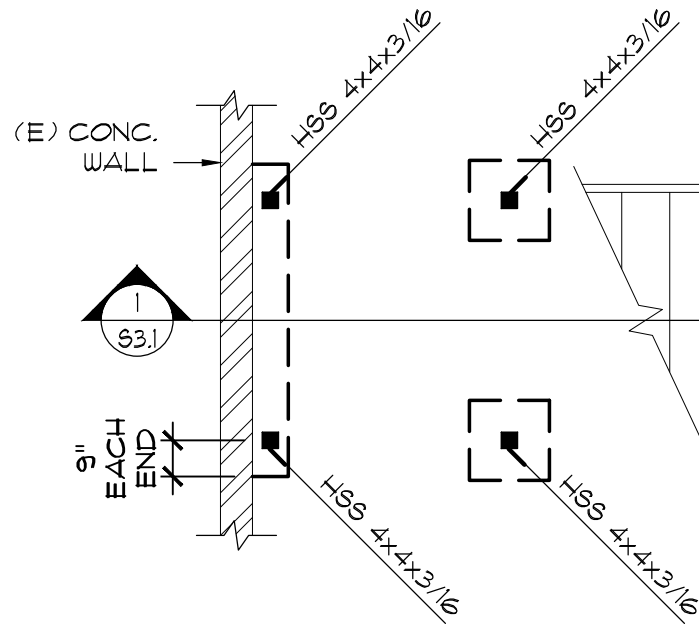
1 FOUNDATION PLAN
S2.1 SCALE: 1/4"=1'-0"

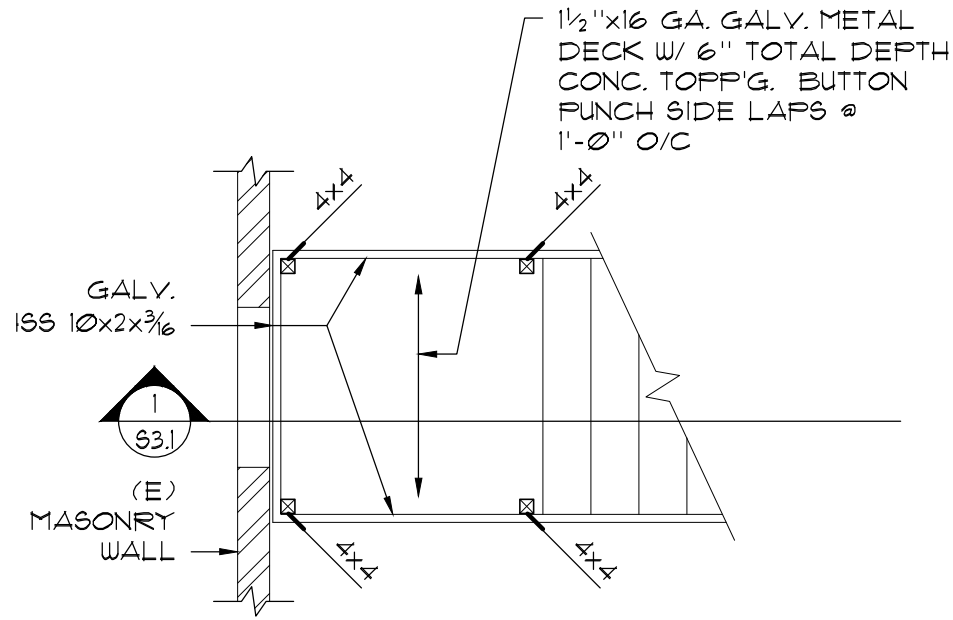
2 PORCH LEVEL FRAMING PLAN
S2.1 SCALE: 1/4"=1'-0"

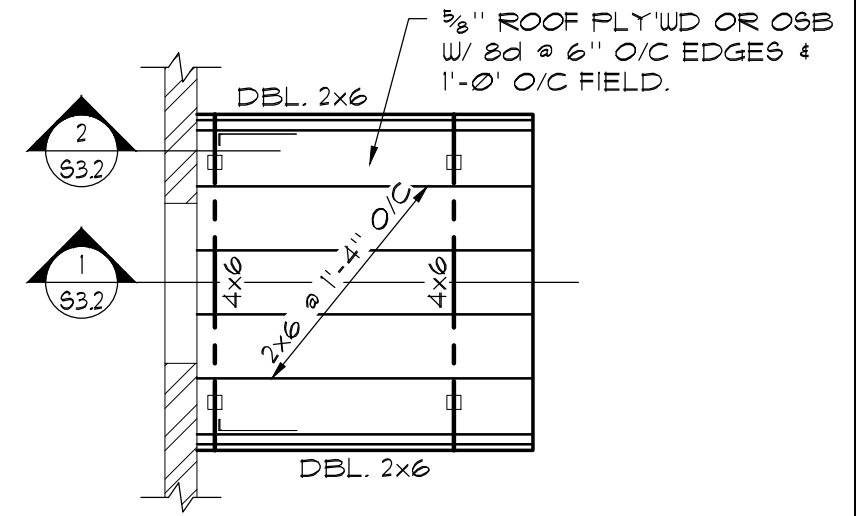
3 ROOF FRAMING PLAN
S2.1 SCALE: 1/4"=1'-0"
