UNIVERSITY OF OREGON

HENDRICKS HALL EXTERIOR RESTORATION PROJECT 2013

EUGENE, OREGON

SODERSTROM ARCHITECTS
 1200 NW Naito Parkway, Suite 410, Portland, Oregon 97209
 503.228.5617
 www.sdra.com

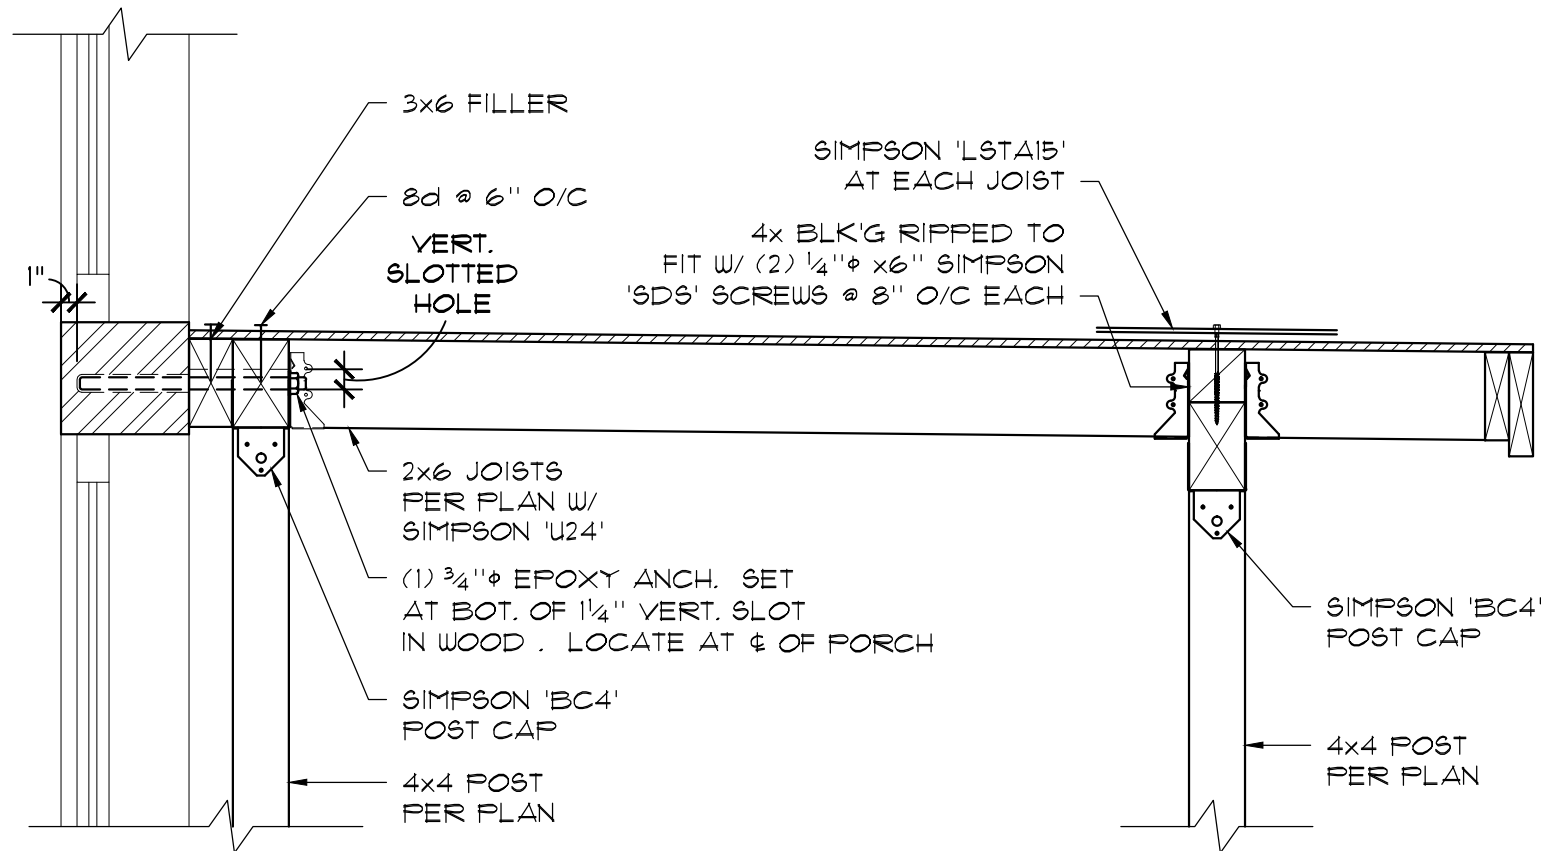
1 TYP. ROOF FRAMING SECTION
S3.2 10215-02

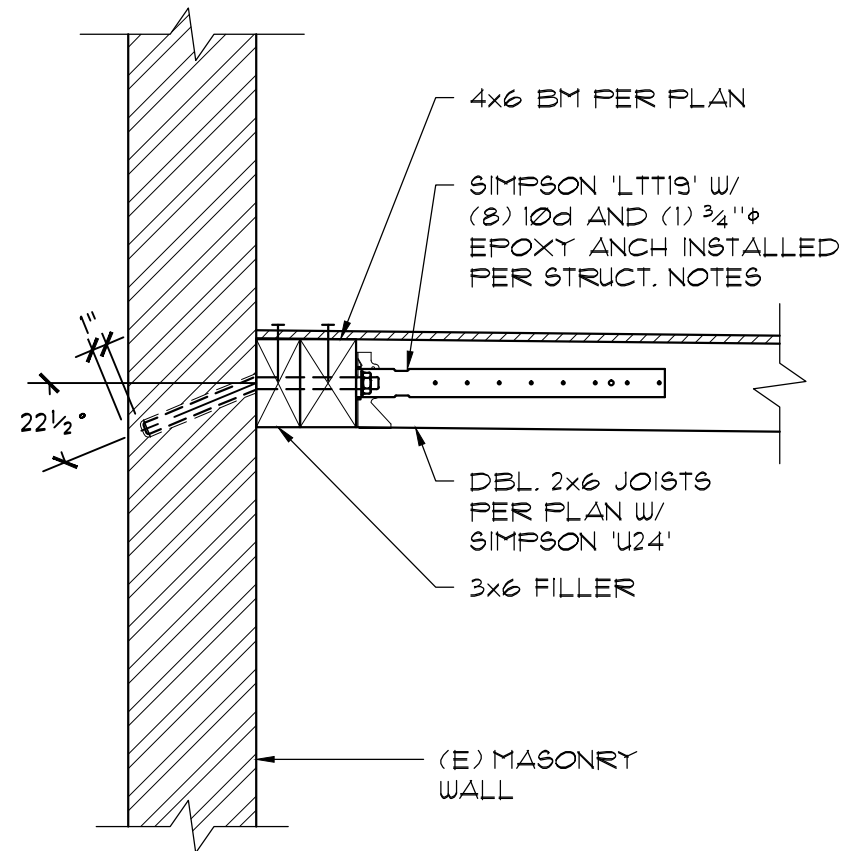
2 ROOF TIE TO (E) MASONRY WALL
S3.2 10215-01
