**PORTLAND STATE UNIVERSITY**  
**UNIVERSITY CENTER BUILDING**  
**BUILDING NUMBER: UCB**  
**FACILITY CONDITION ANALYSIS**  
**MAY 20, 2008**

### A. EXECUTIVE SUMMARY - UNIVERSITY CENTER BUILDING

**Building Code:** UCB  
**Building Name:** UNIVERSITY CENTER BUILDING  
**Year Built:** 1969  
**Building Use:** Multi-use  
**Square Feet:** 185,319

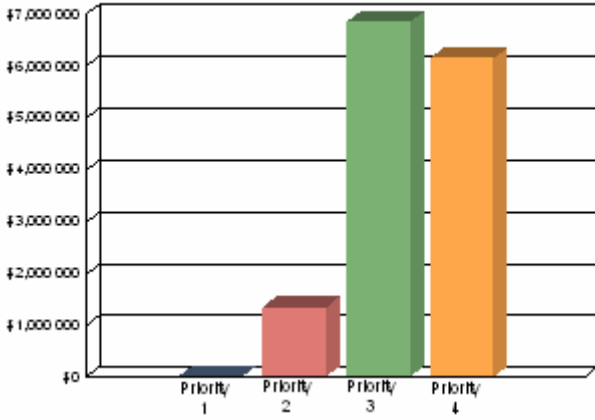
**Project Costs by Priority**

**Priority 1:** \$0  
**Priority 2:** \$1,345,147  
**Priority 3:** \$6,853,759  
**Priority 4:** \$6,149,683  
**Total Project Costs:** \$14,348,589  
**Facility Replacement Cost:** \$50,934,141

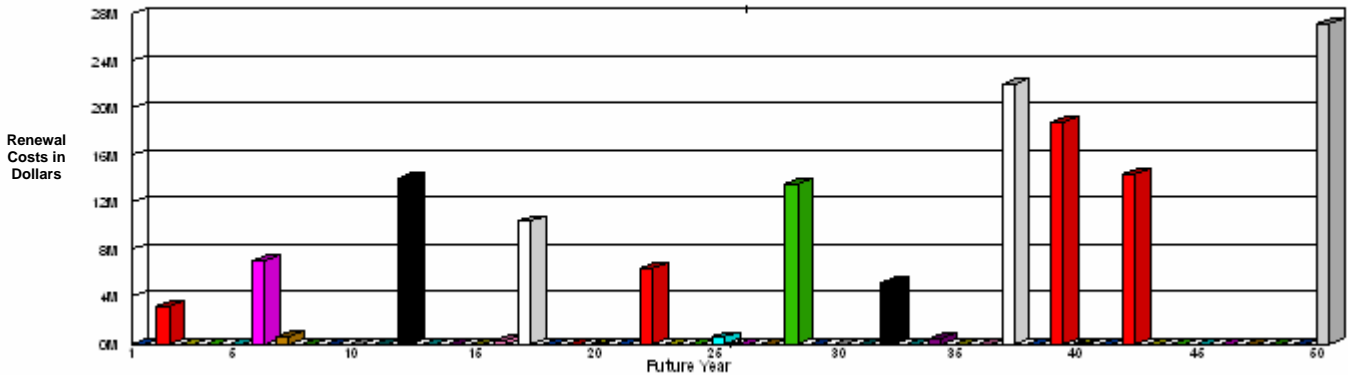
### Life Cycle Model Expenditure Projections

**Average Annual Renewal Cost per SqFt \$6.61**

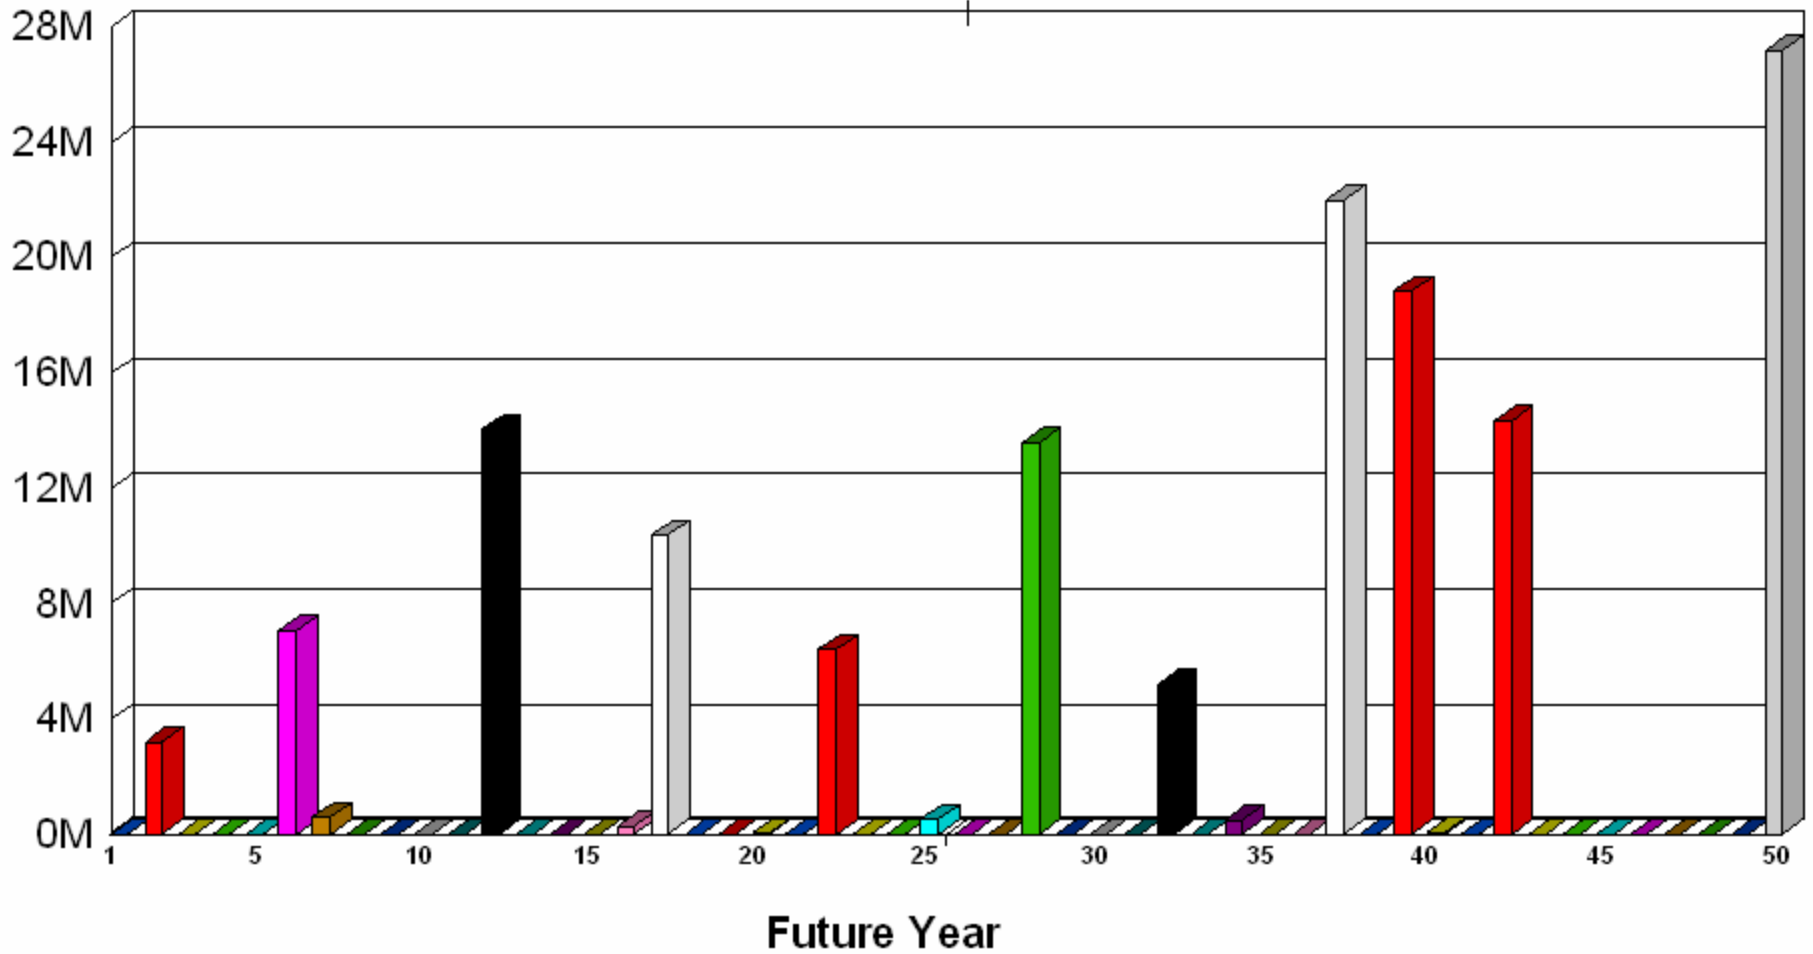
# Life Cycle Model Expenditure Projections

Average Annual Renewal Cost per SqFt \$6.61
