**PORTLAND STATE UNIVERSITY
GRADUATE SCHOOL OF EDUCATION**

BUILDING NUMBER: ED

FACILITY CONDITION ANALYSIS

APRIL 1, 2008

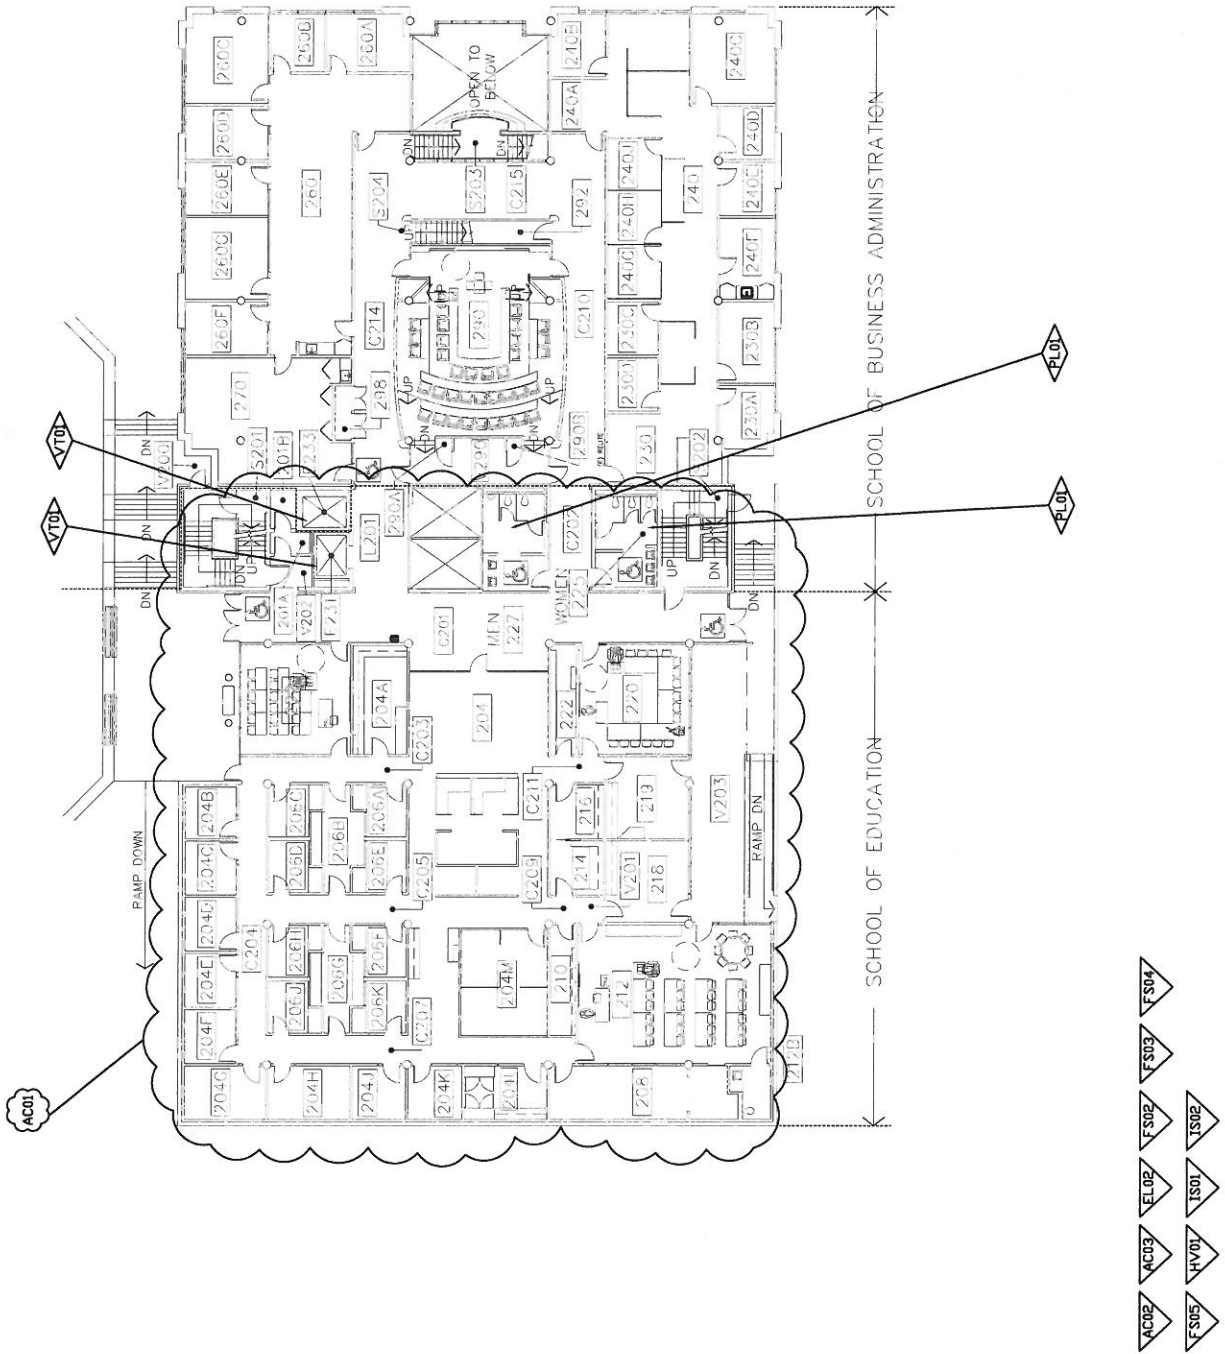
SECOND FLOOR PLAN
 Sheet No.

Date: 04/06/08
 Drawn: T.T.Y.
 Project No. 06-006
 Drawing: PG_ED_F02
