Appendix 5.09
GPR Data

Portland State Parking Structure PS1

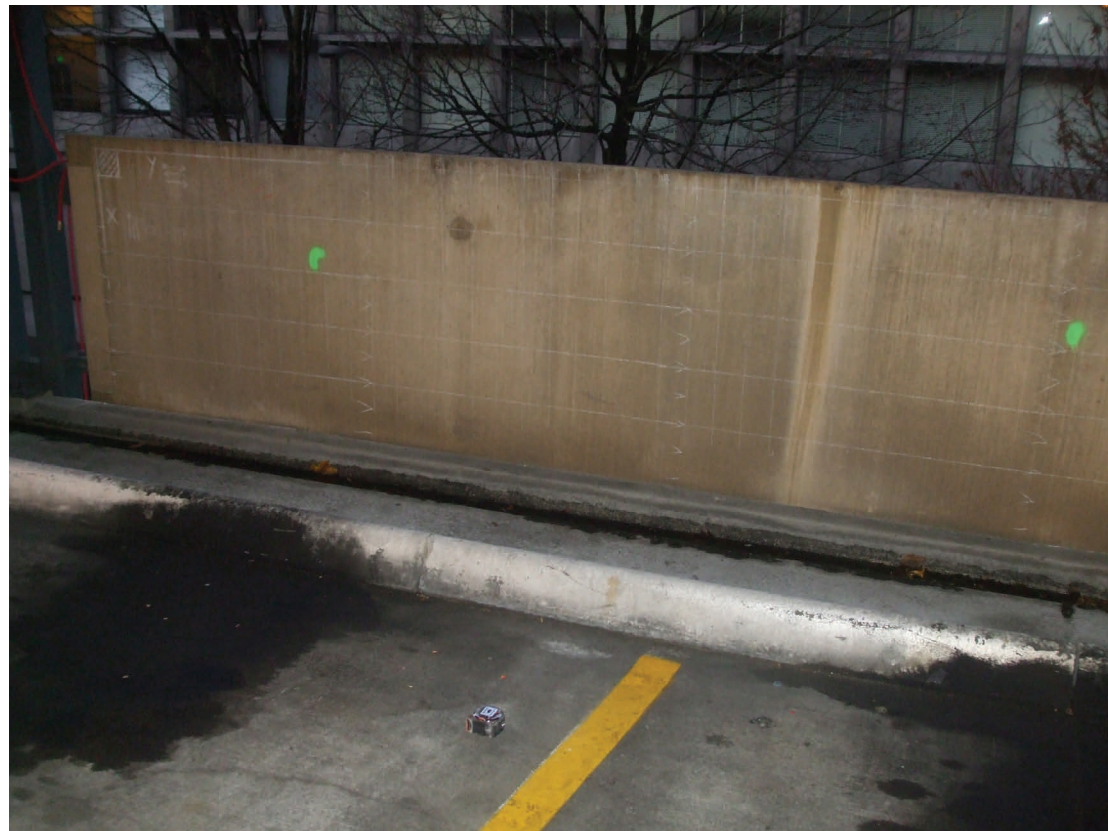
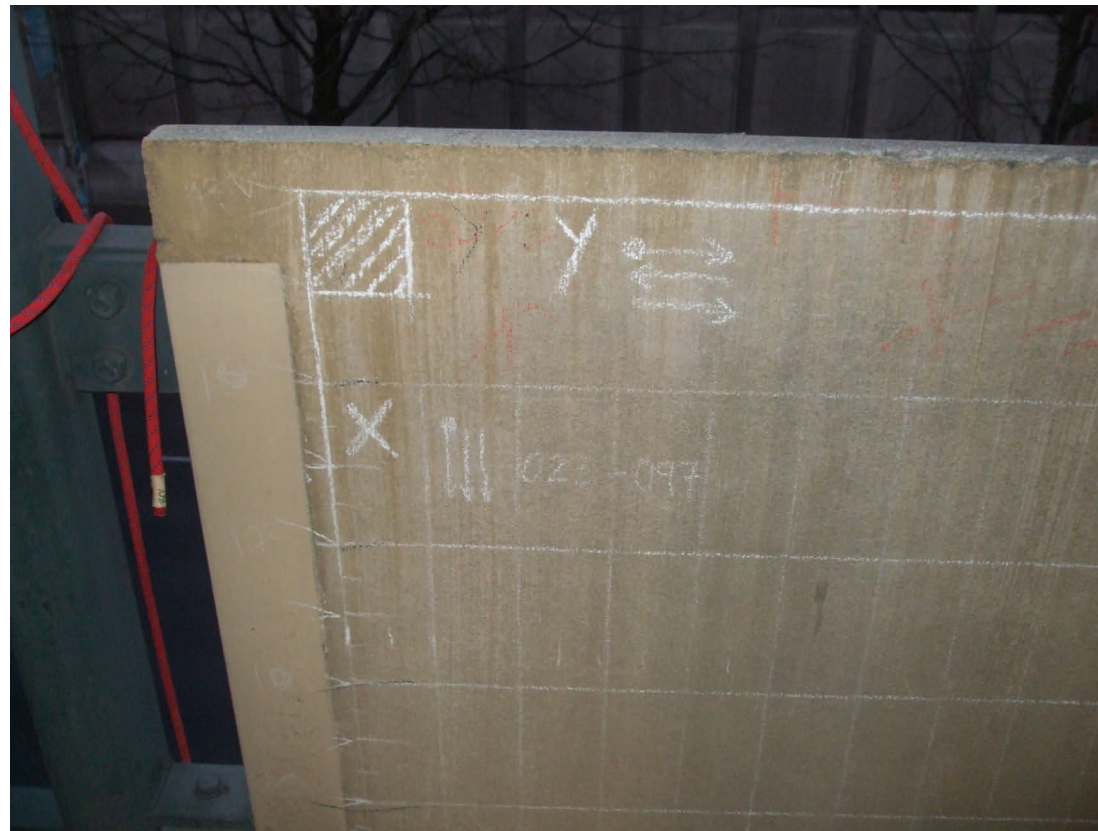
Fascia Panel 5th Floor West Side

Scan Level 1 panel grid West Side,
 Grid 5 PW. 6" to Panel Edge
 X → 023-097
 Y ↑ 098-167
 11' to bottom edge
 all panels
 0,0 point
 6" to Panel Edge

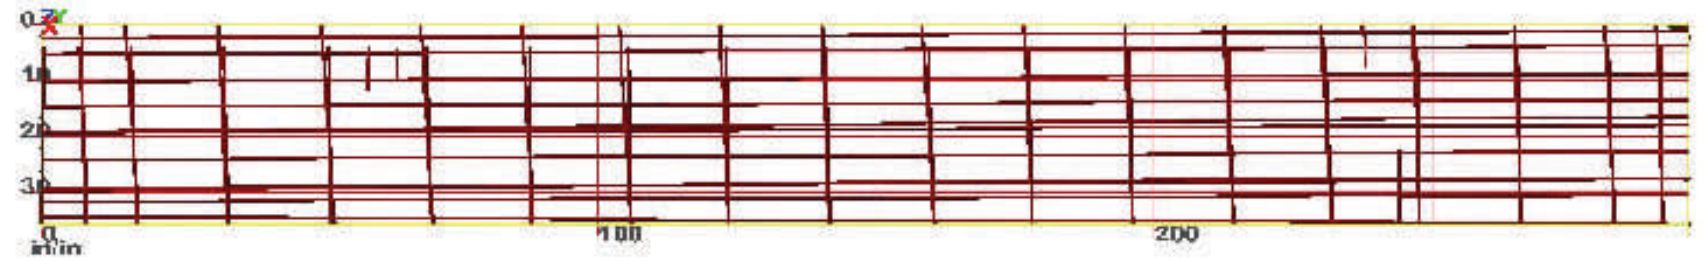
Plan view of panel reinforcing.

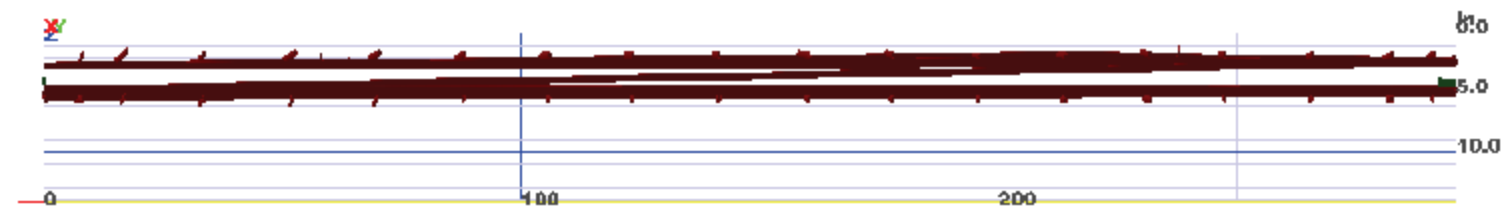
Side view of panel reinforcing.

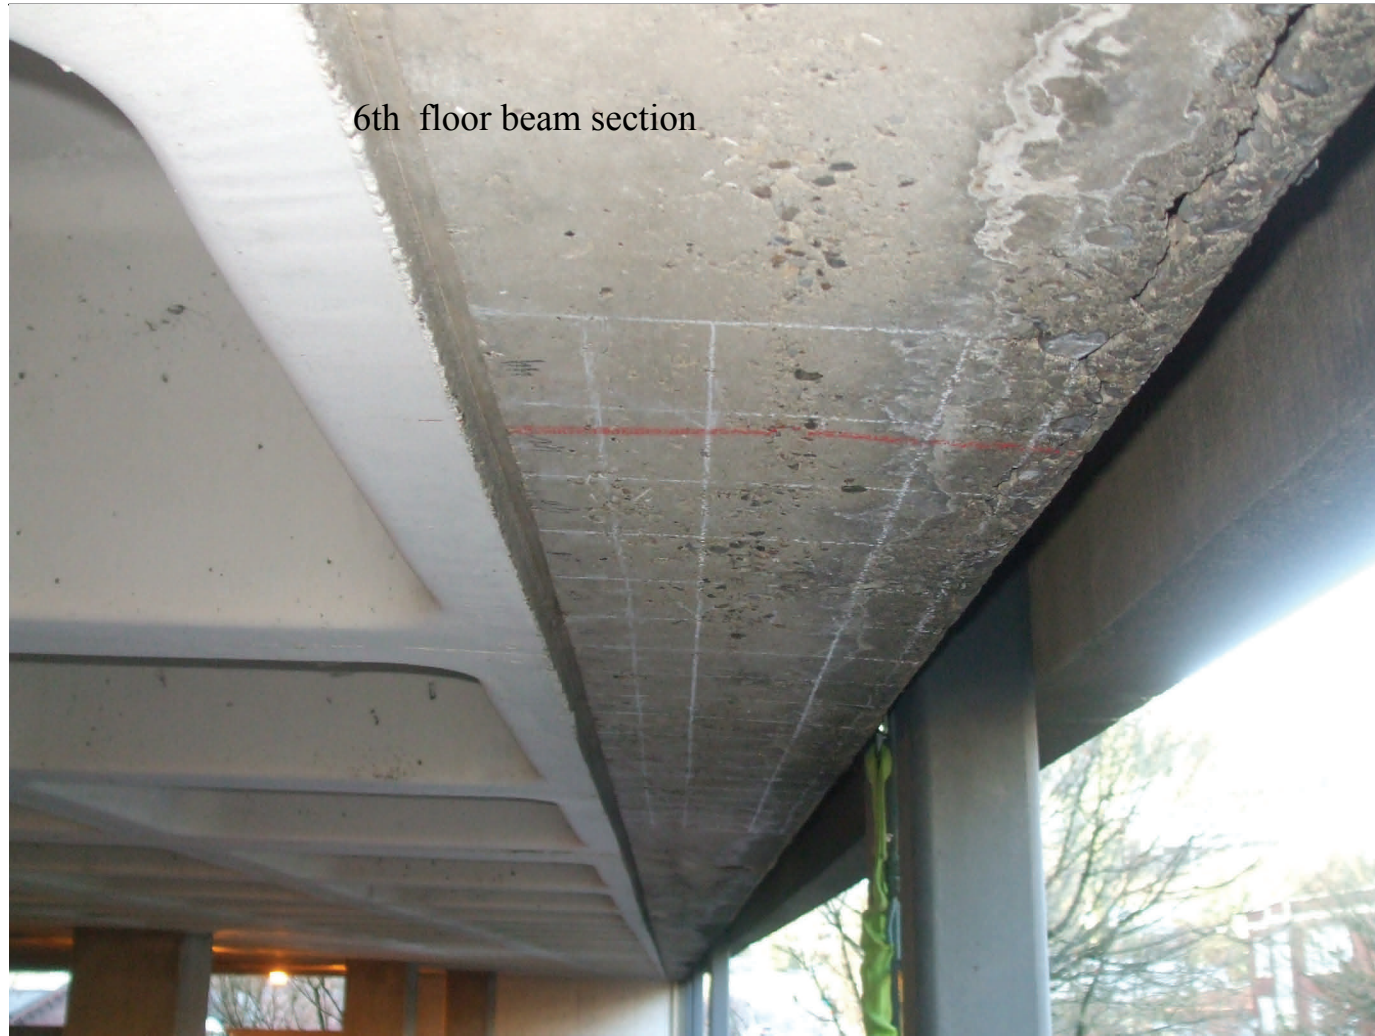
6th floor beam section

Fifth floor looking up at 6th floor beam bottom. Beam bottom face running along west side as per inset diagram.

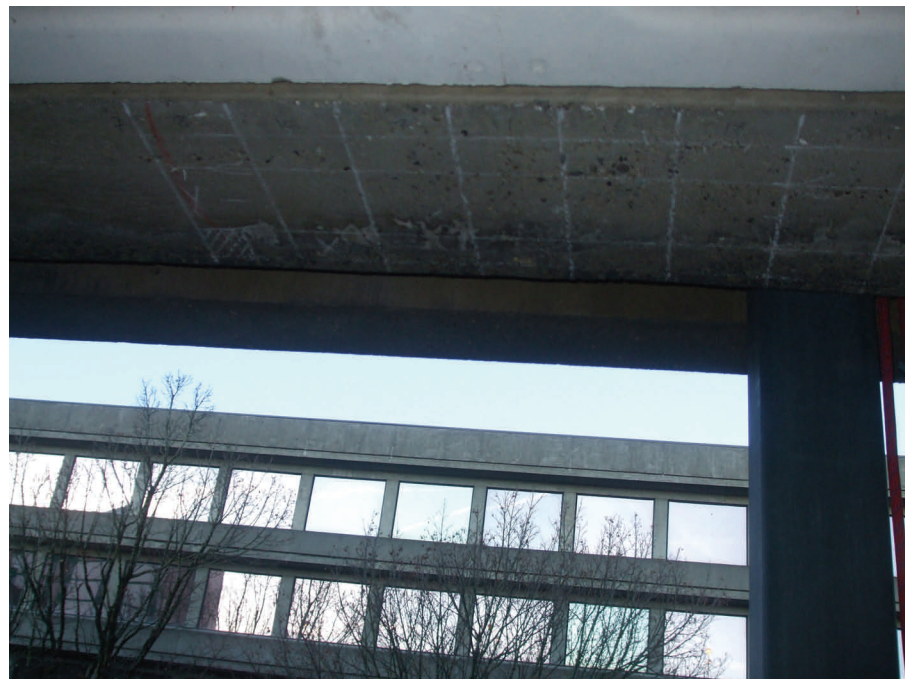
West side beam bottom view on 5th floor looking up.

Note the delaminated areas as shown with the horizontal red lines.

Looking up into parking structure beam at rebar that is very faint and very deteriorated.

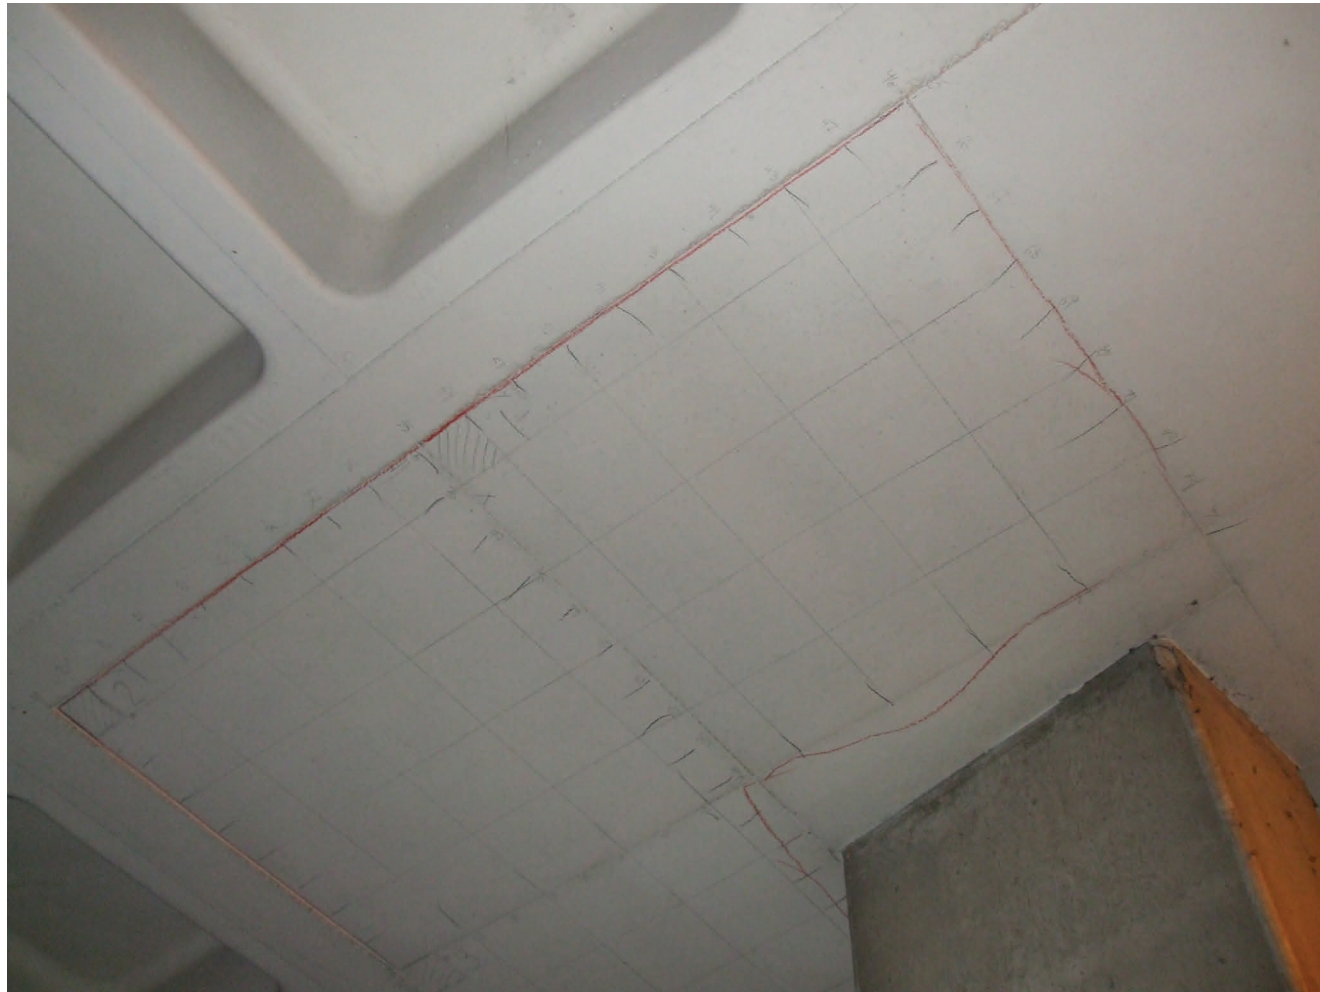
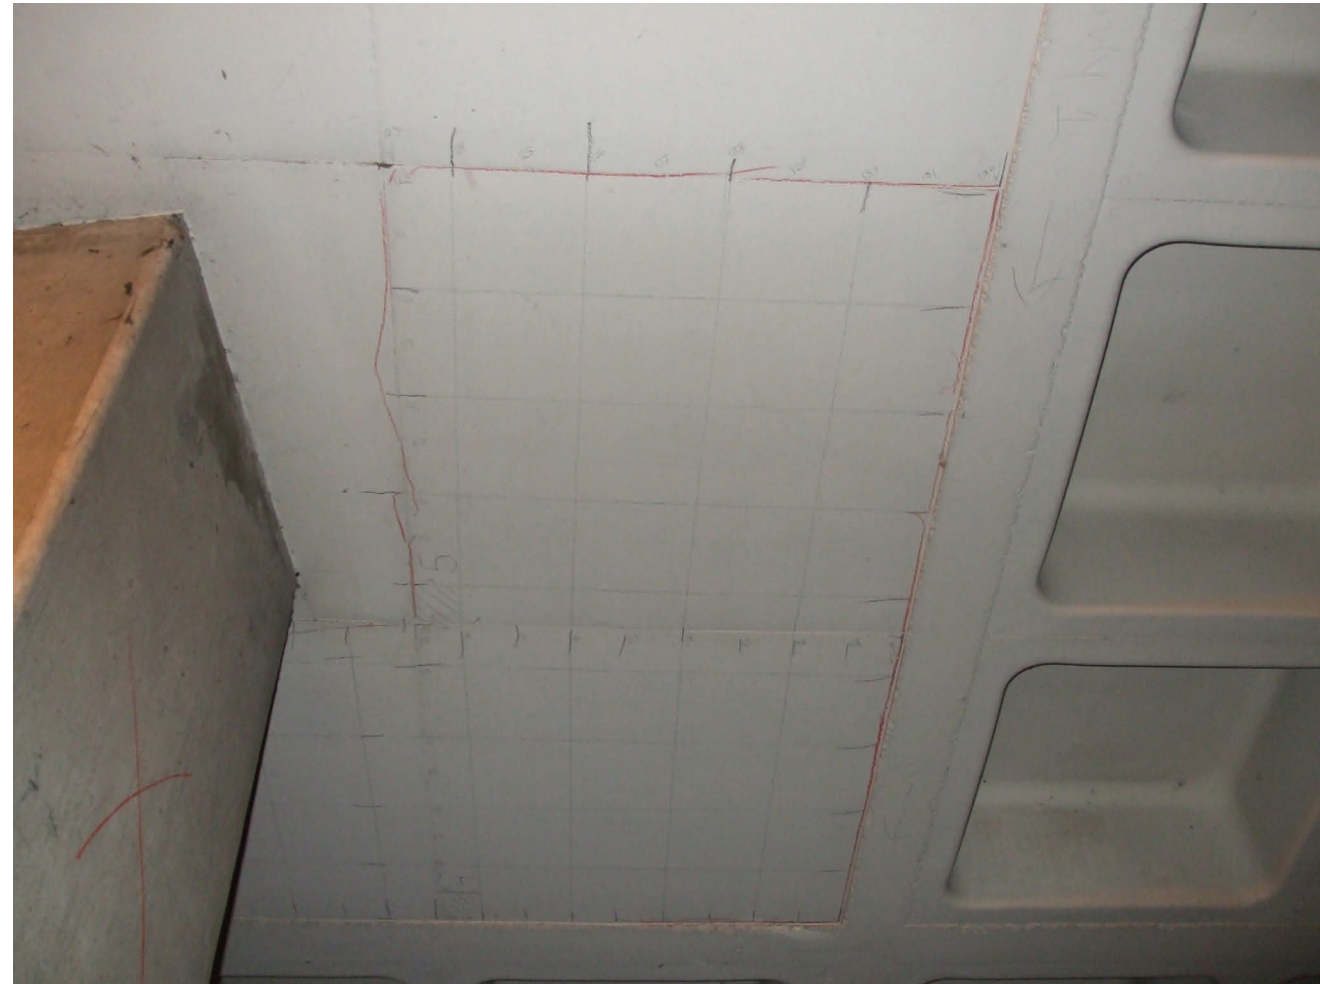
Column Cap Section 5th Floor West Side Looking Up to 6th Floor

Column cap at 5th floor looking up at 6th floor. See inset for location

Diagram of 3D combined grids.

Looking west

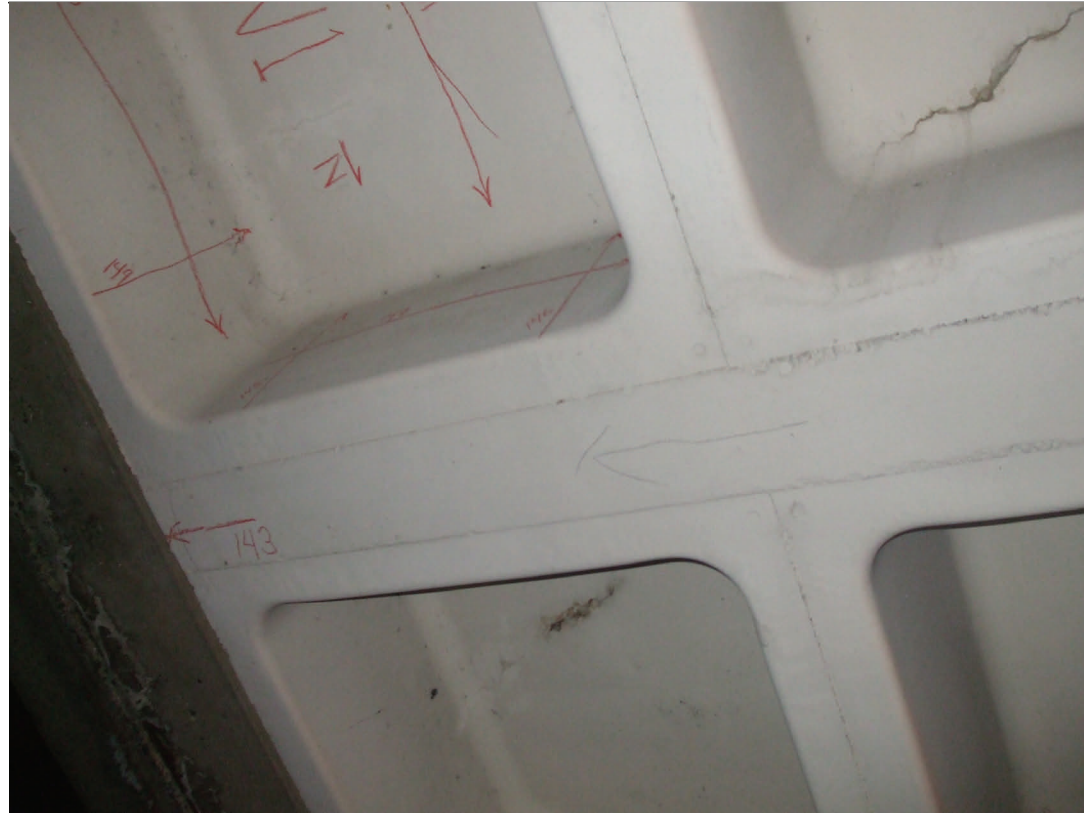
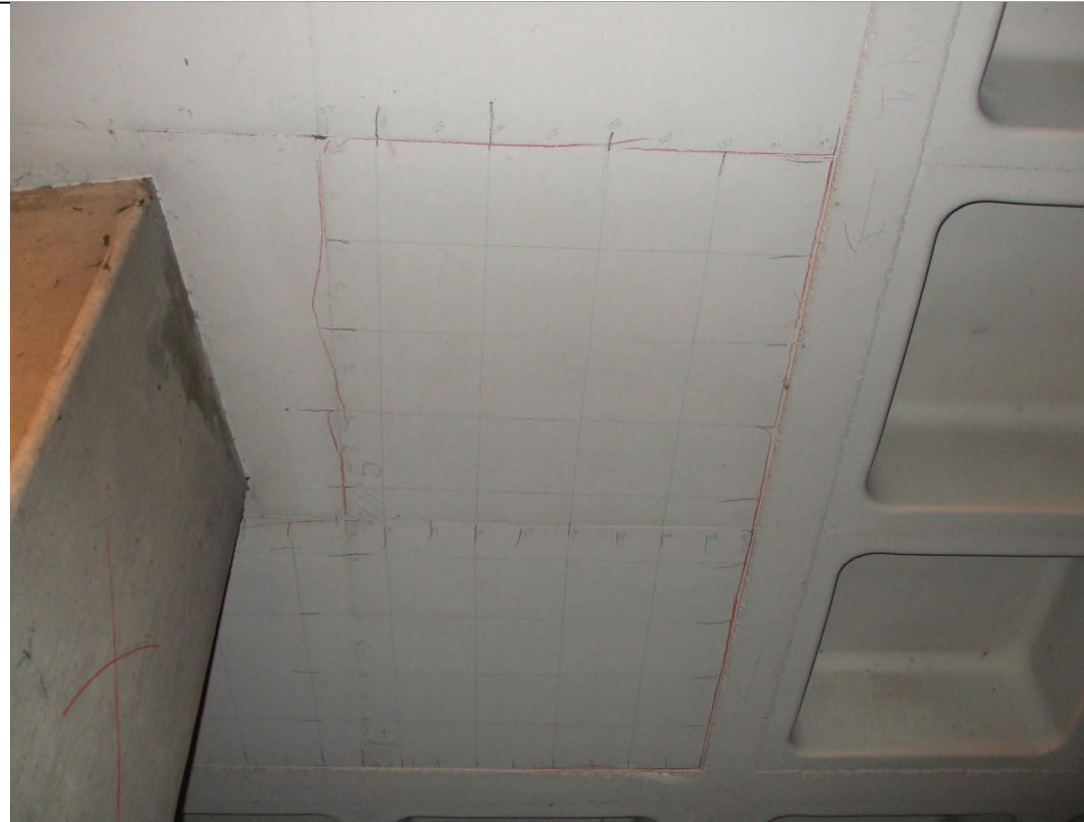
Waffle Panels 5th Floor West Side Looking Up

Waffles surveyed contained very little reinforcing except for the top 3-4". Sides of waffles contain 1 piece or in some cases no reinforcing.

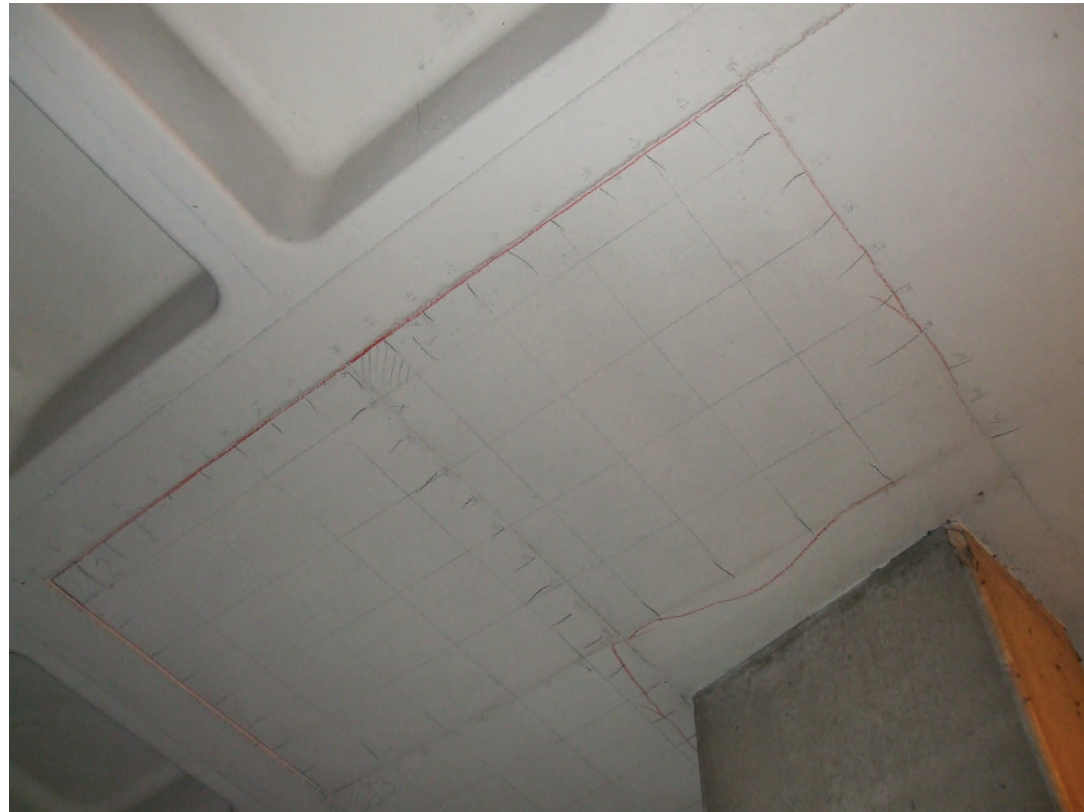
Scans below (148 and 149) show 2 pieces of rebar.

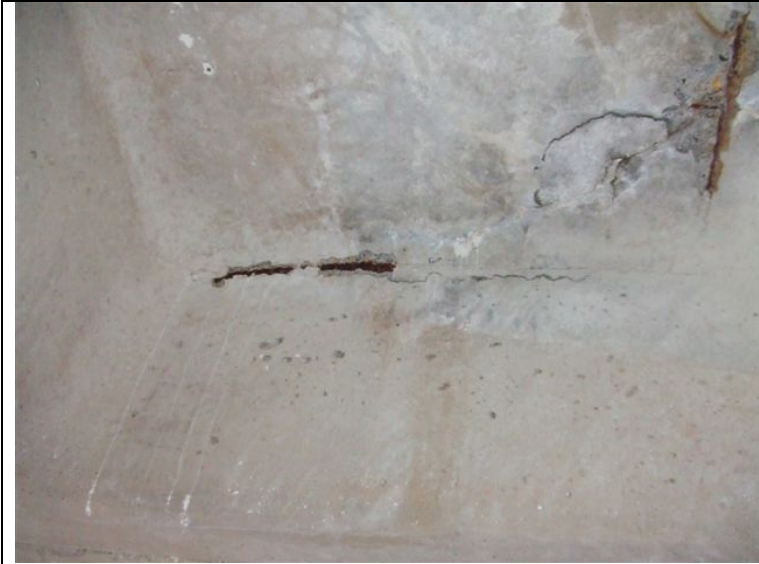
1636

THIRD FLOOR PHOTOS (SEE PLAN S-3 FOR LOCATION)
